Profile/Photo Observation Report

Date:	04/25/2018	Weather:		Coding:	PACP 6.0
Pipe Length (ft):		Owner:	City of Hobart	Pre Clean:	No Pre-Cleaning
P.O.#:	81	Surveyor:	M. Pielacha	PSR:	P-405-012-011
Customer:	City of Hobart	Clean Date:		Shape:	C

Street:	3rd Street	Flow Control:	Not Controlled
City:	Hobart, IN	Year Renewed:	
Location:	Light Highway	Tape/Media #:	DEP 81
Purpose:	Routine Assessment	Dia/Height:	15"
Use:	Sanitary	Material:	CP
Drain Area:		Lining:	
Category:	NA		
Comment:	YES501824 Submittal 2		
Location Details:		Direction of Survey:	Downstream
US MH:	M-405-012	DS MH:	M-405-011
		Total Length Surveyed (ft):	111.1

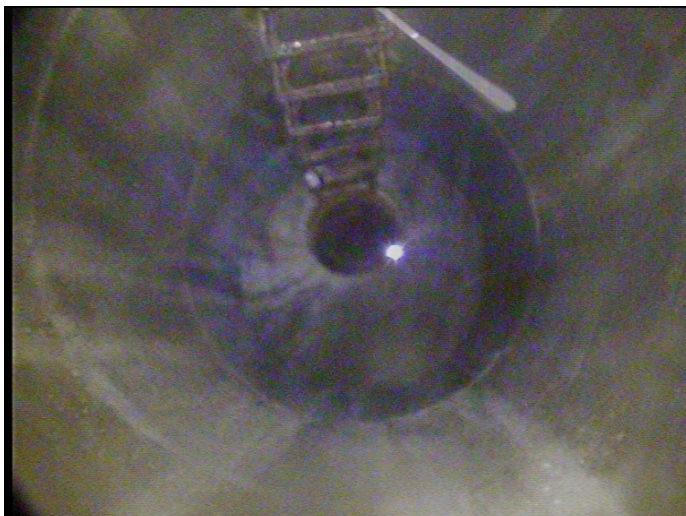
Code: **AMH**
Description: **Manhole**

Distance (ft): **.0**
Structural Grade: **0**
O&M Grade: **0**
Clock Start/From:
Clock To:
1st Value:
2nd Value:
Value Percent:
Continuous Index:
Within 8" of Joint: **NO**
Remarks: **M-405-012**

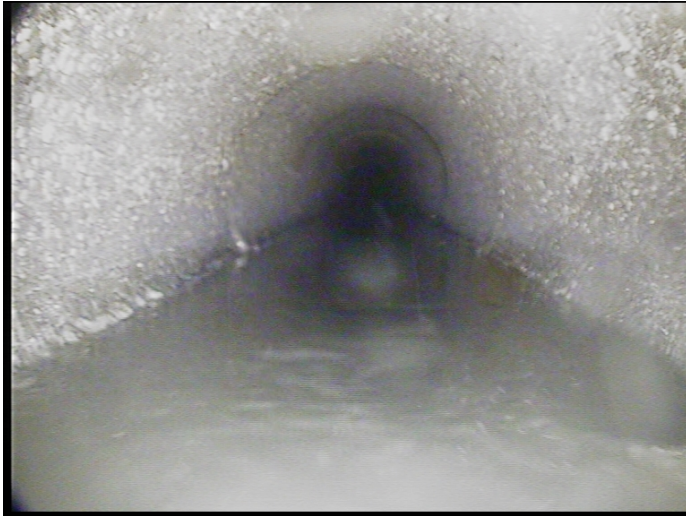
Code: **MWL**
Description: **Water Level**

Distance (ft): **.0**
Structural Grade: **0**
O&M Grade: **0**
Clock Start/From:
Clock To:
1st Value:
2nd Value:
Value Percent: **10.000**
Continuous Index:
Within 8" of Joint: **NO**
Remarks:

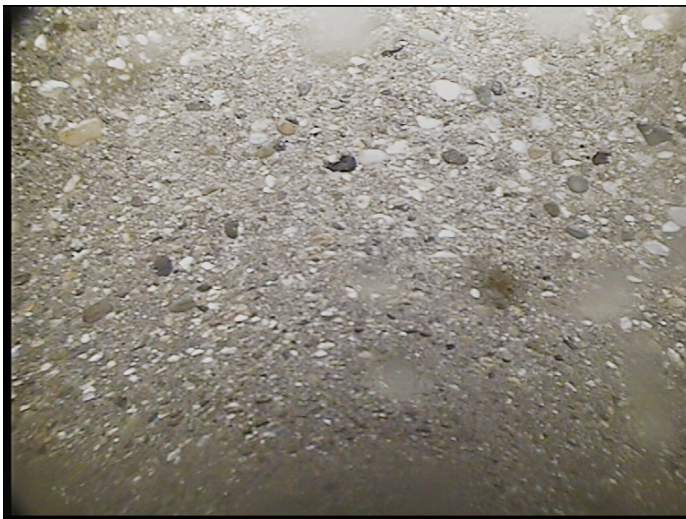
Code: **SAV**
Description: **Surface Aggregate Visible**

Distance (ft): **3.2**
Structural Grade: **3**
O&M Grade: **0**
Clock Start/From: **8**
Clock To: **4**
1st Value:
2nd Value:
Value Percent:
Continuous Index: **S01**
Within 8" of Joint: **YES**
Remarks:

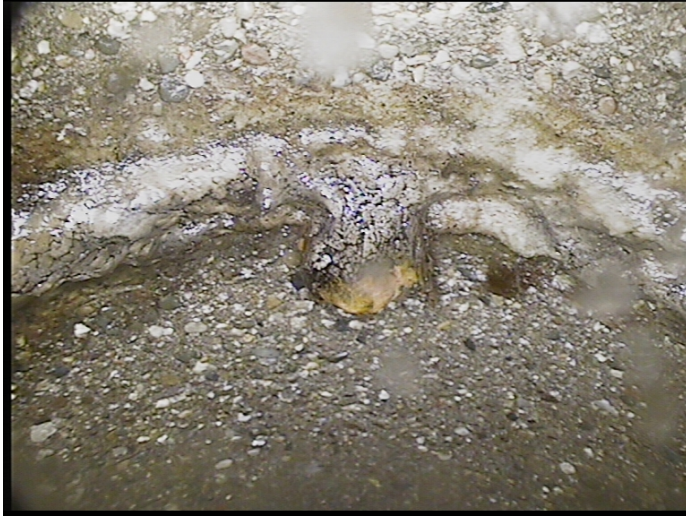
Code:	ID
Description:	Infil Dripper
Distance (ft):	48.4
Structural Grade:	0
O&M Grade:	3
Clock Start/From:	12
Clock To:	
1st Value:	
2nd Value:	
Value Percent:	
Continuous Index:	
Within 8" of Joint:	YES
Remarks:

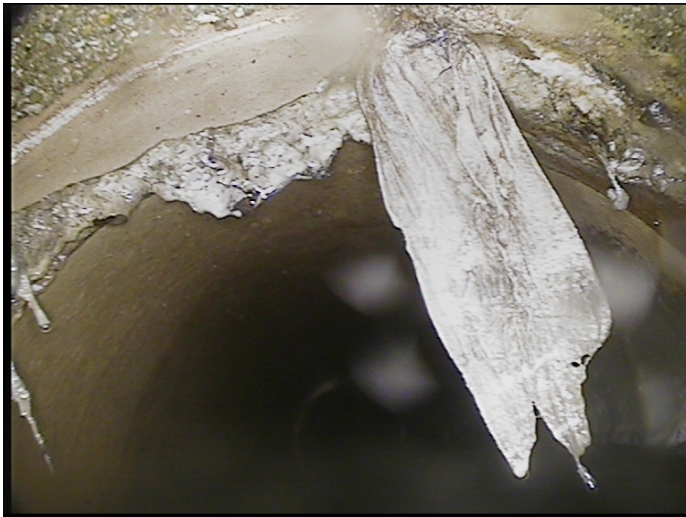
Code:	DAR
Description:	Deposits Attached Ragging
Distance (ft):	54.2
Structural Grade:	0
O&M Grade:	2
Clock Start/From:	12
Clock To:	2
1st Value:	
2nd Value:	
Value Percent:	5.000
Continuous Index:	
Within 8" of Joint:	YES
Remarks:

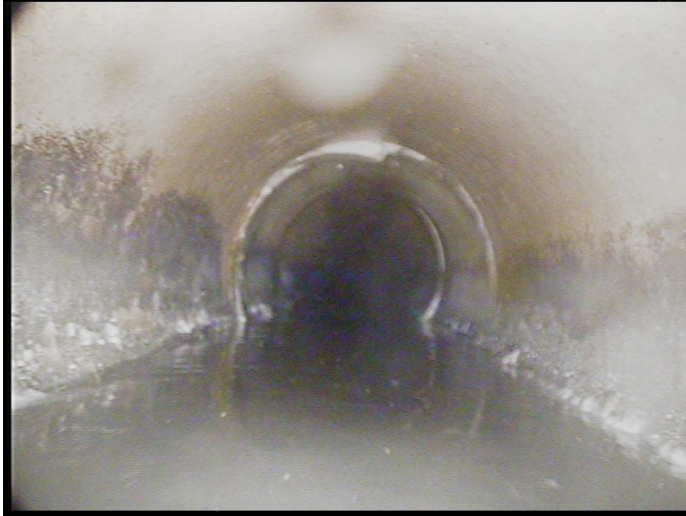
Code: **SAV**
Description: **Surface Aggregate Visible**

Distance (ft): **58.9**
Structural Grade: **3**
O&M Grade: **0**
Clock Start/From: **8**
Clock To: **4**
1st Value:
2nd Value:
Value Percent:
Continuous Index: **F01**
Within 8" of Joint: **NO**
Remarks:

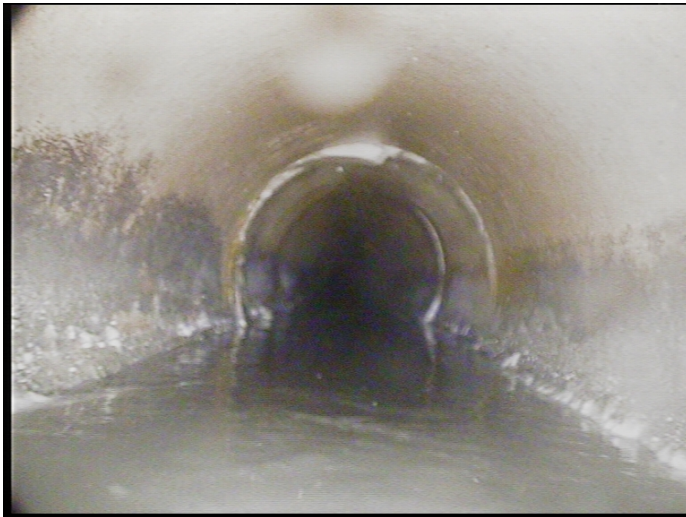
Code: **MMC**
Description: **Material Change**

Distance (ft): **58.9**
Structural Grade: **0**
O&M Grade: **0**
Clock Start/From:
Clock To:
1st Value:
2nd Value:
Value Percent:
Continuous Index:
Within 8" of Joint: **NO**
Remarks: **vcp**

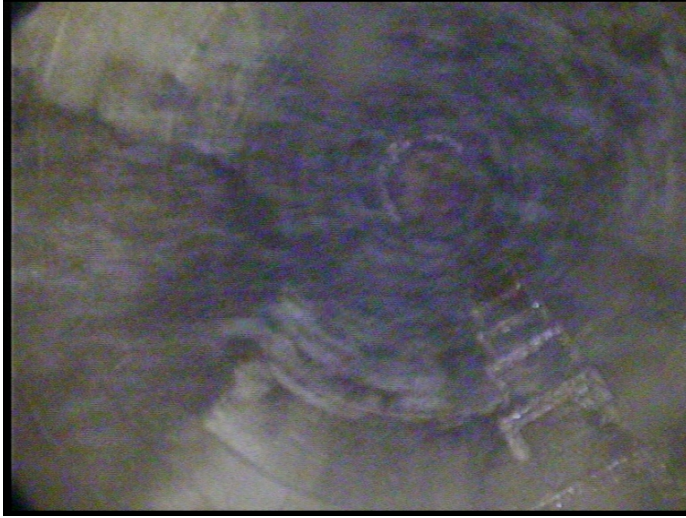
Code:	AMH
Description:	Manhole
Distance (ft):	111.1
Structural Grade:	0
O&M Grade:	0
Clock Start/From:	
Clock To:	
1st Value:	
2nd Value:	
Value Percent:	
Continuous Index:	
Within 8" of Joint:	NO
Remarks:	M-405-011
