Profile/Photo Observation Report

Date:	02/15/2024	Weather:		Coding:	PACP 7.0
Pipe Length (ft):	63.0	Owner:	City of Hobart	Pre Clean:	Heavy Cleaning
P.O.#:	YES502259	Surveyor:	S. Bucklin	PSR:	P-405-013-012
Customer:	City of Hobart	Clean Date:	03/15/2023	Shape:	C

Street:	LASALLE PL	Flow Control:	Not Controlled
City:	Hobart, IN	Year Renewed:	
Location:	Easement/Right of Way	Tape/Media #:	
Purpose:	Routine Assessment	Dia/Height:	8"
Use:	Sanitary Sewage Pipe	Material:	DIP
Drain Area:		Lining:	None
Category:	NA		
Comment:			
Location Details:		Direction of Survey:	Downstream
US MH:	M-405-012	DS MH:	M-405-013
		Total Length Surveyed (ft):	65.2

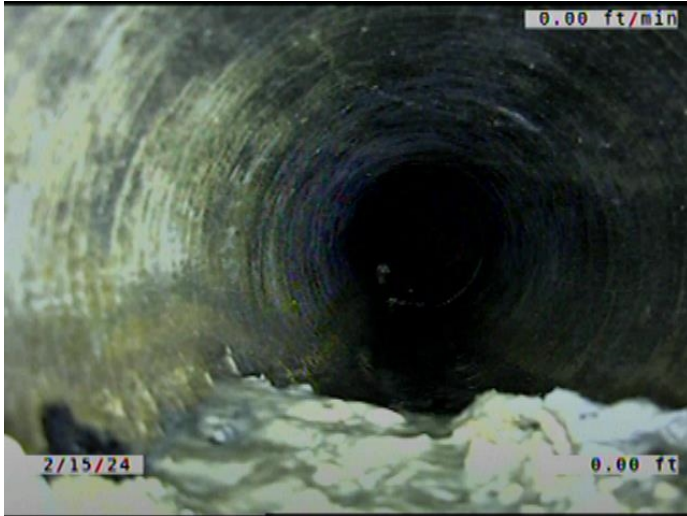
Code: **MWL**
Description: **Miscellaneous Water Level**

Distance (ft): **.0**
Structural Grade: **0**
O&M Grade: **0**
Clock Start/From:
Clock To:
1st Value:
2nd Value:
Value Percent: **5.000**
Continuous Index:
Within 8" of Joint: **NO**
Remarks:

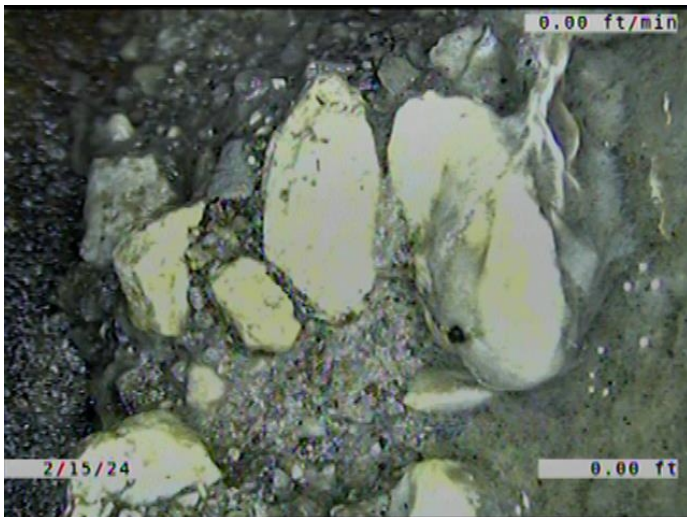
Code: **DSC**
Description: **Deposits Settled Hard/Compacted**

Distance (ft): **.0**
Structural Grade: **0**
O&M Grade: **2**
Clock Start/From: **5**
Clock To: **7**
1st Value:
2nd Value:
Value Percent: **10.000**
Continuous Index: **S01**
Within 8" of Joint: **YES**
Remarks: **CONCRETE FROM WHEN THE BENCH AND CHANNEL WAS BUILT.**

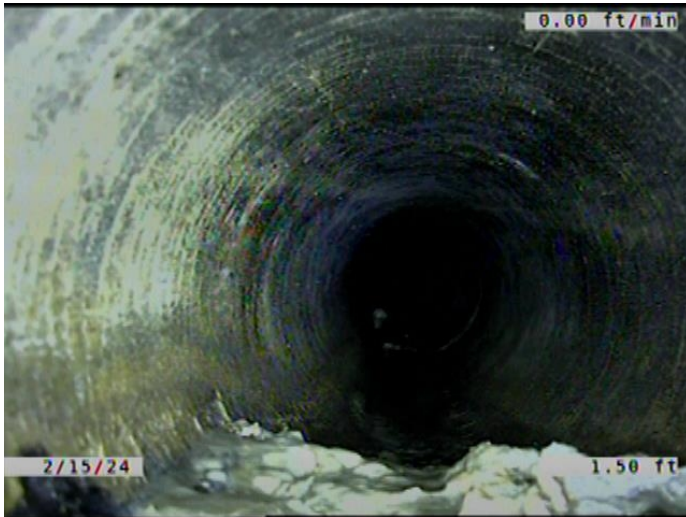
Code: **MGO**
Description: **Miscellaneous General Observation**

Distance (ft): **1.5**
Structural Grade: **0**
O&M Grade: **0**
Clock Start/From:
Clock To:
1st Value:
2nd Value:
Value Percent:
Continuous Index:
Within 8" of Joint: **NO**
Remarks: **TIGHT ACCESS IN THE MANHOLE.
HAD TO START IN THE PIPE.**

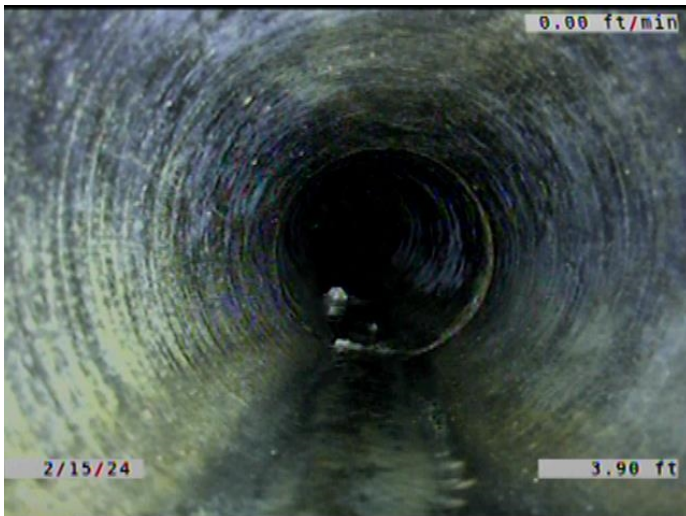
Code: **DSC**
Description: **Deposits Settled Hard/Compacted**

Distance (ft): **3.9**
Structural Grade: **0**
O&M Grade: **2**
Clock Start/From: **5**
Clock To: **7**
1st Value:
2nd Value:
Value Percent: **10.000**
Continuous Index: **F01**
Within 8" of Joint: **YES**
Remarks: **CONCRETE FROM WHEN THE BENCH
AND CHANNEL WAS BUILT.**

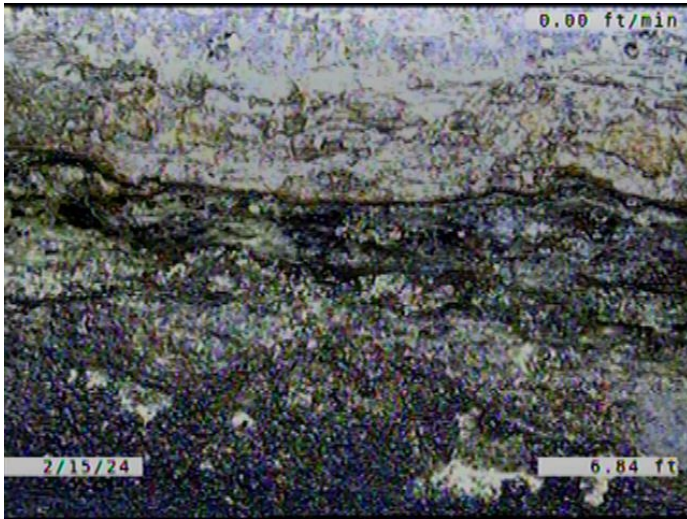
Code:	SSC
Description:	Surface Spalling of Damage Coating
Distance (ft):	6.8
Structural Grade:	1
O&M Grade:	0
Clock Start/From:	7
Clock To:	5
1st Value:	
2nd Value:	
Value Percent:	
Continuous Index:	
Within 8" of Joint:	YES
Remarks:

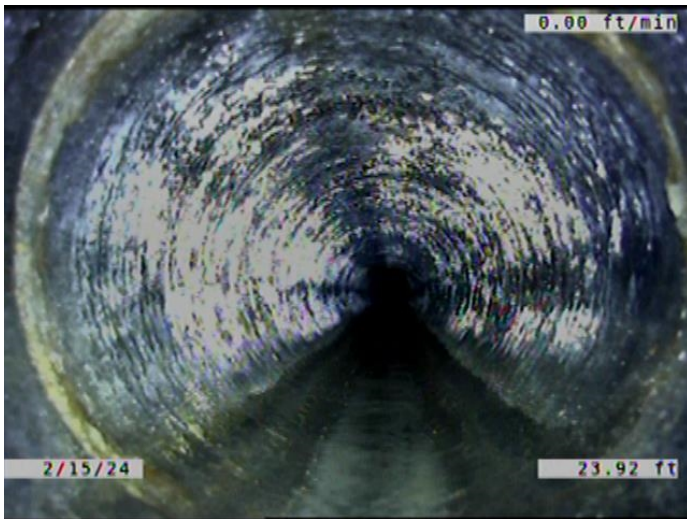
Code:	LRD
Description:	Line Right Down
Distance (ft):	23.9
Structural Grade:	0
O&M Grade:	2
Clock Start/From:	
Clock To:	
1st Value:	
2nd Value:	
Value Percent:	15.000
Continuous Index:	
Within 8" of Joint:	NO
Remarks:

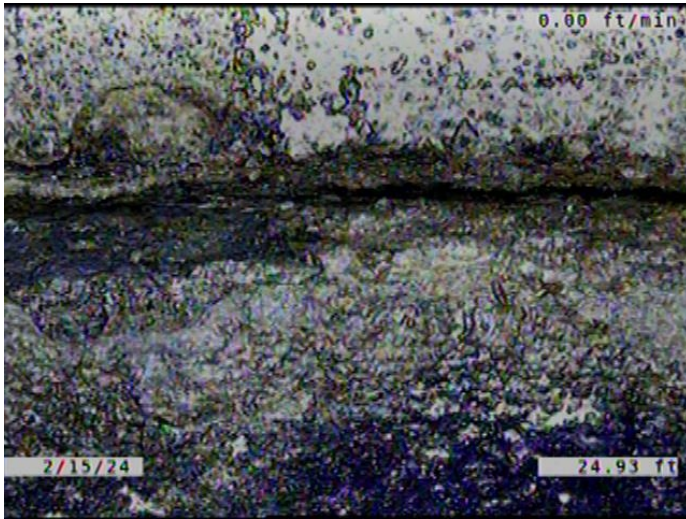
Code: **SSC**
Description: **Surface Spalling of Damage Coating**

Distance (ft): **24.9**
Structural Grade: **1**
O&M Grade: **0**
Clock Start/From: **7**
Clock To: **5**
1st Value:
2nd Value:
Value Percent:
Continuous Index:
Within 8" of Joint: **YES**
Remarks:

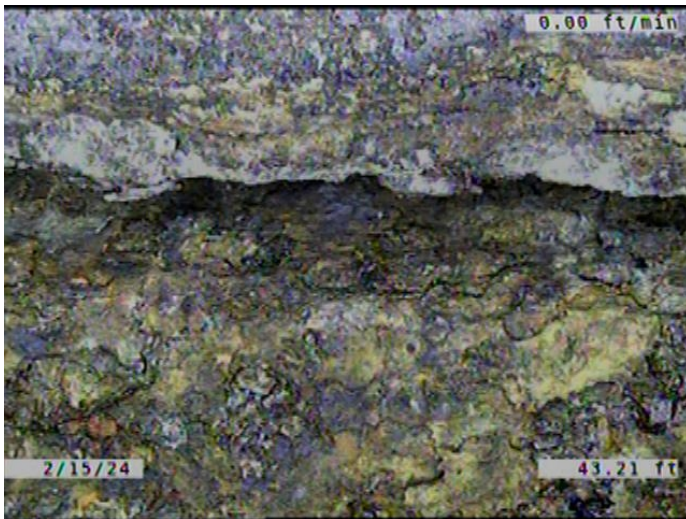
Code: **SSC**
Description: **Surface Spalling of Damage Coating**

Distance (ft): **43.2**
Structural Grade: **1**
O&M Grade: **0**
Clock Start/From: **7**
Clock To: **5**
1st Value:
2nd Value:
Value Percent:
Continuous Index: **S02**
Within 8" of Joint: **YES**
Remarks:

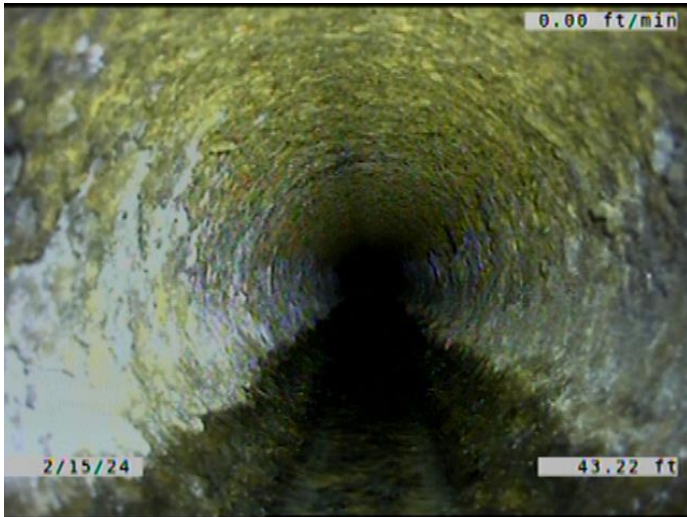
Code: **LD**
Description: **Line Down**

Distance (ft): **43.2**
Structural Grade: **0**
O&M Grade: **1**
Clock Start/From:
Clock To:
1st Value:
2nd Value:
Value Percent: **10.000**
Continuous Index:
Within 8" of Joint: **NO**
Remarks:

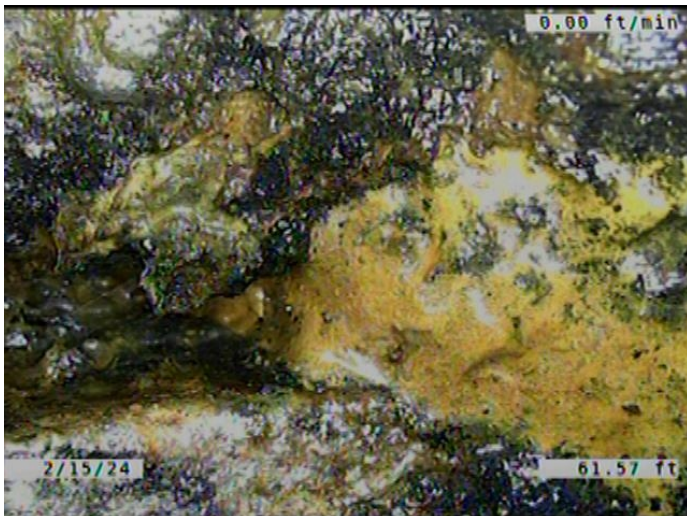
Code: **DAE**
Description: **Deposits Attached Encrustation**

Distance (ft): **61.6**
Structural Grade: **0**
O&M Grade: **2**
Clock Start/From: **7**
Clock To: **5**
1st Value:
2nd Value:
Value Percent: **5.000**
Continuous Index:
Within 8" of Joint: **YES**
Remarks:

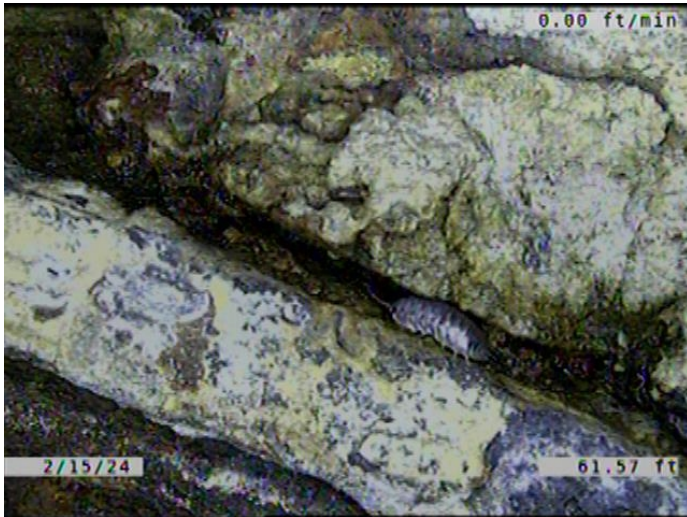
Code: **JAL**
Description: **Joint Angular Large**

Distance (ft): **61.6**
Structural Grade: **4**
O&M Grade: **0**
Clock Start/From:
Clock To:
1st Value:
2nd Value:
Value Percent:
Continuous Index:
Within 8" of Joint: **NO**
Remarks:

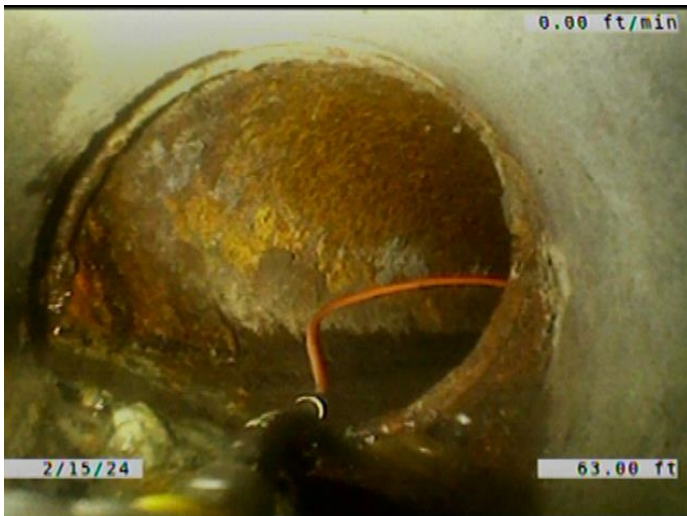
Code: **MGO**
Description: **Miscellaneous General Observation**

Distance (ft): **63.0**
Structural Grade: **0**
O&M Grade: **0**
Clock Start/From:
Clock To:
1st Value:
2nd Value:
Value Percent:
Continuous Index:
Within 8" of Joint: **NO**
Remarks: **ANGLED JOINT FROM THE OTHER SIDE. (REAR VIEW CAMERA).**

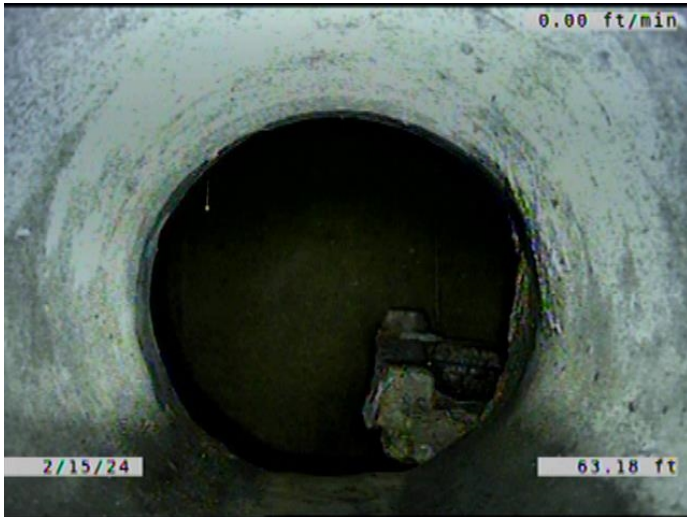
Code:	SSC
Description:	Surface Spalling of Damage Coating
Distance (ft):	63.2
Structural Grade:	1
O&M Grade:	0
Clock Start/From:	7
Clock To:	5
1st Value:	
2nd Value:	
Value Percent:	
Continuous Index:	F02
Within 8" of Joint:	YES
Remarks:
