Profile/Photo Observation Report

Date:	04/16/2018	Weather:		Coding:	PACP 6.0
Pipe Length (ft):	296.8	Owner:	NA	Pre Clean:	No Pre-Cleaning
P.O.#:		Surveyor:	Selasie Honu	PSR:	P-405-015-012
Customer:		Clean Date:	01/01/1900	Shape:	C

Street:	W 3RD ST	Flow Control:	Not Controlled
City:	Hobart, IN	Year Renewed:	
Location:	Yard	Tape/Media #:	
Purpose:	Routine Assessment	Dia/Height:	12"
Use:	Sanitary	Material:	VCP
Drain Area:	NA	Lining:	
Category:	NA		
Comment:	False MH_F, 15\" line. Flow direction is marked wrong.		
Location Details:		Direction of Survey:	Downstream
US MH:	M-405-012	DS MH:	M-405-015
		Total Length Surveyed (ft):	6.5

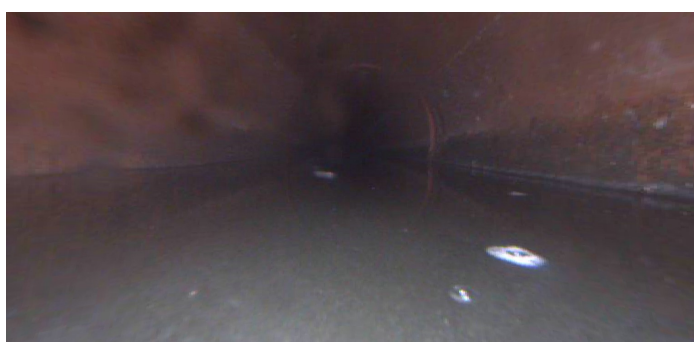
Code: **AMH**
Description: **Manhole**

Distance (ft): **.0**
Structural Grade: **0**
O&M Grade: **0**
Clock Start/From:
Clock To:
1st Value:
2nd Value:
Value Percent:
Continuous Index:
Within 8" of Joint: **NO**
Remarks: **M-405-012**

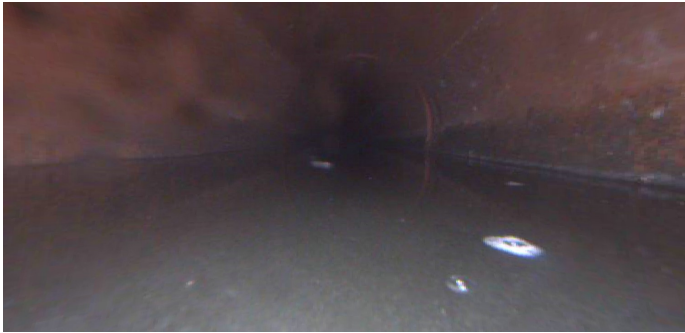
Code:	MWL
Description:	Water Level

Distance (ft):	.0
Structural Grade:	0
O&M Grade:	0
Clock Start/From:	
Clock To:	
1st Value:	
2nd Value:	
Value Percent:	5.000
Continuous Index:	
Within 8" of Joint:	NO
Remarks:

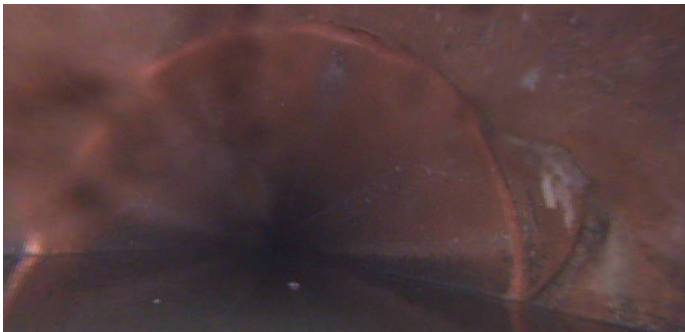
Code:	FC
Description:	Fracture Circumferential

Distance (ft):	2.7
Structural Grade:	2
O&M Grade:	0
Clock Start/From:	12
Clock To:	4
1st Value:	
2nd Value:	
Value Percent:	
Continuous Index:	
Within 8" of Joint:	YES
Remarks:

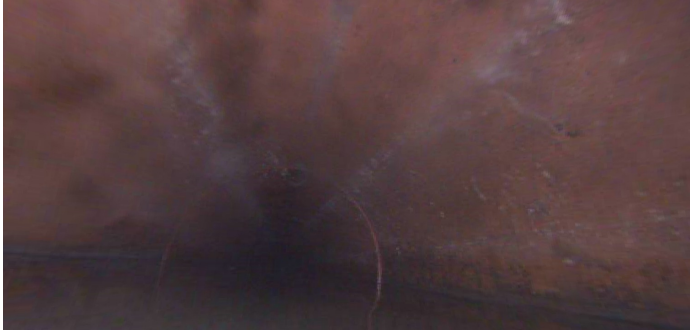
Code:	MSA
Description:	Abandoned Survey
Distance (ft):	6.5
Structural Grade:	0
O&M Grade:	0
Clock Start/From:	
Clock To:	
1st Value:	
2nd Value:	
Value Percent:	
Continuous Index:	
Within 8" of Joint:	NO
Remarks:	Debris under water
