Profile/Photo Observation Report

Street:	FOXCROFT STREET	Flow Control:	Not Controlled
City:	Hobart, IN	Year Renewed:	
Location:	Yard	Tape/Media #:	
Purpose:	Routine Assessment	Dia/Height:	12"
Use:	Sanitary	Material:	VCP
Drain Area:	NA	Lining:	
Category:	NA		
Comment:	False MH_F, 15\" line. Flow direction is marked wrong.		
Location Details:		Direction of Survey:	Downstream
US MH:	M-405-012	DS MH:	M-405-015
		Total Length Surveyed (ft):	6.5

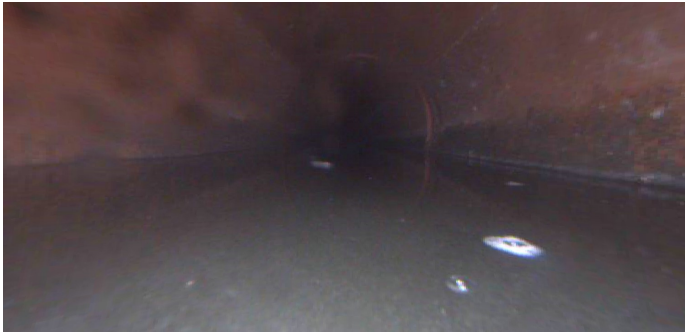
Code:	MWL
Description:	Water Level

Distance (ft):	.0
Structural Grade:	0
O&M Grade:	0
Clock Start/From:	
Clock To:	
1st Value:	
2nd Value:	
Value Percent:	5.000
Continuous Index:	
Within 8" of Joint:	NO
Remarks:

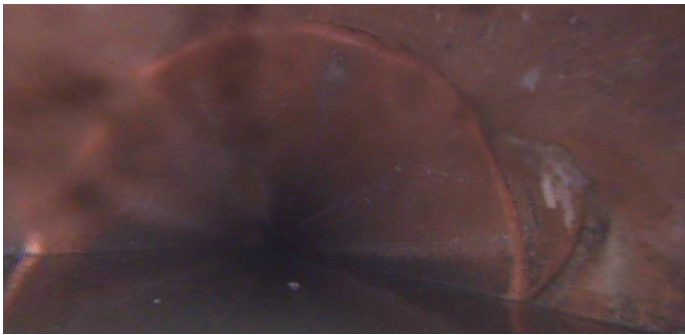
Code:	FC
Description:	Fracture Circumferential

Distance (ft):	2.7
Structural Grade:	2
O&M Grade:	0
Clock Start/From:	12
Clock To:	4
1st Value:	
2nd Value:	
Value Percent:	
Continuous Index:	
Within 8" of Joint:	YES
Remarks:

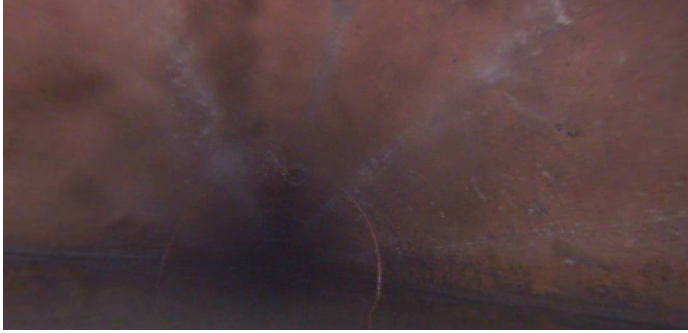
Code:	MSA
Description:	Abandoned Survey
Distance (ft):	6.5
Structural Grade:	0
O&M Grade:	0
Clock Start/From:	
Clock To:	
1st Value:	
2nd Value:	
Value Percent:	
Continuous Index:	
Within 8" of Joint:	NO
Remarks:	Debris under water
