Profile/Photo Observation Report

Date:	02/15/2024	Weather:		Coding:	PACP 7.0
Pipe Length (ft):	191.0	Owner:	City of Hobart	Pre Clean:	Heavy Cleaning
P.O.#:	YES502259	Surveyor:	S. Bucklin	PSR:	P-405-014.1-013
Customer:	City of Hobart	Clean Date:	03/15/2023	Shape:	C

Street:	LASALLE PL	Flow Control:	Not Controlled
City:	Hobart, IN	Year Renewed:	
Location:	Easement/Right of Way	Tape/Media #:	
Purpose:	Routine Assessment	Dia/Height:	8"
Use:	Sanitary Sewage Pipe	Material:	VCP
Drain Area:		Lining:	None
Category:	NA		
Comment:			
Location Details:		Direction of Survey:	Downstream
US MH:	M-405-014.1	DS MH:	M-405-013
		Total Length Surveyed (ft):	191.1

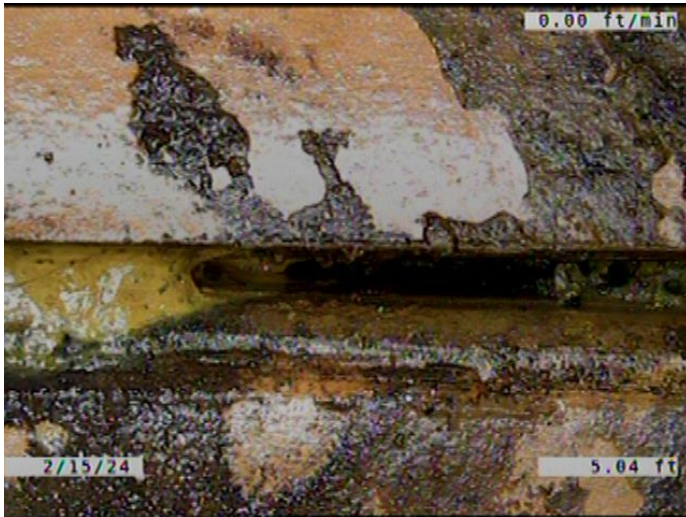
Code: **DAE**
Description: **Deposits Attached Encrustation**

Distance (ft): **5.0**
Structural Grade: **0**
O&M Grade: **2**
Clock Start/From: **7**
Clock To: **5**
1st Value:
2nd Value:
Value Percent: **5.000**
Continuous Index: **S01**
Within 8" of Joint: **YES**
Remarks:

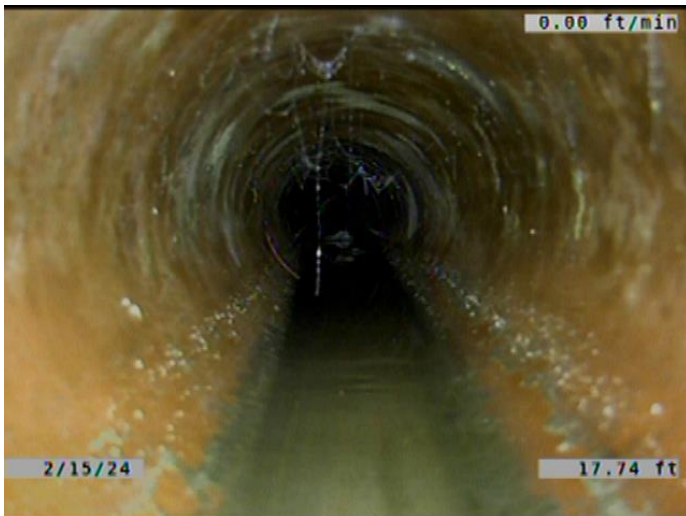
Code: **MWLS**
Description: **Miscellaneous Water Level Sag**

Distance (ft): **17.7**
Structural Grade: **2**
O&M Grade: **0**
Clock Start/From:
Clock To:
1st Value:
2nd Value:
Value Percent: **10.000**
Continuous Index: **S02**
Within 8" of Joint: **NO**
Remarks:

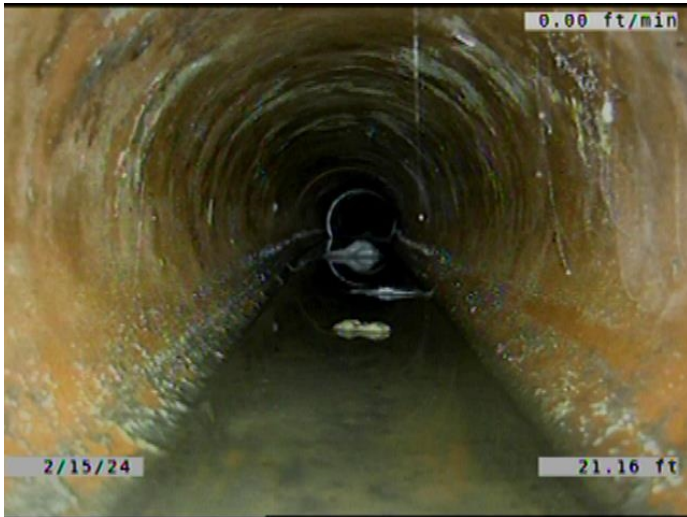
Code: **DSF**
Description: **Deposits Settled Fine**

Distance (ft): **21.2**
Structural Grade: **0**
O&M Grade: **2**
Clock Start/From: **5**
Clock To: **7**
1st Value:
2nd Value:
Value Percent: **5.000**
Continuous Index: **S03**
Within 8" of Joint: **YES**
Remarks:

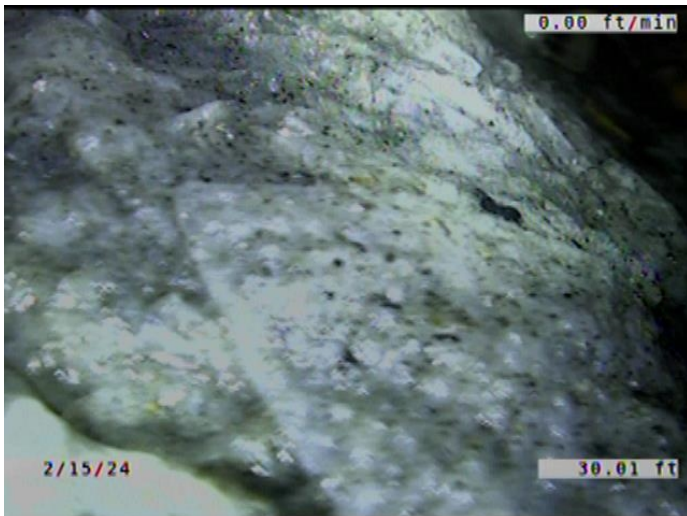
Code: **DAR**
Description: **Deposits Attached Ragging**

Distance (ft): **30.0**
Structural Grade: **0**
O&M Grade: **2**
Clock Start/From: **4**
Clock To: **8**
1st Value:
2nd Value:
Value Percent: **10.000**
Continuous Index:
Within 8" of Joint: **YES**
Remarks:

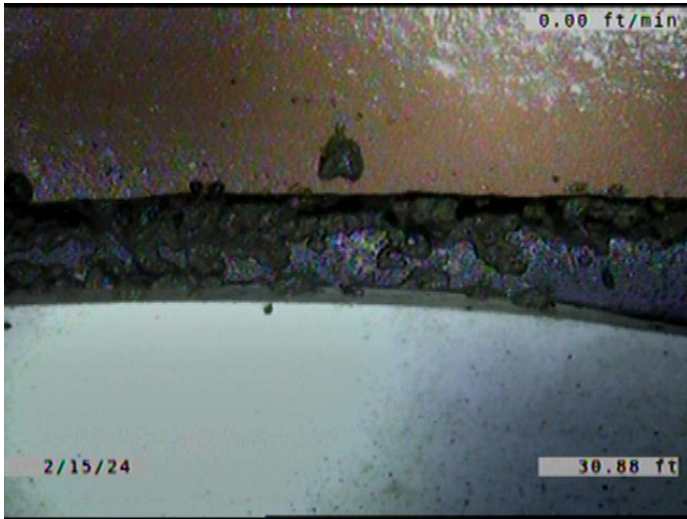
Code: **RPR**
Description: **Point Repair Replacement**

Distance (ft): **30.9**
Structural Grade: **0**
O&M Grade: **0**
Clock Start/From:
Clock To:
1st Value:
2nd Value:
Value Percent:
Continuous Index: **S04**
Within 8" of Joint: **YES**
Remarks: **REPLACED WITH PVC**

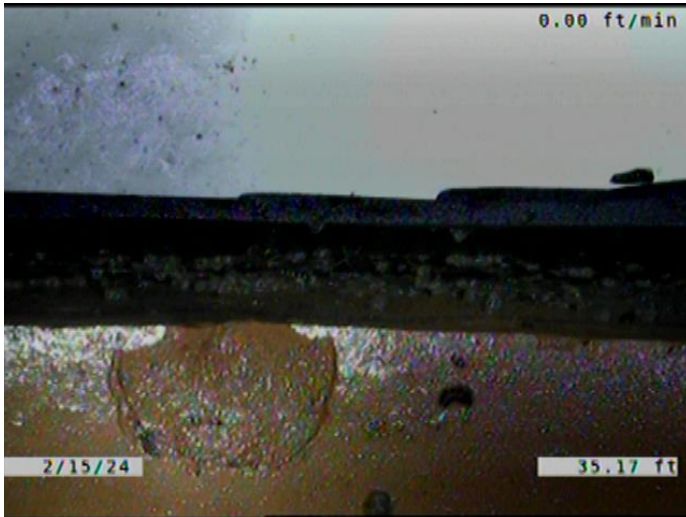
Code: **RPR**
Description: **Point Repair Replacement**

Distance (ft): **35.2**
Structural Grade: **0**
O&M Grade: **0**
Clock Start/From:
Clock To:
1st Value:
2nd Value:
Value Percent:
Continuous Index: **F04**
Within 8" of Joint: **YES**
Remarks: **REPLACED WITH PVC**

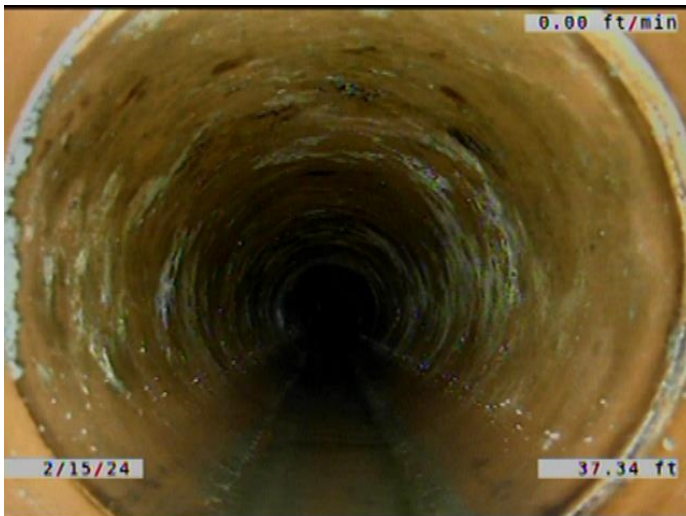
Code: **MWLS**
Description: **Miscellaneous Water Level Sag**

Distance (ft): **37.3**
Structural Grade: **2**
O&M Grade: **0**
Clock Start/From:
Clock To:
1st Value:
2nd Value:
Value Percent: **10.000**
Continuous Index: **F02**
Within 8" of Joint: **NO**
Remarks:

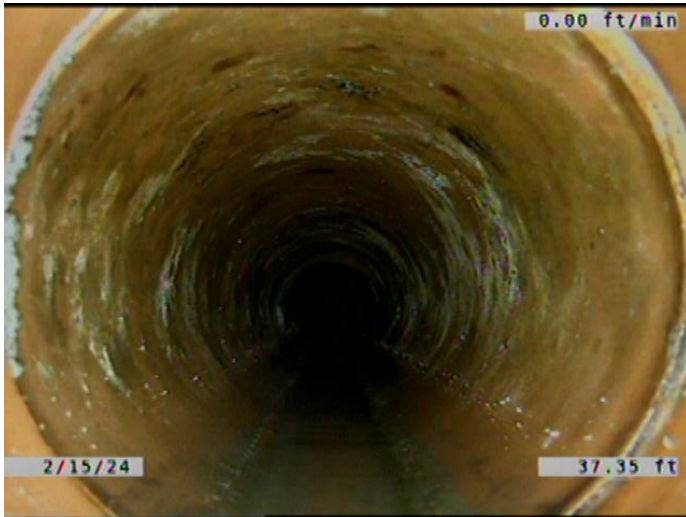
Code: **DSF**
Description: **Deposits Settled Fine**

Distance (ft): **37.3**
Structural Grade: **0**
O&M Grade: **2**
Clock Start/From: **5**
Clock To: **7**
1st Value:
2nd Value:
Value Percent: **5.000**
Continuous Index: **F03**
Within 8" of Joint: **YES**
Remarks:

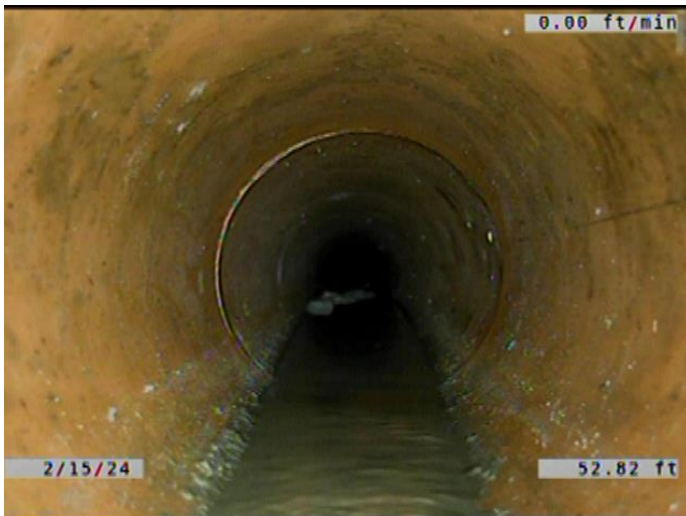
Code: **MWLS**
Description: **Miscellaneous Water Level Sag**

Distance (ft): **52.8**
Structural Grade: **2**
O&M Grade: **0**
Clock Start/From:
Clock To:
1st Value:
2nd Value:
Value Percent: **15.000**
Continuous Index: **S05**
Within 8" of Joint: **NO**
Remarks:

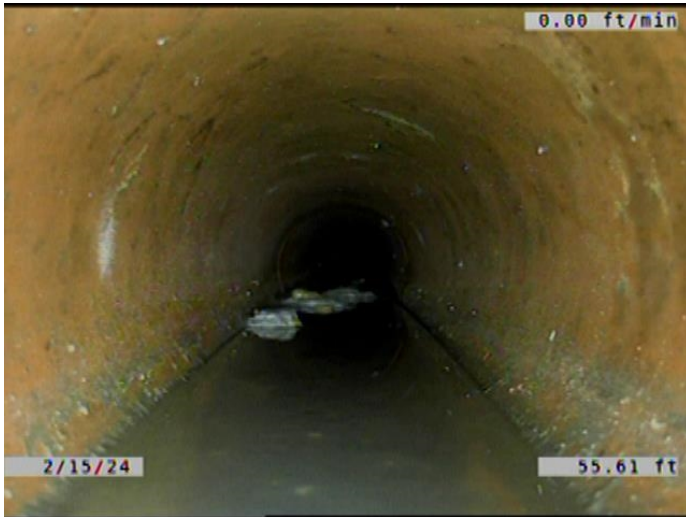
Code: **DSF**
Description: **Deposits Settled Fine**

Distance (ft): **55.6**
Structural Grade: **0**
O&M Grade: **2**
Clock Start/From: **5**
Clock To: **7**
1st Value:
2nd Value:
Value Percent: **5.000**
Continuous Index: **S06**
Within 8" of Joint: **YES**
Remarks:

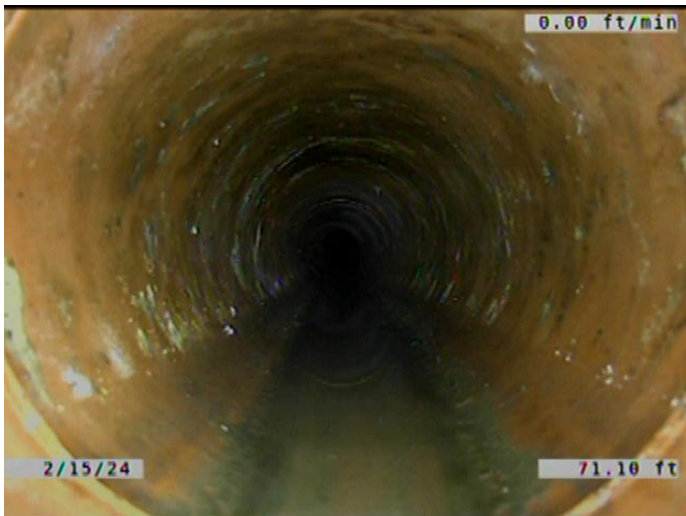
Code: **MWLS**
Description: **Miscellaneous Water Level Sag**

Distance (ft): **71.1**
Structural Grade: **2**
O&M Grade: **0**
Clock Start/From:
Clock To:
1st Value:
2nd Value:
Value Percent: **15.000**
Continuous Index: **F05**
Within 8" of Joint: **NO**
Remarks:

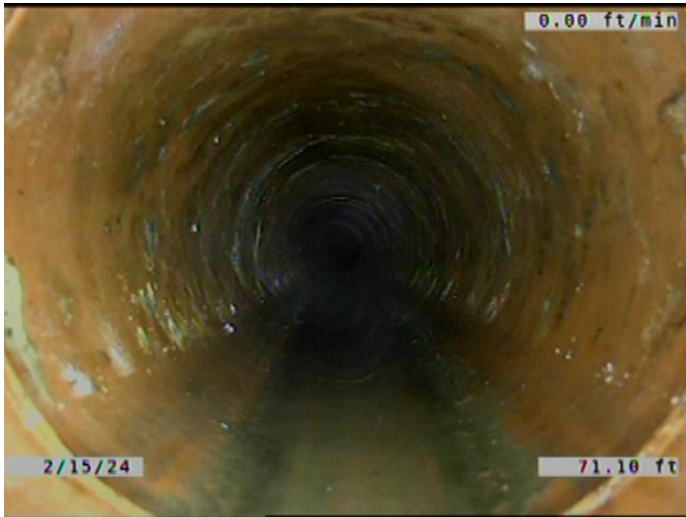
Code: **DSF**
Description: **Deposits Settled Fine**

Distance (ft): **71.1**
Structural Grade: **0**
O&M Grade: **2**
Clock Start/From: **5**
Clock To: **7**
1st Value:
2nd Value:
Value Percent: **5.000**
Continuous Index: **F06**
Within 8" of Joint: **YES**
Remarks:

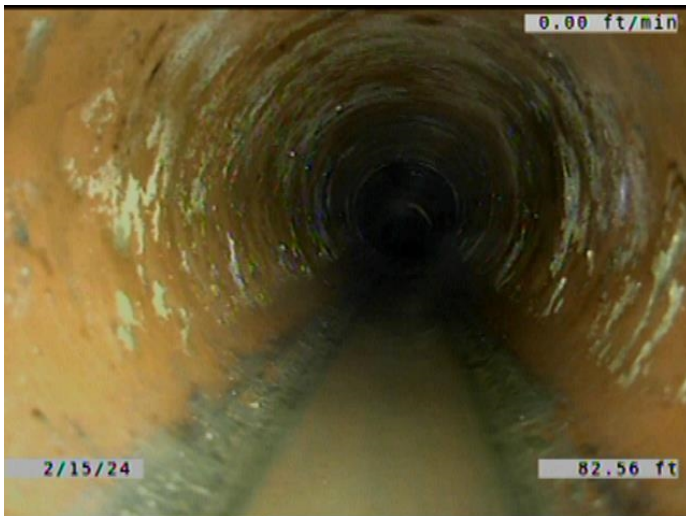
Code: **LR**
Description: **Line Right**

Distance (ft): **82.6**
Structural Grade: **0**
O&M Grade: **1**
Clock Start/From:
Clock To:
1st Value:
2nd Value:
Value Percent: **5.000**
Continuous Index:
Within 8" of Joint: **NO**
Remarks:

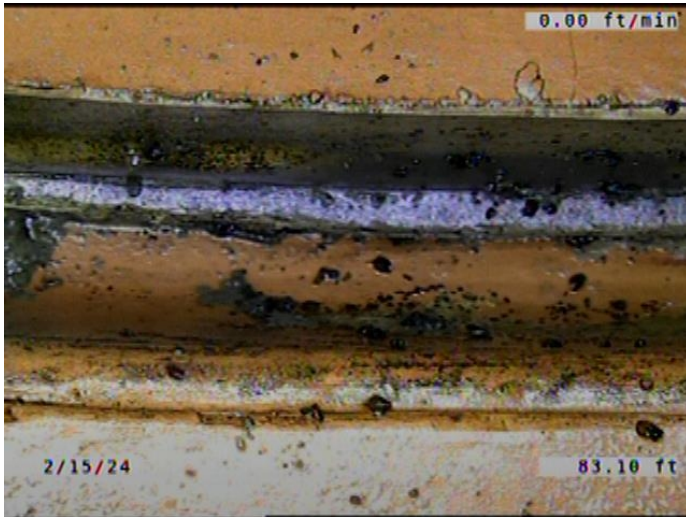
Code: **JAM**
Description: **Joint Angular Medium**

Distance (ft): **83.1**
Structural Grade: **3**
O&M Grade: **0**
Clock Start/From:
Clock To:
1st Value:
2nd Value:
Value Percent:
Continuous Index:
Within 8" of Joint: **NO**
Remarks:

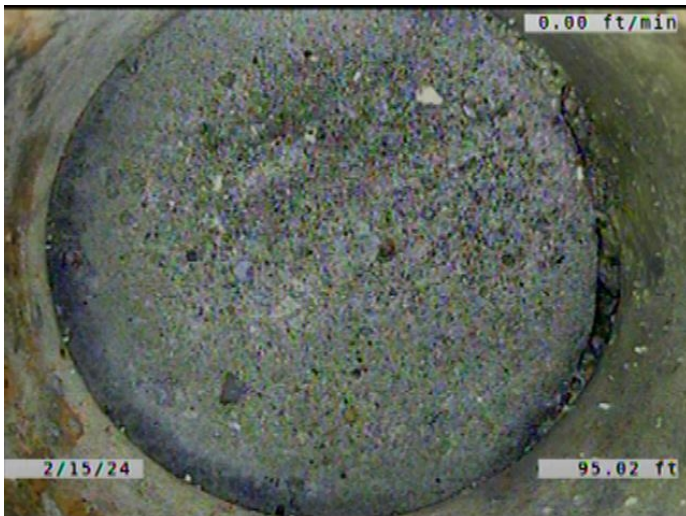
Code: **TFD**
Description: **Tap Factory Defective**

Distance (ft): **95.0**
Structural Grade: **0**
O&M Grade: **3**
Clock Start/From: **1**
Clock To:
1st Value: **6.000**
2nd Value:
Value Percent:
Continuous Index:
Within 8" of Joint: **YES**
Remarks: **CAPPED. ENCRUSTATION COMING AROUND THE CAP INTO THE MAIN.**

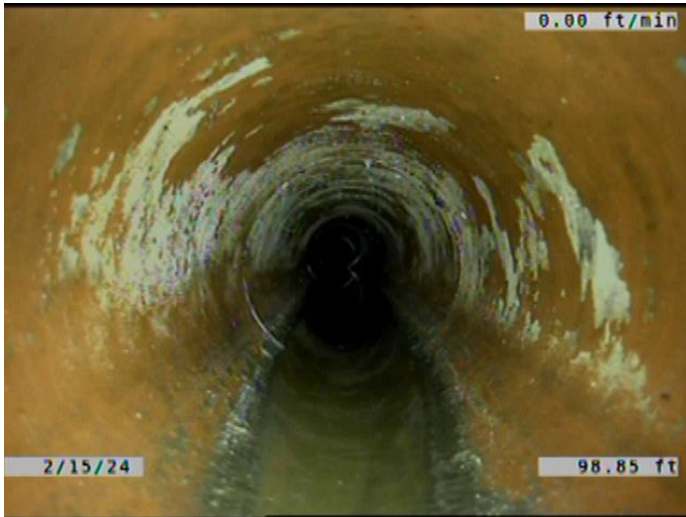
Code: **MWLS**
Description: **Miscellaneous Water Level Sag**

Distance (ft): **98.9**
Structural Grade: **2**
O&M Grade: **0**
Clock Start/From:
Clock To:
1st Value:
2nd Value:
Value Percent: **10.000**
Continuous Index: **S07**
Within 8" of Joint: **NO**
Remarks:

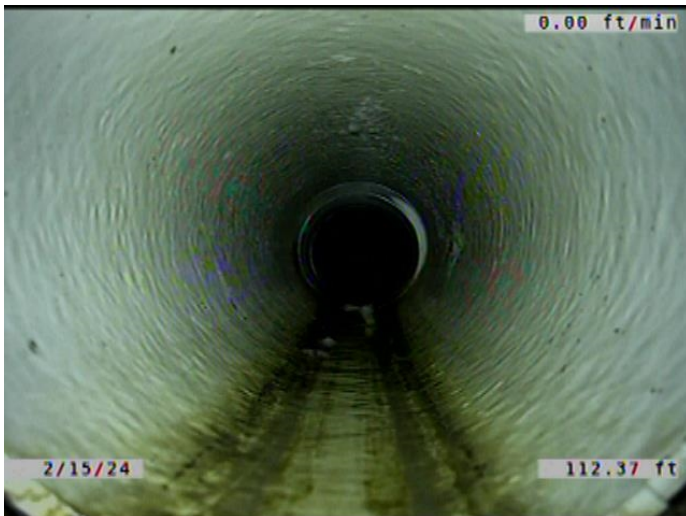
Code: **MWLS**
Description: **Miscellaneous Water Level Sag**

Distance (ft): **112.4**
Structural Grade: **2**
O&M Grade: **0**
Clock Start/From:
Clock To:
1st Value:
2nd Value:
Value Percent: **10.000**
Continuous Index: **F07**
Within 8" of Joint: **NO**
Remarks:

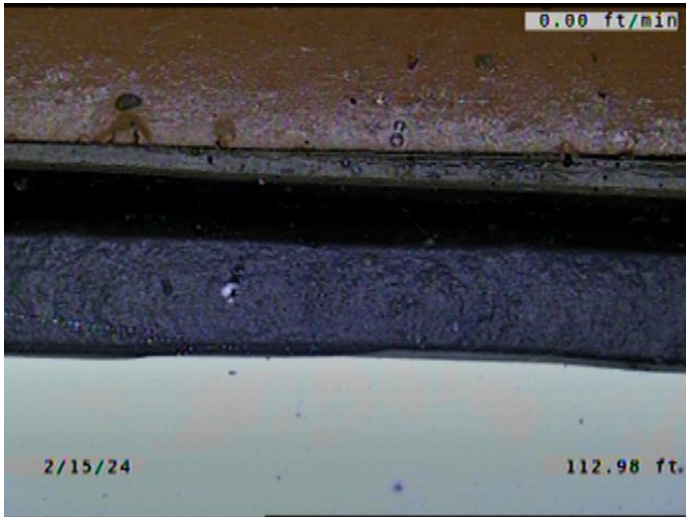
Code: **RPR**
Description: **Point Repair Replacement**

Distance (ft): **113.0**
Structural Grade: **0**
O&M Grade: **0**
Clock Start/From:
Clock To:
1st Value:
2nd Value:
Value Percent:
Continuous Index: **S08**
Within 8" of Joint: **YES**
Remarks: **REPLACED WITH PVC.**

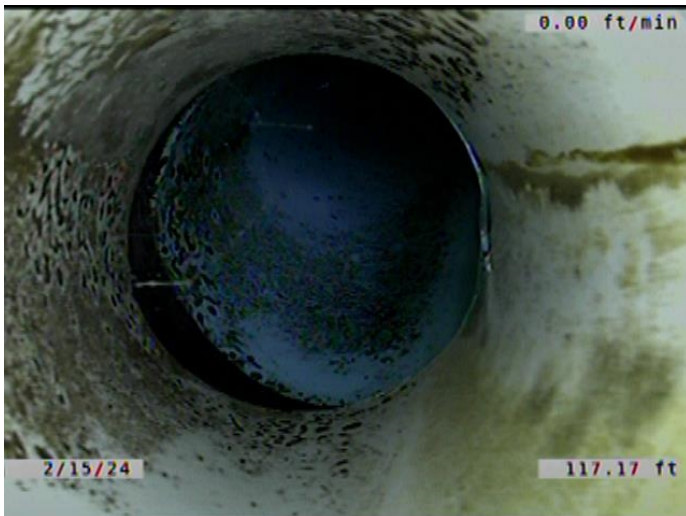
Code: **TF**
Description: **Tap Factory**

Distance (ft): **117.2**
Structural Grade: **0**
O&M Grade: **0**
Clock Start/From: **3**
Clock To:
1st Value: **6.000**
2nd Value:
Value Percent:
Continuous Index:
Within 8" of Joint: **YES**
Remarks: **CONSTANTLY RUNNING WATER.**

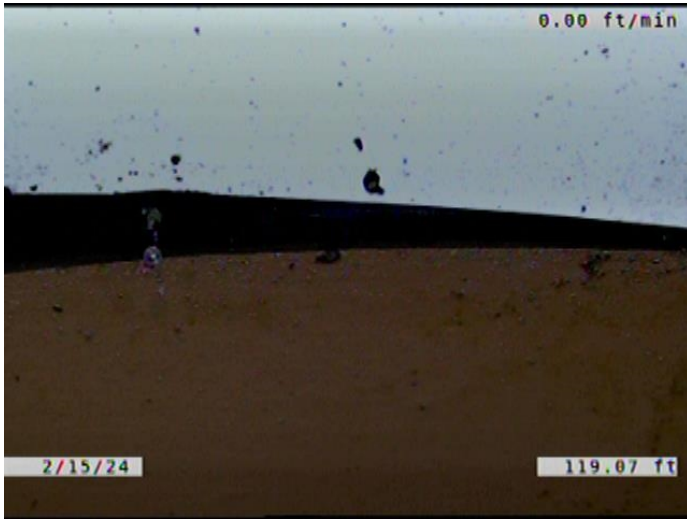
Code: **RPR**
Description: **Point Repair Replacement**

Distance (ft): **119.1**
Structural Grade: **0**
O&M Grade: **0**
Clock Start/From:
Clock To:
1st Value:
2nd Value:
Value Percent:
Continuous Index: **F08**
Within 8" of Joint: **YES**
Remarks: **REPLACED WITH PVC.**

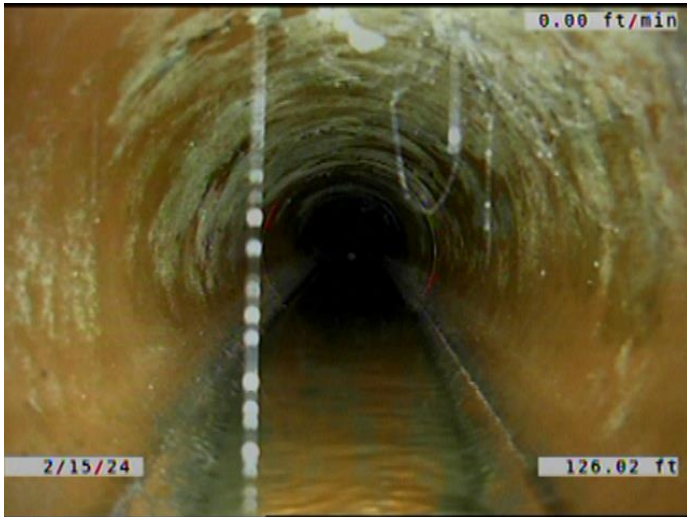
Code: **MWLS**
Description: **Miscellaneous Water Level Sag**

Distance (ft): **126.0**
Structural Grade: **2**
O&M Grade: **0**
Clock Start/From:
Clock To:
1st Value:
2nd Value:
Value Percent: **10.000**
Continuous Index: **S09**
Within 8" of Joint: **NO**
Remarks:

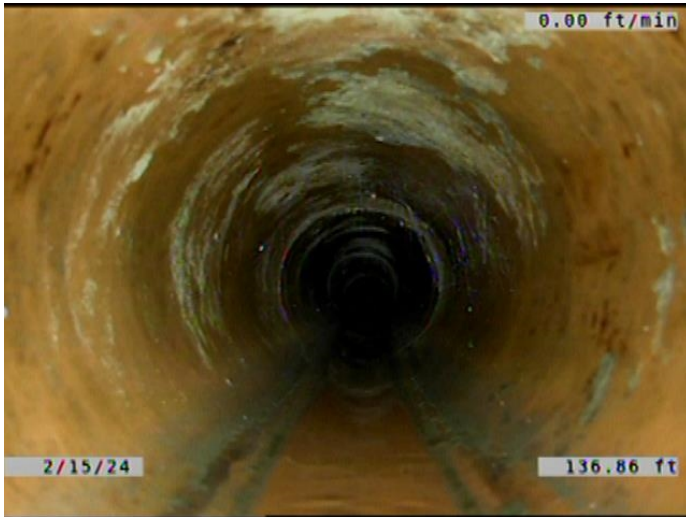
Code: **MWLS**
Description: **Miscellaneous Water Level Sag**

Distance (ft): **136.9**
Structural Grade: **2**
O&M Grade: **0**
Clock Start/From:
Clock To:
1st Value:
2nd Value:
Value Percent: **10.000**
Continuous Index: **F09**
Within 8" of Joint: **NO**
Remarks:

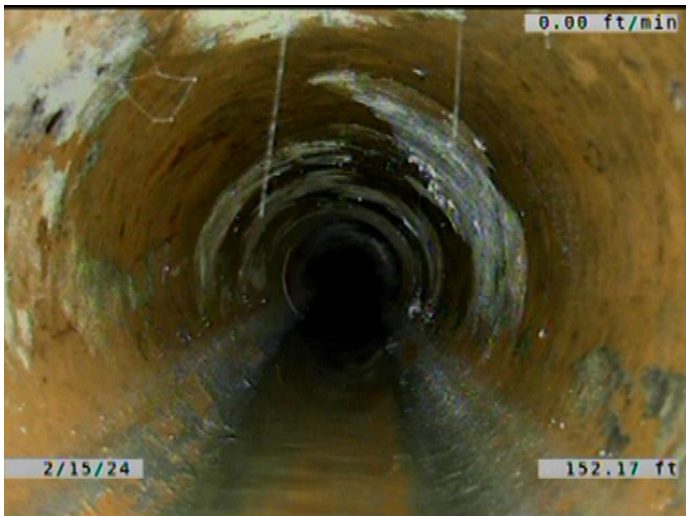
Code: **MWLS**
Description: **Miscellaneous Water Level Sag**

Distance (ft): **152.2**
Structural Grade: **2**
O&M Grade: **0**
Clock Start/From:
Clock To:
1st Value:
2nd Value:
Value Percent: **10.000**
Continuous Index: **S10**
Within 8" of Joint: **NO**
Remarks:

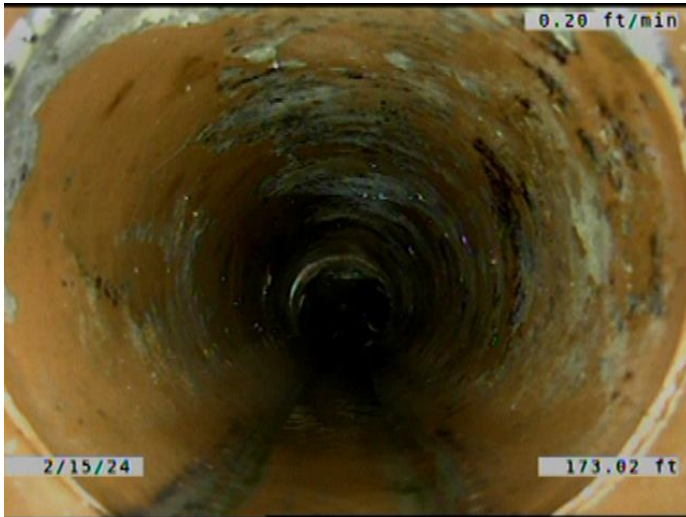
Code: **MWLS**
Description: **Miscellaneous Water Level Sag**

Distance (ft): **173.0**
Structural Grade: **2**
O&M Grade: **0**
Clock Start/From:
Clock To:
1st Value:
2nd Value:
Value Percent: **10.000**
Continuous Index: **F10**
Within 8" of Joint: **NO**
Remarks:

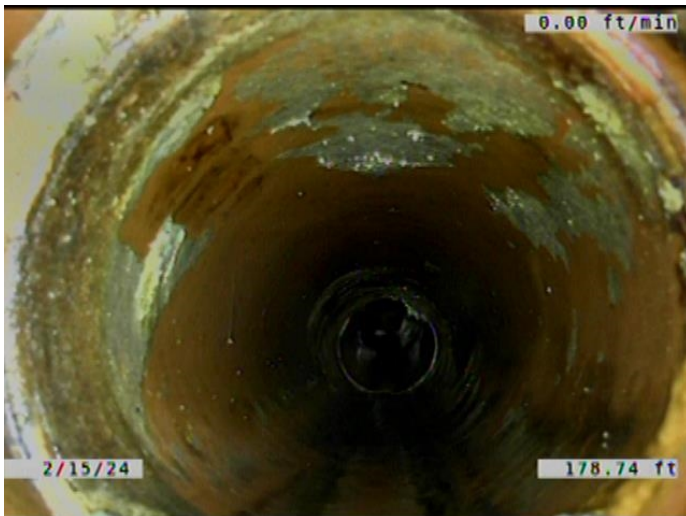
Code: **LD**
Description: **Line Down**

Distance (ft): **178.7**
Structural Grade: **0**
O&M Grade: **1**
Clock Start/From:
Clock To:
1st Value:
2nd Value:
Value Percent: **10.000**
Continuous Index:
Within 8" of Joint: **NO**
Remarks:

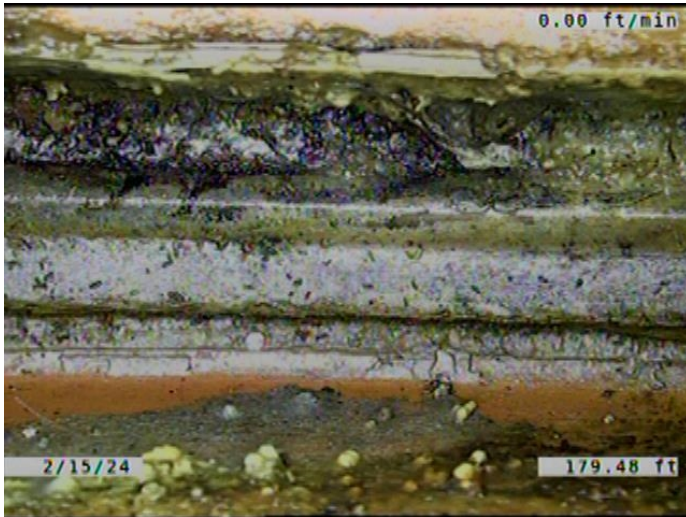
Code: **JAM**
 Description: **Joint Angular Medium**

Distance (ft): **179.5**
 Structural Grade: **3**
 O&M Grade: **0**
 Clock Start/From:
 Clock To:
 1st Value:
 2nd Value:
 Value Percent:
 Continuous Index:
 Within 8" of Joint: **NO**
 Remarks:

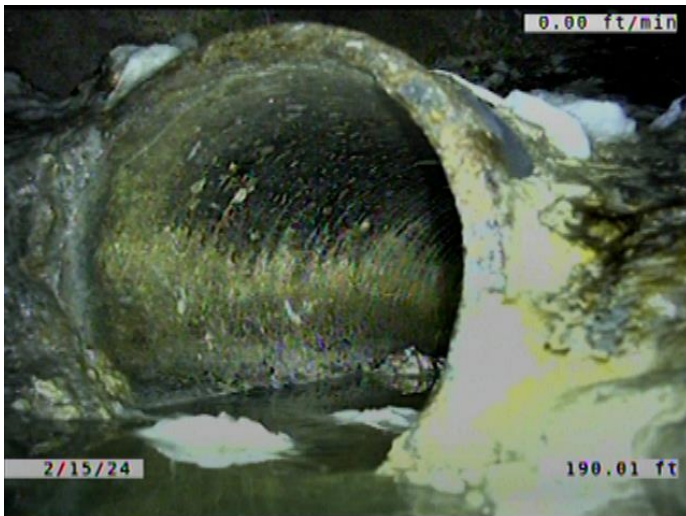
Code: **DAE**
 Description: **Deposits Attached Encrustation**

Distance (ft): **190.0**
 Structural Grade: **0**
 O&M Grade: **2**
 Clock Start/From: **7**
 Clock To: **5**
 1st Value:
 2nd Value:
 Value Percent: **5.000**
 Continuous Index: **F01**
 Within 8" of Joint: **YES**
 Remarks:
