## Profile/Photo Observation Report

Date:	<b>02/15/2024</b>	Weather:		Coding:	<b>PACP 7.0</b>
Pipe Length (ft):	<b>157.2</b>	Owner:	<b>City of Hobart</b>	Pre Clean:	<b>Heavy Cleaning</b>
P.O.#:	<b>YES502259</b>	Surveyor:	<b>S. Bucklin</b>	PSR:	<b>P-405-014-014.1</b>
Customer:	<b>City of Hobart</b>	Clean Date:	<b>03/15/2023</b>	Shape:	<b>C</b>

Street:	<b>LASALLE PL</b>	Flow Control:	<b>Not Controlled</b>
City:	<b>Hobart, IN</b>	Year Renewed:	
Location:	<b>Easement/Right of Way</b>	Tape/Media #:	
Purpose:	<b>Routine Assessment</b>	Dia/Height:	<b>8"</b>
Use:	<b>Sanitary Sewage Pipe</b>	Material:	<b>VCP</b>
Drain Area:		Lining:	<b>None</b>
Category:	<b>NA</b>		
Comment:			
Location Details:		Direction of Survey:	<b>Downstream</b>
US MH:	<b>M-405-014</b>	DS MH:	<b>M-405-014.1</b>
		Total Length Surveyed (ft):	<b>157.3</b>

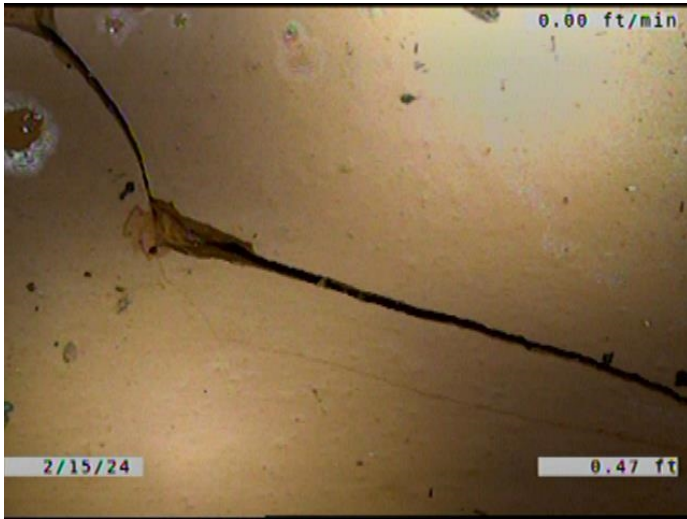
Code: **B**  
Description: **Broken**

Distance (ft): **.5**  
Structural Grade: **4**  
O&M Grade: **0**  
Clock Start/From: **9**  
Clock To: **3**  
1st Value:  
2nd Value:  
Value Percent:  
Continuous Index:  
Within 8" of Joint: **YES**  
Remarks:

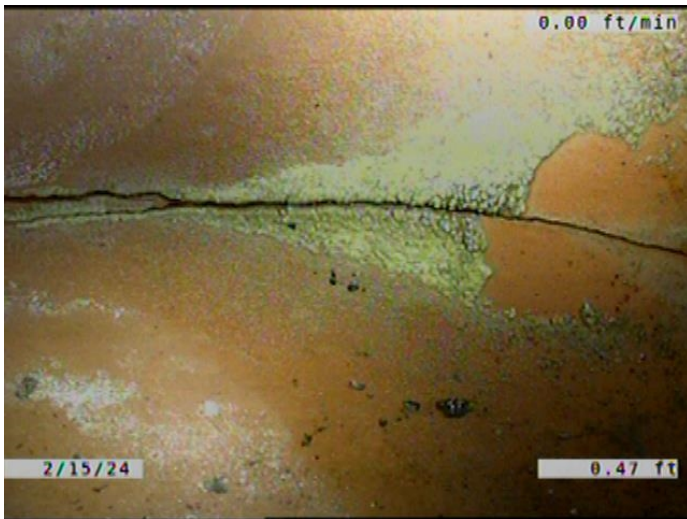
Code: **DAE**  
Description: **Deposits Attached Encrustation**

Distance (ft): **.5**  
Structural Grade: **0**  
O&M Grade: **2**  
Clock Start/From: **3**  
Clock To: **5**  
1st Value:  
2nd Value:  
Value Percent: **5.000**  
Continuous Index:  
Within 8" of Joint: **YES**  
Remarks:

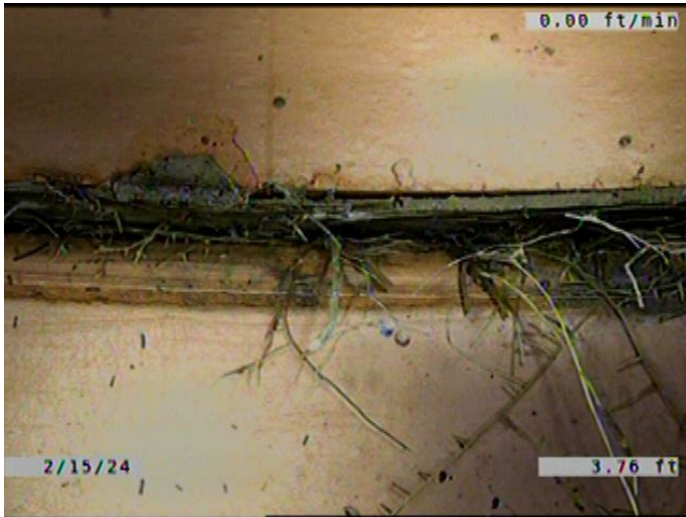
Code: **RFJ**  
Description: **Roots Fine Joint**

Distance (ft): **3.8**  
Structural Grade: **0**  
O&M Grade: **1**  
Clock Start/From: **8**  
Clock To: **4**  
1st Value:  
2nd Value:  
Value Percent:  
Continuous Index: **S01**  
Within 8" of Joint: **YES**  
Remarks:

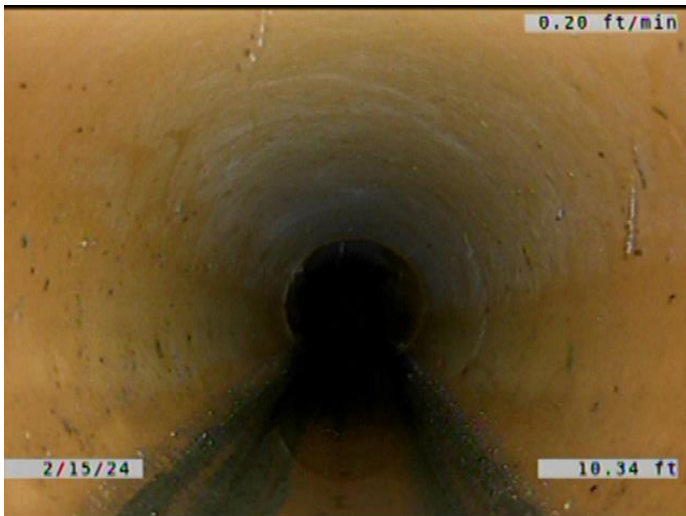
Code: **MWLS**  
Description: **Miscellaneous Water Level Sag**

Distance (ft): **10.3**  
Structural Grade: **2**  
O&M Grade: **0**  
Clock Start/From:  
Clock To:  
1st Value:  
2nd Value:  
Value Percent: **5.000**  
Continuous Index: **S02**  
Within 8" of Joint: **NO**  
Remarks:

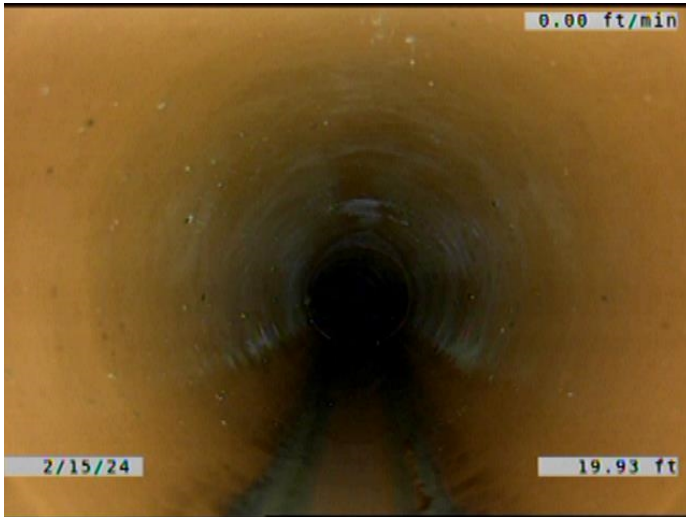
Code: **MWLS**  
Description: **Miscellaneous Water Level Sag**

Distance (ft): **19.9**  
Structural Grade: **2**  
O&M Grade: **0**  
Clock Start/From:  
Clock To:  
1st Value:  
2nd Value:  
Value Percent: **5.000**  
Continuous Index: **F02**  
Within 8" of Joint: **NO**  
Remarks:

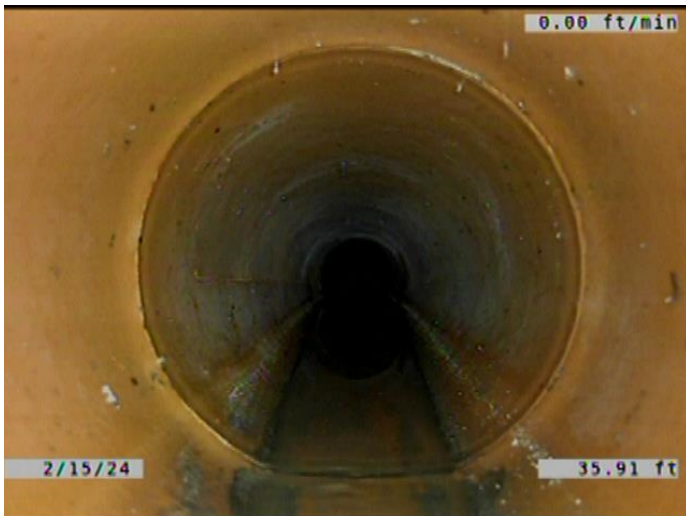
Code: **MWLS**  
Description: **Miscellaneous Water Level Sag**

Distance (ft): **35.9**  
Structural Grade: **2**  
O&M Grade: **0**  
Clock Start/From:  
Clock To:  
1st Value:  
2nd Value:  
Value Percent: **10.000**  
Continuous Index: **S03**  
Within 8" of Joint: **NO**  
Remarks:

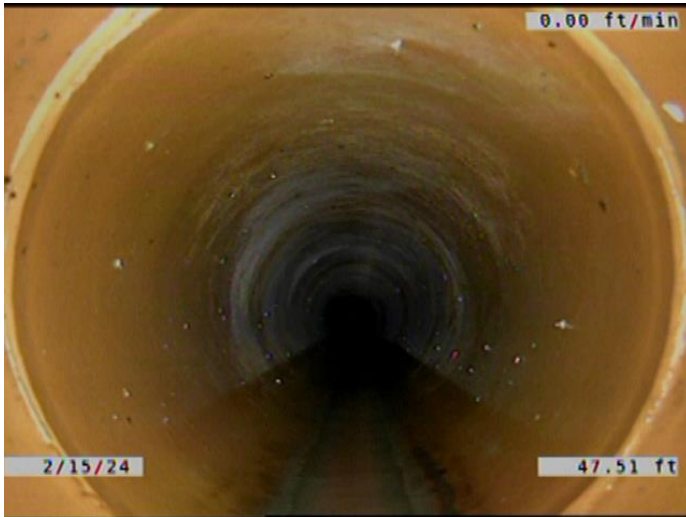
Code: **MWLS**  
Description: **Miscellaneous Water Level Sag**

Distance (ft): **47.5**  
Structural Grade: **2**  
O&M Grade: **0**  
Clock Start/From:  
Clock To:  
1st Value:  
2nd Value:  
Value Percent: **10.000**  
Continuous Index: **F03**  
Within 8" of Joint: **NO**  
Remarks:

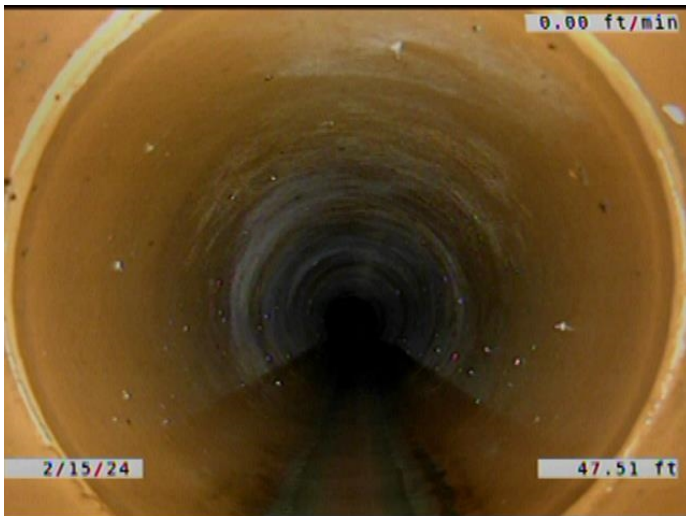
Code: **RFJ**  
Description: **Roots Fine Joint**

Distance (ft): **47.5**  
Structural Grade: **0**  
O&M Grade: **1**  
Clock Start/From: **8**  
Clock To: **4**  
1st Value:  
2nd Value:  
Value Percent:  
Continuous Index: **F01**  
Within 8" of Joint: **YES**  
Remarks:

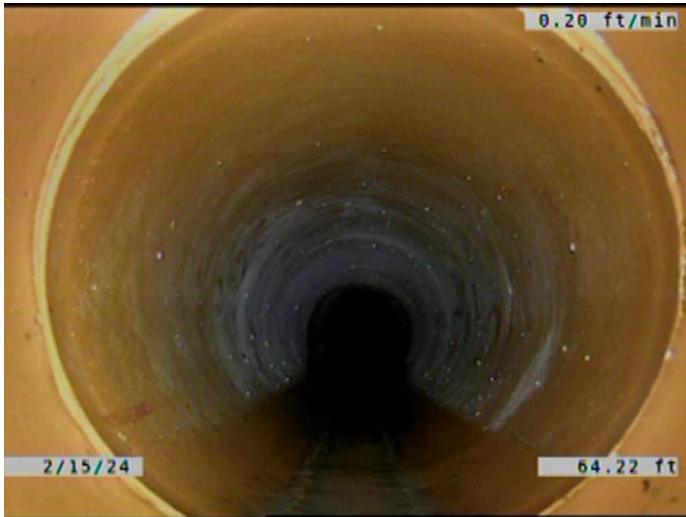
Code: **LD**  
Description: **Line Down**

Distance (ft): **64.2**  
Structural Grade: **0**  
O&M Grade: **1**  
Clock Start/From:  
Clock To:  
1st Value:  
2nd Value:  
Value Percent: **5.000**  
Continuous Index:  
Within 8" of Joint: **NO**  
Remarks:

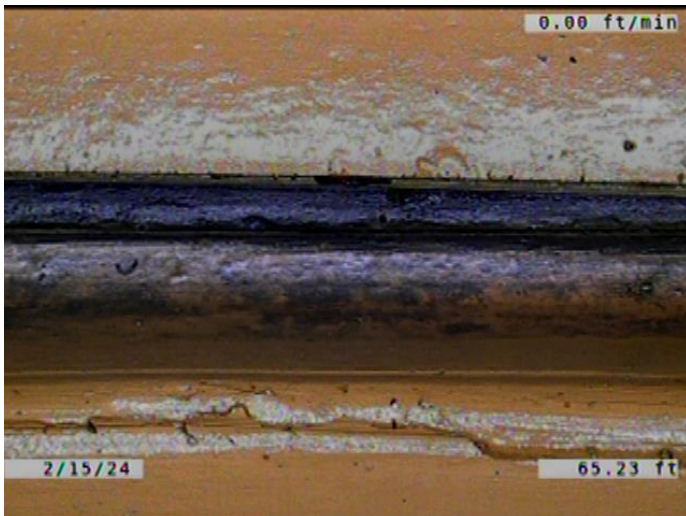
Code: **JAM**  
Description: **Joint Angular Medium**

Distance (ft): **65.2**  
Structural Grade: **3**  
O&M Grade: **0**  
Clock Start/From:  
Clock To:  
1st Value:  
2nd Value:  
Value Percent:  
Continuous Index:  
Within 8" of Joint: **NO**  
Remarks:

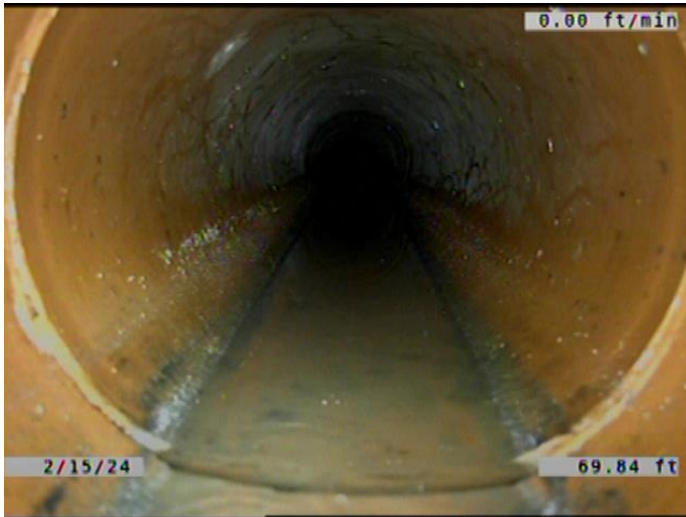
Code: **MWLS**  
Description: **Miscellaneous Water Level Sag**

Distance (ft): **69.8**  
Structural Grade: **2**  
O&M Grade: **0**  
Clock Start/From:  
Clock To:  
1st Value:  
2nd Value:  
Value Percent: **15.000**  
Continuous Index: **S04**  
Within 8" of Joint: **NO**  
Remarks:

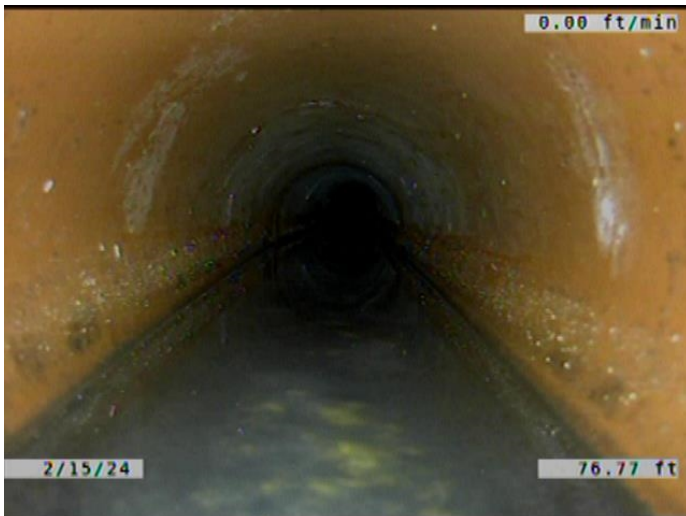
Code: **DSF**  
Description: **Deposits Settled Fine**

Distance (ft): **76.8**  
Structural Grade: **0**  
O&M Grade: **2**  
Clock Start/From: **5**  
Clock To: **7**  
1st Value:  
2nd Value:  
Value Percent: **5.000**  
Continuous Index: **S05**  
Within 8" of Joint: **YES**  
Remarks:

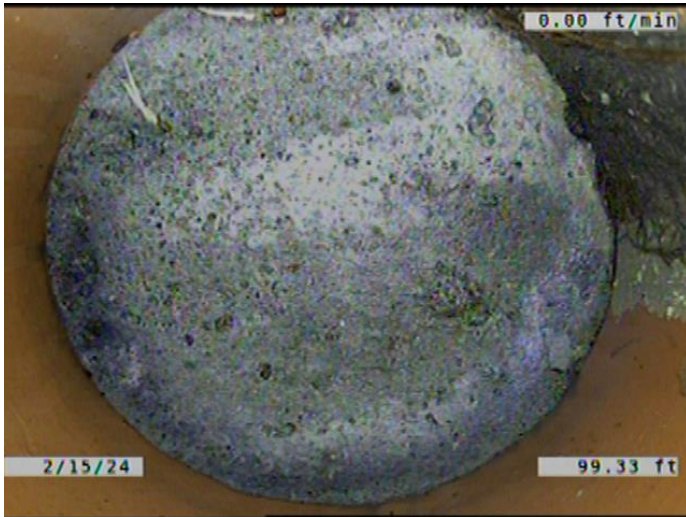
Code: **TFD**  
Description: **Tap Factory Defective**

Distance (ft): **99.3**  
Structural Grade: **0**  
O&M Grade: **3**  
Clock Start/From: **2**  
Clock To:  
1st Value: **6.000**  
2nd Value:  
Value Percent:  
Continuous Index:  
Within 8" of Joint: **YES**  
Remarks: **CAPPED. ENCRUSTATION AND ROOTS COMING AROUND THE CAP I**

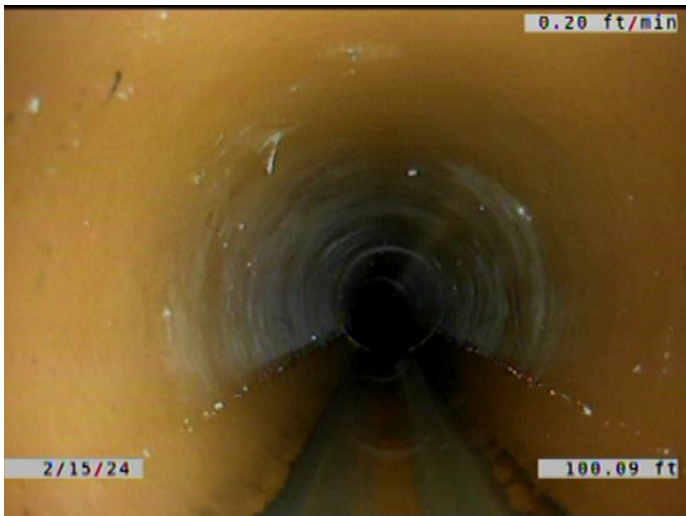
Code: **MWLS**  
Description: **Miscellaneous Water Level Sag**

Distance (ft): **100.1**  
Structural Grade: **2**  
O&M Grade: **0**  
Clock Start/From:  
Clock To:  
1st Value:  
2nd Value:  
Value Percent: **15.000**  
Continuous Index: **F04**  
Within 8" of Joint: **NO**  
Remarks:

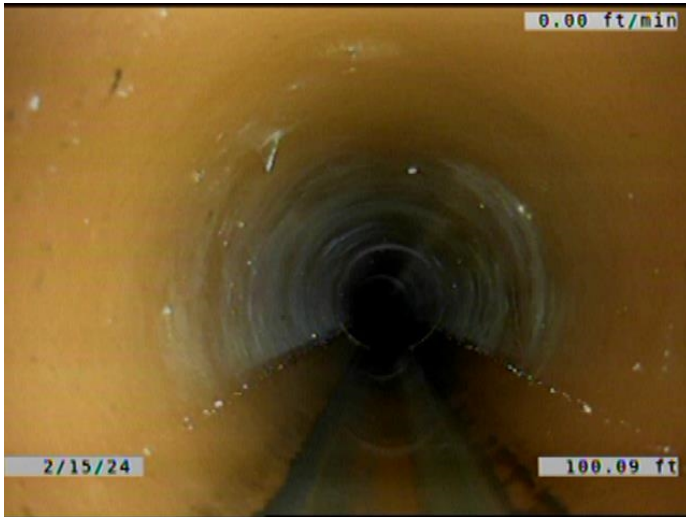
Code: **DSF**  
Description: **Deposits Settled Fine**

Distance (ft): **100.1**  
Structural Grade: **0**  
O&M Grade: **2**  
Clock Start/From: **5**  
Clock To: **7**  
1st Value:  
2nd Value:  
Value Percent: **5.000**  
Continuous Index: **F05**  
Within 8" of Joint: **YES**  
Remarks:

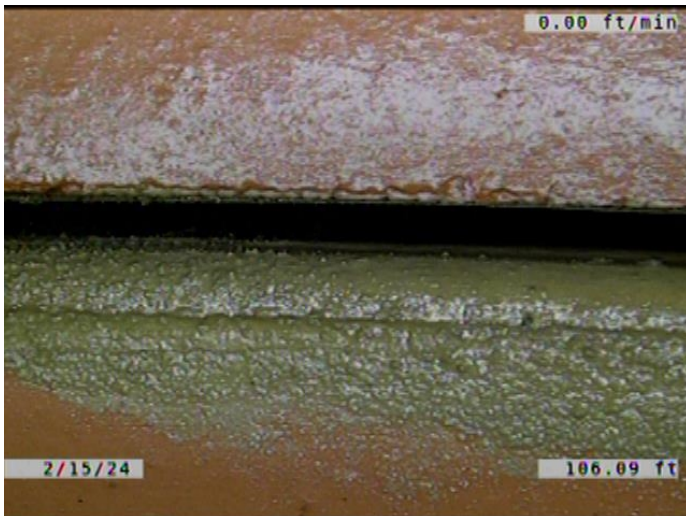
Code: **IDJ**  
Description: **Infiltration Dripper Joint**

Distance (ft): **106.1**  
Structural Grade: **0**  
O&M Grade: **3**  
Clock Start/From: **3**  
Clock To:  
1st Value:  
2nd Value:  
Value Percent:  
Continuous Index:  
Within 8" of Joint: **YES**  
Remarks:

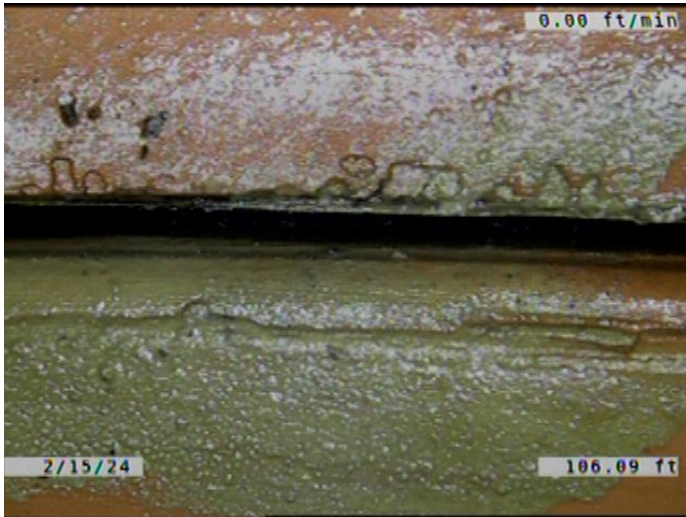
Code:	DAE
Description:	Deposits Attached Encrustation
Distance (ft):	106.1
Structural Grade:	0
O&M Grade:	2
Clock Start/From:	12
Clock To:	5
1st Value:	
2nd Value:	
Value Percent:	5.000
Continuous Index:	
Within 8" of Joint:	YES
Remarks:

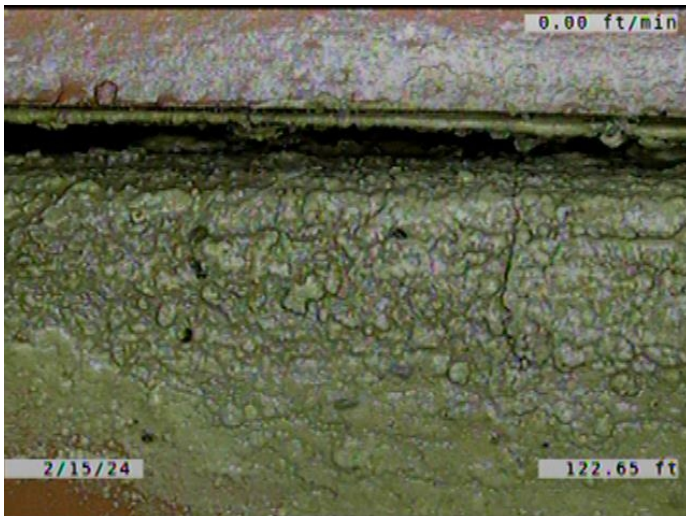
Code:	DAE
Description:	Deposits Attached Encrustation
Distance (ft):	122.6
Structural Grade:	0
O&M Grade:	2
Clock Start/From:	7
Clock To:	5
1st Value:	
2nd Value:	
Value Percent:	5.000
Continuous Index:	S06
Within 8" of Joint:	YES
Remarks:

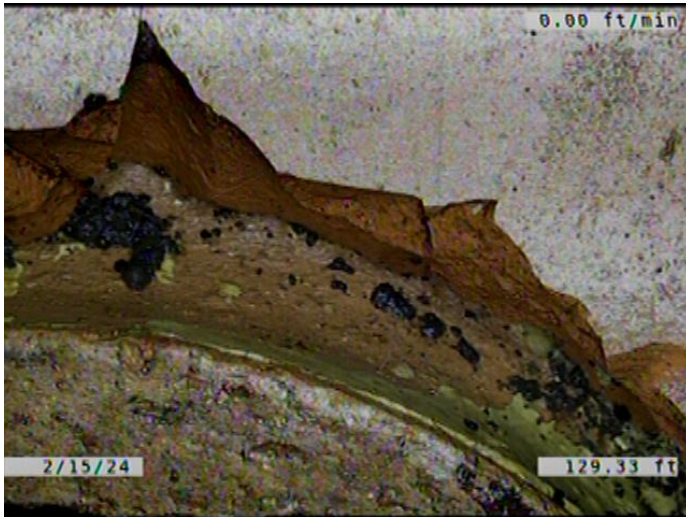
Code: **SSS**  
Description: **Surface Damage Surface Spalling**

Distance (ft): **129.3**  
Structural Grade: **2**  
O&M Grade: **0**  
Clock Start/From: **10**  
Clock To: **3**  
1st Value:  
2nd Value:  
Value Percent:  
Continuous Index:  
Within 8" of Joint: **YES**  
Remarks:

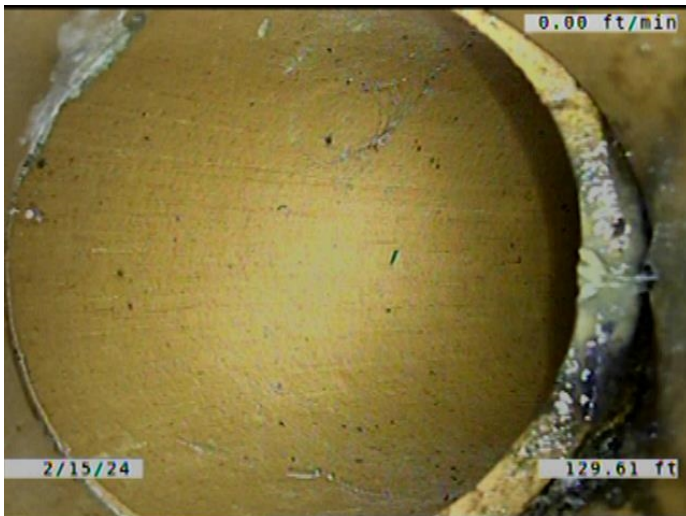
Code: **TBI**  
Description: **Tap Break-in Intruding**

Distance (ft): **129.6**  
Structural Grade: **0**  
O&M Grade: **2**  
Clock Start/From: **1**  
Clock To:  
1st Value: **6.000**  
2nd Value: **1.000**  
Value Percent:  
Continuous Index:  
Within 8" of Joint: **YES**  
Remarks: **CONSTANTLY RUNNING WATER.**

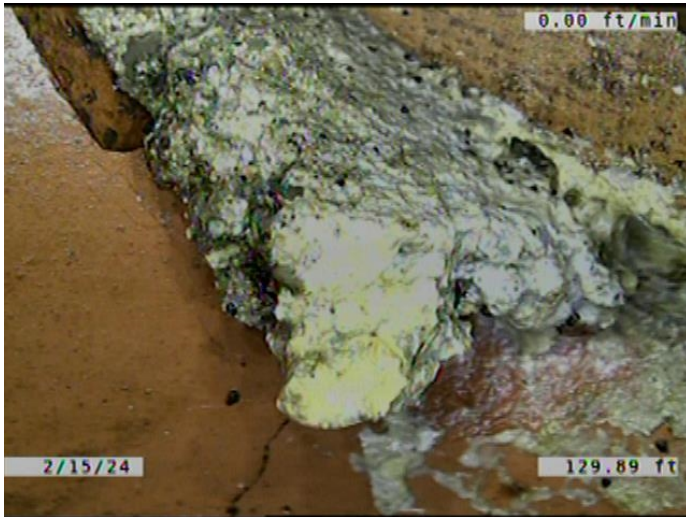
Code:	<b>ISGT</b>
Description:	<b>Intruding Sealing Material Grout</b>
Distance (ft):	<b>129.9</b>
Structural Grade:	<b>0</b>
O&M Grade:	<b>2</b>
Clock Start/From:	<b>11</b>
Clock To:	<b>12</b>
1st Value:	
2nd Value:	
Value Percent:	<b>5.000</b>
Continuous Index:	
Within 8" of Joint:	<b>NO</b>
Remarks:

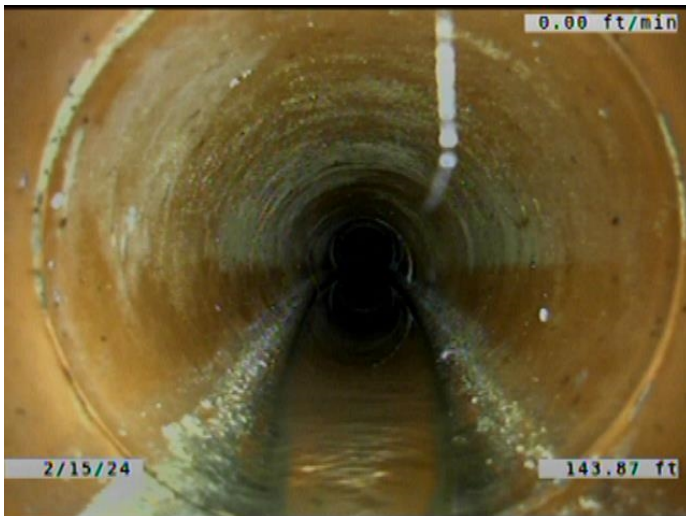
Code:	<b>MWLS</b>
Description:	<b>Miscellaneous Water Level Sag</b>
Distance (ft):	<b>143.9</b>
Structural Grade:	<b>2</b>
O&M Grade:	<b>0</b>
Clock Start/From:	
Clock To:	
1st Value:	
2nd Value:	
Value Percent:	<b>10.000</b>
Continuous Index:	<b>S07</b>
Within 8" of Joint:	<b>NO</b>
Remarks:

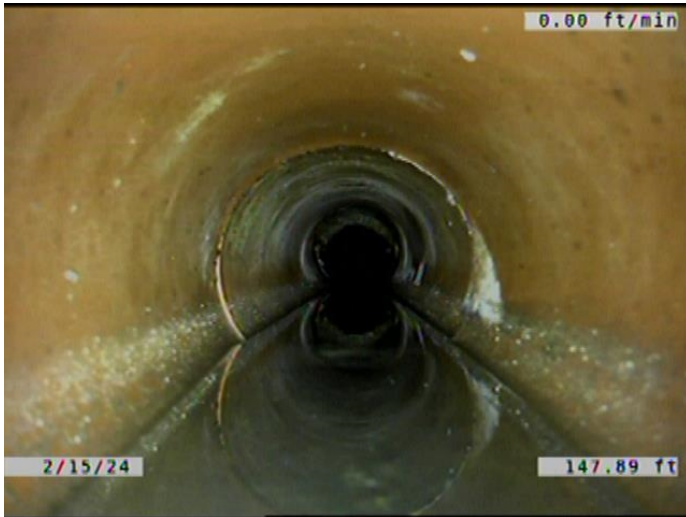
Code: **DSF**  
 Description: **Deposits Settled Fine**

Distance (ft): **147.9**  
 Structural Grade: **0**  
 O&M Grade: **2**  
 Clock Start/From: **5**  
 Clock To: **7**  
 1st Value:  
 2nd Value:  
 Value Percent: **5.000**  
 Continuous Index:  
 Within 8" of Joint: **YES**  
 Remarks:

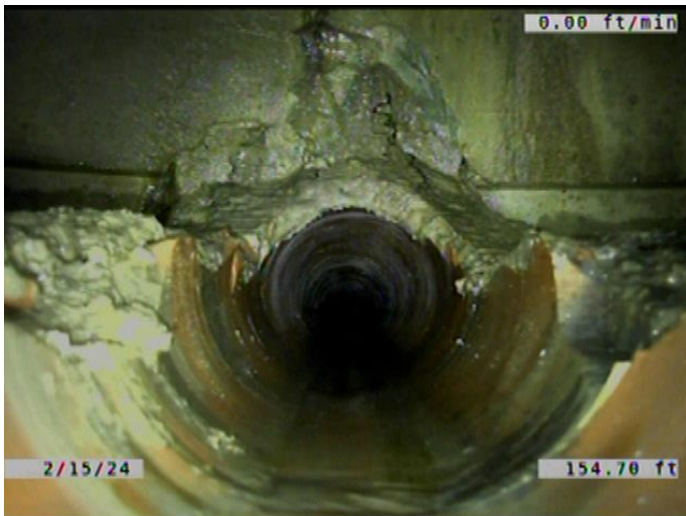
Code: **DAE**  
 Description: **Deposits Attached Encrustation**

Distance (ft): **154.7**  
 Structural Grade: **0**  
 O&M Grade: **2**  
 Clock Start/From: **7**  
 Clock To: **5**  
 1st Value:  
 2nd Value:  
 Value Percent: **5.000**  
 Continuous Index: **F06**  
 Within 8" of Joint: **YES**  
 Remarks:

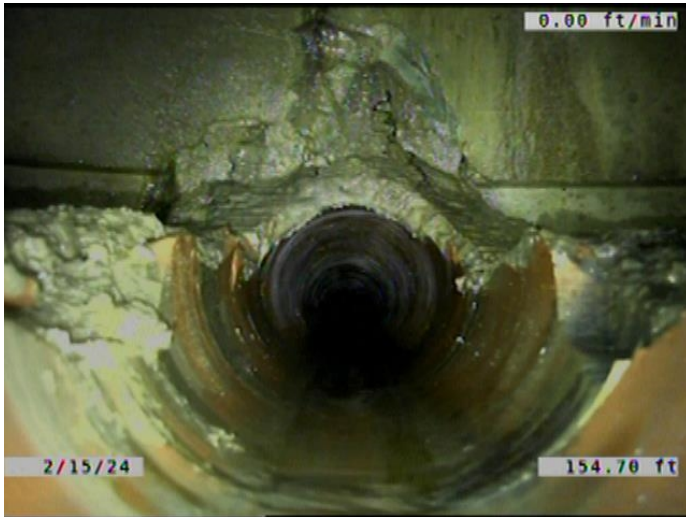
Code: **MWLS**  
 Description: **Miscellaneous Water Level Sag**

Distance (ft): **154.7**  
 Structural Grade: **2**  
 O&M Grade: **0**  
 Clock Start/From:  
 Clock To:  
 1st Value:  
 2nd Value:  
 Value Percent: **10.000**  
 Continuous Index: **F07**  
 Within 8" of Joint: **NO**  
 Remarks:
