Profile/Photo Observation Report

Date:	04/25/2018	Weather:		Coding:	PACP 6.0
Pipe Length (ft):		Owner:	City of Hobart	Pre Clean:	No Pre-Cleaning
P.O.#:	81	Surveyor:	M. Pielacha	PSR:	P-405-020-012
Customer:	City of Hobart	Clean Date:		Shape:	C

Street:	3rd Street	Flow Control:	Not Controlled
City:	Hobart, IN	Year Renewed:	
Location:	Light Highway	Tape/Media #:	DEP 81
Purpose:	Routine Assessment	Dia/Height:	15"
Use:	Sanitary	Material:	CP
Drain Area:		Lining:	
Category:	NA		
Comment:	YES501824 Submittal 2		
Location Details:		Direction of Survey:	Downstream
US MH:	M-405-020	DS MH:	M-405-012
		Total Length Surveyed (ft):	308.9

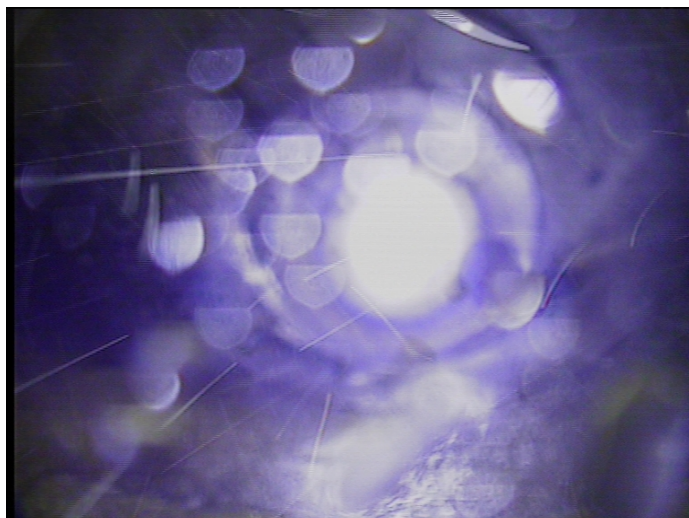
Code: **AMH**
Description: **Manhole**

Distance (ft): **.0**
Structural Grade: **0**
O&M Grade: **0**
Clock Start/From:
Clock To:
1st Value:
2nd Value:
Value Percent:
Continuous Index:
Within 8" of Joint: **NO**
Remarks: **M-405-020**

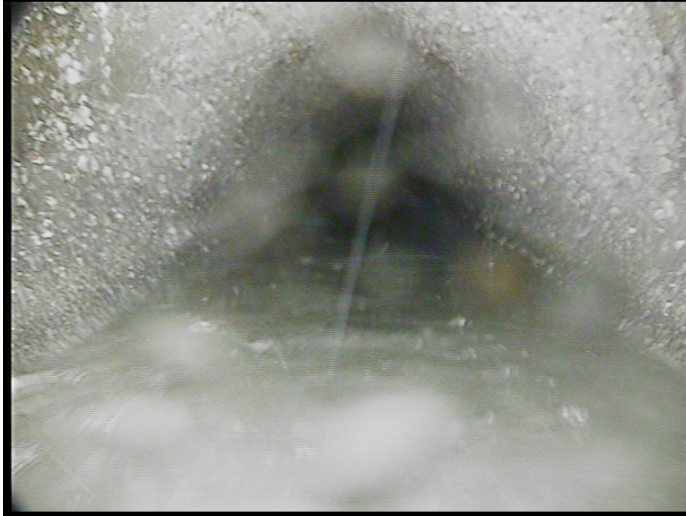
Code: **MWL**
Description: **Water Level**

Distance (ft): **.0**
Structural Grade: **0**
O&M Grade: **0**
Clock Start/From:
Clock To:
1st Value:
2nd Value:
Value Percent: **10.000**
Continuous Index:
Within 8" of Joint: **NO**
Remarks:

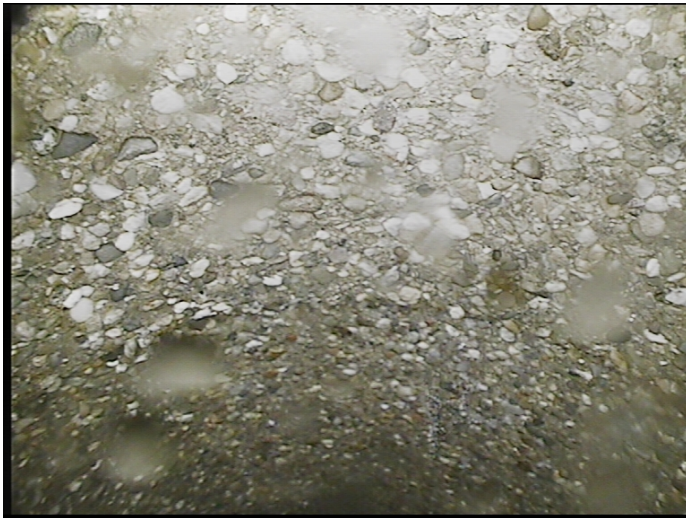
Code: **SAV**
Description: **Surface Aggregate Visible**

Distance (ft): **11.8**
Structural Grade: **3**
O&M Grade: **0**
Clock Start/From: **8**
Clock To: **4**
1st Value:
2nd Value:
Value Percent:
Continuous Index: **S01**
Within 8" of Joint: **YES**
Remarks:

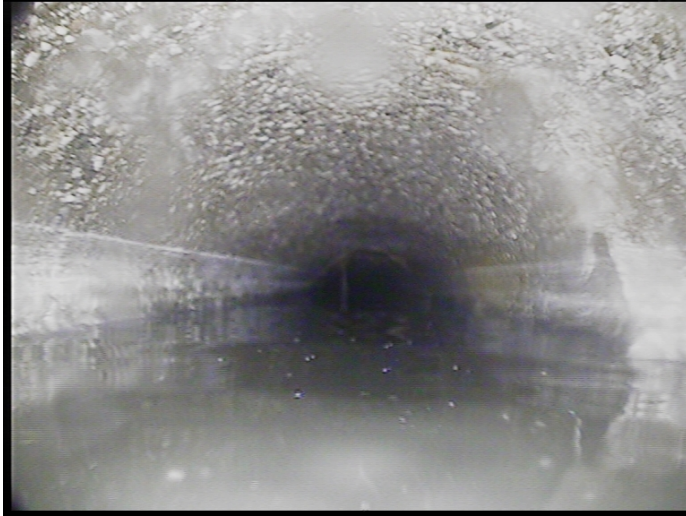
Code: **MWL**
Description: **Water Level**

Distance (ft): **86.5**
Structural Grade: **0**
O&M Grade: **0**
Clock Start/From:
Clock To:
1st Value:
2nd Value:
Value Percent: **35.000**
Continuous Index:
Within 8" of Joint: **NO**
Remarks:

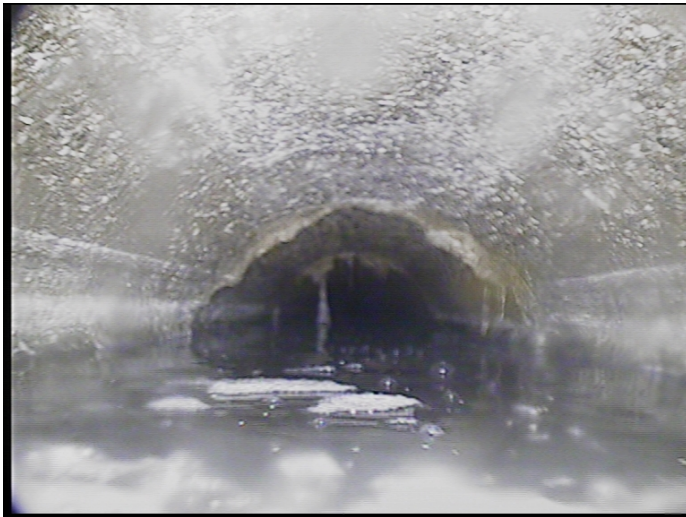
Code: **MWL**
Description: **Water Level**

Distance (ft): **91.6**
Structural Grade: **0**
O&M Grade: **0**
Clock Start/From:
Clock To:
1st Value:
2nd Value:
Value Percent: **55.000**
Continuous Index:
Within 8" of Joint: **NO**
Remarks:

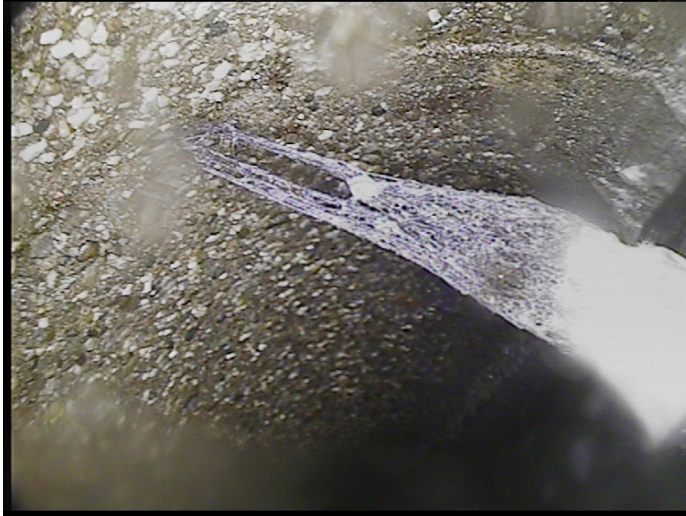
Code: **RFJ**
Description: **Roots Fine Joint**

Distance (ft): **132.8**
Structural Grade: **0**
O&M Grade: **1**
Clock Start/From: **10**
Clock To: **2**
1st Value:
2nd Value:
Value Percent:
Continuous Index:
Within 8" of Joint: **YES**
Remarks:

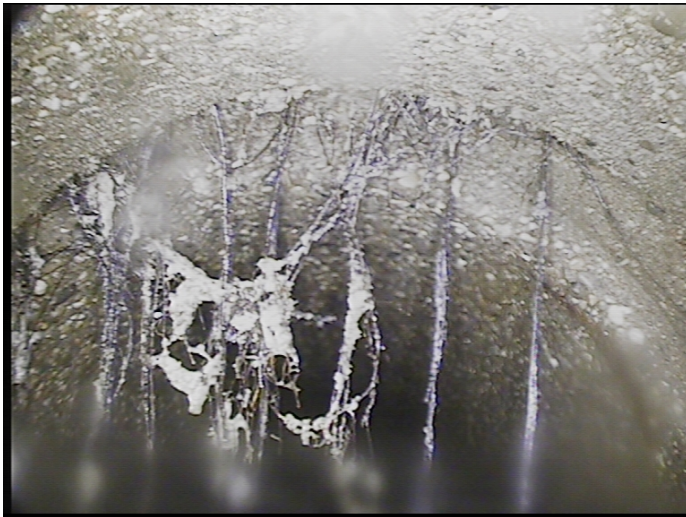
Code: **RFJ**
Description: **Roots Fine Joint**

Distance (ft): **138.7**
Structural Grade: **0**
O&M Grade: **1**
Clock Start/From: **9**
Clock To: **1**
1st Value:
2nd Value:
Value Percent:
Continuous Index:
Within 8" of Joint: **YES**
Remarks:

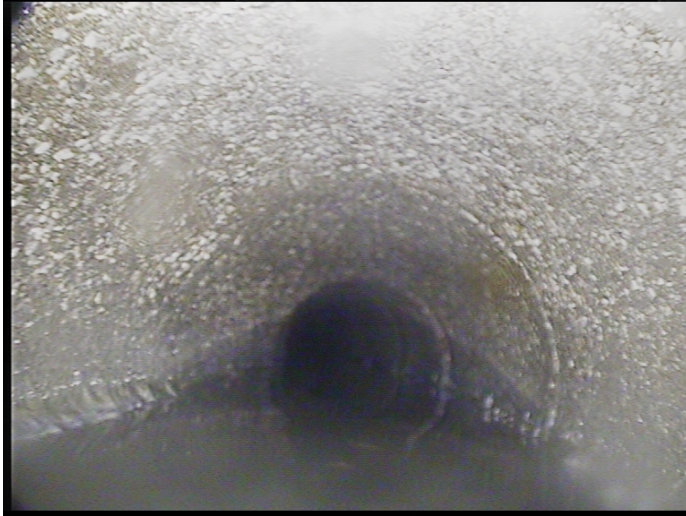
Code: **MWL**
Description: **Water Level**

Distance (ft): **170.6**
Structural Grade: **0**
O&M Grade: **0**
Clock Start/From:
Clock To:
1st Value:
2nd Value:
Value Percent: **30.000**
Continuous Index:
Within 8" of Joint: **NO**
Remarks:

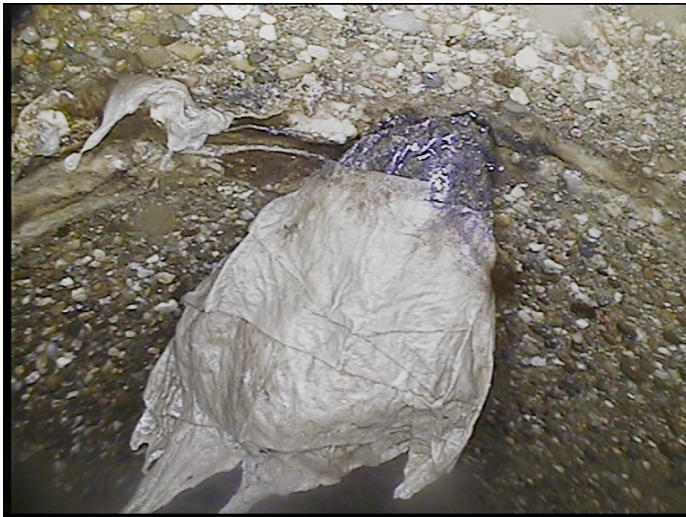
Code: **RMJ**
Description: **Roots Medium Joint**

Distance (ft): **269.6**
Structural Grade: **0**
O&M Grade: **3**
Clock Start/From: **10**
Clock To:
1st Value:
2nd Value:
Value Percent: **5.000**
Continuous Index:
Within 8" of Joint: **YES**
Remarks:

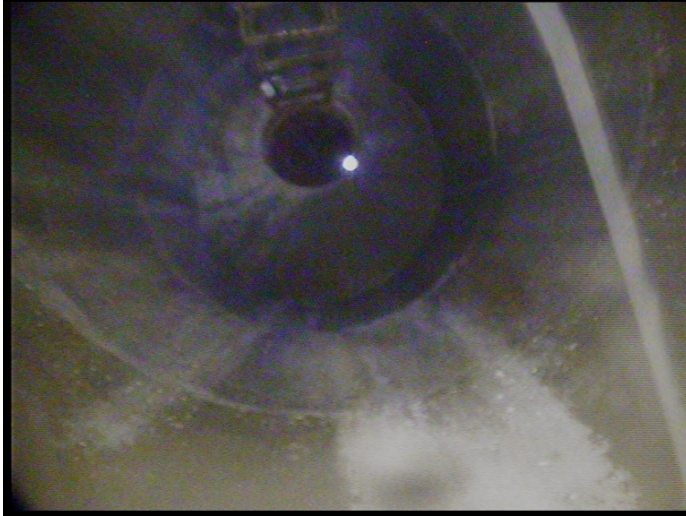
Code: **SAV**
Description: **Surface Aggregate Visible**

Distance (ft): **308.9**
Structural Grade: **3**
O&M Grade: **0**
Clock Start/From: **8**
Clock To: **4**
1st Value:
2nd Value:
Value Percent:
Continuous Index: **F01**
Within 8" of Joint: **NO**
Remarks:

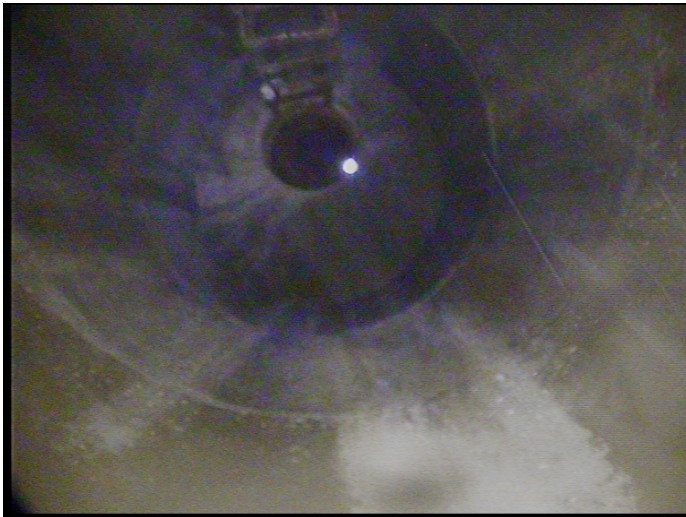
Code: **AMH**
Description: **Manhole**

Distance (ft): **308.9**
Structural Grade: **0**
O&M Grade: **0**
Clock Start/From:
Clock To:
1st Value:
2nd Value:
Value Percent:
Continuous Index:
Within 8" of Joint: **NO**
Remarks: **M-405-012**
