Profile/Photo Observation Report

Date:	04/16/2018	Weather:		Coding:	PACP 6.0
Pipe Length (ft):	177.3	Owner:	NA	Pre Clean:	No Pre-Cleaning
P.O.#:		Surveyor:	Selasie Honu	PSR:	P-405-049-020
Customer:		Clean Date:	01/01/1900	Shape:	C

Street:	W 3RD ST	Flow Control:	Not Controlled
City:	Hobart, IN	Year Renewed:	
Location:	Yard	Tape/Media #:	
Purpose:	Routine Assessment	Dia/Height:	12"
Use:	Sanitary	Material:	VCP
Drain Area:	NA	Lining:	
Category:	NA		
Comment:	Flow ism too dtrong, flow direction is marked wrong.		
Location Details:		Direction of Survey:	Downstream
US MH:	M-405-020	DS MH:	M-405-049
		Total Length Surveyed (ft):	2.3

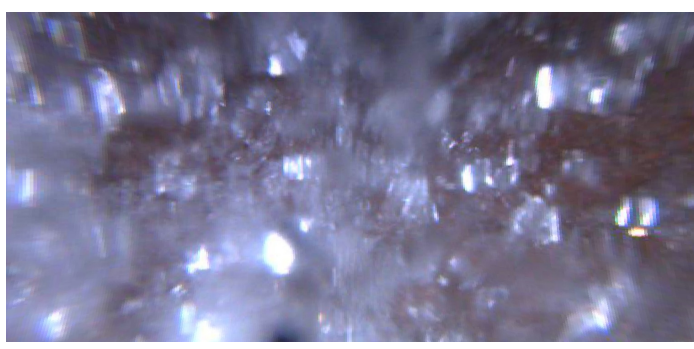
Code: **AMH**
Description: **Manhole**

Distance (ft): **.0**
Structural Grade: **0**
O&M Grade: **0**
Clock Start/From:
Clock To:
1st Value:
2nd Value:
Value Percent:
Continuous Index:
Within 8" of Joint: **NO**
Remarks: **M-405-020**

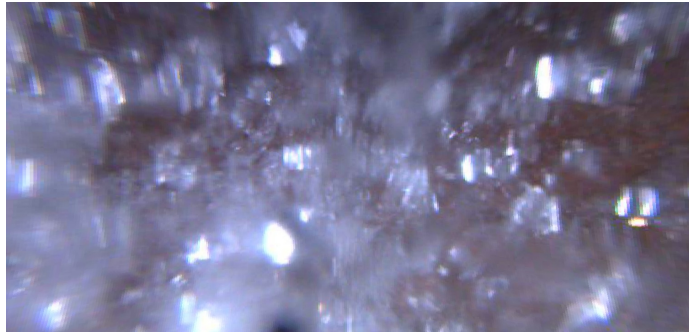
Code: **MWL**
Description: **Water Level**

Distance (ft): **.0**
Structural Grade: **0**
O&M Grade: **0**
Clock Start/From:
Clock To:
1st Value:
2nd Value:
Value Percent: **5.000**
Continuous Index:
Within 8" of Joint: **NO**
Remarks:
