Profile/Photo Observation Report

Street:	FOXCROFT STREET	Flow Control:	Not Controlled
City:	Hobart, IN	Year Renewed:	
Location:	Yard	Tape/Media #:	
Purpose:	Routine Assessment	Dia/Height:	12"
Use:	Sanitary	Material:	VCP
Drain Area:	NA	Lining:	
Category:	NA		
Comment:	Flow ism too dtrong, flow direction is marked wrong.		
Location Details:		Direction of Survey:	Downstream
US MH:	M-405-020	DS MH:	M-405-049
		Total Length Surveyed (ft):	2.3

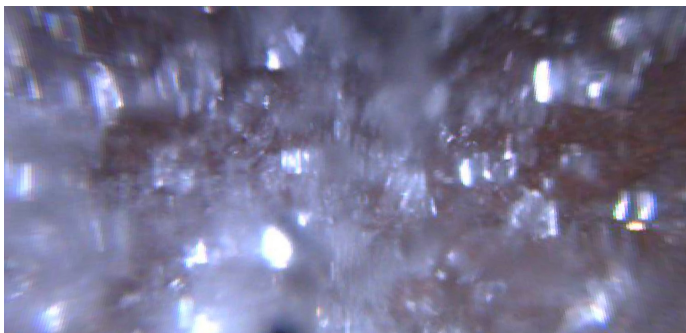
Code: **AMH**
Description: **Manhole**

Distance (ft): **.0**
Structural Grade: **0**
O&M Grade: **0**
Clock Start/From:
Clock To:
1st Value:
2nd Value:
Value Percent:
Continuous Index:
Within 8" of Joint: **NO**
Remarks: **M-405-020**

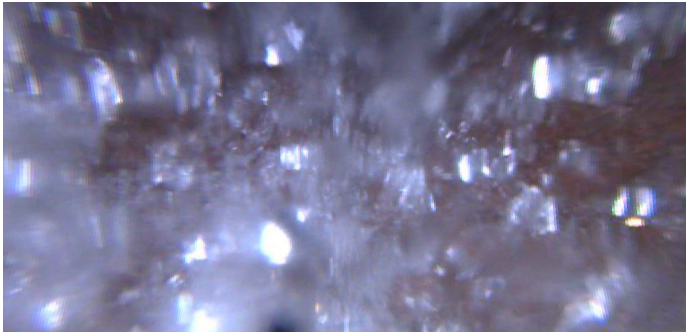
Code:	MWL
Description:	Water Level

Distance (ft):	.0
Structural Grade:	0
O&M Grade:	0
Clock Start/From:	
Clock To:	
1st Value:	
2nd Value:	
Value Percent:	5.000
Continuous Index:	
Within 8" of Joint:	NO
Remarks:
