## Profile/Photo Observation Report

Date:	<b>04/16/2018</b>	Weather:		Coding:	<b>PACP 6.0</b>
Pipe Length (ft):	<b>177.3</b>	Owner:	<b>NA</b>	Pre Clean:	<b>No Pre-Cleaning</b>
P.O.#:		Surveyor:	<b>Selasie Honu</b>	PSR:	<b>P-405-049-020</b>
Customer:		Clean Date:	<b>01/01/1900</b>	Shape:	<b>C</b>

Street:	<b>W 3RD ST</b>	Flow Control:	<b>Not Controlled</b>
City:	<b>Hobart, IN</b>	Year Renewed:	
Location:	<b>Yard</b>	Tape/Media #:	
Purpose:	<b>Routine Assessment</b>	Dia/Height:	<b>12"</b>
Use:	<b>Sanitary</b>	Material:	<b>VCP</b>
Drain Area:	<b>NA</b>	Lining:	
Category:	<b>NA</b>		
Comment:	<b>Flow direction is marked wrong.</b>		
Location Details:		Direction of Survey:	<b>Upstream</b>
US MH:	<b>M-405-020</b>	DS MH:	<b>M-405-049</b>
		Total Length Surveyed (ft):	<b>41.6</b>

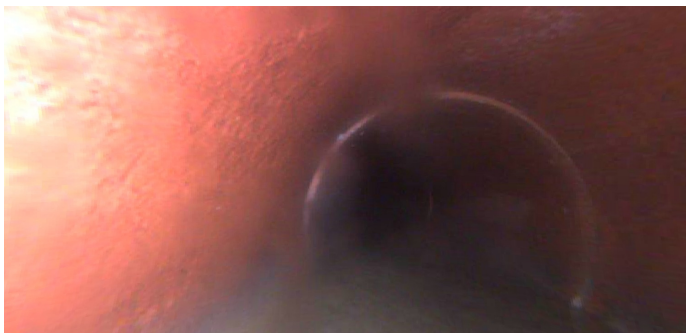
Code: **AMH**  
Description: **Manhole**

Distance (ft): **.0**  
Structural Grade: **0**  
O&M Grade: **0**  
Clock Start/From:  
Clock To:  
1st Value:  
2nd Value:  
Value Percent:  
Continuous Index:  
Within 8" of Joint: **NO**  
Remarks: **M-405-049**

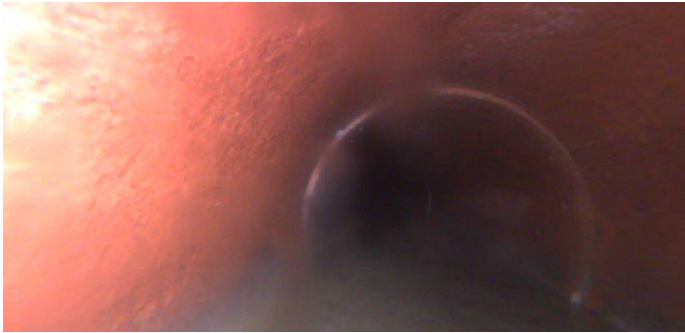
Code:	<b>MWL</b>
Description:	<b>Water Level</b>

Distance (ft):	<b>.0</b>
Structural Grade:	<b>0</b>
O&M Grade:	<b>0</b>
Clock Start/From:	
Clock To:	
1st Value:	
2nd Value:	
Value Percent:	<b>5.000</b>
Continuous Index:	
Within 8" of Joint:	<b>NO</b>
Remarks:

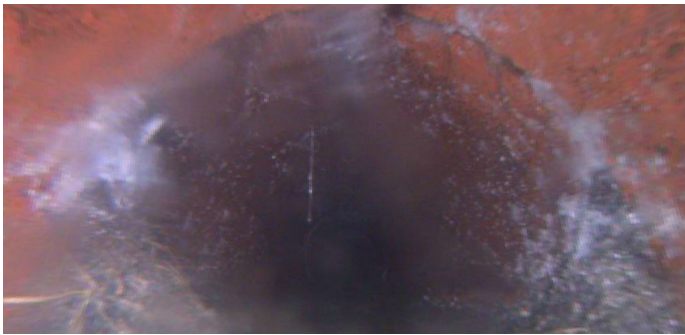
Code:	<b>RMJ</b>
Description:	<b>Roots Medium Joint</b>

Distance (ft):	<b>22.4</b>
Structural Grade:	<b>0</b>
O&M Grade:	<b>3</b>
Clock Start/From:	<b>7</b>
Clock To:	<b>5</b>
1st Value:	
2nd Value:	
Value Percent:	<b>10.000</b>
Continuous Index:	
Within 8" of Joint:	<b>YES</b>
Remarks:

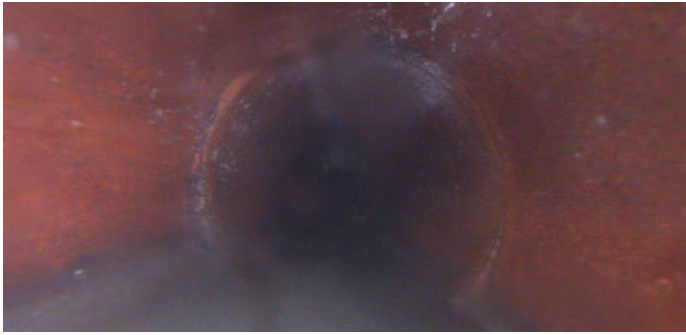
Code: **RFJ**  
Description: **Roots Fine Joint**

Distance (ft): **25.0**  
Structural Grade: **0**  
O&M Grade: **1**  
Clock Start/From: **7**  
Clock To: **5**  
1st Value:  
2nd Value:  
Value Percent:  
Continuous Index:  
Within 8" of Joint: **YES**  
Remarks:

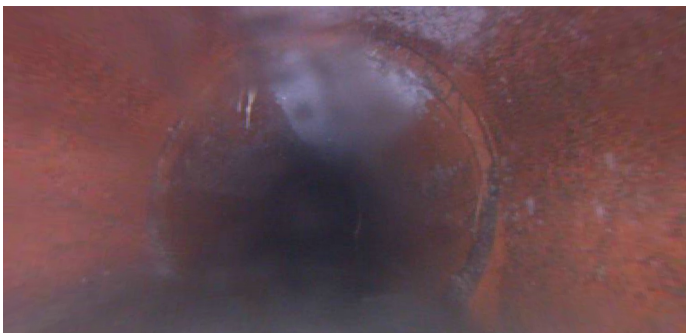
Code: **RFJ**  
Description: **Roots Fine Joint**

Distance (ft): **28.0**  
Structural Grade: **0**  
O&M Grade: **1**  
Clock Start/From: **7**  
Clock To: **5**  
1st Value:  
2nd Value:  
Value Percent:  
Continuous Index:  
Within 8" of Joint: **YES**  
Remarks:

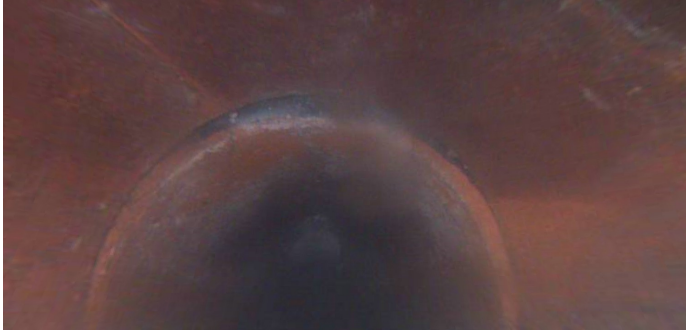
Code: **CM**  
Description: **Crack Multiple**

Distance (ft): **32.6**  
Structural Grade: **3**  
O&M Grade: **0**  
Clock Start/From: **10**  
Clock To: **1**  
1st Value:  
2nd Value:  
Value Percent:  
Continuous Index:  
Within 8" of Joint: **YES**  
Remarks:

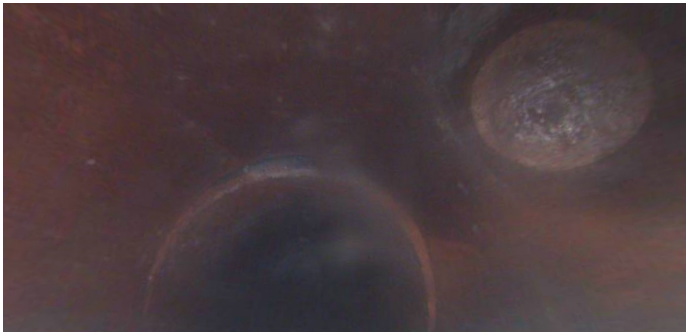
Code: **TFC**  
Description: **Tap Factory Capped**

Distance (ft): **33.0**  
Structural Grade: **0**  
O&M Grade: **0**  
Clock Start/From: **10**  
Clock To:  
1st Value: **4.000**  
2nd Value:  
Value Percent:  
Continuous Index:  
Within 8" of Joint:  
Remarks:

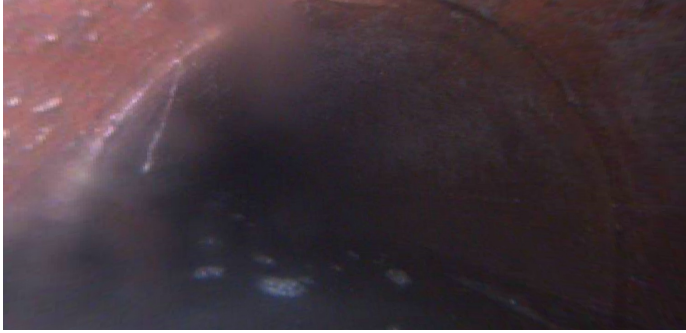
Code: **RFJ**  
Description: **Roots Fine Joint**

Distance (ft): **39.7**  
Structural Grade: **0**  
O&M Grade: **1**  
Clock Start/From: **10**  
Clock To:  
1st Value:  
2nd Value:  
Value Percent:  
Continuous Index:  
Within 8" of Joint: **YES**  
Remarks:

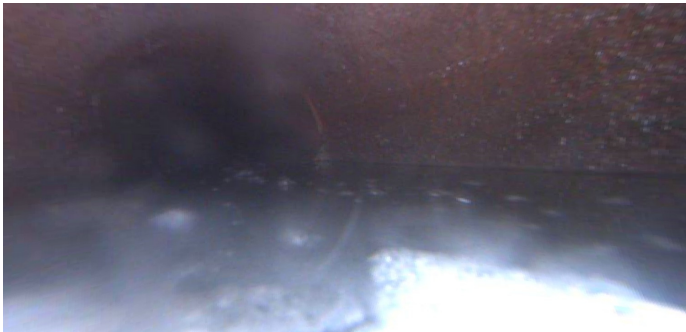
Code: **MSA**  
Description: **Abandoned Survey**

Distance (ft): **41.6**  
Structural Grade: **0**  
O&M Grade: **0**  
Clock Start/From:  
Clock To:  
1st Value:  
2nd Value:  
Value Percent:  
Continuous Index:  
Within 8" of Joint: **NO**  
Remarks: **camera stopped**
