Profile/Photo Observation Report

Street:	FOXCROFT STREET	Flow Control:	Not Controlled
City:	Hobart, IN	Year Renewed:	
Location:	Yard	Tape/Media #:	
Purpose:	Routine Assessment	Dia/Height:	12"
Use:	Sanitary	Material:	VCP
Drain Area:	NA	Lining:	
Category:	NA		
Comment:	Flow direction is marked wrong.		
Location Details:		Direction of Survey:	Upstream
US MH:	M-405-020	DS MH:	M-405-049
		Total Length Surveyed (ft):	41.6

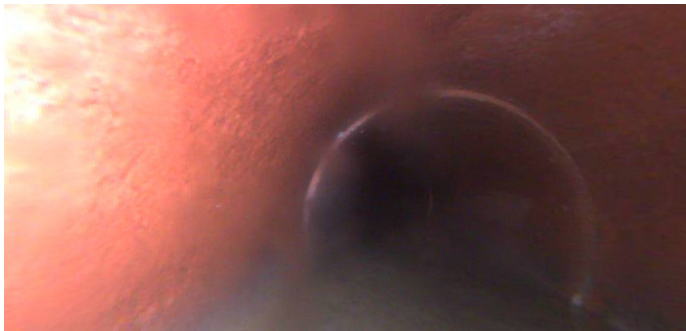
Code: **AMH**
Description: **Manhole**

Distance (ft): **.0**
Structural Grade: **0**
O&M Grade: **0**
Clock Start/From:
Clock To:
1st Value:
2nd Value:
Value Percent:
Continuous Index:
Within 8" of Joint: **NO**
Remarks: **M-405-049**

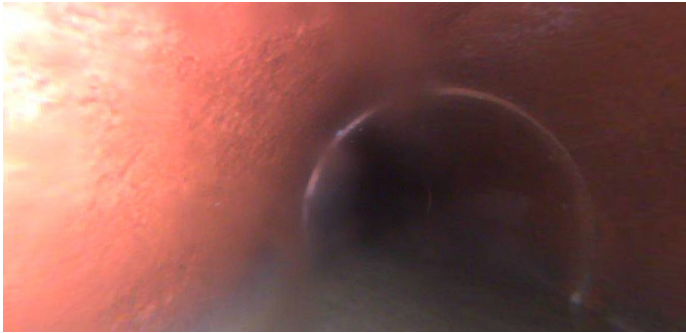
Code:	MWL
Description:	Water Level

Distance (ft):	.0
Structural Grade:	0
O&M Grade:	0
Clock Start/From:	
Clock To:	
1st Value:	
2nd Value:	
Value Percent:	5.000
Continuous Index:	
Within 8" of Joint:	NO
Remarks:

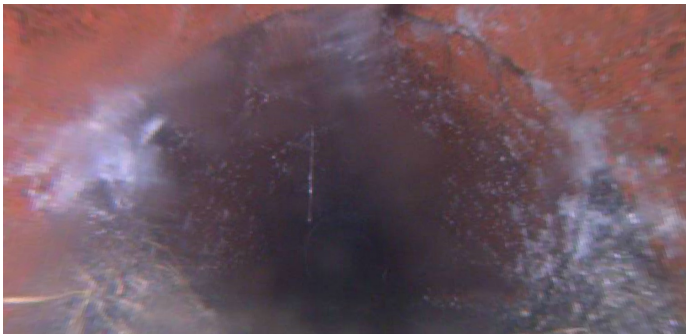
Code:	RMJ
Description:	Roots Medium Joint

Distance (ft):	22.4
Structural Grade:	0
O&M Grade:	3
Clock Start/From:	7
Clock To:	5
1st Value:	
2nd Value:	
Value Percent:	10.000
Continuous Index:	
Within 8" of Joint:	YES
Remarks:

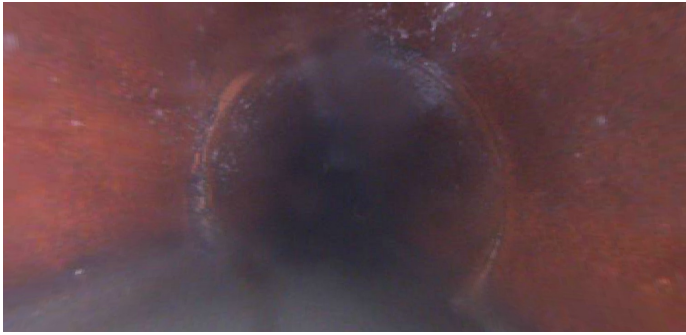
Code: **RFJ**
Description: **Roots Fine Joint**

Distance (ft): **25.0**
Structural Grade: **0**
O&M Grade: **1**
Clock Start/From: **7**
Clock To: **5**
1st Value:
2nd Value:
Value Percent:
Continuous Index:
Within 8" of Joint: **YES**
Remarks:

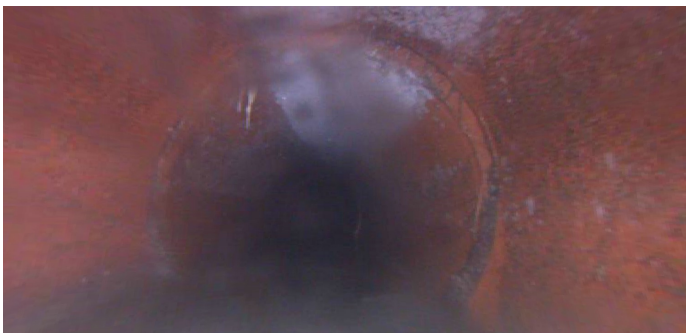
Code: **RFJ**
Description: **Roots Fine Joint**

Distance (ft): **28.0**
Structural Grade: **0**
O&M Grade: **1**
Clock Start/From: **7**
Clock To: **5**
1st Value:
2nd Value:
Value Percent:
Continuous Index:
Within 8" of Joint: **YES**
Remarks:

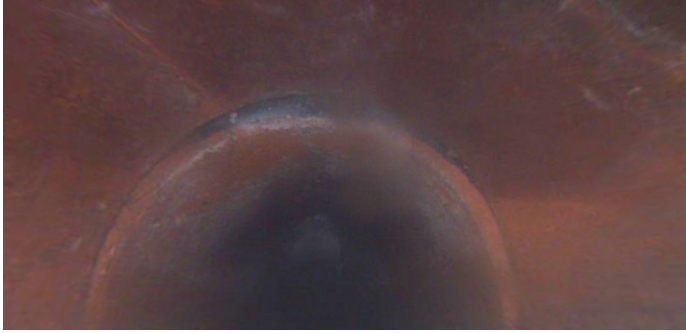
Code: **CM**
Description: **Crack Multiple**

Distance (ft): **32.6**
Structural Grade: **3**
O&M Grade: **0**
Clock Start/From: **10**
Clock To: **1**
1st Value:
2nd Value:
Value Percent:
Continuous Index:
Within 8" of Joint: **YES**
Remarks:

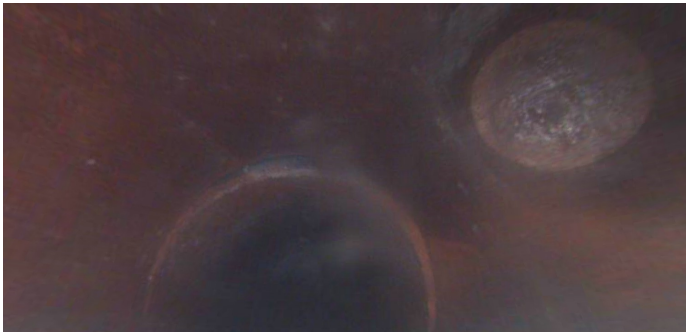
Code: **TFC**
Description: **Tap Factory Capped**

Distance (ft): **33.0**
Structural Grade: **0**
O&M Grade: **0**
Clock Start/From: **10**
Clock To:
1st Value: **4.000**
2nd Value:
Value Percent:
Continuous Index:
Within 8" of Joint:
Remarks:

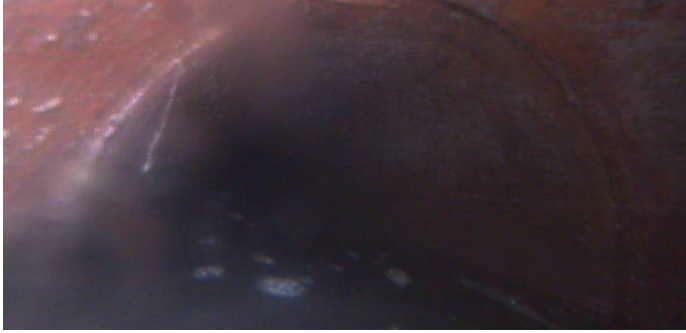
Code: **RFJ**
Description: **Roots Fine Joint**

Distance (ft): **39.7**
Structural Grade: **0**
O&M Grade: **1**
Clock Start/From: **10**
Clock To:
1st Value:
2nd Value:
Value Percent:
Continuous Index:
Within 8" of Joint: **YES**
Remarks:

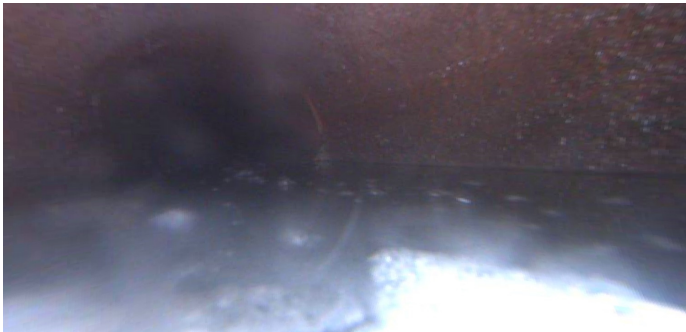
Code: **MSA**
Description: **Abandoned Survey**

Distance (ft): **41.6**
Structural Grade: **0**
O&M Grade: **0**
Clock Start/From:
Clock To:
1st Value:
2nd Value:
Value Percent:
Continuous Index:
Within 8" of Joint: **NO**
Remarks: **camera stopped**
