## Profile/Photo Observation Report

Date:	<b>09/15/2022</b>	Weather:		Coding:	<b>PACP 7.0</b>
Pipe Length (ft):	<b>177.0</b>	Owner:	<b>City of Hobart</b>	Pre Clean:	<b>Heavy Cleaning</b>
P.O.#:	<b>YES502259</b>	Surveyor:	<b>S. Bucklin</b>	PSR:	<b>P-405-049-020</b>
Customer:	<b>City of Hobart</b>	Clean Date:	<b>08/17/2022</b>	Shape:	<b>C</b>

Street:	<b>West 3rd Street</b>	Flow Control:	<b>Not Controlled</b>
City:	<b>Hobart, IN</b>	Year Renewed:	
Location:	<b>Easement/Right of Way</b>	Tape/Media #:	
Purpose:	<b>Routine Assessment</b>	Dia/Height:	<b>12"</b>
Use:	<b>Sanitary Sewage Pipe</b>	Material:	<b>VCP</b>
Drain Area:		Lining:	<b>None</b>
Category:	<b>NA</b>		
Comment:			
Location Details:	<b>IN A WOODED NOT MAINTAINED EA</b>	Direction of Survey:	<b>Downstream</b>
US MH:	<b>M-405-020</b>	DS MH:	<b>M-405-049</b>
		Total Length Surveyed (ft):	<b>171.9</b>

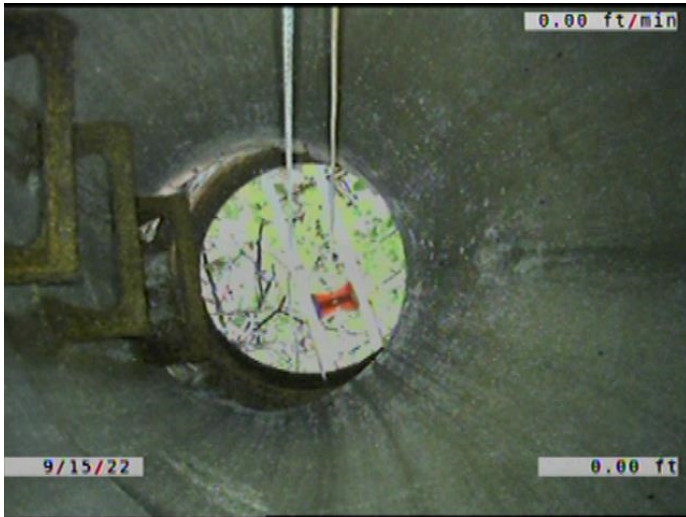
Code: **AMH**  
Description: **Manhole**

Distance (ft): **.0**  
Structural Grade: **0**  
O&M Grade: **0**  
Clock Start/From:  
Clock To:  
1st Value:  
2nd Value:  
Value Percent:  
Continuous Index:  
Within 8" of Joint: **NO**  
Remarks: **M-405-020**

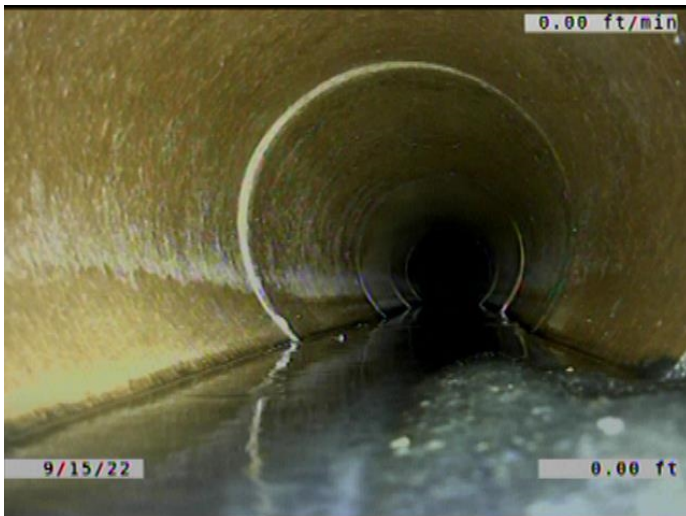
Code: **MWL**  
Description: **Miscellaneous Water Level**

Distance (ft): **.0**  
Structural Grade: **0**  
O&M Grade: **0**  
Clock Start/From:  
Clock To:  
1st Value:  
2nd Value:  
Value Percent: **5.000**  
Continuous Index:  
Within 8" of Joint: **NO**  
Remarks:

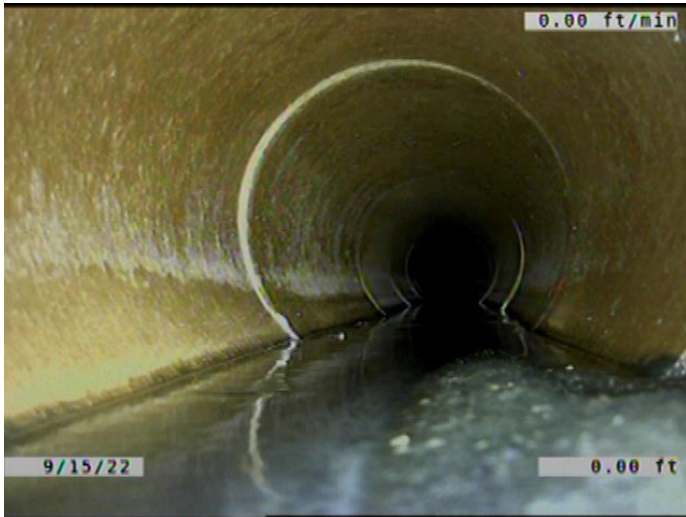
Code: **DSF**  
 Description: **Deposits Settled Fine**

Distance (ft): **.0**  
 Structural Grade: **0**  
 O&M Grade: **2**  
 Clock Start/From: **5**  
 Clock To: **7**  
 1st Value:  
 2nd Value:  
 Value Percent: **5.000**  
 Continuous Index: **S01**  
 Within 8" of Joint: **YES**  
 Remarks:

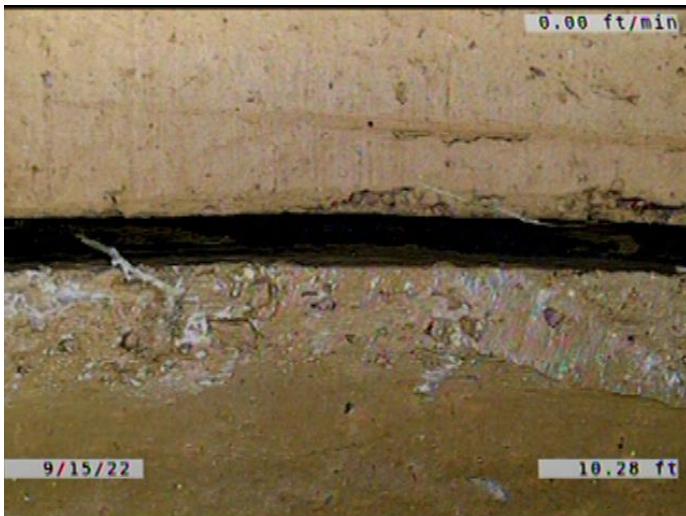
Code: **RFJ**  
 Description: **Roots Fine Joint**

Distance (ft): **10.3**  
 Structural Grade: **0**  
 O&M Grade: **1**  
 Clock Start/From: **11**  
 Clock To:  
 1st Value:  
 2nd Value:  
 Value Percent:  
 Continuous Index:  
 Within 8" of Joint: **YES**  
 Remarks:

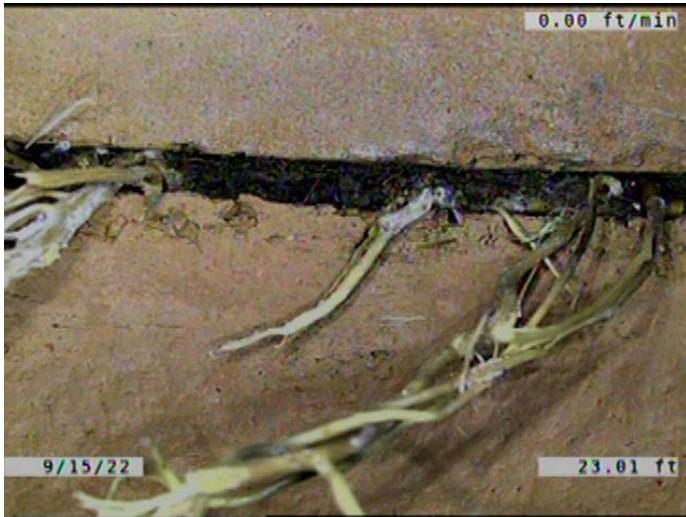
Code: **RFJ**  
Description: **Roots Fine Joint**

Distance (ft): **23.0**  
Structural Grade: **0**  
O&M Grade: **1**  
Clock Start/From: **8**  
Clock To: **4**  
1st Value:  
2nd Value:  
Value Percent:  
Continuous Index: **S02**  
Within 8" of Joint: **YES**  
Remarks:

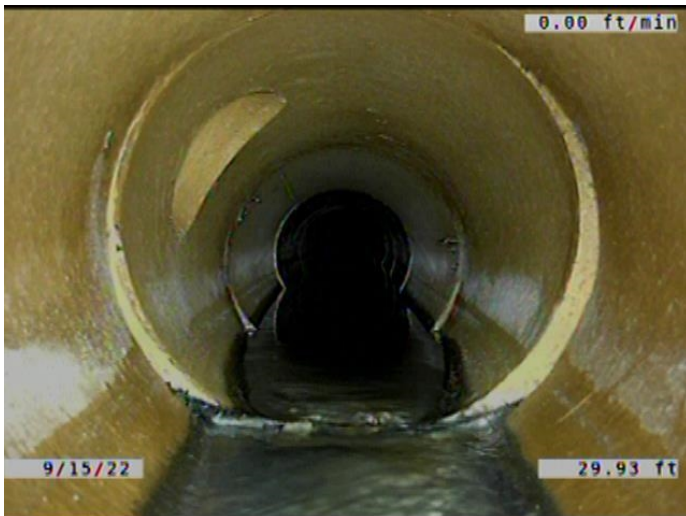
Code: **MWLS**  
Description: **Miscellaneous Water Level Sag**

Distance (ft): **29.9**  
Structural Grade: **2**  
O&M Grade: **0**  
Clock Start/From:  
Clock To:  
1st Value:  
2nd Value:  
Value Percent: **15.000**  
Continuous Index: **S03**  
Within 8" of Joint: **NO**  
Remarks:

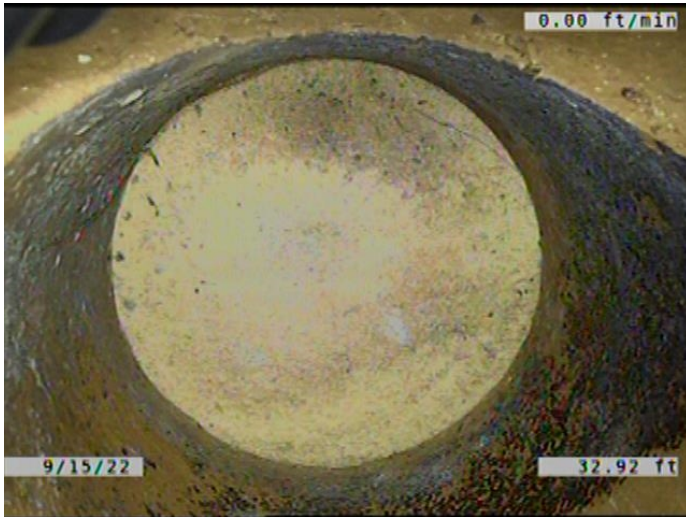
Code: **TFC**  
 Description: **Tap Factory Capped**

Distance (ft): **32.9**  
 Structural Grade: **0**  
 O&M Grade: **0**  
 Clock Start/From: **10**  
 Clock To:  
 1st Value: **6.000**  
 2nd Value:  
 Value Percent:  
 Continuous Index:  
 Within 8" of Joint: **YES**  
 Remarks:

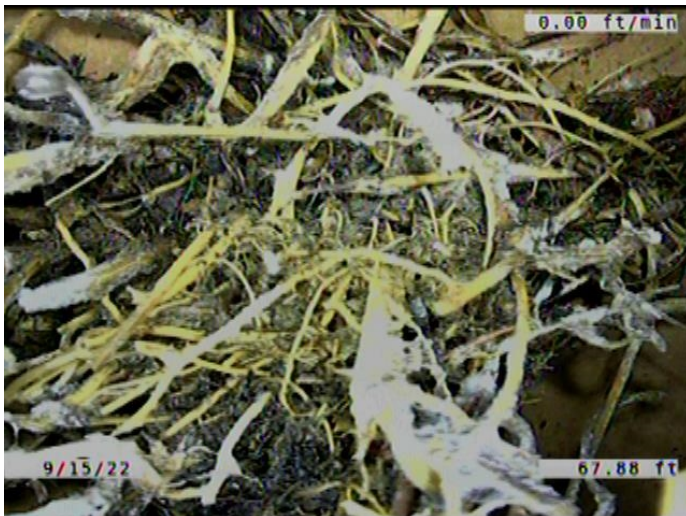
Code: **RMJ**  
 Description: **Roots Medium Joint**

Distance (ft): **67.9**  
 Structural Grade: **0**  
 O&M Grade: **3**  
 Clock Start/From: **8**  
 Clock To: **4**  
 1st Value:  
 2nd Value:  
 Value Percent: **5.000**  
 Continuous Index: **S04**  
 Within 8" of Joint: **YES**  
 Remarks:

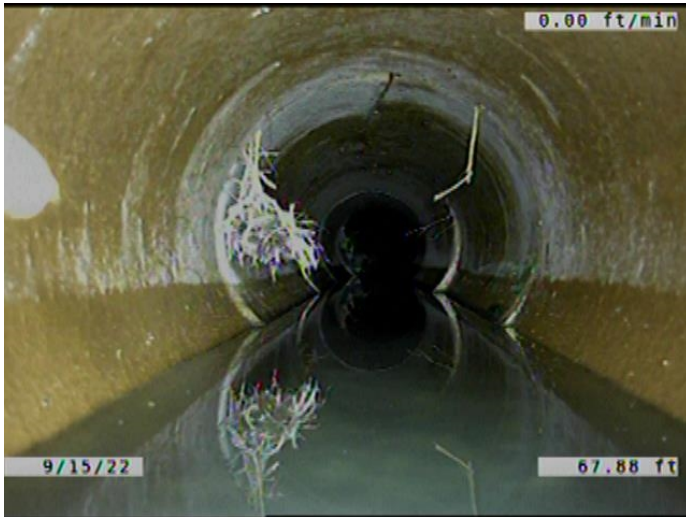
Code: **RFJ**  
Description: **Roots Fine Joint**

Distance (ft): **67.9**  
Structural Grade: **0**  
O&M Grade: **1**  
Clock Start/From: **8**  
Clock To: **4**  
1st Value:  
2nd Value:  
Value Percent:  
Continuous Index: **F02**  
Within 8" of Joint: **YES**  
Remarks:

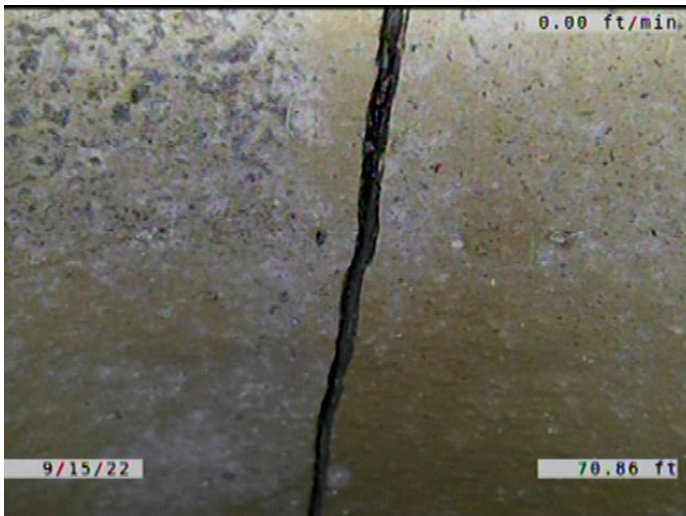
Code: **FM**  
Description: **Fracture Multiple**

Distance (ft): **70.9**  
Structural Grade: **4**  
O&M Grade: **0**  
Clock Start/From: **7**  
Clock To: **5**  
1st Value:  
2nd Value:  
Value Percent:  
Continuous Index:  
Within 8" of Joint: **YES**  
Remarks:

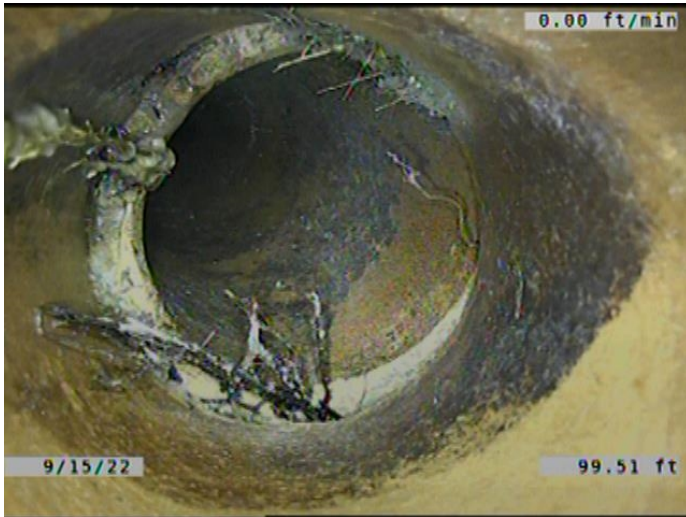
Code:	<b>TF</b>
Description:	<b>Tap Factory</b>
Distance (ft):	<b>99.5</b>
Structural Grade:	<b>0</b>
O&M Grade:	<b>0</b>
Clock Start/From:	<b>10</b>
Clock To:	
1st Value:	<b>6.000</b>
2nd Value:	
Value Percent:	
Continuous Index:	
Within 8" of Joint:	<b>YES</b>
Remarks:	<b>ROOTS GROWING FROM THE SERVICE TO MAIN CONNECTION. SE</b>

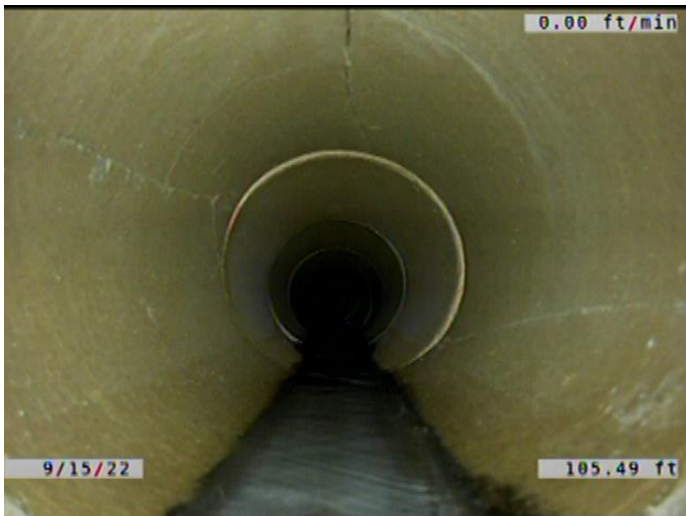
Code:	<b>MWLS</b>
Description:	<b>Miscellaneous Water Level Sag</b>
Distance (ft):	<b>105.5</b>
Structural Grade:	<b>2</b>
O&M Grade:	<b>0</b>
Clock Start/From:	
Clock To:	
1st Value:	
2nd Value:	
Value Percent:	<b>15.000</b>
Continuous Index:	<b>F03</b>
Within 8" of Joint:	<b>NO</b>
Remarks:

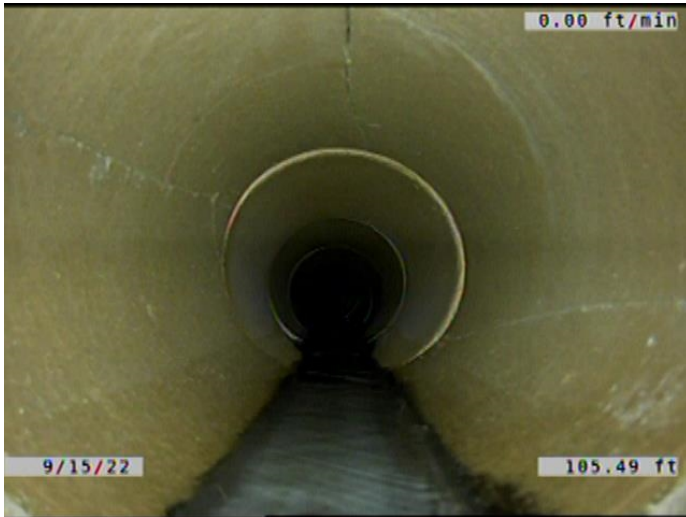
Code: **RMJ**  
Description: **Roots Medium Joint**

Distance (ft): **105.5**  
Structural Grade: **0**  
O&M Grade: **3**  
Clock Start/From: **8**  
Clock To: **4**  
1st Value:  
2nd Value:  
Value Percent: **5.000**  
Continuous Index: **F04**  
Within 8" of Joint: **YES**  
Remarks:

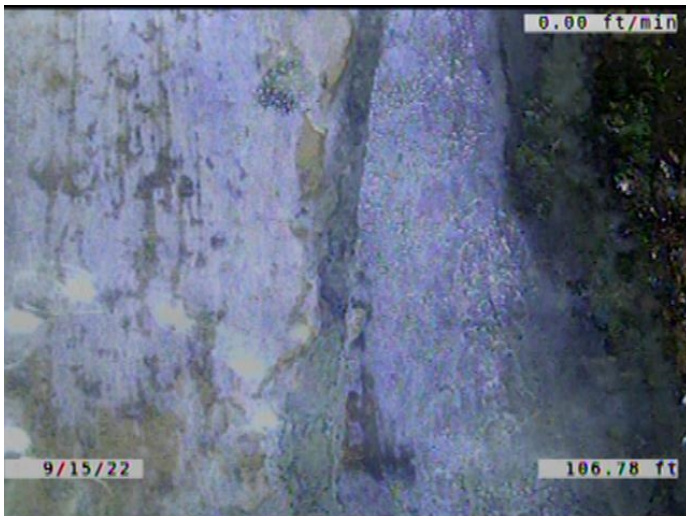
Code: **FM**  
Description: **Fracture Multiple**

Distance (ft): **106.8**  
Structural Grade: **4**  
O&M Grade: **0**  
Clock Start/From: **12**  
Clock To: **12**  
1st Value:  
2nd Value:  
Value Percent:  
Continuous Index:  
Within 8" of Joint: **YES**  
Remarks:

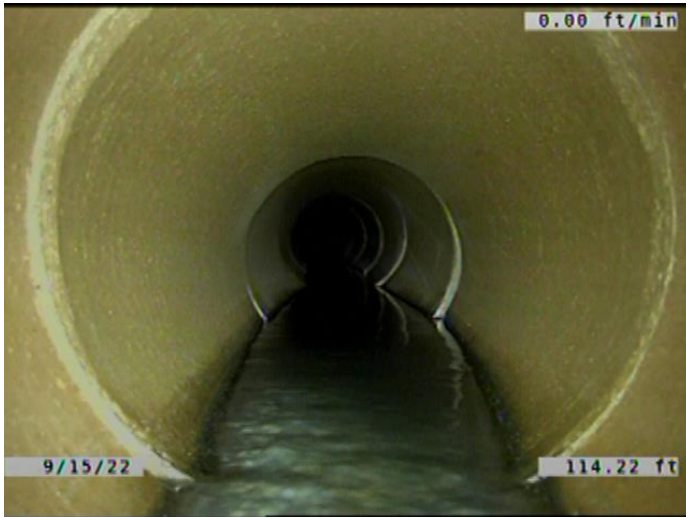
Code: **MWLS**  
Description: **Miscellaneous Water Level Sag**

Distance (ft): **114.2**  
Structural Grade: **2**  
O&M Grade: **0**  
Clock Start/From:  
Clock To:  
1st Value:  
2nd Value:  
Value Percent: **10.000**  
Continuous Index: **S05**  
Within 8" of Joint: **NO**  
Remarks:

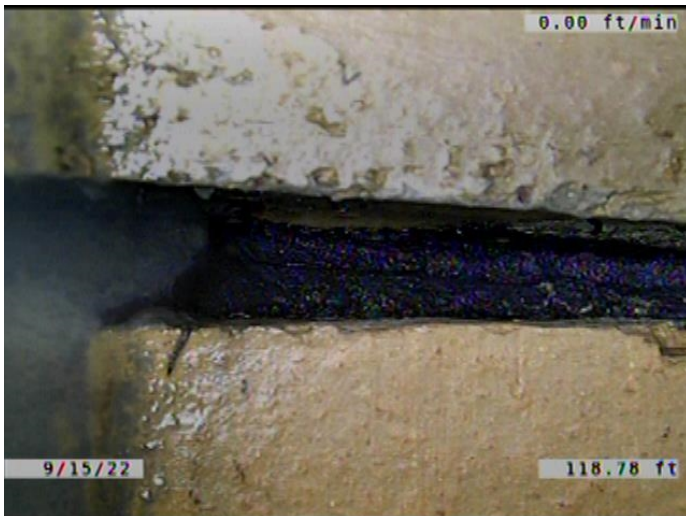
Code: **JAM**  
Description: **Joint Angular Medium**

Distance (ft): **118.8**  
Structural Grade: **3**  
O&M Grade: **0**  
Clock Start/From:  
Clock To:  
1st Value:  
2nd Value:  
Value Percent:  
Continuous Index:  
Within 8" of Joint: **NO**  
Remarks:

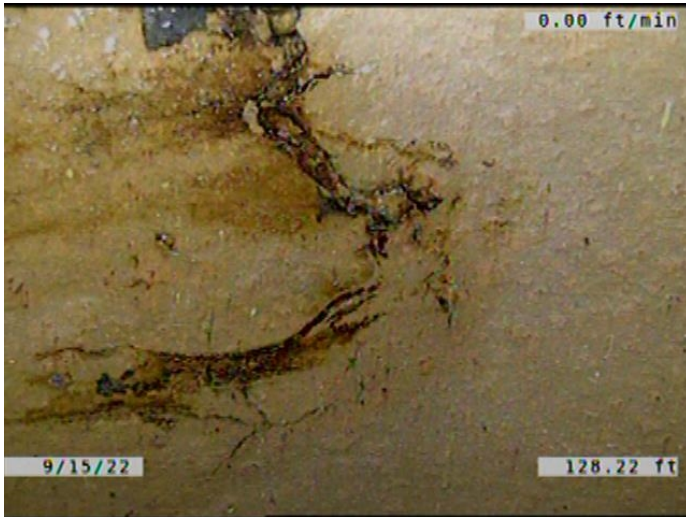
Code: **CM**  
 Description: **Crack Multiple**

Distance (ft): **128.2**  
 Structural Grade: **3**  
 O&M Grade: **0**  
 Clock Start/From: **9**  
 Clock To: **11**  
 1st Value:  
 2nd Value:  
 Value Percent:  
 Continuous Index:  
 Within 8" of Joint: **YES**  
 Remarks:

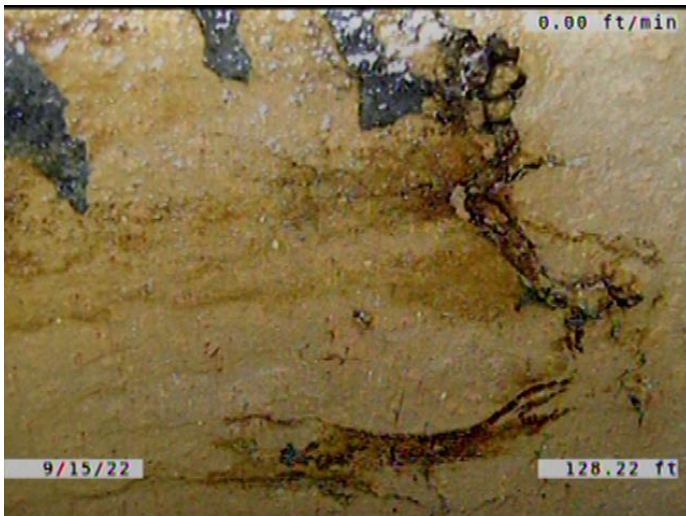
Code: **ISB**  
 Description: **Infiltration Stain Barrel**

Distance (ft): **128.2**  
 Structural Grade: **0**  
 O&M Grade: **1**  
 Clock Start/From: **8**  
 Clock To: **11**  
 1st Value:  
 2nd Value:  
 Value Percent:  
 Continuous Index:  
 Within 8" of Joint: **YES**  
 Remarks:

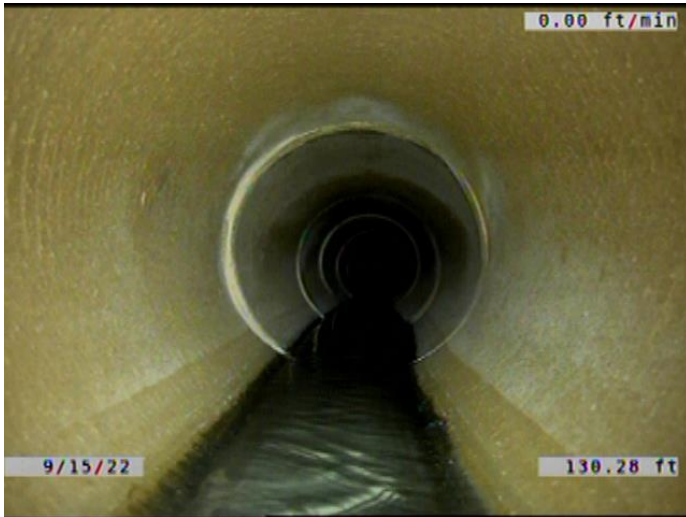
Code: **MWLS**  
 Description: **Miscellaneous Water Level Sag**

Distance (ft): **130.3**  
 Structural Grade: **2**  
 O&M Grade: **0**  
 Clock Start/From:  
 Clock To:  
 1st Value:  
 2nd Value:  
 Value Percent: **10.000**  
 Continuous Index: **F05**  
 Within 8" of Joint: **NO**  
 Remarks:

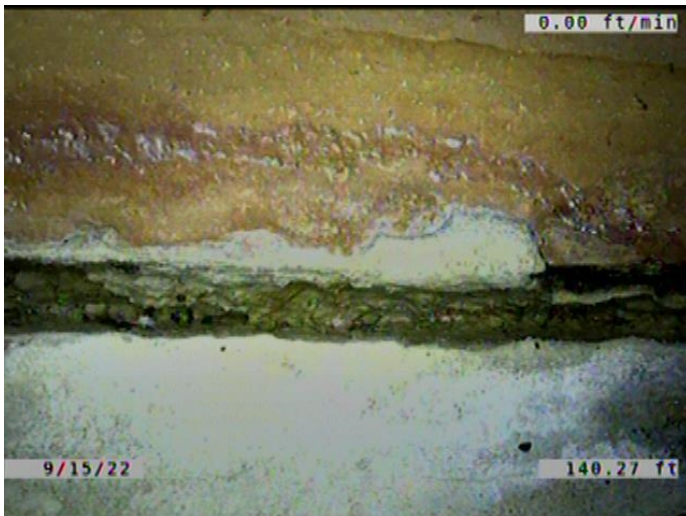
Code: **DAE**  
 Description: **Deposits Attached Encrustation**

Distance (ft): **140.3**  
 Structural Grade: **0**  
 O&M Grade: **2**  
 Clock Start/From: **8**  
 Clock To: **1**  
 1st Value:  
 2nd Value:  
 Value Percent: **5.000**  
 Continuous Index:  
 Within 8" of Joint: **YES**  
 Remarks:

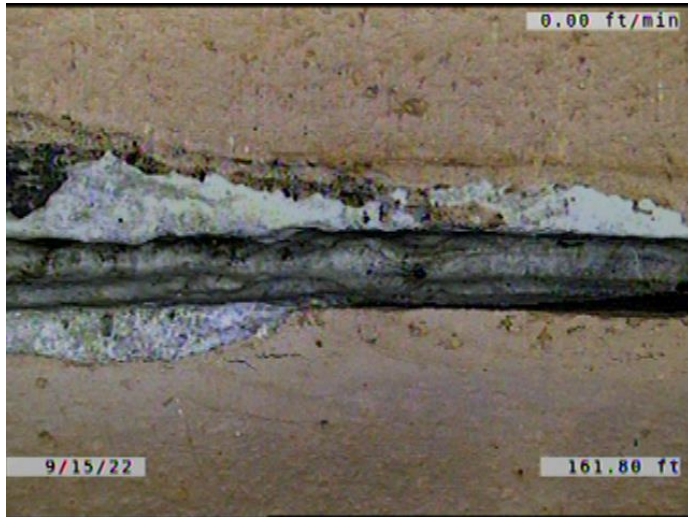
Code: **DAE**  
 Description: **Deposits Attached Encrustation**

Distance (ft): **161.8**  
 Structural Grade: **0**  
 O&M Grade: **2**  
 Clock Start/From: **8**  
 Clock To: **4**  
 1st Value:  
 2nd Value:  
 Value Percent: **5.000**  
 Continuous Index:  
 Within 8" of Joint: **YES**  
 Remarks:

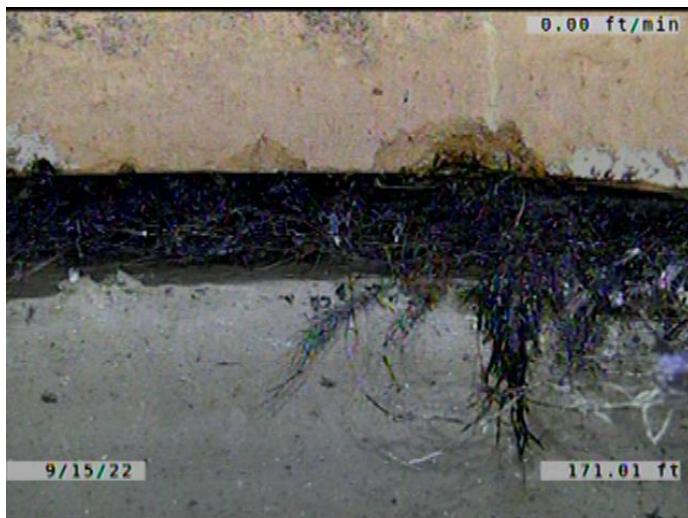
Code: **RFJ**  
 Description: **Roots Fine Joint**

Distance (ft): **171.0**  
 Structural Grade: **0**  
 O&M Grade: **1**  
 Clock Start/From: **9**  
 Clock To: **3**  
 1st Value:  
 2nd Value:  
 Value Percent:  
 Continuous Index:  
 Within 8" of Joint: **YES**  
 Remarks:

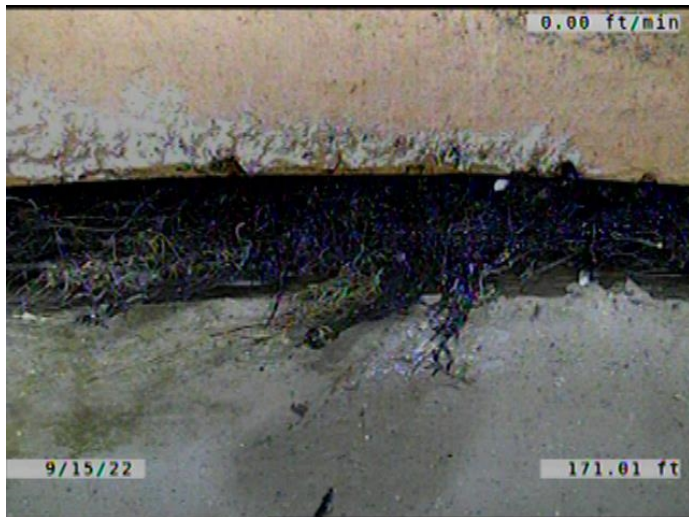
Code: **IWJ**  
 Description: **Infiltration Weeper Joint**

Distance (ft): **171.0**  
 Structural Grade: **0**  
 O&M Grade: **2**  
 Clock Start/From: **11**  
 Clock To:  
 1st Value:  
 2nd Value:  
 Value Percent:  
 Continuous Index:  
 Within 8" of Joint: **YES**  
 Remarks:

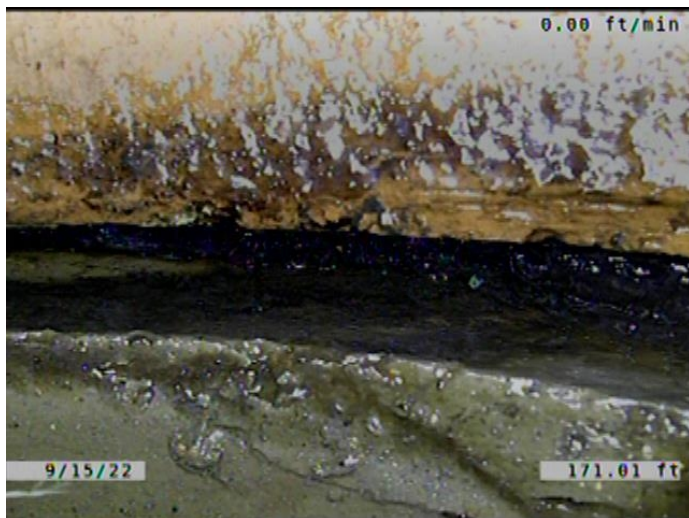
Code: **ISJ**  
 Description: **Infiltration Stain Joint**

Distance (ft): **171.0**  
 Structural Grade: **0**  
 O&M Grade: **1**  
 Clock Start/From: **3**  
 Clock To: **5**  
 1st Value:  
 2nd Value:  
 Value Percent:  
 Continuous Index:  
 Within 8" of Joint: **YES**  
 Remarks:

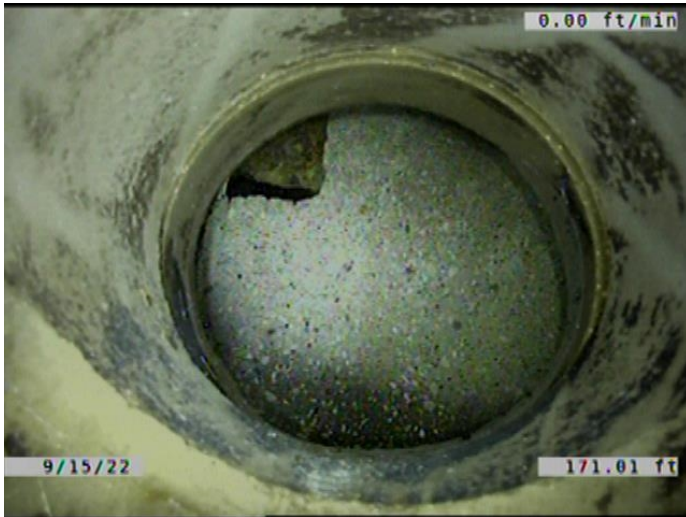
Code: **DSF**  
 Description: **Deposits Settled Fine**

Distance (ft): **171.0**  
 Structural Grade: **0**  
 O&M Grade: **2**  
 Clock Start/From: **5**  
 Clock To: **7**  
 1st Value:  
 2nd Value:  
 Value Percent: **5.000**  
 Continuous Index: **F01**  
 Within 8" of Joint: **YES**  
 Remarks:

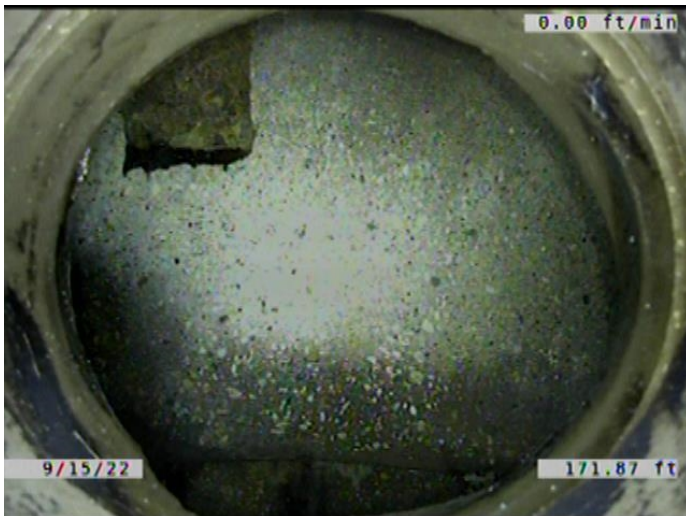
Code: **AMH**  
 Description: **Manhole**

Distance (ft): **171.9**  
 Structural Grade: **0**  
 O&M Grade: **0**  
 Clock Start/From:  
 Clock To:  
 1st Value:  
 2nd Value:  
 Value Percent:  
 Continuous Index:  
 Within 8" of Joint: **NO**  
 Remarks: **M-405-049**
