Profile/Photo Observation Report

Date:	04/16/2018	Weather:		Coding:	PACP 6.0
Pipe Length (ft):	289.0	Owner:	NA	Pre Clean:	No Pre-Cleaning
P.O.#:		Surveyor:	Selasie Honu	PSR:	P-405-021-020
Customer:		Clean Date:	01/01/1900	Shape:	C

Street:	W 3RD ST	Flow Control:	Not Controlled
City:	Hobart, IN	Year Renewed:	
Location:	Yard	Tape/Media #:	
Purpose:	Routine Assessment	Dia/Height:	12"
Use:	Sanitary	Material:	VCP
Drain Area:	NA	Lining:	
Category:	NA		
Comment:			
Location Details:		Direction of Survey:	Upstream
US MH:	M-405-021	DS MH:	M-405-020
		Total Length Surveyed (ft):	156.1

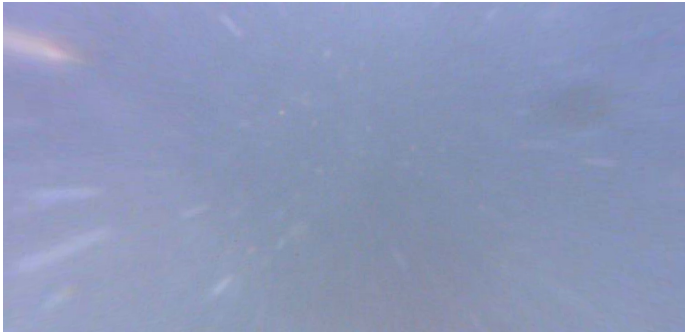
Code: **MWLS**
Description: **Water Level Sag**

Distance (ft): **.9**
Structural Grade: **2**
O&M Grade: **3**
Clock Start/From:
Clock To:
1st Value:
2nd Value:
Value Percent: **15.000**
Continuous Index: **S01**
Within 8" of Joint: **NO**
Remarks:

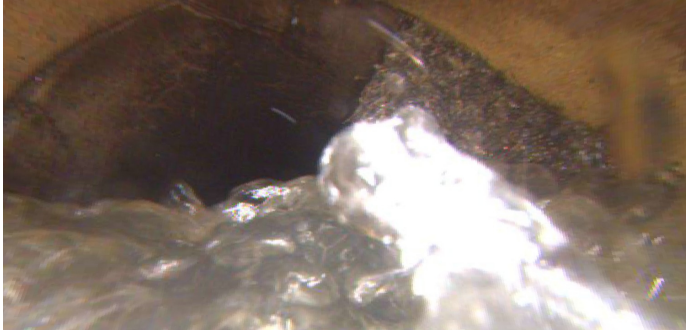
Code: **RMJ**
Description: **Roots Medium Joint**

Distance (ft): **6.7**
Structural Grade: **0**
O&M Grade: **3**
Clock Start/From: **1**
Clock To: **5**
1st Value:
2nd Value:
Value Percent: **15.000**
Continuous Index:
Within 8" of Joint: **YES**
Remarks:

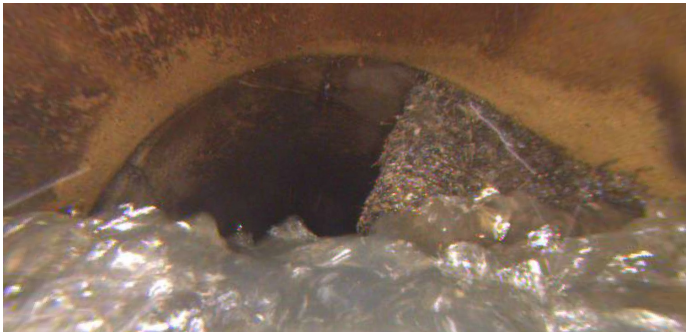
Code: **CM**
Description: **Crack Multiple**

Distance (ft): **6.8**
Structural Grade: **3**
O&M Grade: **0**
Clock Start/From: **11**
Clock To: **1**
1st Value:
2nd Value:
Value Percent:
Continuous Index:
Within 8" of Joint: **YES**
Remarks:

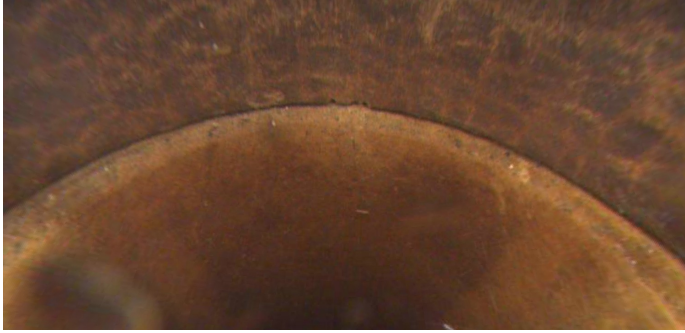
Code: **CM**
Description: **Crack Multiple**

Distance (ft): **12.6**
Structural Grade: **3**
O&M Grade: **0**
Clock Start/From: **10**
Clock To: **2**
1st Value:
2nd Value:
Value Percent:
Continuous Index:
Within 8" of Joint: **YES**
Remarks:

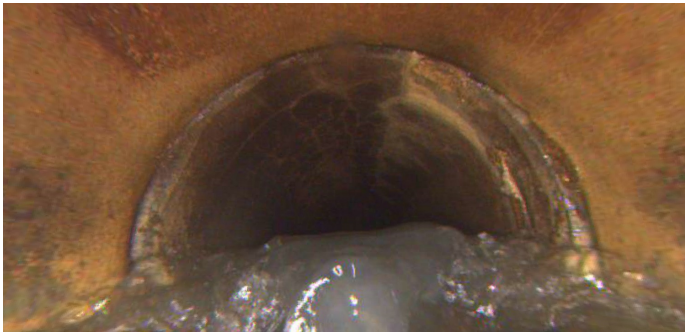
Code: **CM**
Description: **Crack Multiple**

Distance (ft): **15.9**
Structural Grade: **3**
O&M Grade: **0**
Clock Start/From: **8**
Clock To: **4**
1st Value:
2nd Value:
Value Percent:
Continuous Index:
Within 8" of Joint: **YES**
Remarks:

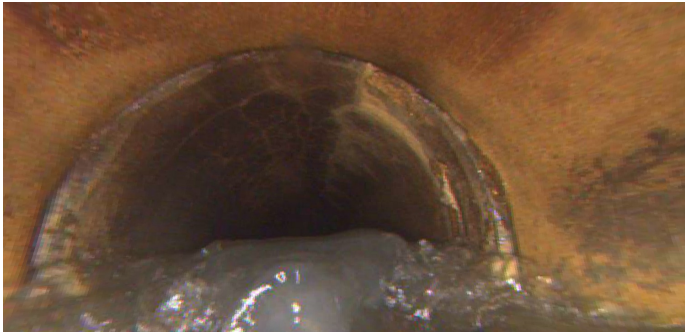
Code: **DAE**
Description: **Deposits Attached Encrustation**

Distance (ft): **15.9**
Structural Grade: **0**
O&M Grade: **2**
Clock Start/From: **1**
Clock To: **4**
1st Value:
2nd Value:
Value Percent: **10.000**
Continuous Index:
Within 8" of Joint: **YES**
Remarks:

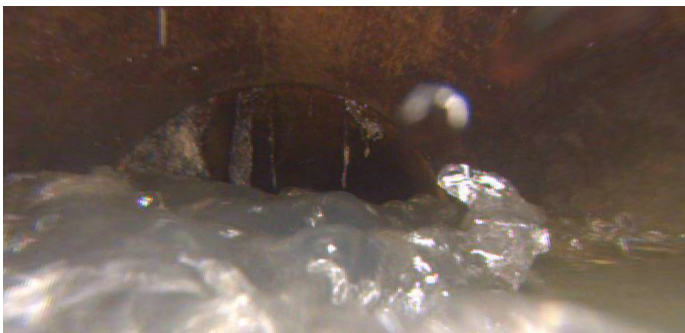
Code: **RMJ**
Description: **Roots Medium Joint**

Distance (ft): **23.3**
Structural Grade: **0**
O&M Grade: **3**
Clock Start/From: **10**
Clock To: **1**
1st Value:
2nd Value:
Value Percent: **15.000**
Continuous Index:
Within 8" of Joint: **YES**
Remarks:

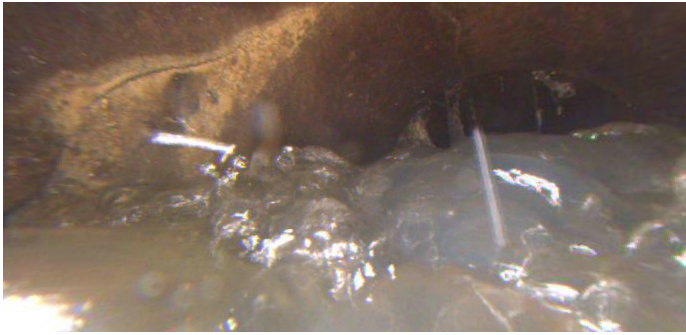
Code: **FC**
Description: **Fracture Circumferential**

Distance (ft): **23.9**
Structural Grade: **2**
O&M Grade: **0**
Clock Start/From: **12**
Clock To: **4**
1st Value:
2nd Value:
Value Percent:
Continuous Index:
Within 8" of Joint:
Remarks:

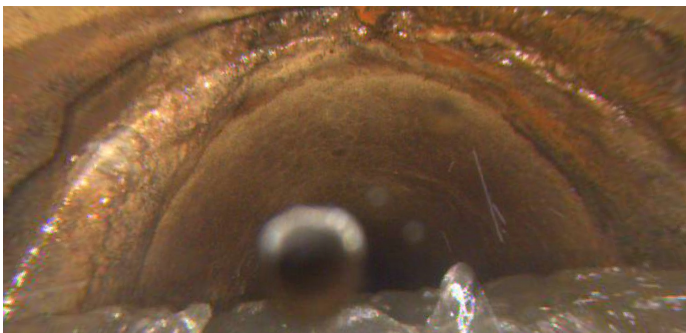
Code: **ID**
Description: **Infil Dripper**

Distance (ft): **41.1**
Structural Grade: **0**
O&M Grade: **3**
Clock Start/From: **12**
Clock To:
1st Value:
2nd Value:
Value Percent:
Continuous Index:
Within 8" of Joint: **YES**
Remarks:

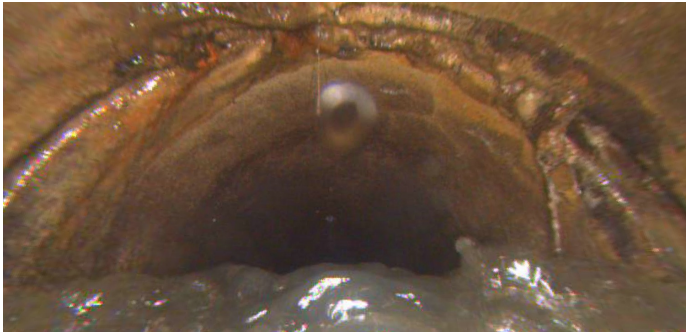
Code: **RFJ**
Description: **Roots Fine Joint**

Distance (ft): **53.1**
Structural Grade: **0**
O&M Grade: **1**
Clock Start/From: **11**
Clock To: **12**
1st Value:
2nd Value:
Value Percent:
Continuous Index:
Within 8" of Joint: **YES**
Remarks:

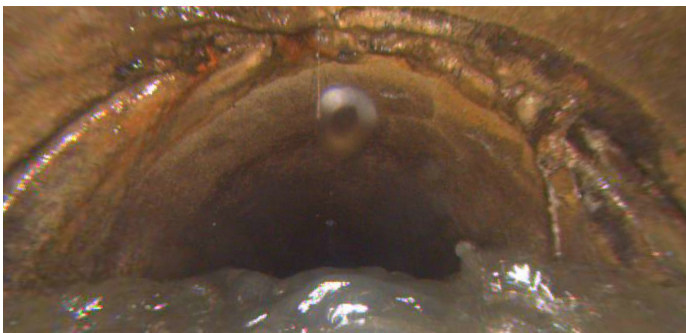
Code: **IW**
Description: **Infil Weeper**

Distance (ft): **53.1**
Structural Grade: **0**
O&M Grade: **2**
Clock Start/From: **8**
Clock To: **4**
1st Value:
2nd Value:
Value Percent:
Continuous Index:
Within 8" of Joint: **YES**
Remarks:

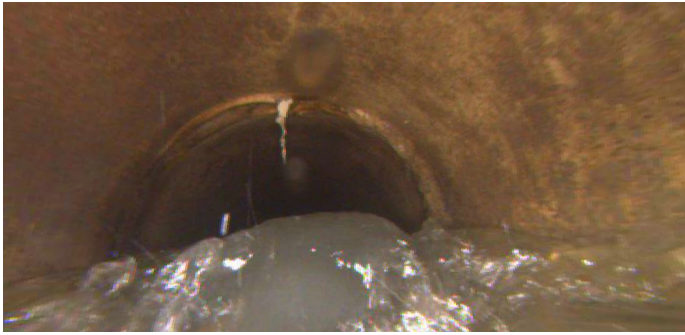
Code: **RFJ**
Description: **Roots Fine Joint**

Distance (ft): **59.8**
Structural Grade: **0**
O&M Grade: **1**
Clock Start/From: **12**
Clock To:
1st Value:
2nd Value:
Value Percent:
Continuous Index:
Within 8" of Joint: **YES**
Remarks:

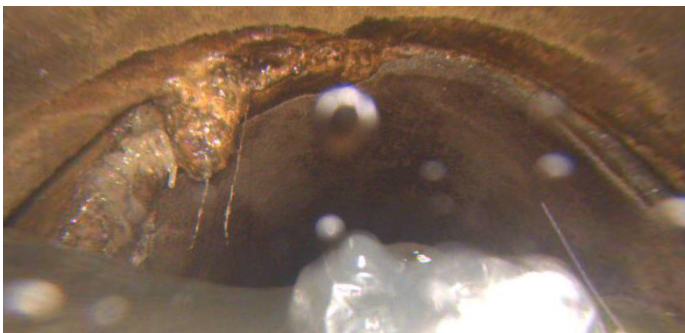
Code: **DAE**
Description: **Deposits Attached Encrustation**

Distance (ft): **62.3**
Structural Grade: **0**
O&M Grade: **2**
Clock Start/From: **12**
Clock To: **3**
1st Value:
2nd Value:
Value Percent: **5.000**
Continuous Index:
Within 8" of Joint: **YES**
Remarks:

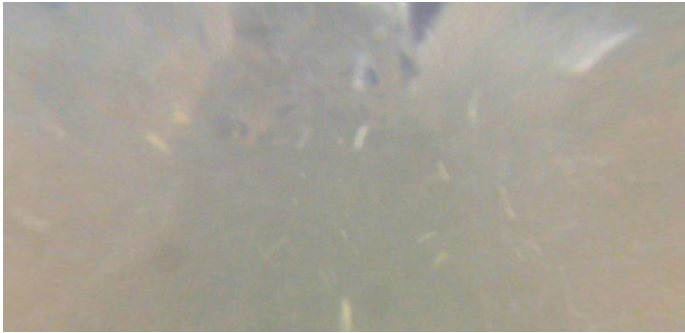
Code: **MCU**
Description: **Camera Underwater**

Distance (ft): **66.6**
Structural Grade: **0**
O&M Grade: **4**
Clock Start/From:
Clock To:
1st Value:
2nd Value:
Value Percent:
Continuous Index: **S02**
Within 8" of Joint: **NO**
Remarks:

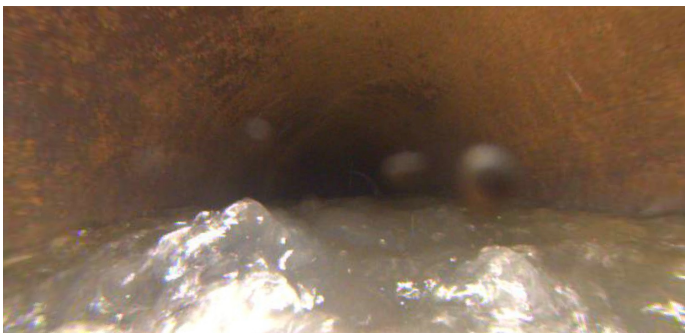
Code: **MCU**
Description: **Camera Underwater**

Distance (ft): **94.0**
Structural Grade: **0**
O&M Grade: **4**
Clock Start/From:
Clock To:
1st Value:
2nd Value:
Value Percent:
Continuous Index: **F02**
Within 8" of Joint: **NO**
Remarks:

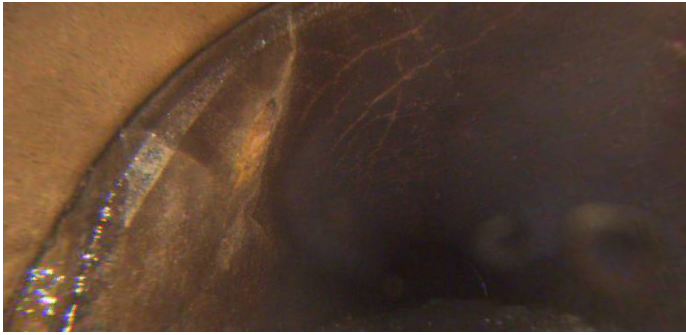
Code: **CM**
Description: **Crack Multiple**

Distance (ft): **98.5**
Structural Grade: **3**
O&M Grade: **0**
Clock Start/From: **12**
Clock To: **4**
1st Value:
2nd Value:
Value Percent:
Continuous Index:
Within 8" of Joint: **YES**
Remarks:

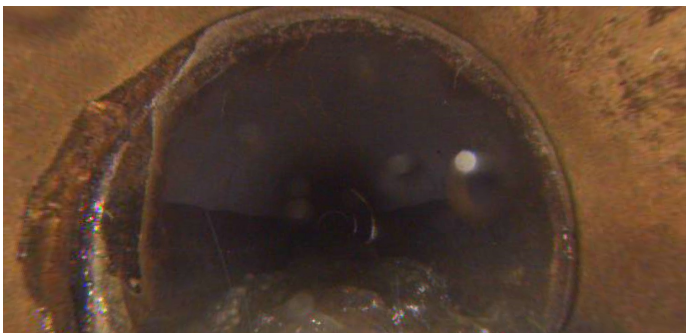
Code: **IW**
Description: **Infil Weeper**

Distance (ft): **126.0**
Structural Grade: **0**
O&M Grade: **2**
Clock Start/From: **1**
Clock To: **4**
1st Value:
2nd Value:
Value Percent:
Continuous Index:
Within 8" of Joint: **YES**
Remarks:

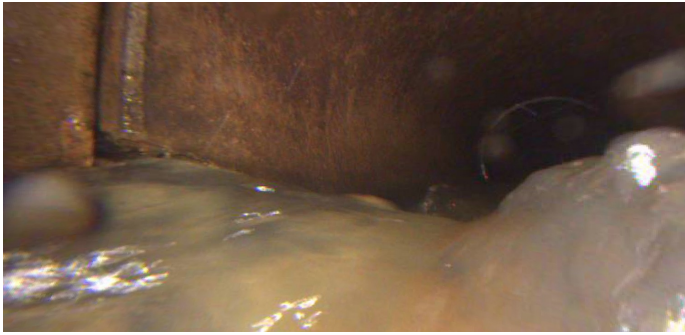
Code: **FL**
Description: **Fracture Longitudinal**

Distance (ft): **128.5**
Structural Grade: **3**
O&M Grade: **0**
Clock Start/From: **3**
Clock To:
1st Value:
2nd Value:
Value Percent:
Continuous Index:
Within 8" of Joint: **YES**
Remarks:

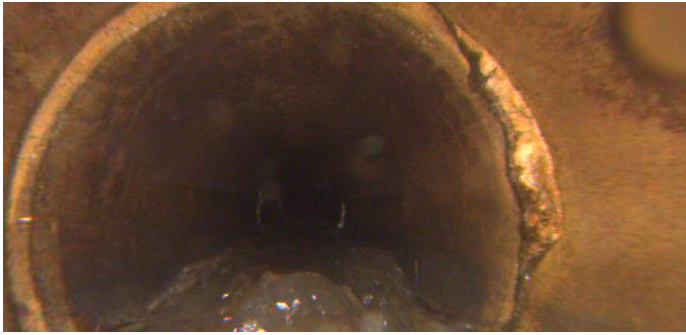
Code: **DAE**
Description: **Deposits Attached Encrustation**

Distance (ft): **144.1**
Structural Grade: **0**
O&M Grade: **2**
Clock Start/From: **9**
Clock To: **11**
1st Value:
2nd Value:
Value Percent: **5.000**
Continuous Index:
Within 8" of Joint: **YES**
Remarks:

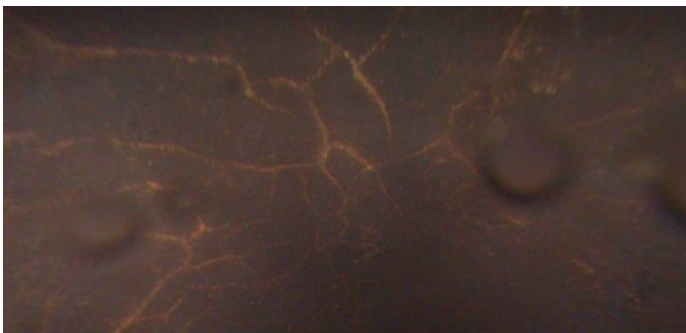
Code: **CM**
Description: **Crack Multiple**

Distance (ft): **149.5**
Structural Grade: **3**
O&M Grade: **0**
Clock Start/From: **8**
Clock To: **4**
1st Value:
2nd Value:
Value Percent:
Continuous Index:
Within 8" of Joint: **YES**
Remarks:

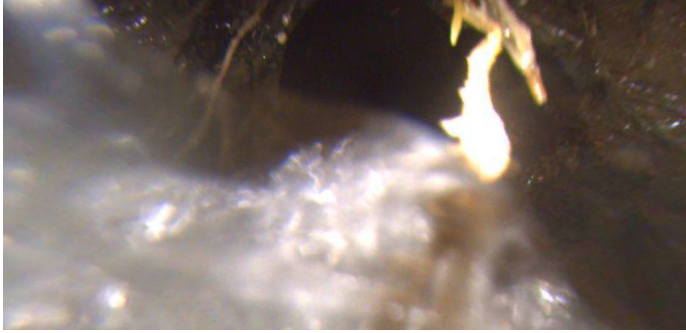
Code: **TBD**
Description: **Tap Break-in Defective**

Distance (ft): **153.1**
Structural Grade: **0**
O&M Grade: **3**
Clock Start/From: **12**
Clock To:
1st Value: **4.000**
2nd Value:
Value Percent:
Continuous Index:
Within 8" of Joint:
Remarks: **ROOTS**

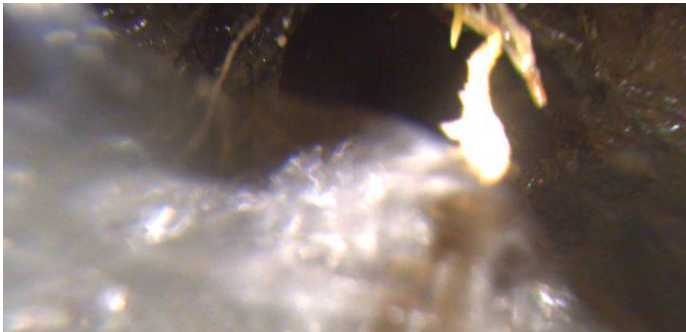
Code: **RFC**
Description: **Roots Fine Connection**

Distance (ft): **153.1**
Structural Grade: **0**
O&M Grade: **1**
Clock Start/From: **11**
Clock To: **1**
1st Value:
2nd Value:
Value Percent:
Continuous Index:
Within 8" of Joint: **NO**
Remarks:

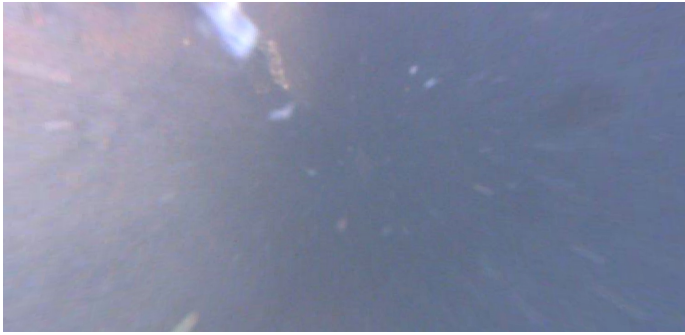
Code: **MWLS**
Description: **Water Level Sag**

Distance (ft): **156.1**
Structural Grade: **2**
O&M Grade: **3**
Clock Start/From:
Clock To:
1st Value:
2nd Value:
Value Percent: **15.000**
Continuous Index: **F01**
Within 8" of Joint: **NO**
Remarks:
