Profile/Photo Observation Report

Street:	FOXCROFT STREET	Flow Control:	Not Controlled
City:	Hobart, IN	Year Renewed:	
Location:	Yard	Tape/Media #:	
Purpose:	Routine Assessment	Dia/Height:	12"
Use:	Sanitary	Material:	VCP
Drain Area:	NA	Lining:	
Category:	NA		
Comment:

Location Details:		Direction of Survey:	Upstream
US MH:	M-405-021	DS MH:	M-405-020
		Total Length Surveyed (ft):	156.1

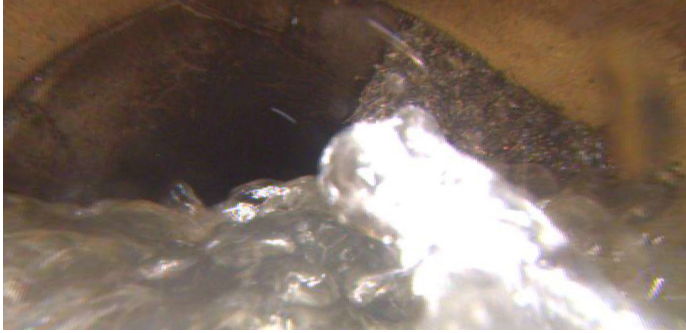
Code: **RMJ**
Description: **Roots Medium Joint**

Distance (ft): **6.7**
Structural Grade: **0**
O&M Grade: **3**
Clock Start/From: **1**
Clock To: **5**
1st Value:
2nd Value:
Value Percent: **15.000**
Continuous Index:
Within 8" of Joint: **YES**
Remarks:

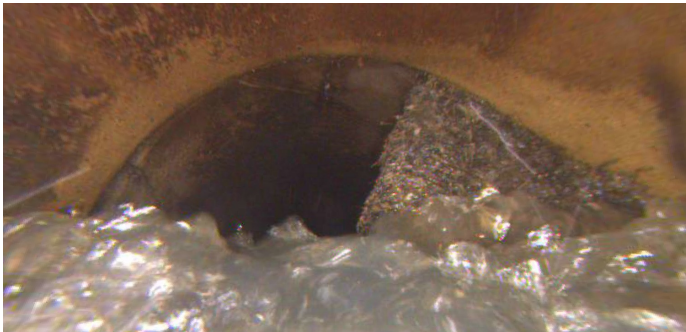
Code: **CM**
Description: **Crack Multiple**

Distance (ft): **6.8**
Structural Grade: **3**
O&M Grade: **0**
Clock Start/From: **11**
Clock To: **1**
1st Value:
2nd Value:
Value Percent:
Continuous Index:
Within 8" of Joint: **YES**
Remarks:

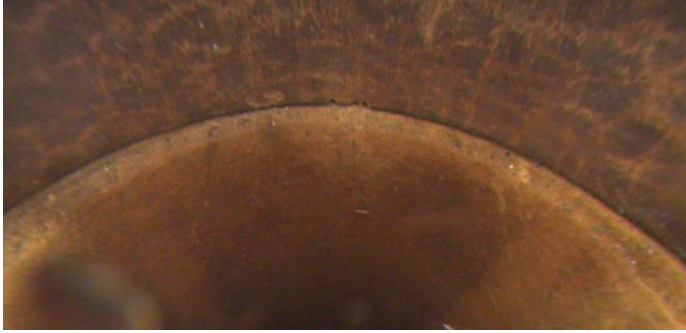
Code: **CM**
Description: **Crack Multiple**

Distance (ft): **12.6**
Structural Grade: **3**
O&M Grade: **0**
Clock Start/From: **10**
Clock To: **2**
1st Value:
2nd Value:
Value Percent:
Continuous Index:
Within 8" of Joint: **YES**
Remarks:

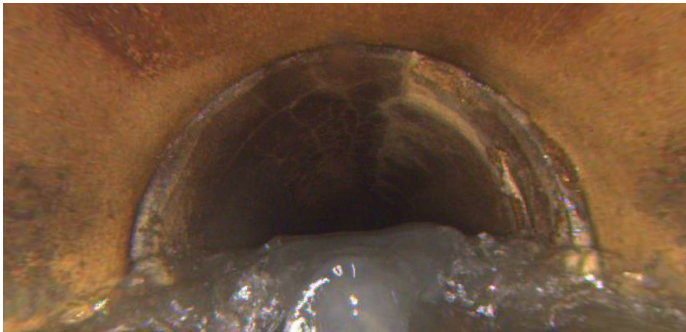
Code: **CM**
Description: **Crack Multiple**

Distance (ft): **15.9**
Structural Grade: **3**
O&M Grade: **0**
Clock Start/From: **8**
Clock To: **4**
1st Value:
2nd Value:
Value Percent:
Continuous Index:
Within 8" of Joint: **YES**
Remarks:

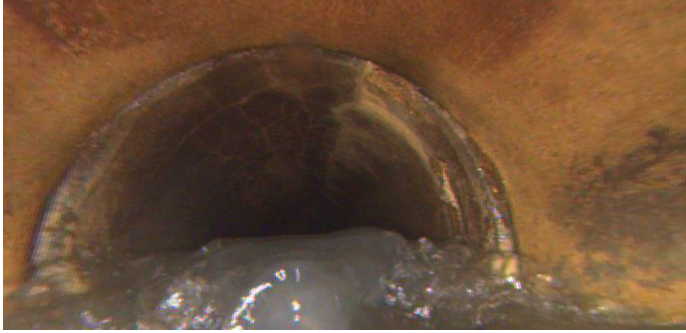
Code: **DAE**
Description: **Deposits Attached Encrustation**

Distance (ft): **15.9**
Structural Grade: **0**
O&M Grade: **2**
Clock Start/From: **1**
Clock To: **4**
1st Value:
2nd Value:
Value Percent: **10.000**
Continuous Index:
Within 8" of Joint: **YES**
Remarks:

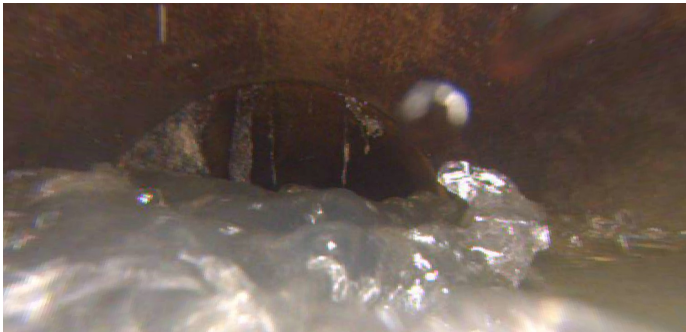
Code: **RMJ**
Description: **Roots Medium Joint**

Distance (ft): **23.3**
Structural Grade: **0**
O&M Grade: **3**
Clock Start/From: **10**
Clock To: **1**
1st Value:
2nd Value:
Value Percent: **15.000**
Continuous Index:
Within 8" of Joint: **YES**
Remarks:

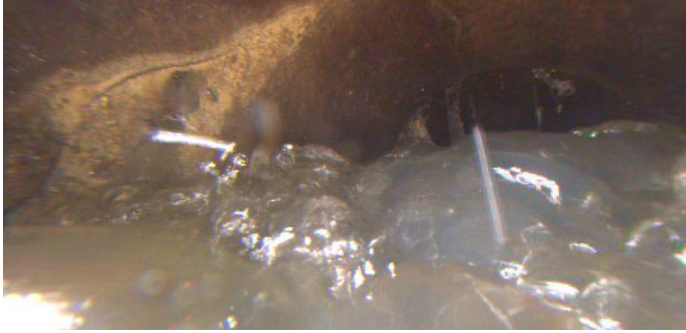
Code: **FC**
Description: **Fracture Circumferential**

Distance (ft): **23.9**
Structural Grade: **2**
O&M Grade: **0**
Clock Start/From: **12**
Clock To: **4**
1st Value:
2nd Value:
Value Percent:
Continuous Index:
Within 8" of Joint:
Remarks:

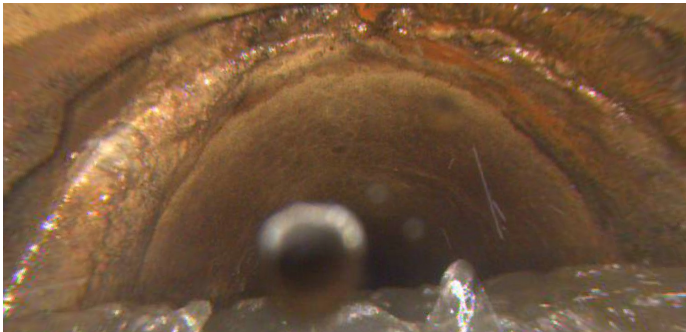
Code: **ID**
Description: **Infil Dripper**

Distance (ft): **41.1**
Structural Grade: **0**
O&M Grade: **3**
Clock Start/From: **12**
Clock To:
1st Value:
2nd Value:
Value Percent:
Continuous Index:
Within 8" of Joint: **YES**
Remarks:

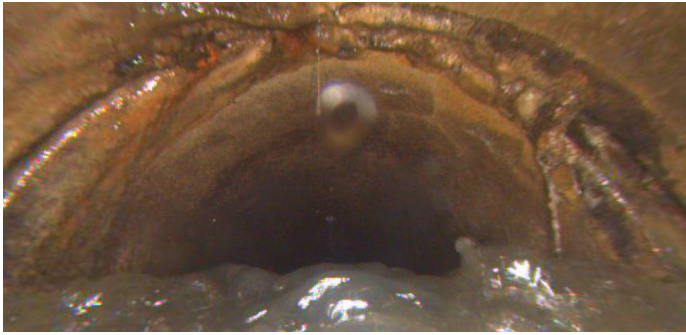
Code: **RFJ**
Description: **Roots Fine Joint**

Distance (ft): **53.1**
Structural Grade: **0**
O&M Grade: **1**
Clock Start/From: **11**
Clock To: **12**
1st Value:
2nd Value:
Value Percent:
Continuous Index:
Within 8" of Joint: **YES**
Remarks:

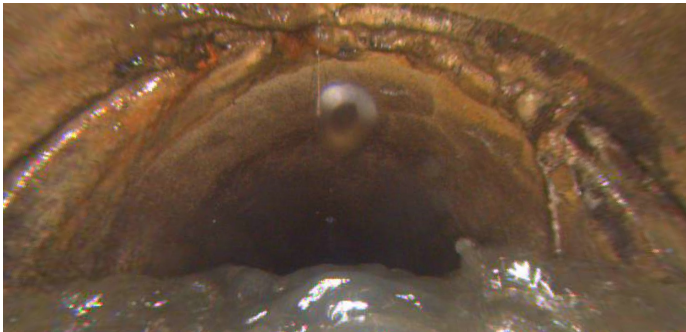
Code: **IW**
Description: **Infil Weeper**

Distance (ft): **53.1**
Structural Grade: **0**
O&M Grade: **2**
Clock Start/From: **8**
Clock To: **4**
1st Value:
2nd Value:
Value Percent:
Continuous Index:
Within 8" of Joint: **YES**
Remarks:

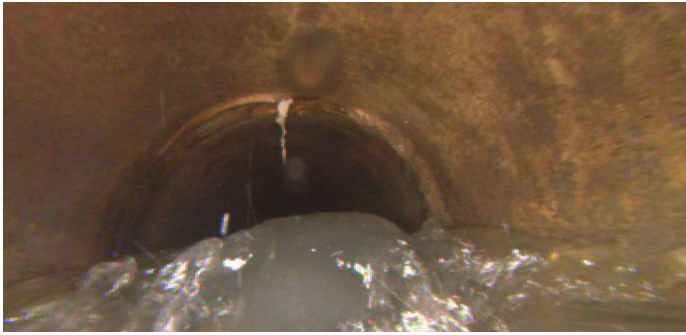
Code: **RFJ**
Description: **Roots Fine Joint**

Distance (ft): **59.8**
Structural Grade: **0**
O&M Grade: **1**
Clock Start/From: **12**
Clock To:
1st Value:
2nd Value:
Value Percent:
Continuous Index:
Within 8" of Joint: **YES**
Remarks:

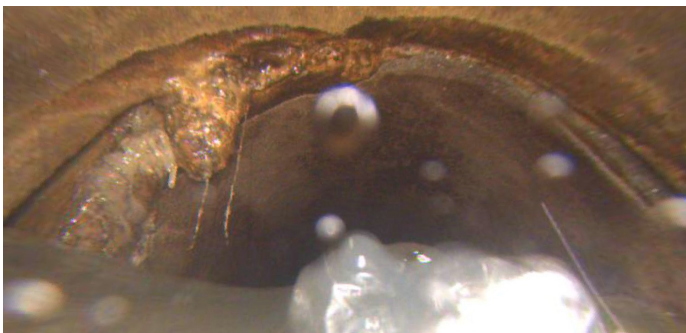
Code: **DAE**
Description: **Deposits Attached Encrustation**

Distance (ft): **62.3**
Structural Grade: **0**
O&M Grade: **2**
Clock Start/From: **12**
Clock To: **3**
1st Value:
2nd Value:
Value Percent: **5.000**
Continuous Index:
Within 8" of Joint: **YES**
Remarks:

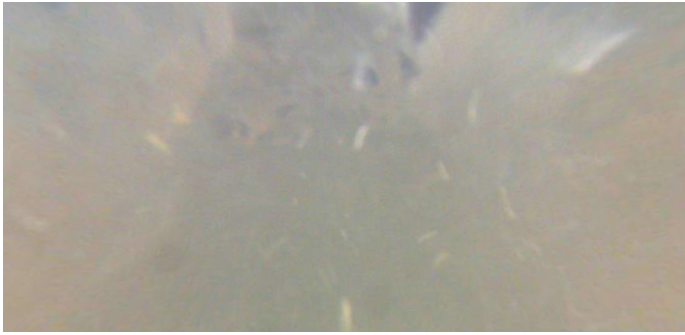
Code: **MCU**
Description: **Camera Underwater**

Distance (ft): **66.6**
Structural Grade: **0**
O&M Grade: **4**
Clock Start/From:
Clock To:
1st Value:
2nd Value:
Value Percent:
Continuous Index: **S02**
Within 8" of Joint: **NO**
Remarks:

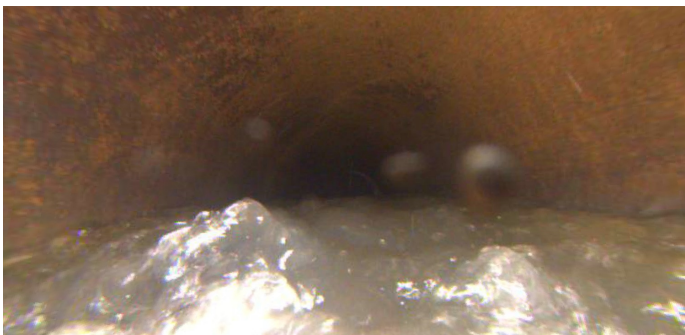
Code: **MCU**
Description: **Camera Underwater**

Distance (ft): **94.0**
Structural Grade: **0**
O&M Grade: **4**
Clock Start/From:
Clock To:
1st Value:
2nd Value:
Value Percent:
Continuous Index: **F02**
Within 8" of Joint: **NO**
Remarks:

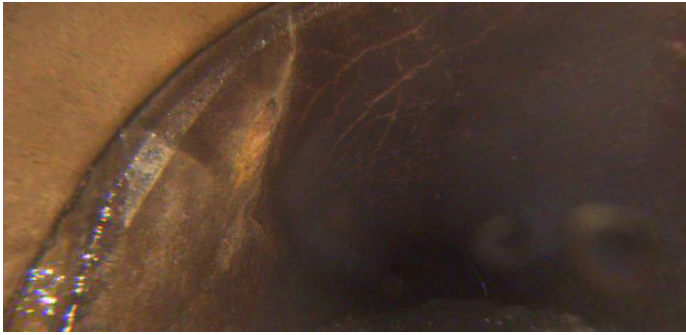
Code: **CM**
Description: **Crack Multiple**

Distance (ft): **98.5**
Structural Grade: **3**
O&M Grade: **0**
Clock Start/From: **12**
Clock To: **4**
1st Value:
2nd Value:
Value Percent:
Continuous Index:
Within 8" of Joint: **YES**
Remarks:

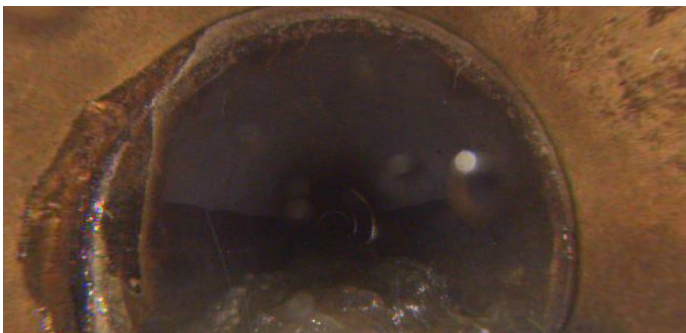
Code: **IW**
Description: **Infil Weeper**

Distance (ft): **126.0**
Structural Grade: **0**
O&M Grade: **2**
Clock Start/From: **1**
Clock To: **4**
1st Value:
2nd Value:
Value Percent:
Continuous Index:
Within 8" of Joint: **YES**
Remarks:

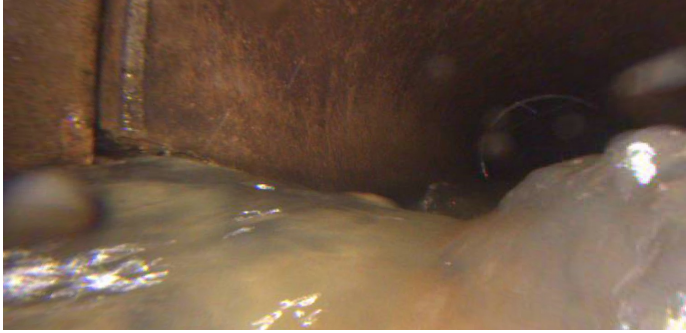
Code: **FL**
Description: **Fracture Longitudinal**

Distance (ft): **128.5**
Structural Grade: **3**
O&M Grade: **0**
Clock Start/From: **3**
Clock To:
1st Value:
2nd Value:
Value Percent:
Continuous Index:
Within 8" of Joint: **YES**
Remarks:

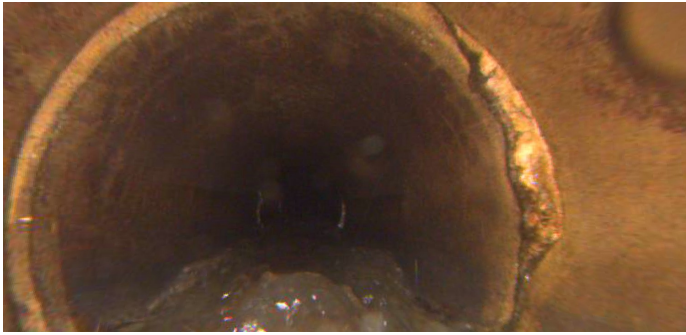
Code: **DAE**
Description: **Deposits Attached Encrustation**

Distance (ft): **144.1**
Structural Grade: **0**
O&M Grade: **2**
Clock Start/From: **9**
Clock To: **11**
1st Value:
2nd Value:
Value Percent: **5.000**
Continuous Index:
Within 8" of Joint: **YES**
Remarks:

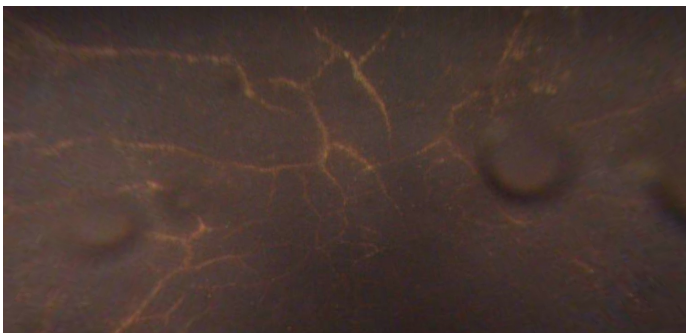
Code: **CM**
Description: **Crack Multiple**

Distance (ft): **149.5**
Structural Grade: **3**
O&M Grade: **0**
Clock Start/From: **8**
Clock To: **4**
1st Value:
2nd Value:
Value Percent:
Continuous Index:
Within 8" of Joint: **YES**
Remarks:

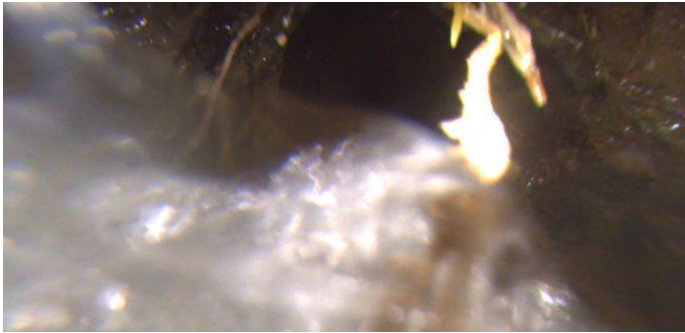
Code: **TBD**
Description: **Tap Break-in Defective**

Distance (ft): **153.1**
Structural Grade: **0**
O&M Grade: **3**
Clock Start/From: **12**
Clock To:
1st Value: **4.000**
2nd Value:
Value Percent:
Continuous Index:
Within 8" of Joint:
Remarks: **ROOTS**

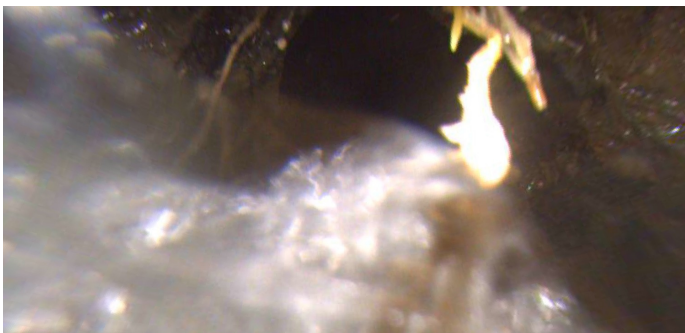
Code: **RFC**
Description: **Roots Fine Connection**

Distance (ft): **153.1**
Structural Grade: **0**
O&M Grade: **1**
Clock Start/From: **11**
Clock To: **1**
1st Value:
2nd Value:
Value Percent:
Continuous Index:
Within 8" of Joint: **NO**
Remarks:

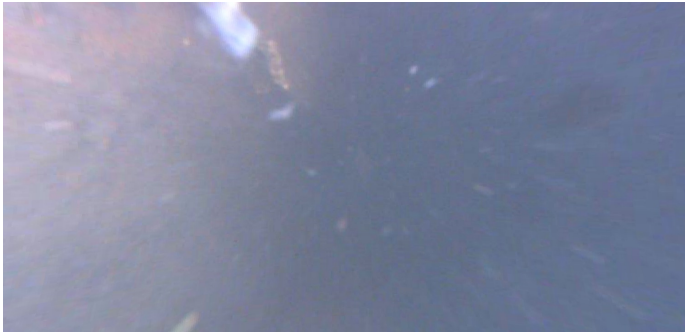
Code: **MWLS**
Description: **Water Level Sag**

Distance (ft): **156.1**
Structural Grade: **2**
O&M Grade: **3**
Clock Start/From:
Clock To:
1st Value:
2nd Value:
Value Percent: **15.000**
Continuous Index: **F01**
Within 8" of Joint: **NO**
Remarks:
