RedZone
ROBOTICS

Total Length Surveyed (ft): **285.2**

M-405-020

M-405-021

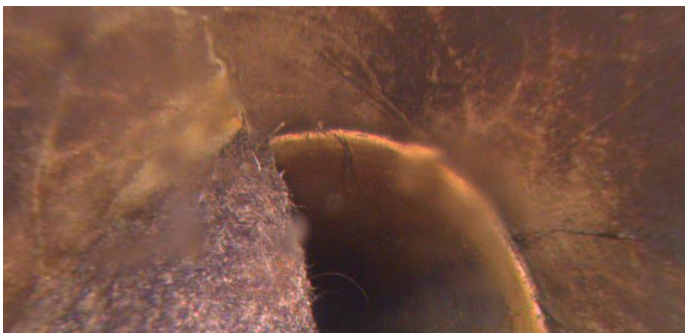
Code: **FM**
Description: **Fracture Multiple**

Distance (ft): **5.7**
Structural Grade: **4**
O&M Grade: **0**
Clock Start/From: **8**
Clock To: **4**
1st Value:
2nd Value:
Value Percent:
Continuous Index:
Within 8" of Joint: **YES**
Remarks:

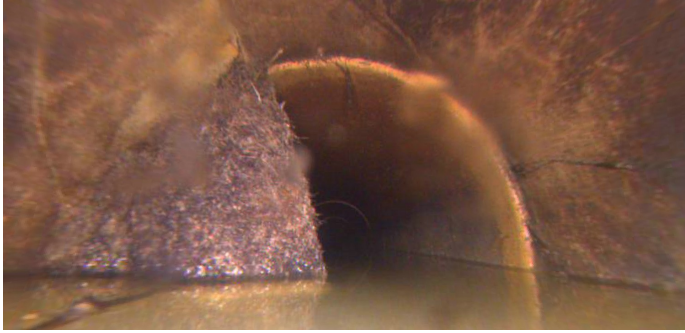
Code: **RMJ**
Description: **Roots Medium Joint**

Distance (ft): **5.7**
Structural Grade: **0**
O&M Grade: **3**
Clock Start/From: **6**
Clock To: **12**
1st Value:
2nd Value:
Value Percent: **40.000**
Continuous Index:
Within 8" of Joint: **YES**
Remarks:

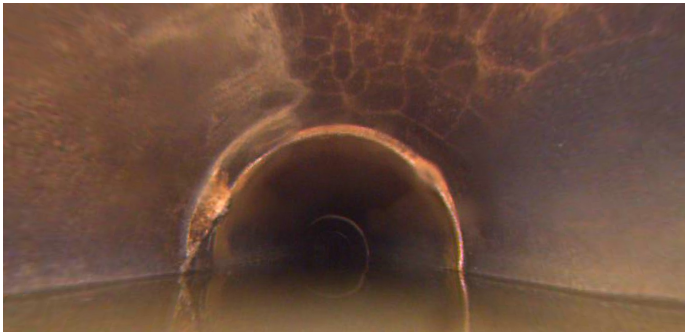
Code: **FM**
Description: **Fracture Multiple**

Distance (ft): **14.1**
Structural Grade: **4**
O&M Grade: **0**
Clock Start/From: **8**
Clock To: **4**
1st Value:
2nd Value:
Value Percent:
Continuous Index: **S01**
Within 8" of Joint: **YES**
Remarks:

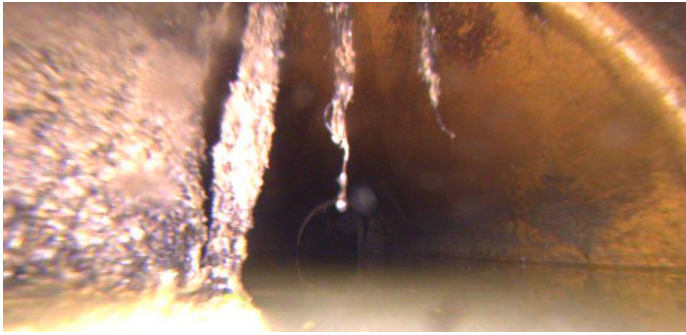
Code: **RMJ**
Description: **Roots Medium Joint**

Distance (ft): **20.8**
Structural Grade: **0**
O&M Grade: **3**
Clock Start/From: **8**
Clock To: **4**
1st Value:
2nd Value:
Value Percent: **20.000**
Continuous Index:
Within 8" of Joint: **YES**
Remarks:

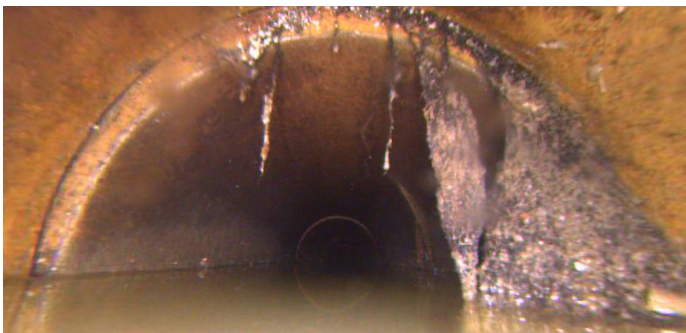
Code: **RMJ**
Description: **Roots Medium Joint**

Distance (ft): **23.6**
Structural Grade: **0**
O&M Grade: **3**
Clock Start/From: **12**
Clock To: **4**
1st Value:
2nd Value:
Value Percent: **20.000**
Continuous Index:
Within 8" of Joint: **YES**
Remarks:

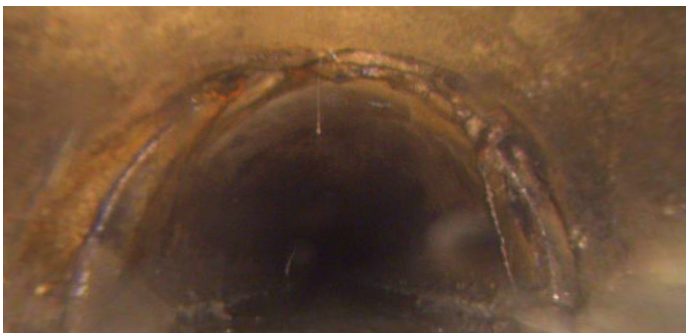
Code: **RFJ**
Description: **Roots Fine Joint**

Distance (ft): **54.6**
Structural Grade: **0**
O&M Grade: **1**
Clock Start/From: **8**
Clock To: **4**
1st Value:
2nd Value:
Value Percent:
Continuous Index:
Within 8" of Joint: **YES**
Remarks:

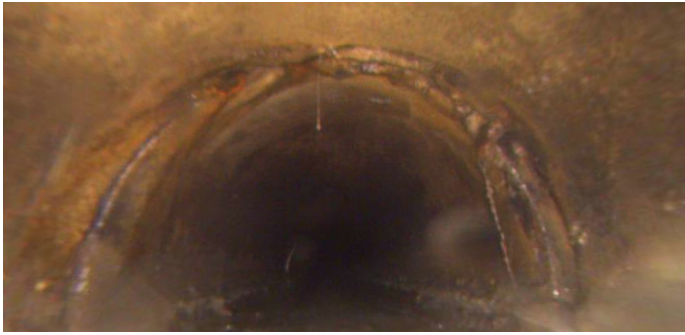
Code: **IW**
Description: **Infil Weeper**

Distance (ft): **54.6**
Structural Grade: **0**
O&M Grade: **2**
Clock Start/From: **8**
Clock To: **4**
1st Value:
2nd Value:
Value Percent:
Continuous Index:
Within 8" of Joint: **YES**
Remarks:

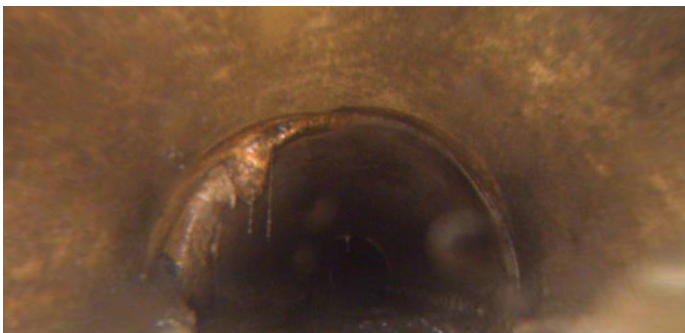
Code: **RFJ**
Description: **Roots Fine Joint**

Distance (ft): **63.9**
Structural Grade: **0**
O&M Grade: **1**
Clock Start/From: **2**
Clock To:
1st Value:
2nd Value:
Value Percent:
Continuous Index:
Within 8" of Joint: **YES**
Remarks:

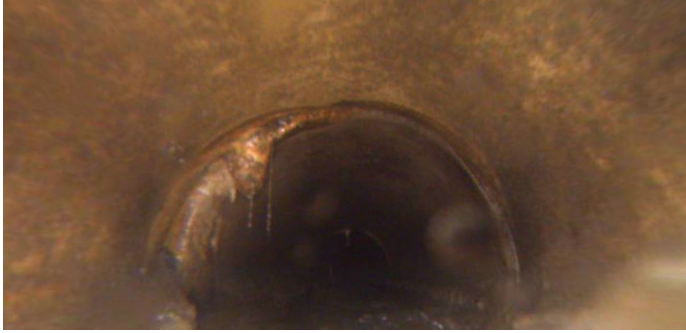
Code: **DAE**
Description: **Deposits Attached Encrustation**

Distance (ft): **63.9**
Structural Grade: **0**
O&M Grade: **2**
Clock Start/From: **12**
Clock To: **4**
1st Value:
2nd Value:
Value Percent: **5.000**
Continuous Index:
Within 8" of Joint: **YES**
Remarks:

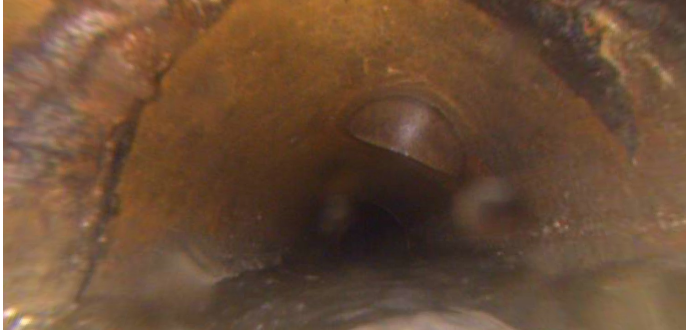
Code:	DAE
Description:	Deposits Attached Encrustation

Distance (ft):	69.4
Structural Grade:	0
O&M Grade:	2
Clock Start/From:	8
Clock To:	4
1st Value:	
2nd Value:	
Value Percent:	5.000
Continuous Index:	
Within 8" of Joint:	YES
Remarks:

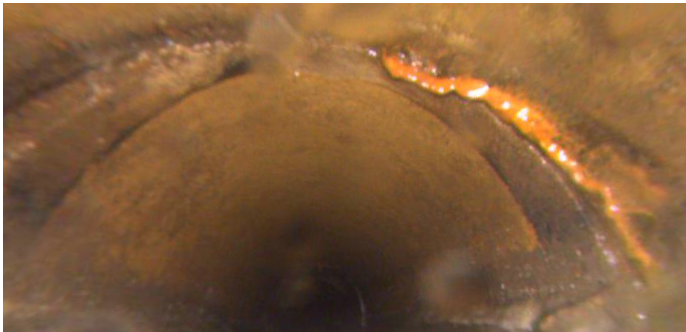
Code:	ID
Description:	Infil Dripper

Distance (ft):	72.3
Structural Grade:	0
O&M Grade:	3
Clock Start/From:	12
Clock To:	
1st Value:	
2nd Value:	
Value Percent:	
Continuous Index:	
Within 8" of Joint:	YES
Remarks:

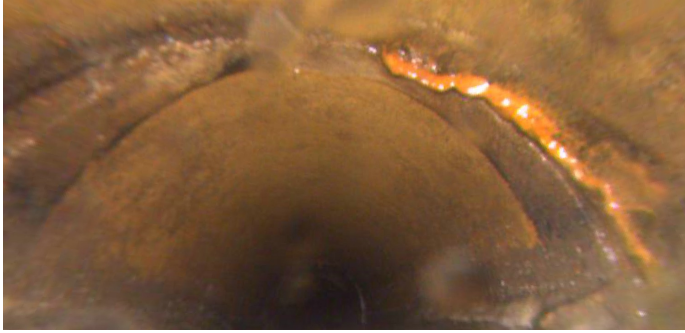
Code:	DAE
Description:	Deposits Attached Encrustation

Distance (ft):	72.3
Structural Grade:	0
O&M Grade:	2
Clock Start/From:	8
Clock To:	4
1st Value:	
2nd Value:	
Value Percent:	5.000
Continuous Index:	
Within 8" of Joint:	YES
Remarks:

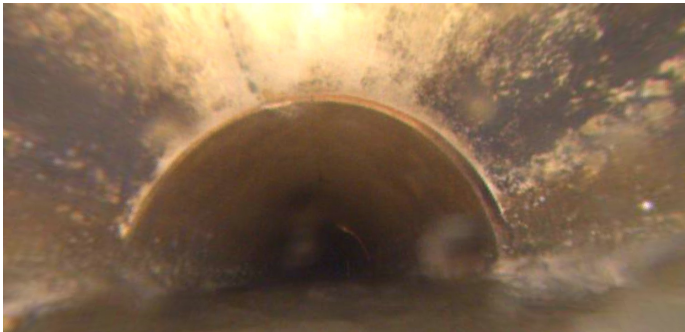
Code:	FM
Description:	Fracture Multiple

Distance (ft):	75.0
Structural Grade:	4
O&M Grade:	0
Clock Start/From:	8
Clock To:	4
1st Value:	
2nd Value:	
Value Percent:	
Continuous Index:	F01
Within 8" of Joint:	YES
Remarks:

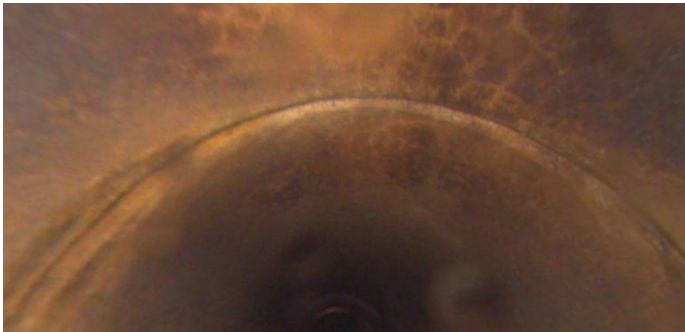
Code: **CM**
Description: **Crack Multiple**

Distance (ft): **87.4**
Structural Grade: **3**
O&M Grade: **0**
Clock Start/From: **11**
Clock To: **1**
1st Value:
2nd Value:
Value Percent:
Continuous Index: **S02**
Within 8" of Joint: **YES**
Remarks:

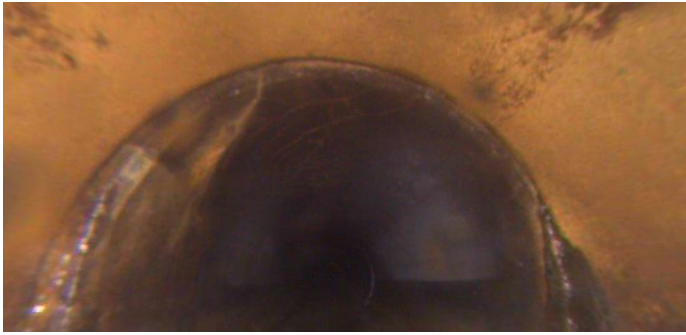
Code: **IW**
Description: **Infil Weeper**

Distance (ft): **99.6**
Structural Grade: **0**
O&M Grade: **2**
Clock Start/From: **8**
Clock To: **4**
1st Value:
2nd Value:
Value Percent:
Continuous Index:
Within 8" of Joint: **YES**
Remarks:

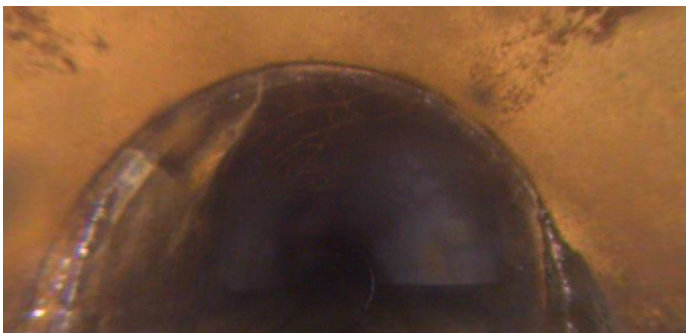
Code: **FM**
Description: **Fracture Multiple**

Distance (ft): **99.6**
Structural Grade: **4**
O&M Grade: **0**
Clock Start/From: **8**
Clock To: **4**
1st Value:
2nd Value:
Value Percent:
Continuous Index:
Within 8" of Joint: **YES**
Remarks:

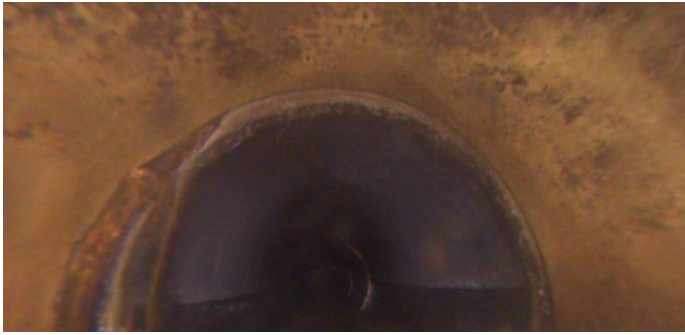
Code: **FM**
Description: **Fracture Multiple**

Distance (ft): **126.7**
Structural Grade: **4**
O&M Grade: **0**
Clock Start/From: **8**
Clock To: **4**
1st Value:
2nd Value:
Value Percent:
Continuous Index:
Within 8" of Joint: **YES**
Remarks:

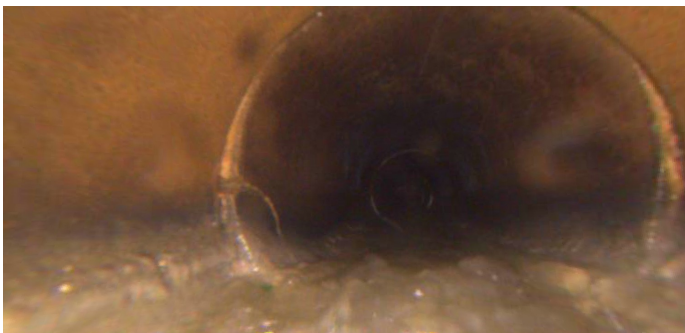
Code: **FS**
Description: **Fracture Spiral**

Distance (ft): **129.7**
Structural Grade: **3**
O&M Grade: **0**
Clock Start/From: **3**
Clock To: **4**
1st Value:
2nd Value:
Value Percent:
Continuous Index:
Within 8" of Joint: **YES**
Remarks:

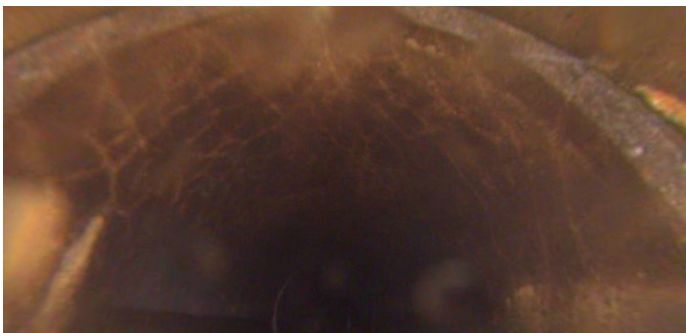
Code: **FM**
Description: **Fracture Multiple**

Distance (ft): **141.5**
Structural Grade: **4**
O&M Grade: **0**
Clock Start/From: **8**
Clock To: **4**
1st Value:
2nd Value:
Value Percent:
Continuous Index: **S03**
Within 8" of Joint: **YES**
Remarks:

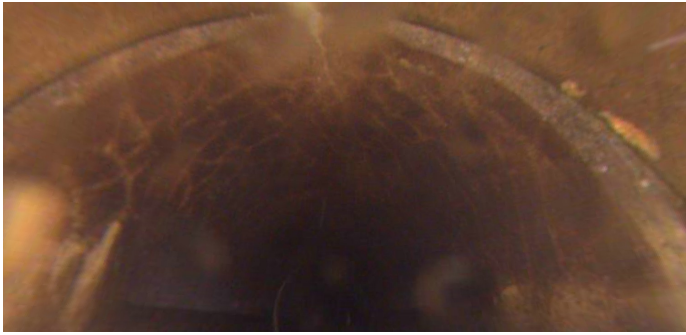
Code: **CM**
Description: **Crack Multiple**

Distance (ft): **141.5**
Structural Grade: **3**
O&M Grade: **0**
Clock Start/From: **11**
Clock To: **1**
1st Value:
2nd Value:
Value Percent:
Continuous Index: **F02**
Within 8" of Joint: **YES**
Remarks:

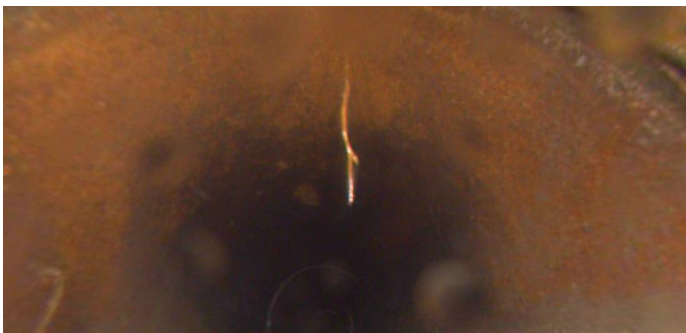
Code: **RFJ**
Description: **Roots Fine Joint**

Distance (ft): **153.3**
Structural Grade: **0**
O&M Grade: **1**
Clock Start/From: **12**
Clock To:
1st Value:
2nd Value:
Value Percent:
Continuous Index:
Within 8" of Joint: **YES**
Remarks:

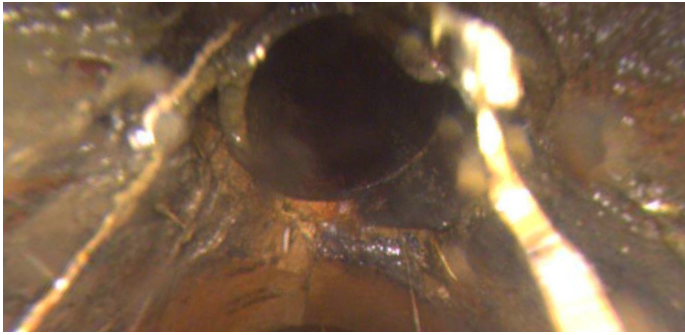
Code: **TBD**
Description: **Tap Break-in Defective**

Distance (ft): **154.3**
Structural Grade: **0**
O&M Grade: **3**
Clock Start/From: **12**
Clock To:
1st Value: **4.000**
2nd Value:
Value Percent:
Continuous Index:
Within 8" of Joint:
Remarks: **roots**

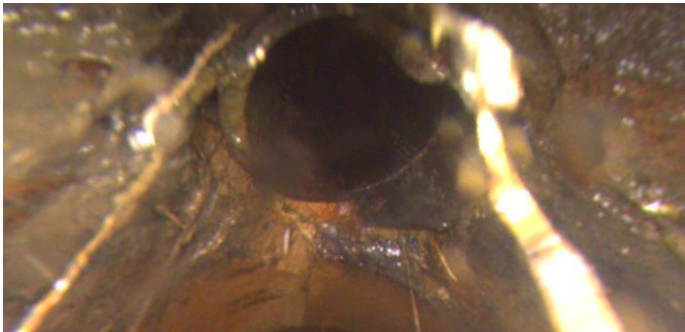
Code: **RFC**
Description: **Roots Fine Connection**

Distance (ft): **154.3**
Structural Grade: **0**
O&M Grade: **1**
Clock Start/From: **11**
Clock To: **1**
1st Value:
2nd Value:
Value Percent:
Continuous Index:
Within 8" of Joint: **NO**
Remarks:

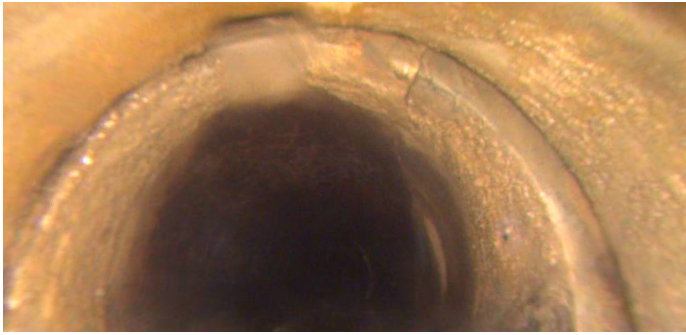
Code: **DAE**
Description: **Deposits Attached Encrustation**

Distance (ft): **168.7**
Structural Grade: **0**
O&M Grade: **2**
Clock Start/From: **8**
Clock To: **4**
1st Value:
2nd Value:
Value Percent: **5.000**
Continuous Index:
Within 8" of Joint: **YES**
Remarks:

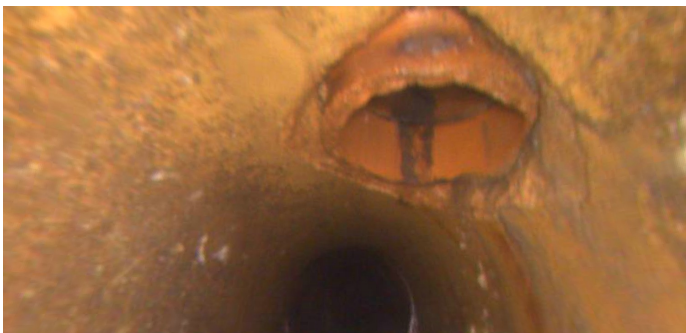
Code: **TBI**
Description: **Tap Break-in Intruding**

Distance (ft): **191.8**
Structural Grade: **0**
O&M Grade: **2**
Clock Start/From: **11**
Clock To:
1st Value: **4.000**
2nd Value: **1.000**
Value Percent:
Continuous Index:
Within 8" of Joint:
Remarks:

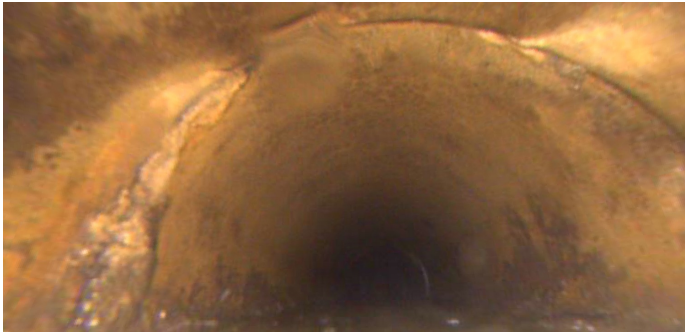
Code: **DAE**
Description: **Deposits Attached Encrustation**

Distance (ft): **216.7**
Structural Grade: **0**
O&M Grade: **2**
Clock Start/From: **8**
Clock To: **4**
1st Value:
2nd Value:
Value Percent: **5.000**
Continuous Index: **S04**
Within 8" of Joint: **YES**
Remarks:

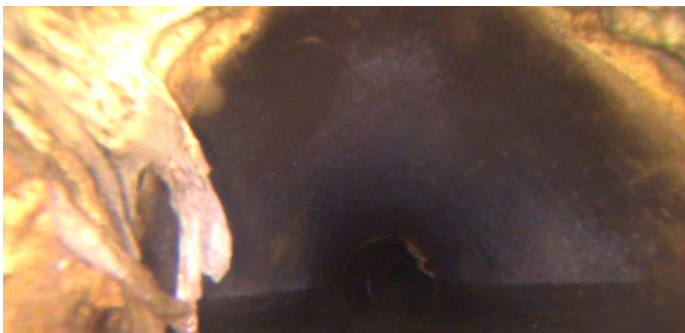
Code: **DAR**
Description: **Deposits Attached Ragging**

Distance (ft): **255.6**
Structural Grade: **0**
O&M Grade: **2**
Clock Start/From: **3**
Clock To: **4**
1st Value:
2nd Value:
Value Percent: **10.000**
Continuous Index:
Within 8" of Joint: **YES**
Remarks:

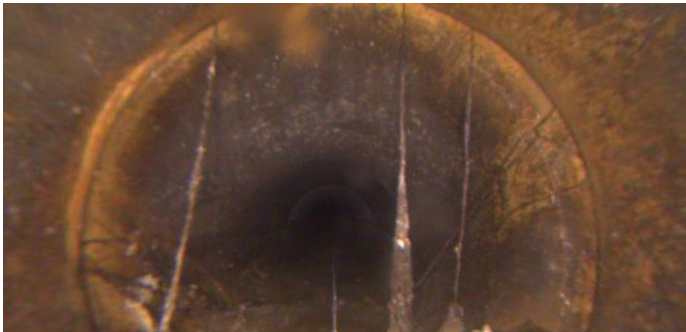
Code: **RFJ**
Description: **Roots Fine Joint**

Distance (ft): **282.7**
Structural Grade: **0**
O&M Grade: **1**
Clock Start/From: **8**
Clock To: **4**
1st Value:
2nd Value:
Value Percent:
Continuous Index:
Within 8" of Joint: **YES**
Remarks:

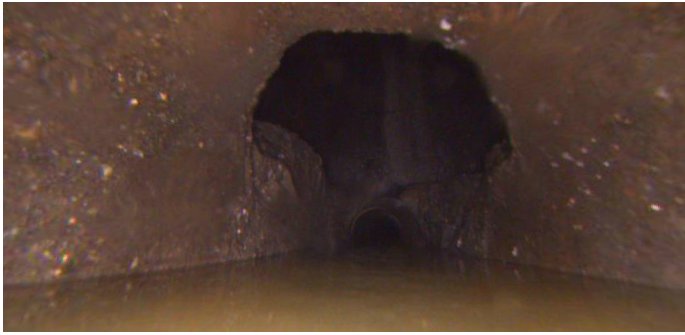
Code: **DAE**
Description: **Deposits Attached Encrustation**

Distance (ft): **282.7**
Structural Grade: **0**
O&M Grade: **2**
Clock Start/From: **8**
Clock To: **4**
1st Value:
2nd Value:
Value Percent: **5.000**
Continuous Index: **F04**
Within 8" of Joint: **YES**
Remarks:

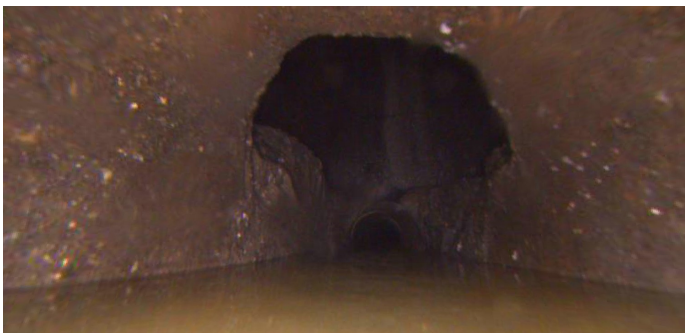
Code: **FM**
Description: **Fracture Multiple**

Distance (ft): **282.7**
Structural Grade: **4**
O&M Grade: **0**
Clock Start/From: **8**
Clock To: **4**
1st Value:
2nd Value:
Value Percent:
Continuous Index: **F03**
Within 8" of Joint: **YES**
Remarks:
