Profile/Photo Observation Report

Date:	04/16/2018	Weather:		Coding:	PACP 6.0
Pipe Length (ft):	262.5	Owner:	NA	Pre Clean:	No Pre-Cleaning
P.O.#:		Surveyor:	Selasie Honu	PSR:	P-405-022-021
Customer:		Clean Date:	01/01/1900	Shape:	C

Street:	ALLEY BETWEEN DRIFTWOOD DR &	Flow Control:	Not Controlled
City:	Hobart, IN	Year Renewed:	
Location:	Yard	Tape/Media #:	
Purpose:	Routine Assessment	Dia/Height:	12"
Use:	Sanitary	Material:	CP
Drain Area:	NA	Lining:	
Category:	NA		
Comment:

Location Details:		Direction of Survey:	Downstream
US MH:	M-405-022	DS MH:	M-405-021
		Total Length Surveyed (ft):	129.4

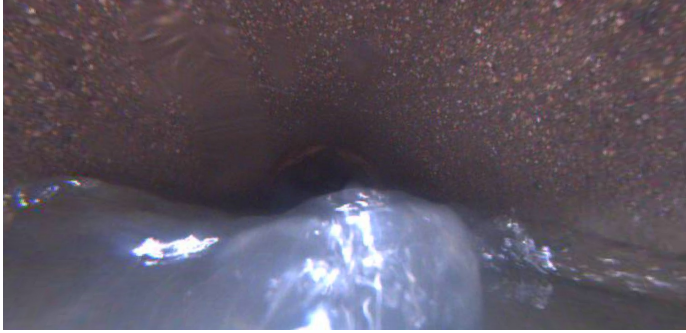
Code: **SAP**
Description: **Surface Aggregate Projecting**

Distance (ft): **.0**
Structural Grade: **3**
O&M Grade: **0**
Clock Start/From: **8**
Clock To: **4**
1st Value:
2nd Value:
Value Percent:
Continuous Index: **S05**
Within 8" of Joint:
Remarks:

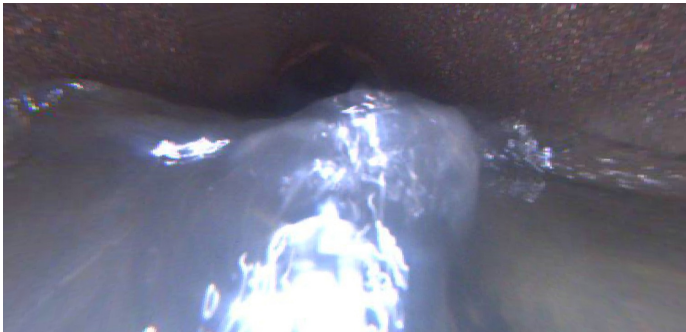
Code: **AMH**
Description: **Manhole**

Distance (ft): **.0**
Structural Grade: **0**
O&M Grade: **0**
Clock Start/From:
Clock To:
1st Value:
2nd Value:
Value Percent:
Continuous Index:
Within 8" of Joint: **NO**
Remarks: **M-405-022**

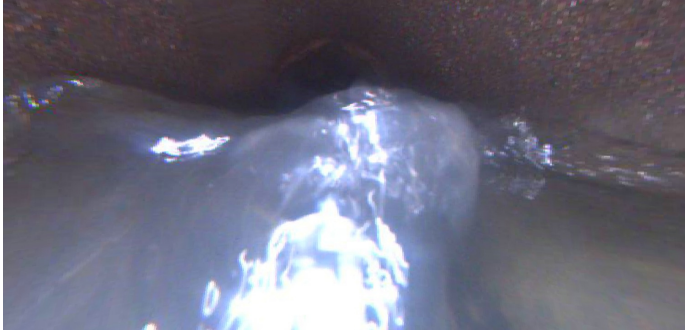
Code: **MWL**
Description: **Water Level**

Distance (ft): **.0**
Structural Grade: **0**
O&M Grade: **0**
Clock Start/From:
Clock To:
1st Value:
2nd Value:
Value Percent: **5.000**
Continuous Index:
Within 8" of Joint: **NO**
Remarks:

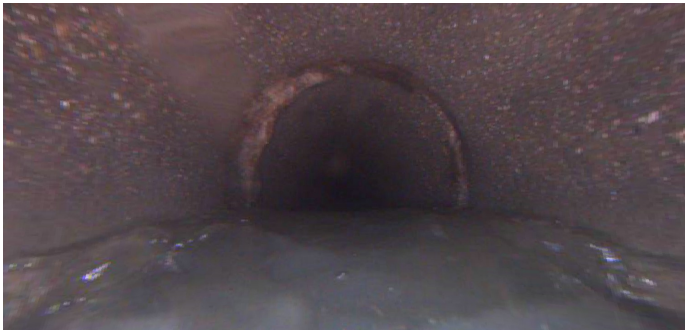
Code: **DAE**
Description: **Deposits Attached Encrustation**

Distance (ft): **6.2**
Structural Grade: **0**
O&M Grade: **2**
Clock Start/From: **8**
Clock To: **12**
1st Value:
2nd Value:
Value Percent: **10.000**
Continuous Index: **S06**
Within 8" of Joint: **YES**
Remarks:

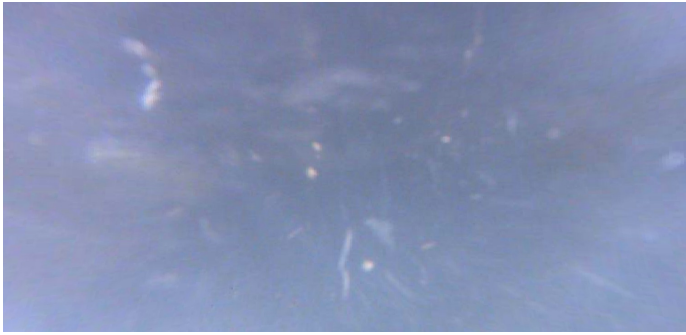
Code: **MWLS**
Description: **Water Level Sag**

Distance (ft): **14.3**
Structural Grade: **2**
O&M Grade: **3**
Clock Start/From:
Clock To:
1st Value:
2nd Value:
Value Percent: **10.000**
Continuous Index: **S01**
Within 8" of Joint: **NO**
Remarks:

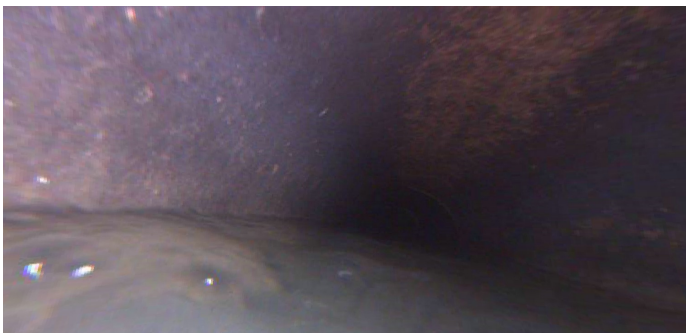
Code: **MWLS**
Description: **Water Level Sag**

Distance (ft): **20.0**
Structural Grade: **2**
O&M Grade: **3**
Clock Start/From:
Clock To:
1st Value:
2nd Value:
Value Percent: **10.000**
Continuous Index: **F01**
Within 8" of Joint: **NO**
Remarks:

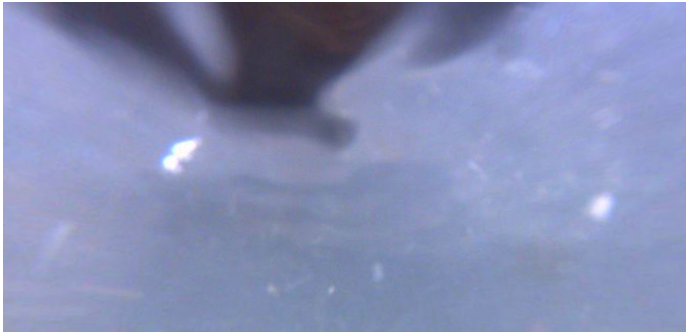
Code: **DAE**
Description: **Deposits Attached Encrustation**

Distance (ft): **21.6**
Structural Grade: **0**
O&M Grade: **2**
Clock Start/From: **8**
Clock To: **12**
1st Value:
2nd Value:
Value Percent: **10.000**
Continuous Index: **F06**
Within 8" of Joint: **YES**
Remarks:

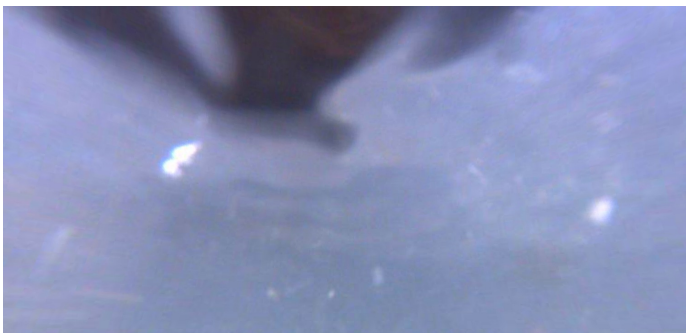
Code: **MCU**
Description: **Camera Underwater**

Distance (ft): **21.6**
Structural Grade: **0**
O&M Grade: **4**
Clock Start/From:
Clock To:
1st Value:
2nd Value:
Value Percent:
Continuous Index: **S07**
Within 8" of Joint: **NO**
Remarks:

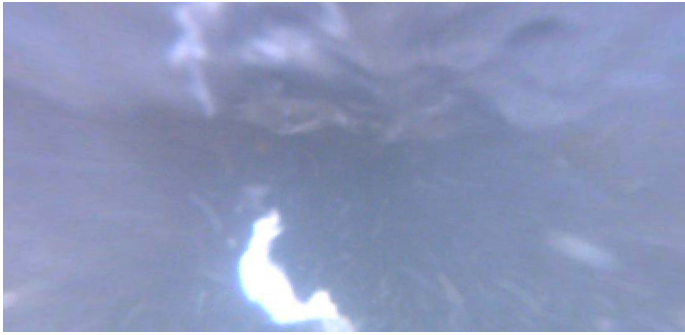
Code: **MWLS**
Description: **Water Level Sag**

Distance (ft): **22.3**
Structural Grade: **2**
O&M Grade: **3**
Clock Start/From:
Clock To:
1st Value:
2nd Value:
Value Percent: **10.000**
Continuous Index:
Within 8" of Joint: **NO**
Remarks:

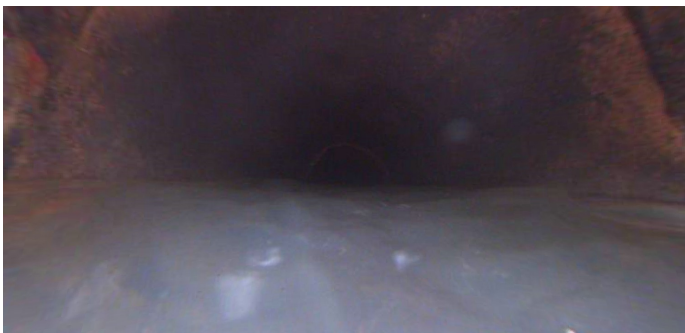
Code: **SAP**
Description: **Surface Aggregate Projecting**

Distance (ft): **25.3**
Structural Grade: **3**
O&M Grade: **0**
Clock Start/From: **8**
Clock To: **4**
1st Value:
2nd Value:
Value Percent:
Continuous Index: **F05**
Within 8" of Joint:
Remarks:

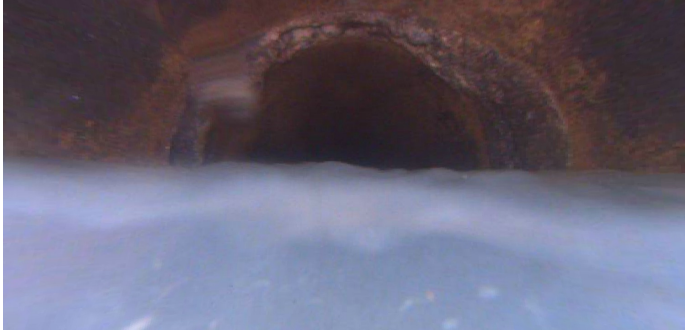
Code: **MWLS**
Description: **Water Level Sag**

Distance (ft): **27.8**
Structural Grade: **2**
O&M Grade: **3**
Clock Start/From:
Clock To:
1st Value:
2nd Value:
Value Percent: **10.000**
Continuous Index: **S02**
Within 8" of Joint: **NO**
Remarks:

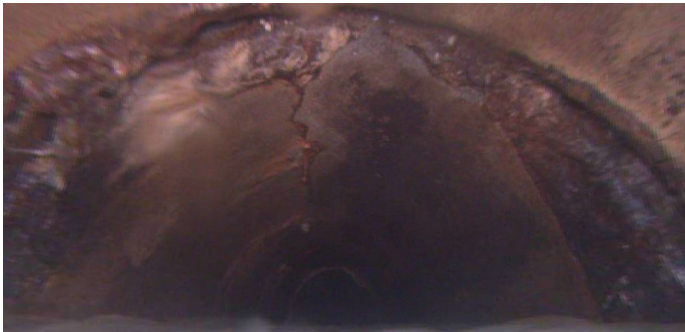
Code: **FM**
Description: **Fracture Multiple**

Distance (ft): **58.4**
Structural Grade: **4**
O&M Grade: **0**
Clock Start/From: **7**
Clock To: **3**
1st Value:
2nd Value:
Value Percent:
Continuous Index:
Within 8" of Joint: **YES**
Remarks:

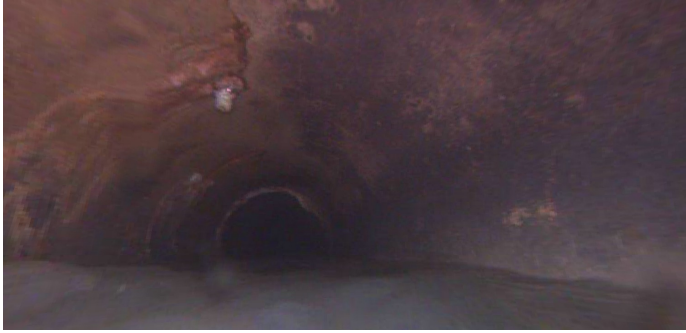
Code: **FC**
Description: **Fracture Circumferential**

Distance (ft): **59.1**
Structural Grade: **2**
O&M Grade: **0**
Clock Start/From: **9**
Clock To: **12**
1st Value:
2nd Value:
Value Percent:
Continuous Index:
Within 8" of Joint:
Remarks:

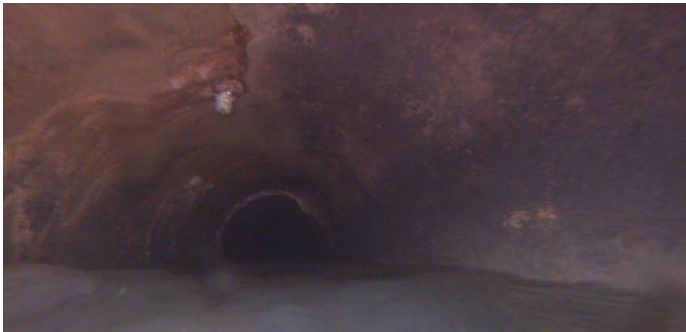
Code: **IS**
Description: **Infil Stain**

Distance (ft): **59.1**
Structural Grade: **0**
O&M Grade: **0**
Clock Start/From: **9**
Clock To: **12**
1st Value:
2nd Value:
Value Percent:
Continuous Index:
Within 8" of Joint:
Remarks:

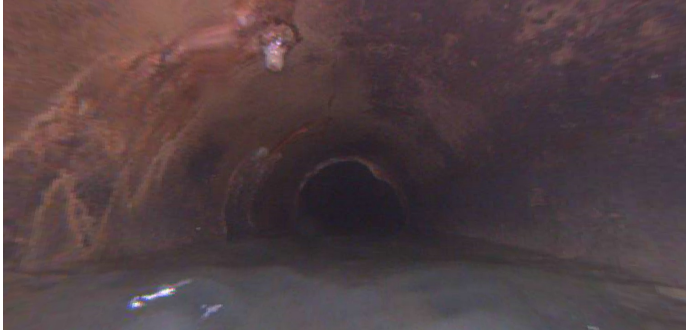
Code: **MWLS**
Description: **Water Level Sag**

Distance (ft): **59.3**
Structural Grade: **2**
O&M Grade: **3**
Clock Start/From:
Clock To:
1st Value:
2nd Value:
Value Percent: **10.000**
Continuous Index: **F02**
Within 8" of Joint: **NO**
Remarks:

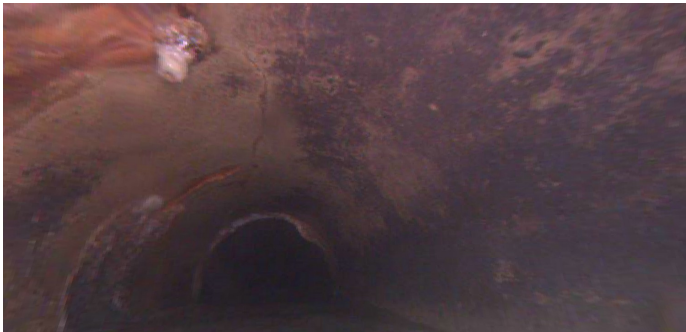
Code: **FL**
Description: **Fracture Longitudinal**

Distance (ft): **59.6**
Structural Grade: **3**
O&M Grade: **0**
Clock Start/From: **12**
Clock To:
1st Value:
2nd Value:
Value Percent:
Continuous Index:
Within 8" of Joint:
Remarks:

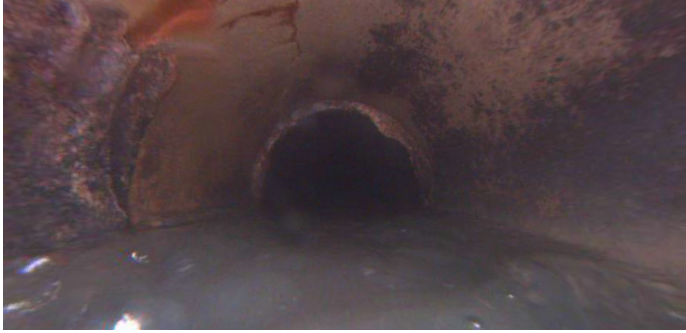
Code: **MCU**
Description: **Camera Underwater**

Distance (ft): **60.2**
Structural Grade: **0**
O&M Grade: **4**
Clock Start/From:
Clock To:
1st Value:
2nd Value:
Value Percent:
Continuous Index: **F07**
Within 8" of Joint: **NO**
Remarks:

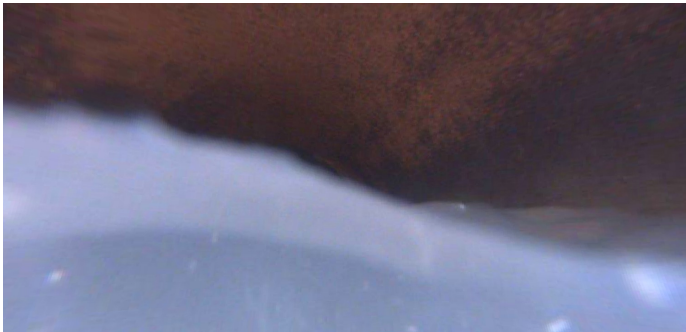
Code: **MWLS**
Description: **Water Level Sag**

Distance (ft): **66.4**
Structural Grade: **2**
O&M Grade: **3**
Clock Start/From:
Clock To:
1st Value:
2nd Value:
Value Percent: **10.000**
Continuous Index: **S03**
Within 8" of Joint: **NO**
Remarks:

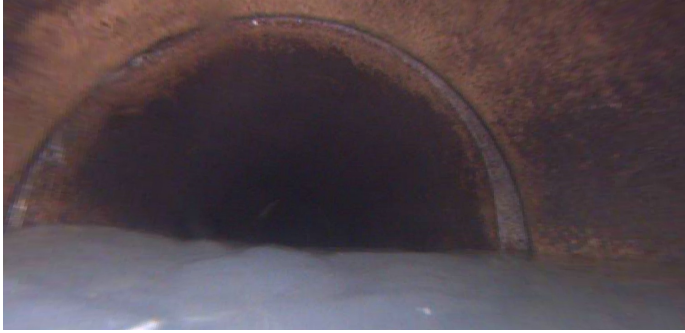
Code: **MWLS**
Description: **Water Level Sag**

Distance (ft): **73.3**
Structural Grade: **2**
O&M Grade: **3**
Clock Start/From:
Clock To:
1st Value:
2nd Value:
Value Percent: **10.000**
Continuous Index: **F03**
Within 8" of Joint: **NO**
Remarks:

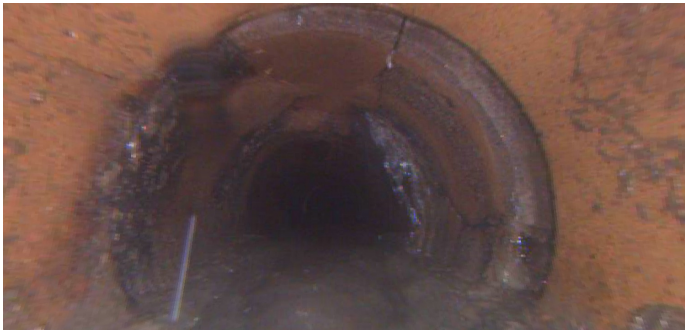
Code: **B**
Description: **Broken**

Distance (ft): **82.3**
Structural Grade: **5**
O&M Grade: **0**
Clock Start/From: **9**
Clock To: **4**
1st Value:
2nd Value:
Value Percent:
Continuous Index:
Within 8" of Joint: **YES**
Remarks:

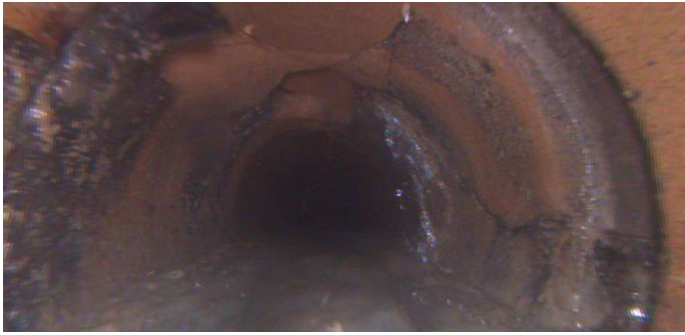
Code: **TBA**
Description: **Tap Break-in Active**

Distance (ft): **82.5**
Structural Grade: **0**
O&M Grade: **0**
Clock Start/From: **12**
Clock To:
1st Value: **4.000**
2nd Value:
Value Percent:
Continuous Index:
Within 8" of Joint:
Remarks:

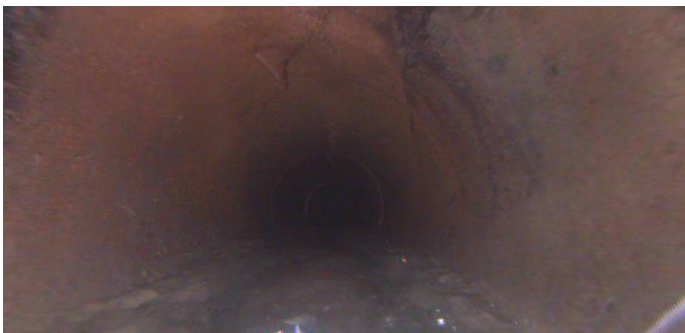
Code: **FM**
Description: **Fracture Multiple**

Distance (ft): **83.5**
Structural Grade: **4**
O&M Grade: **0**
Clock Start/From: **10**
Clock To: **5**
1st Value:
2nd Value:
Value Percent:
Continuous Index:
Within 8" of Joint: **YES**
Remarks:

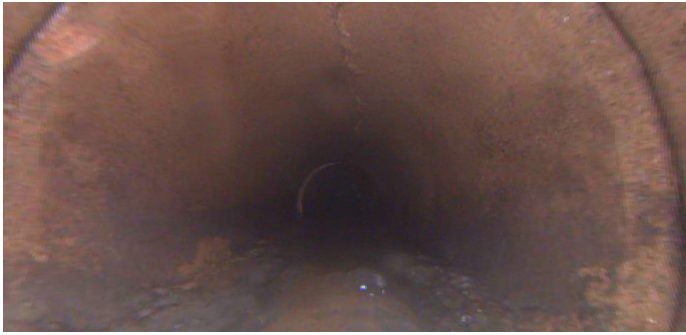
Code: **FL**
Description: **Fracture Longitudinal**

Distance (ft): **85.6**
Structural Grade: **3**
O&M Grade: **0**
Clock Start/From: **12**
Clock To:
1st Value:
2nd Value:
Value Percent:
Continuous Index:
Within 8" of Joint: **YES**
Remarks:

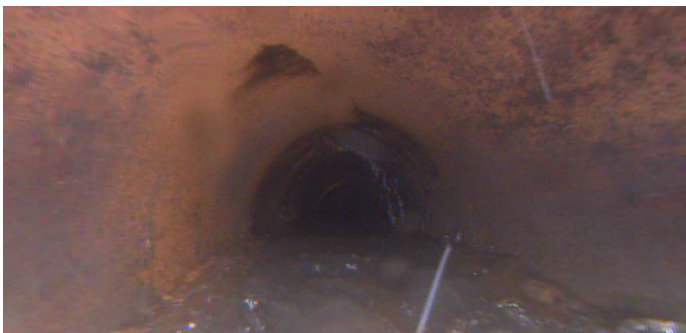
Code: **IS**
Description: **Infil Stain**

Distance (ft): **89.4**
Structural Grade: **0**
O&M Grade: **0**
Clock Start/From: **7**
Clock To: **12**
1st Value:
2nd Value:
Value Percent:
Continuous Index:
Within 8" of Joint: **YES**
Remarks:

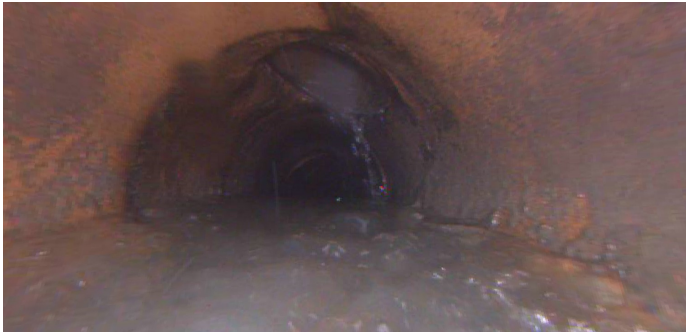
Code: **TFA**
Description: **Tap Factory Active**

Distance (ft): **89.9**
Structural Grade: **0**
O&M Grade: **0**
Clock Start/From: **1**
Clock To:
1st Value: **4.000**
2nd Value:
Value Percent:
Continuous Index:
Within 8" of Joint:
Remarks:

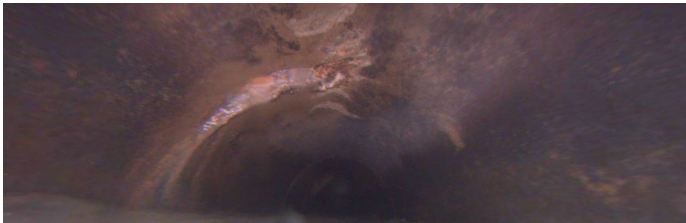
Code: **DAE**
Description: **Deposits Attached Encrustation**

Distance (ft): **93.2**
Structural Grade: **0**
O&M Grade: **2**
Clock Start/From: **9**
Clock To: **12**
1st Value:
2nd Value:
Value Percent: **5.000**
Continuous Index:
Within 8" of Joint: **NO**
Remarks:

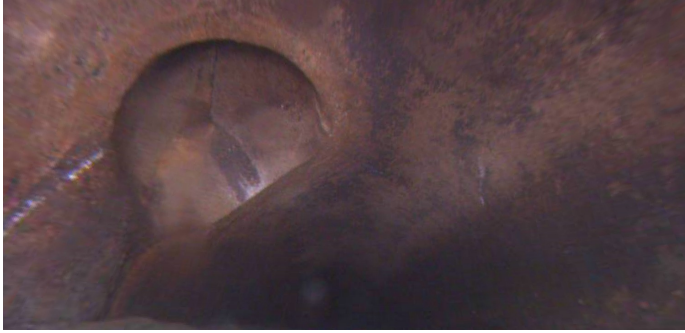
Code: **TF**
Description: **Tap Factory**

Distance (ft): **95.3**
Structural Grade: **0**
O&M Grade: **0**
Clock Start/From: **11**
Clock To:
1st Value: **4.000**
2nd Value:
Value Percent:
Continuous Index:
Within 8" of Joint:
Remarks:

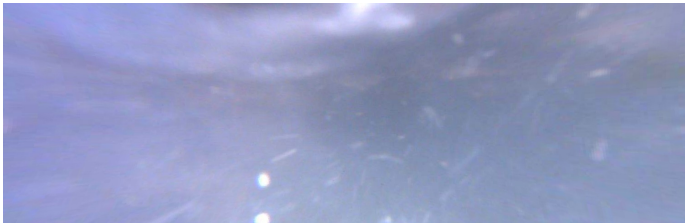
Code: **MWLS**
Description: **Water Level Sag**

Distance (ft): **97.7**
Structural Grade: **2**
O&M Grade: **3**
Clock Start/From:
Clock To:
1st Value:
2nd Value:
Value Percent: **15.000**
Continuous Index:
Within 8" of Joint: **NO**
Remarks:

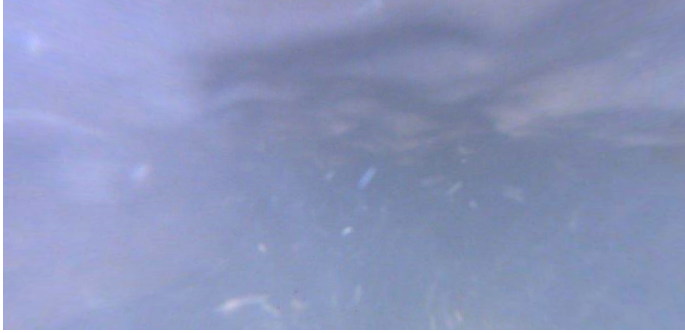
Code: **MWLS**
Description: **Water Level Sag**

Distance (ft): **106.5**
Structural Grade: **2**
O&M Grade: **3**
Clock Start/From:
Clock To:
1st Value:
2nd Value:
Value Percent: **15.000**
Continuous Index:
Within 8" of Joint: **NO**
Remarks:

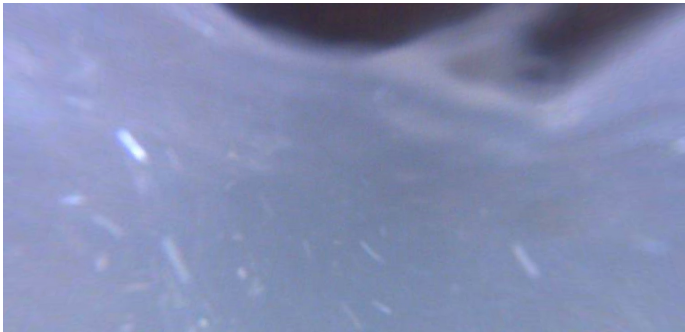
Code: **MCU**
Description: **Camera Underwater**

Distance (ft): **106.9**
Structural Grade: **0**
O&M Grade: **4**
Clock Start/From:
Clock To:
1st Value:
2nd Value:
Value Percent:
Continuous Index: **S08**
Within 8" of Joint: **NO**
Remarks:

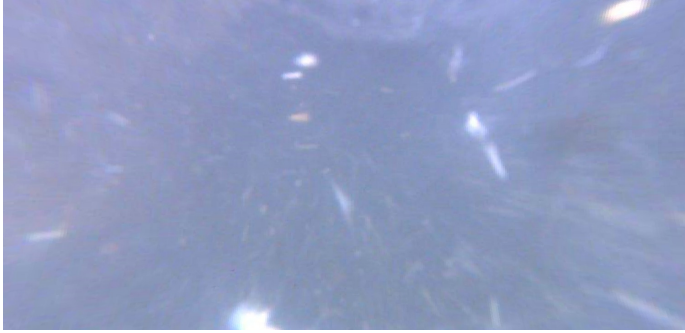
Code: **MWLS**
Description: **Water Level Sag**

Distance (ft): **109.2**
Structural Grade: **2**
O&M Grade: **3**
Clock Start/From:
Clock To:
1st Value:
2nd Value:
Value Percent: **15.000**
Continuous Index:
Within 8" of Joint: **NO**
Remarks:

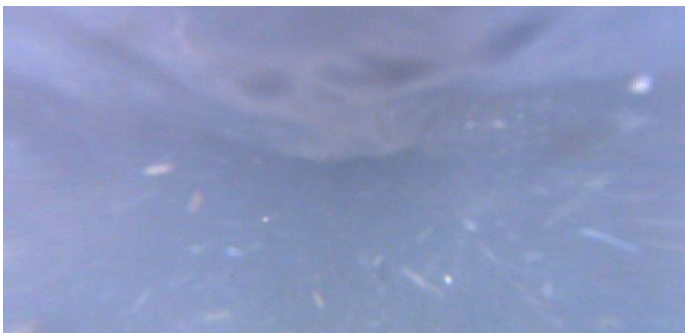
Code: **MWLS**
Description: **Water Level Sag**

Distance (ft): **115.1**
Structural Grade: **2**
O&M Grade: **3**
Clock Start/From:
Clock To:
1st Value:
2nd Value:
Value Percent: **15.000**
Continuous Index: **S04**
Within 8" of Joint: **NO**
Remarks:

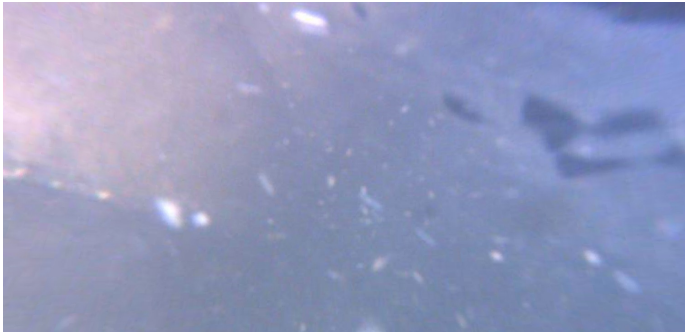
Code: **MCU**
Description: **Camera Underwater**

Distance (ft): **129.4**
Structural Grade: **0**
O&M Grade: **4**
Clock Start/From:
Clock To:
1st Value:
2nd Value:
Value Percent:
Continuous Index: **F08**
Within 8" of Joint: **NO**
Remarks:

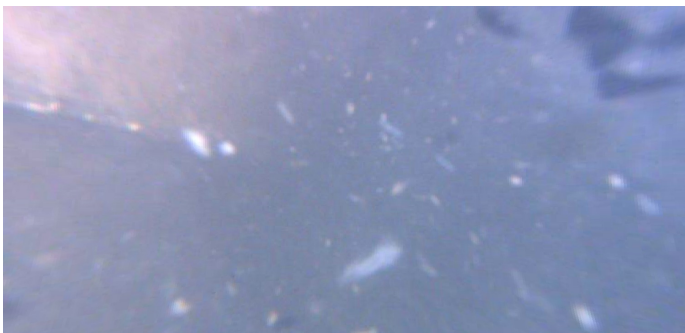
Code: **MWLS**
Description: **Water Level Sag**

Distance (ft): **129.4**
Structural Grade: **2**
O&M Grade: **3**
Clock Start/From:
Clock To:
1st Value:
2nd Value:
Value Percent: **15.000**
Continuous Index: **F04**
Within 8" of Joint: **NO**
Remarks:

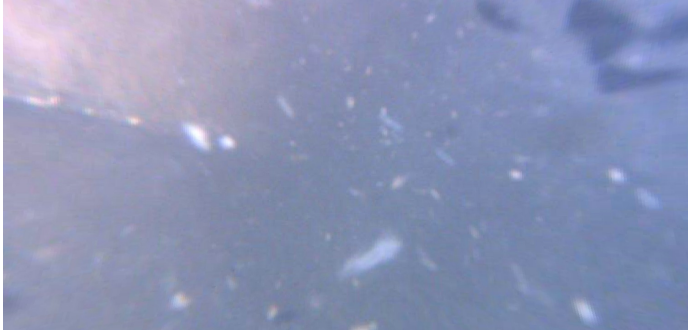
Code:	MSA
Description:	Abandoned Survey
Distance (ft):	129.4
Structural Grade:	0
O&M Grade:	0
Clock Start/From:	
Clock To:	
1st Value:	
2nd Value:	
Value Percent:	
Continuous Index:	
Within 8" of Joint:	NO
Remarks:	camera stopped under water
