Profile/Photo Observation Report

Street:	FOXCROFT STREET	Flow Control:	Not Controlled
City:	Hobart, IN	Year Renewed:	
Location:	Yard	Tape/Media #:	
Purpose:	Routine Assessment	Dia/Height:	12"
Use:	Sanitary	Material:	CP
Drain Area:	NA	Lining:	
Category:	NA		
Comment:

Location Details:		Direction of Survey:	Downstream
US MH:	M-405-022	DS MH:	M-405-021
		Total Length Surveyed (ft):	129.4

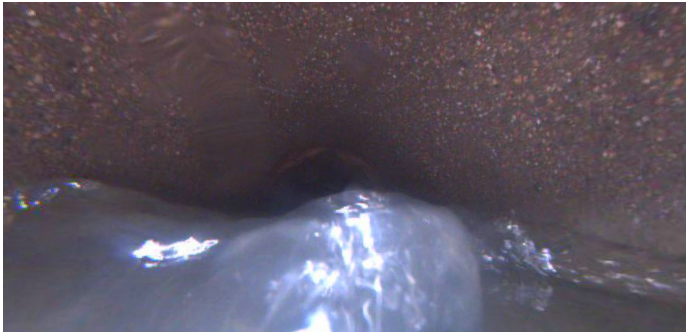
Code: **SAP**
Description: **Surface Aggregate Projecting**

Distance (ft): **.0**
Structural Grade: **3**
O&M Grade: **0**
Clock Start/From: **8**
Clock To: **4**
1st Value:
2nd Value:
Value Percent:
Continuous Index: **S05**
Within 8" of Joint:
Remarks:

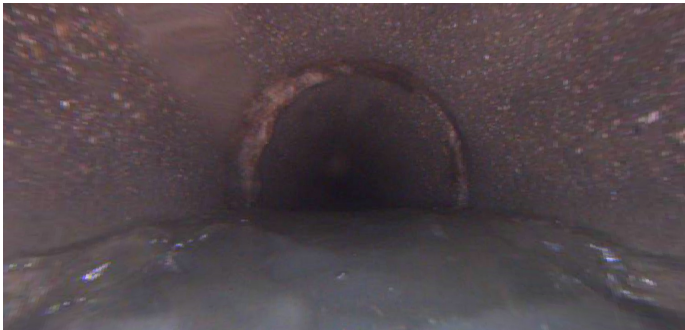
Code: **DAE**
Description: **Deposits Attached Encrustation**

Distance (ft): **6.2**
Structural Grade: **0**
O&M Grade: **2**
Clock Start/From: **8**
Clock To: **12**
1st Value:
2nd Value:
Value Percent: **10.000**
Continuous Index: **S06**
Within 8" of Joint: **YES**
Remarks:

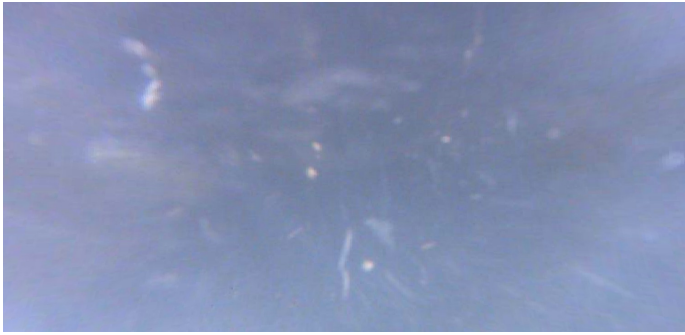
Code: **MWLS**
Description: **Water Level Sag**

Distance (ft): **14.3**
Structural Grade: **2**
O&M Grade: **3**
Clock Start/From:
Clock To:
1st Value:
2nd Value:
Value Percent: **10.000**
Continuous Index: **S01**
Within 8" of Joint: **NO**
Remarks:

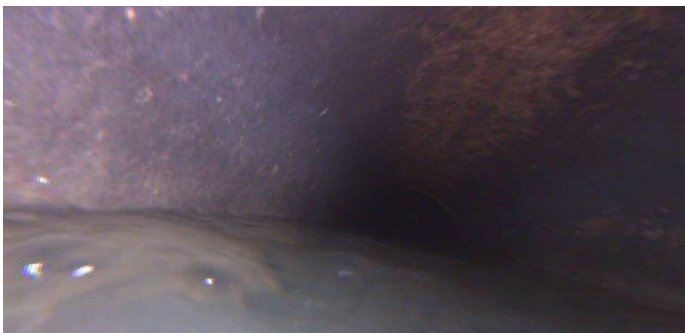
Code: **MWLS**
Description: **Water Level Sag**

Distance (ft): **20.0**
Structural Grade: **2**
O&M Grade: **3**
Clock Start/From:
Clock To:
1st Value:
2nd Value:
Value Percent: **10.000**
Continuous Index: **F01**
Within 8" of Joint: **NO**
Remarks:

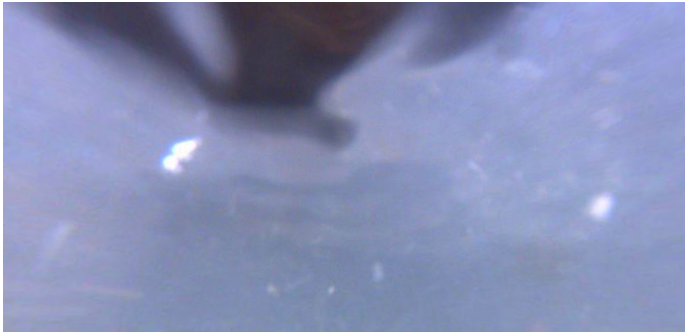
Code: **DAE**
Description: **Deposits Attached Encrustation**

Distance (ft): **21.6**
Structural Grade: **0**
O&M Grade: **2**
Clock Start/From: **8**
Clock To: **12**
1st Value:
2nd Value:
Value Percent: **10.000**
Continuous Index: **F06**
Within 8" of Joint: **YES**
Remarks:

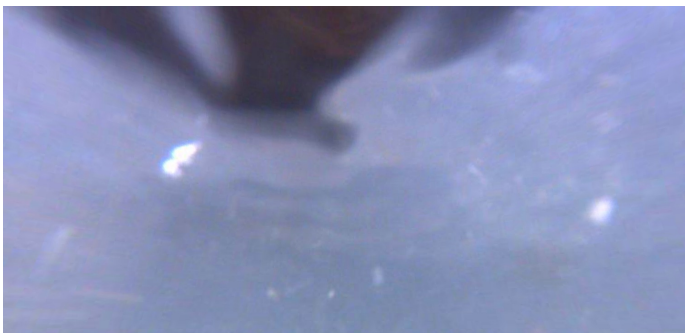
Code: **MCU**
Description: **Camera Underwater**

Distance (ft): **21.6**
Structural Grade: **0**
O&M Grade: **4**
Clock Start/From:
Clock To:
1st Value:
2nd Value:
Value Percent:
Continuous Index: **S07**
Within 8" of Joint: **NO**
Remarks:

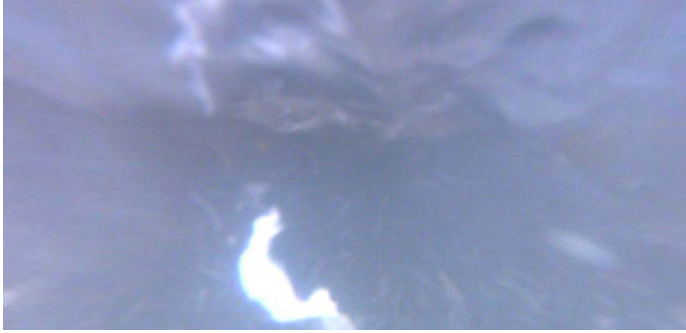
Code: **MWLS**
Description: **Water Level Sag**

Distance (ft): **22.3**
Structural Grade: **2**
O&M Grade: **3**
Clock Start/From:
Clock To:
1st Value:
2nd Value:
Value Percent: **10.000**
Continuous Index:
Within 8" of Joint: **NO**
Remarks:

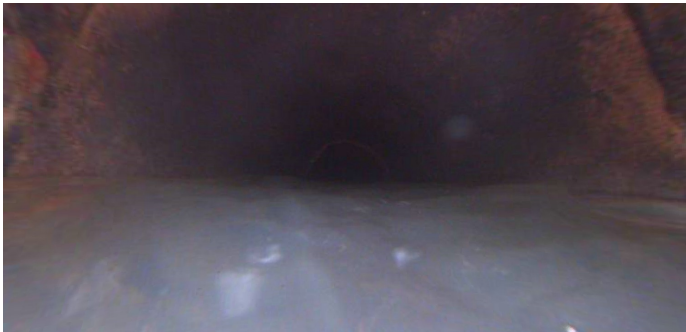
Code: **SAP**
Description: **Surface Aggregate Projecting**

Distance (ft): **25.3**
Structural Grade: **3**
O&M Grade: **0**
Clock Start/From: **8**
Clock To: **4**
1st Value:
2nd Value:
Value Percent:
Continuous Index: **F05**
Within 8" of Joint:
Remarks:

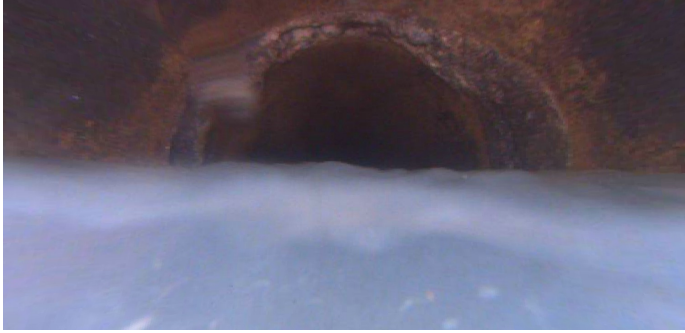
Code: **MWLS**
Description: **Water Level Sag**

Distance (ft): **27.8**
Structural Grade: **2**
O&M Grade: **3**
Clock Start/From:
Clock To:
1st Value:
2nd Value:
Value Percent: **10.000**
Continuous Index: **S02**
Within 8" of Joint: **NO**
Remarks:

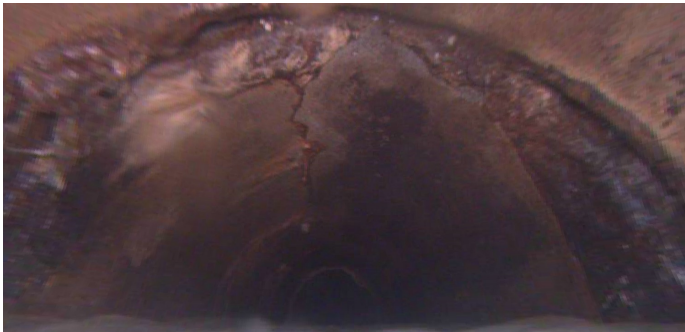
Code: **FM**
Description: **Fracture Multiple**

Distance (ft): **58.4**
Structural Grade: **4**
O&M Grade: **0**
Clock Start/From: **7**
Clock To: **3**
1st Value:
2nd Value:
Value Percent:
Continuous Index:
Within 8" of Joint: **YES**
Remarks:

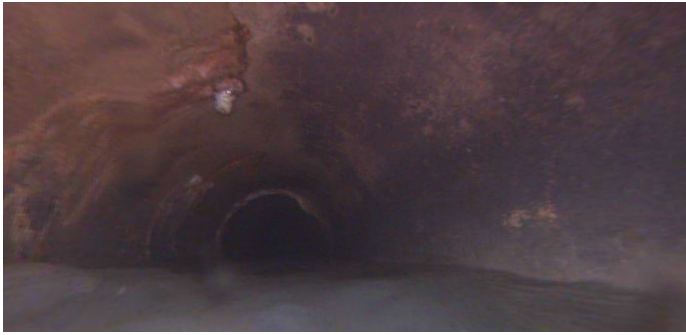
Code: **FC**
Description: **Fracture Circumferential**

Distance (ft): **59.1**
Structural Grade: **2**
O&M Grade: **0**
Clock Start/From: **9**
Clock To: **12**
1st Value:
2nd Value:
Value Percent:
Continuous Index:
Within 8" of Joint:
Remarks:

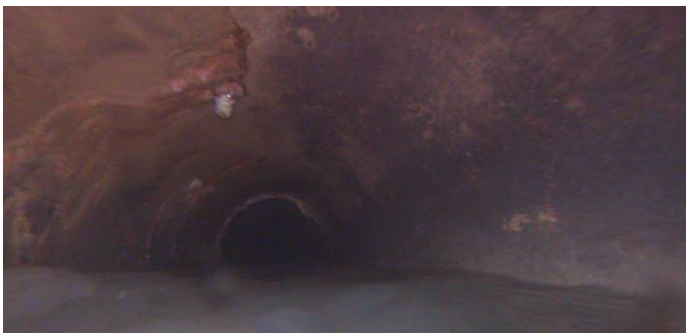
Code: **IS**
Description: **Infil Stain**

Distance (ft): **59.1**
Structural Grade: **0**
O&M Grade: **0**
Clock Start/From: **9**
Clock To: **12**
1st Value:
2nd Value:
Value Percent:
Continuous Index:
Within 8" of Joint:
Remarks:

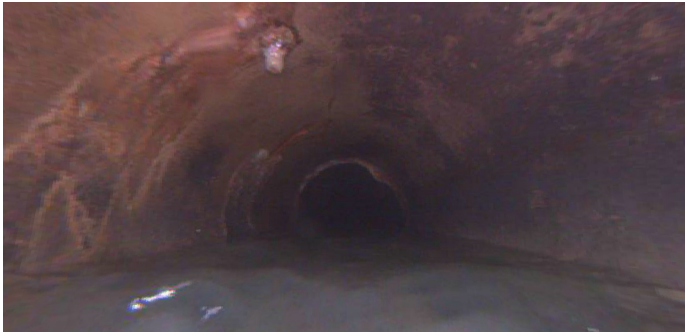
Code: **MWLS**
Description: **Water Level Sag**

Distance (ft): **59.3**
Structural Grade: **2**
O&M Grade: **3**
Clock Start/From:
Clock To:
1st Value:
2nd Value:
Value Percent: **10.000**
Continuous Index: **F02**
Within 8" of Joint: **NO**
Remarks:

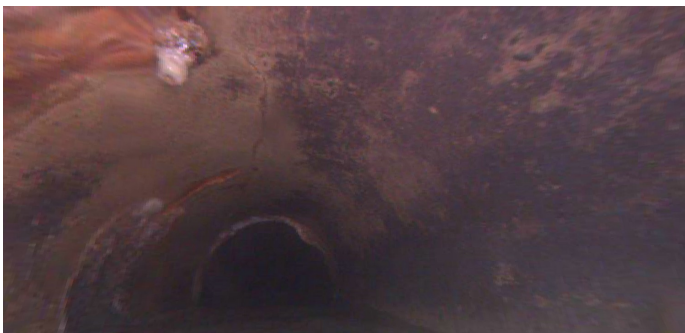
Code: **FL**
Description: **Fracture Longitudinal**

Distance (ft): **59.6**
Structural Grade: **3**
O&M Grade: **0**
Clock Start/From: **12**
Clock To:
1st Value:
2nd Value:
Value Percent:
Continuous Index:
Within 8" of Joint:
Remarks:

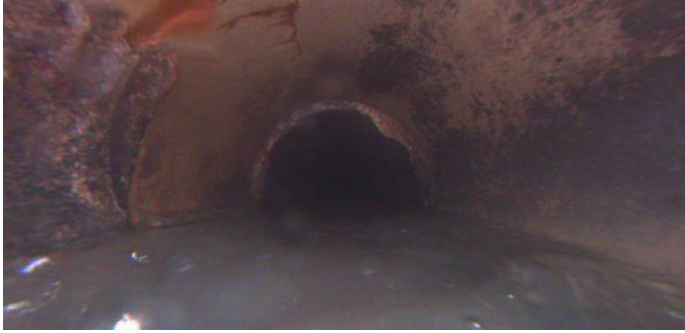
Code: **MCU**
Description: **Camera Underwater**

Distance (ft): **60.2**
Structural Grade: **0**
O&M Grade: **4**
Clock Start/From:
Clock To:
1st Value:
2nd Value:
Value Percent:
Continuous Index: **F07**
Within 8" of Joint: **NO**
Remarks:

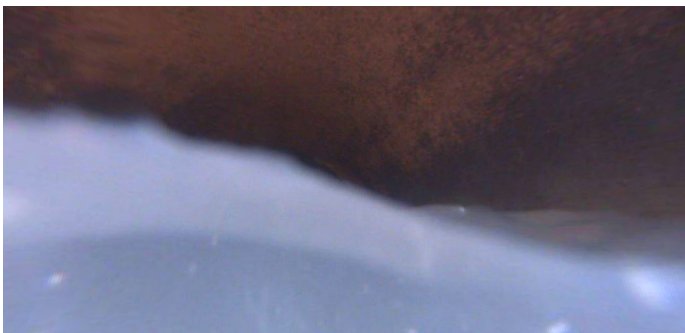
Code: **MWLS**
Description: **Water Level Sag**

Distance (ft): **66.4**
Structural Grade: **2**
O&M Grade: **3**
Clock Start/From:
Clock To:
1st Value:
2nd Value:
Value Percent: **10.000**
Continuous Index: **S03**
Within 8" of Joint: **NO**
Remarks:

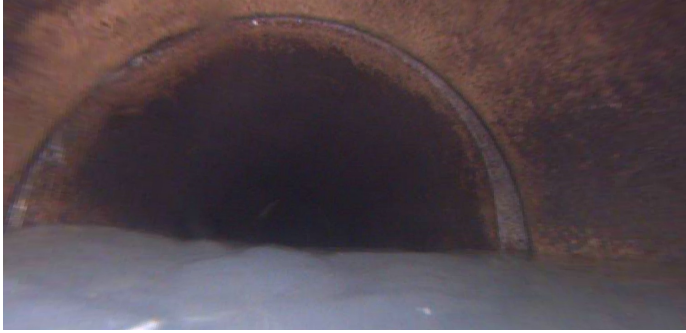
Code: **MWLS**
Description: **Water Level Sag**

Distance (ft): **73.3**
Structural Grade: **2**
O&M Grade: **3**
Clock Start/From:
Clock To:
1st Value:
2nd Value:
Value Percent: **10.000**
Continuous Index: **F03**
Within 8" of Joint: **NO**
Remarks:

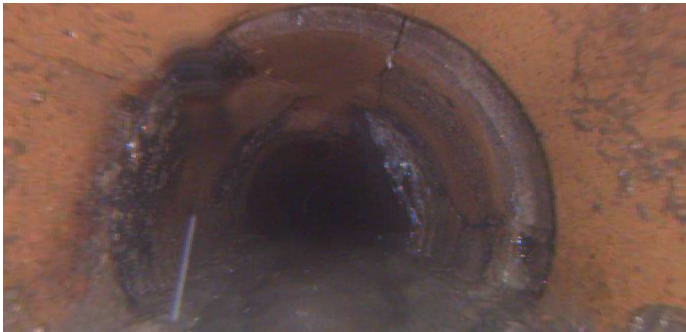
Code: **B**
Description: **Broken**

Distance (ft): **82.3**
Structural Grade: **5**
O&M Grade: **0**
Clock Start/From: **9**
Clock To: **4**
1st Value:
2nd Value:
Value Percent:
Continuous Index:
Within 8" of Joint: **YES**
Remarks:

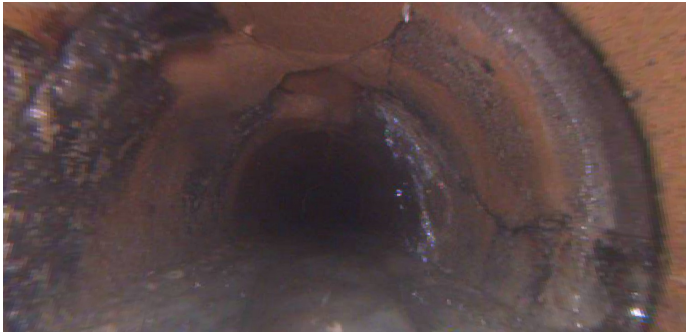
Code: **TBA**
Description: **Tap Break-in Active**

Distance (ft): **82.5**
Structural Grade: **0**
O&M Grade: **0**
Clock Start/From: **12**
Clock To:
1st Value: **4.000**
2nd Value:
Value Percent:
Continuous Index:
Within 8" of Joint:
Remarks:

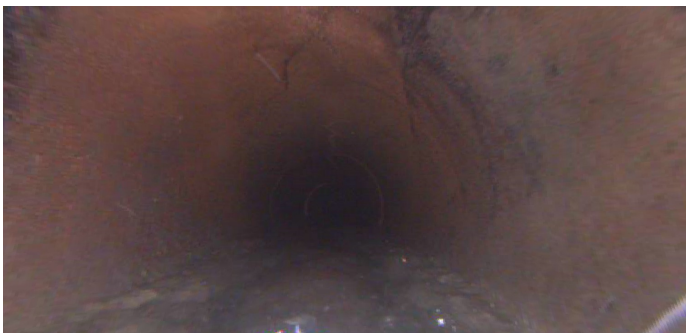
Code: **FM**
Description: **Fracture Multiple**

Distance (ft): **83.5**
Structural Grade: **4**
O&M Grade: **0**
Clock Start/From: **10**
Clock To: **5**
1st Value:
2nd Value:
Value Percent:
Continuous Index:
Within 8" of Joint: **YES**
Remarks:

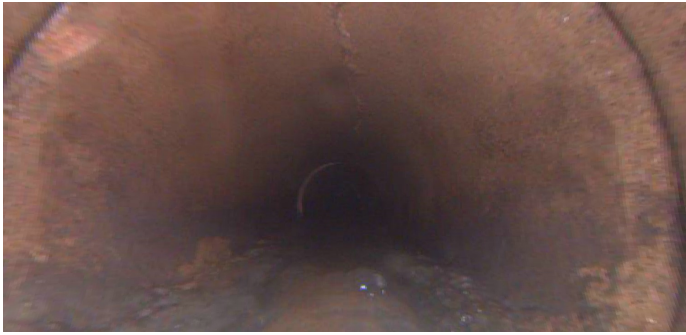
Code: **FL**
Description: **Fracture Longitudinal**

Distance (ft): **85.6**
Structural Grade: **3**
O&M Grade: **0**
Clock Start/From: **12**
Clock To:
1st Value:
2nd Value:
Value Percent:
Continuous Index:
Within 8" of Joint: **YES**
Remarks:

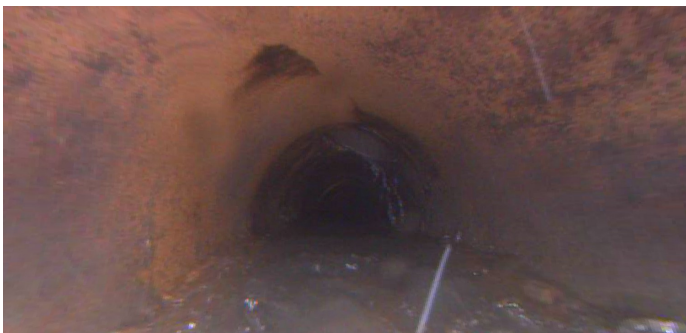
Code: **IS**
Description: **Infil Stain**

Distance (ft): **89.4**
Structural Grade: **0**
O&M Grade: **0**
Clock Start/From: **7**
Clock To: **12**
1st Value:
2nd Value:
Value Percent:
Continuous Index:
Within 8" of Joint: **YES**
Remarks:

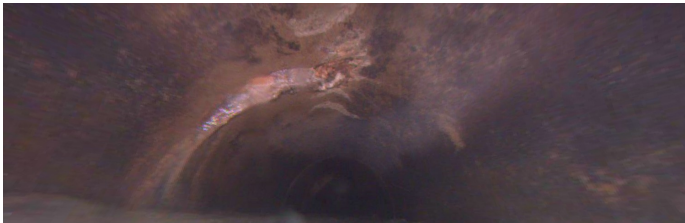
Code: **DAE**
Description: **Deposits Attached Encrustation**

Distance (ft): **93.2**
Structural Grade: **0**
O&M Grade: **2**
Clock Start/From: **9**
Clock To: **12**
1st Value:
2nd Value:
Value Percent: **5.000**
Continuous Index:
Within 8" of Joint: **NO**
Remarks:

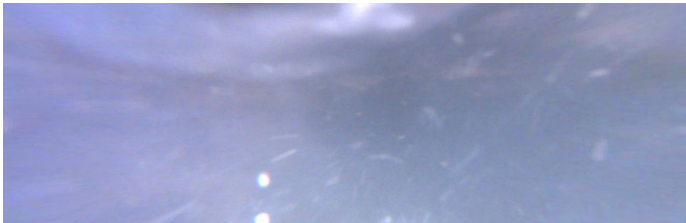
Code: **MWLS**
Description: **Water Level Sag**

Distance (ft): **97.7**
Structural Grade: **2**
O&M Grade: **3**
Clock Start/From:
Clock To:
1st Value:
2nd Value:
Value Percent: **15.000**
Continuous Index:
Within 8" of Joint: **NO**
Remarks:

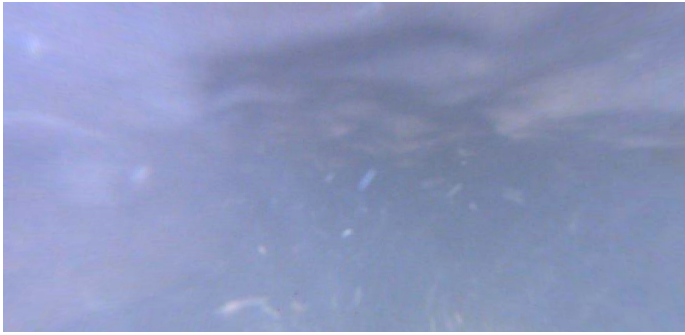
Code: **MWLS**
Description: **Water Level Sag**

Distance (ft): **106.5**
Structural Grade: **2**
O&M Grade: **3**
Clock Start/From:
Clock To:
1st Value:
2nd Value:
Value Percent: **15.000**
Continuous Index:
Within 8" of Joint: **NO**
Remarks:

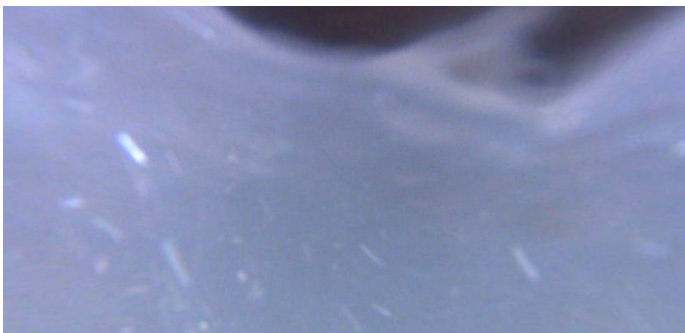
Code: **MCU**
Description: **Camera Underwater**

Distance (ft): **106.9**
Structural Grade: **0**
O&M Grade: **4**
Clock Start/From:
Clock To:
1st Value:
2nd Value:
Value Percent:
Continuous Index: **S08**
Within 8" of Joint: **NO**
Remarks:

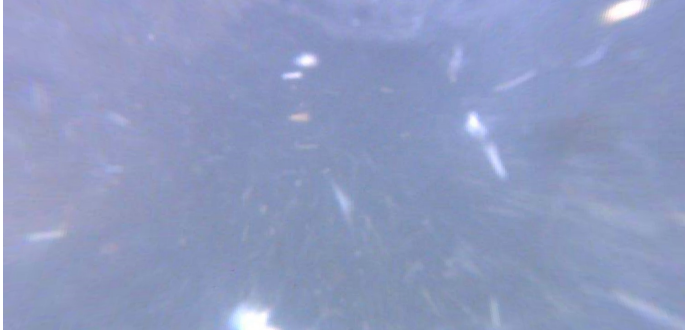
Code: **MWLS**
Description: **Water Level Sag**

Distance (ft): **109.2**
Structural Grade: **2**
O&M Grade: **3**
Clock Start/From:
Clock To:
1st Value:
2nd Value:
Value Percent: **15.000**
Continuous Index:
Within 8" of Joint: **NO**
Remarks:

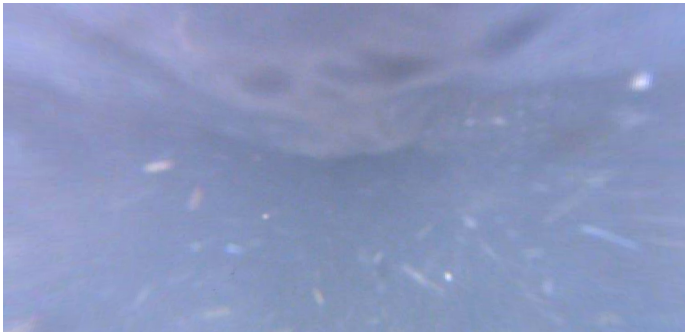
Code: **MWLS**
Description: **Water Level Sag**

Distance (ft): **115.1**
Structural Grade: **2**
O&M Grade: **3**
Clock Start/From:
Clock To:
1st Value:
2nd Value:
Value Percent: **15.000**
Continuous Index: **S04**
Within 8" of Joint: **NO**
Remarks:

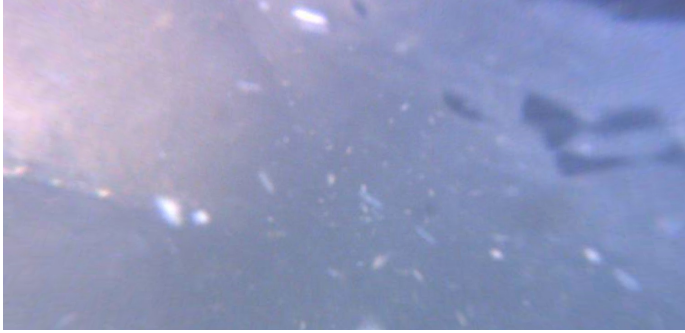
Code: **MCU**
Description: **Camera Underwater**

Distance (ft): **129.4**
Structural Grade: **0**
O&M Grade: **4**
Clock Start/From:
Clock To:
1st Value:
2nd Value:
Value Percent:
Continuous Index: **F08**
Within 8" of Joint: **NO**
Remarks:

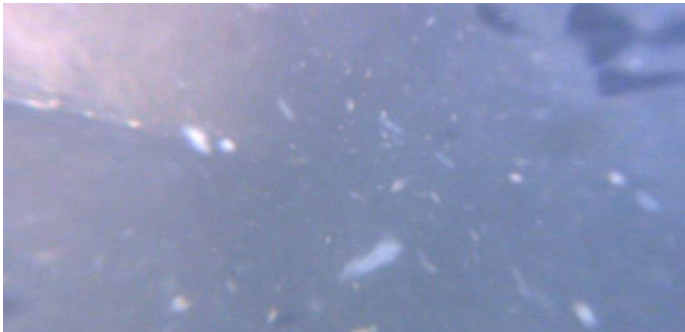
Code: **MWLS**
Description: **Water Level Sag**

Distance (ft): **129.4**
Structural Grade: **2**
O&M Grade: **3**
Clock Start/From:
Clock To:
1st Value:
2nd Value:
Value Percent: **15.000**
Continuous Index: **F04**
Within 8" of Joint: **NO**
Remarks:

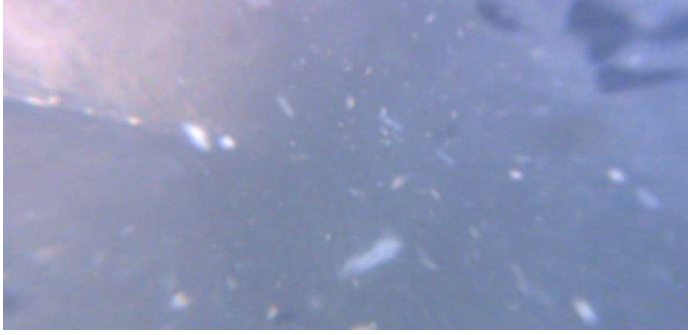
Code:	MSA
Description:	Abandoned Survey
Distance (ft):	129.4
Structural Grade:	0
O&M Grade:	0
Clock Start/From:	
Clock To:	
1st Value:	
2nd Value:	
Value Percent:	
Continuous Index:	
Within 8" of Joint:	NO
Remarks:	camera stopped under water
