# Profile/Photo Observation Report

Date:	<b>04/23/2018</b>	Weather:		Coding:	<b>PACP 6.0</b>
Pipe Length (ft):	<b>262.5</b>	Owner:	<b>NA</b>	Pre Clean:	<b>No Pre-Cleaning</b>
P.O.#:		Surveyor:	<b>Jen Costello</b>	PSR:	<b>P-405-022-021</b>
Customer:		Clean Date:	<b>01/01/1900</b>	Shape:	<b>C</b>

Street:	<b>ALLEY BETWEEN DRIFTWOOD DR &amp;</b>	Flow Control:	<b>Not Controlled</b>
City:	<b>Hobart, IN</b>	Year Renewed:	
Location:	<b>Yard</b>	Tape/Media #:	
Purpose:	<b>Routine Assessment</b>	Dia/Height:	<b>12"</b>
Use:	<b>Sanitary</b>	Material:	<b>CP</b>
Drain Area:	<b>NA</b>	Lining:	
Category:	<b>NA</b>		
Comment:	<b>P_C at 247 ft debris</b>		
Location Details:		Direction of Survey:	<b>Downstream</b>
US MH:	<b>M-405-022</b>	DS MH:	<b>M-405-021</b>
		Total Length Surveyed (ft):	<b>249.0</b>

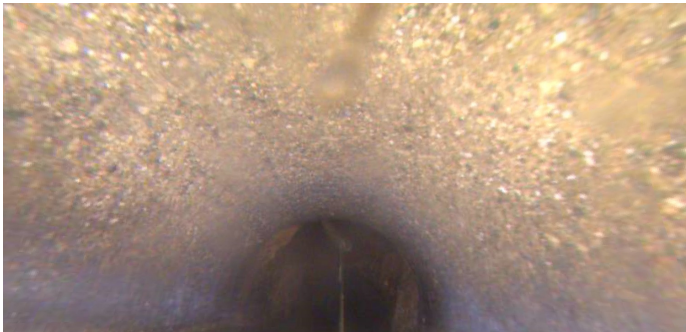
Code: **SAP**  
Description: **Surface Aggregate Projecting**

Distance (ft): **1.2**  
Structural Grade: **3**  
O&M Grade: **0**  
Clock Start/From: **8**  
Clock To: **4**  
1st Value:  
2nd Value:  
Value Percent:  
Continuous Index: **S01**  
Within 8" of Joint:  
Remarks:

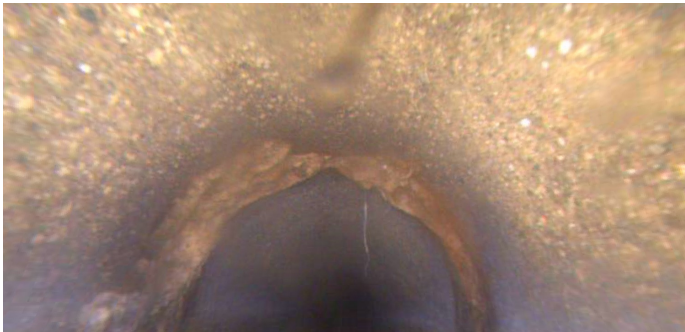
Code: **DAE**  
Description: **Deposits Attached Encrustation**

Distance (ft): **4.4**  
Structural Grade: **0**  
O&M Grade: **2**  
Clock Start/From: **8**  
Clock To: **4**  
1st Value:  
2nd Value:  
Value Percent: **10.000**  
Continuous Index: **S02**  
Within 8" of Joint: **YES**  
Remarks:

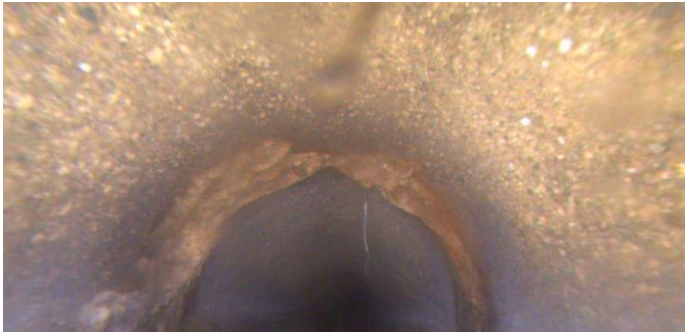
Code: **RFJ**  
Description: **Roots Fine Joint**

Distance (ft): **4.4**  
Structural Grade: **0**  
O&M Grade: **1**  
Clock Start/From: **12**  
Clock To:  
1st Value:  
2nd Value:  
Value Percent:  
Continuous Index:  
Within 8" of Joint: **YES**  
Remarks:

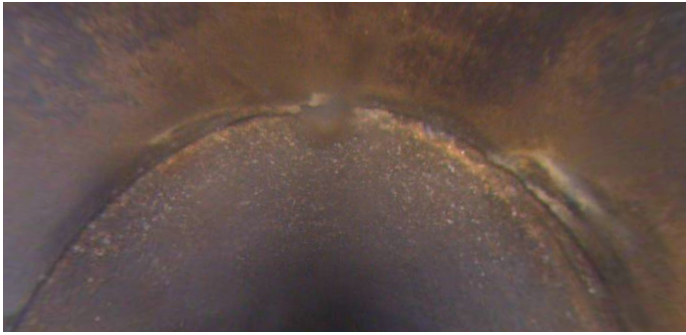
Code: **SAP**  
Description: **Surface Aggregate Projecting**

Distance (ft): **19.9**  
Structural Grade: **3**  
O&M Grade: **0**  
Clock Start/From: **8**  
Clock To: **4**  
1st Value:  
2nd Value:  
Value Percent:  
Continuous Index: **F01**  
Within 8" of Joint:  
Remarks:

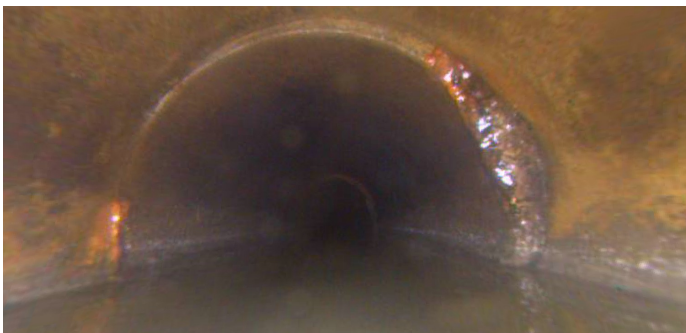
Code: **IW**  
Description: **Infil Weeper**

Distance (ft): **41.0**  
Structural Grade: **0**  
O&M Grade: **2**  
Clock Start/From: **8**  
Clock To: **4**  
1st Value:  
2nd Value:  
Value Percent:  
Continuous Index:  
Within 8" of Joint: **YES**  
Remarks:

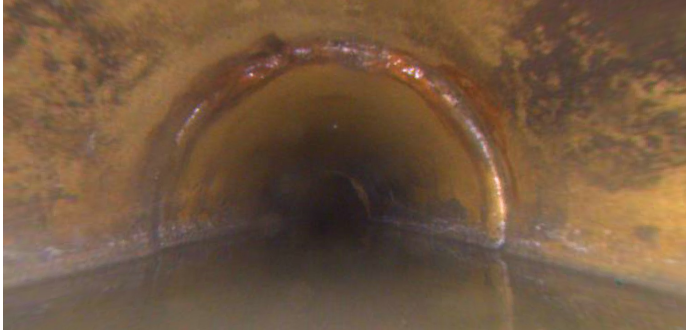
Code: **IW**  
Description: **Infil Weeper**

Distance (ft): **50.1**  
Structural Grade: **0**  
O&M Grade: **2**  
Clock Start/From: **8**  
Clock To: **4**  
1st Value:  
2nd Value:  
Value Percent:  
Continuous Index:  
Within 8" of Joint: **YES**  
Remarks:

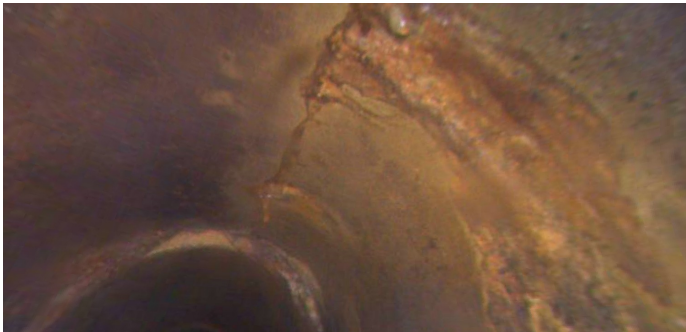
Code: **DAE**  
Description: **Deposits Attached Encrustation**

Distance (ft): **59.6**  
Structural Grade: **0**  
O&M Grade: **2**  
Clock Start/From: **9**  
Clock To: **12**  
1st Value:  
2nd Value:  
Value Percent: **5.000**  
Continuous Index:  
Within 8" of Joint: **NO**  
Remarks:

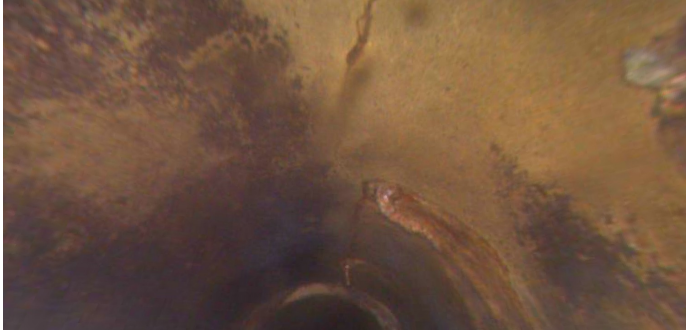
Code: **FL**  
Description: **Fracture Longitudinal**

Distance (ft): **60.3**  
Structural Grade: **3**  
O&M Grade: **0**  
Clock Start/From: **12**  
Clock To:  
1st Value:  
2nd Value:  
Value Percent:  
Continuous Index: **S03**  
Within 8" of Joint: **YES**  
Remarks:

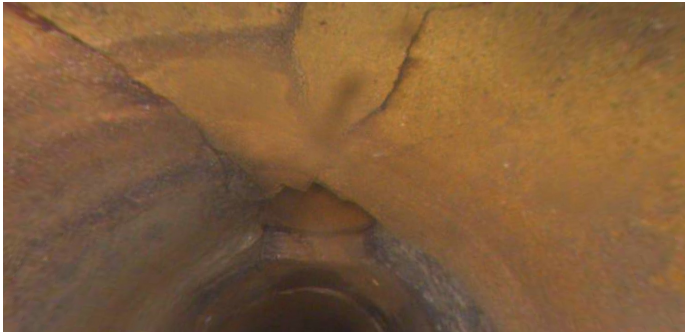
Code: **FM**  
Description: **Fracture Multiple**

Distance (ft): **84.0**  
Structural Grade: **4**  
O&M Grade: **0**  
Clock Start/From: **11**  
Clock To: **1**  
1st Value:  
2nd Value:  
Value Percent:  
Continuous Index:  
Within 8" of Joint:  
Remarks:

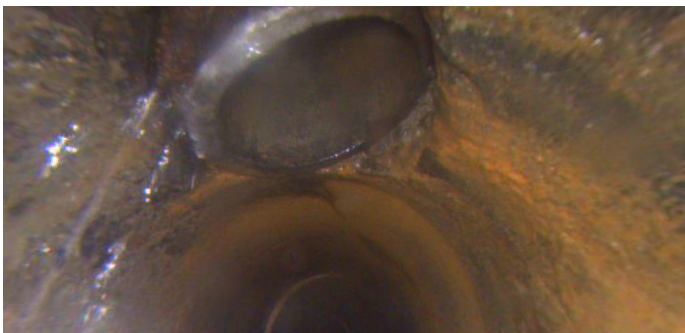
Code: **TBI**  
Description: **Tap Break-in Intruding**

Distance (ft): **91.0**  
Structural Grade: **0**  
O&M Grade: **2**  
Clock Start/From: **12**  
Clock To:  
1st Value: **4.000**  
2nd Value: **1.000**  
Value Percent:  
Continuous Index:  
Within 8" of Joint:  
Remarks: **ACTIVE**

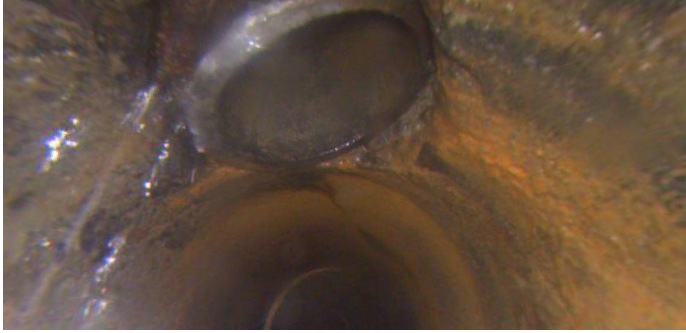
Code: **DAE**  
Description: **Deposits Attached Encrustation**

Distance (ft): **91.0**  
Structural Grade: **0**  
O&M Grade: **2**  
Clock Start/From: **8**  
Clock To: **4**  
1st Value:  
2nd Value:  
Value Percent: **10.000**  
Continuous Index: **F02**  
Within 8" of Joint: **YES**  
Remarks:

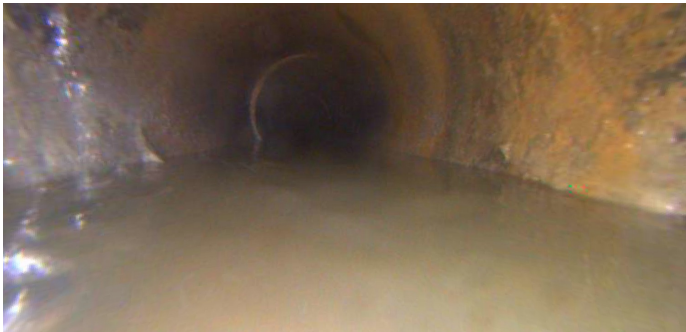
Code: **FL**  
Description: **Fracture Longitudinal**

Distance (ft): **91.0**  
Structural Grade: **3**  
O&M Grade: **0**  
Clock Start/From: **12**  
Clock To:  
1st Value:  
2nd Value:  
Value Percent:  
Continuous Index: **F03**  
Within 8" of Joint: **YES**  
Remarks:

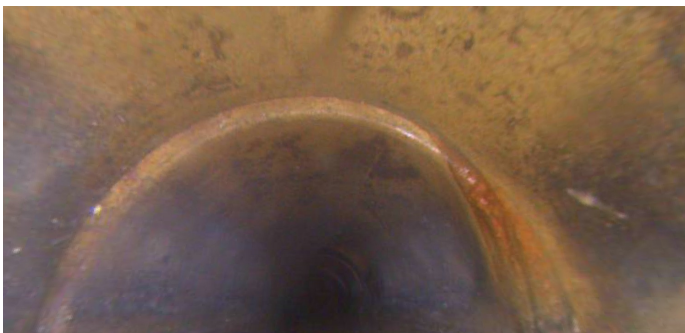
Code: **IW**  
Description: **Infil Weeper**

Distance (ft): **97.9**  
Structural Grade: **0**  
O&M Grade: **2**  
Clock Start/From: **9**  
Clock To: **11**  
1st Value:  
2nd Value:  
Value Percent:  
Continuous Index:  
Within 8" of Joint: **YES**  
Remarks:

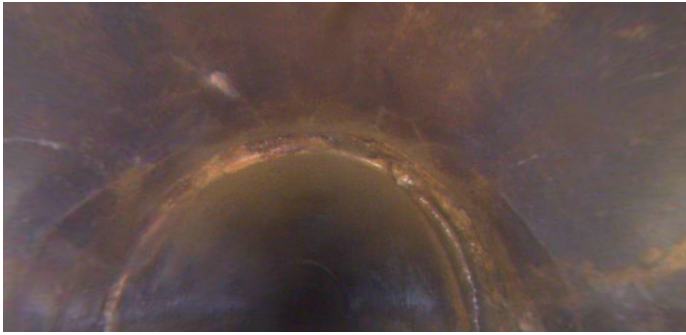
Code: **FM**  
Description: **Fracture Multiple**

Distance (ft): **101.1**  
Structural Grade: **4**  
O&M Grade: **0**  
Clock Start/From: **8**  
Clock To: **4**  
1st Value:  
2nd Value:  
Value Percent:  
Continuous Index:  
Within 8" of Joint: **YES**  
Remarks:

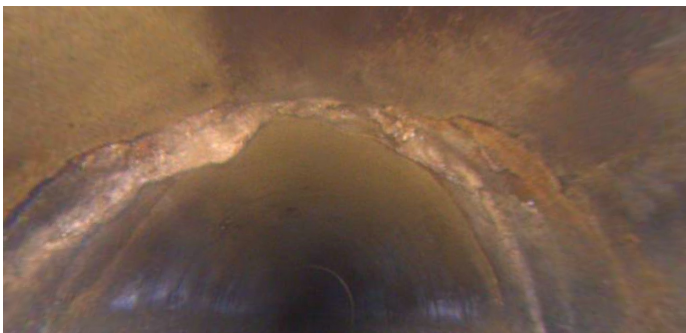
Code: **DAE**  
Description: **Deposits Attached Encrustation**

Distance (ft): **106.9**  
Structural Grade: **0**  
O&M Grade: **2**  
Clock Start/From: **8**  
Clock To: **4**  
1st Value:  
2nd Value:  
Value Percent: **5.000**  
Continuous Index: **S04**  
Within 8" of Joint: **YES**  
Remarks:

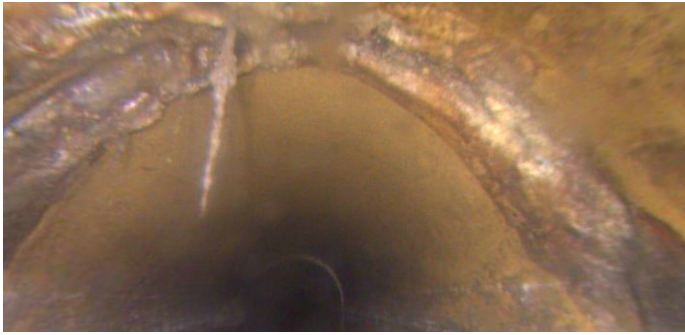
Code: **RFJ**  
Description: **Roots Fine Joint**

Distance (ft): **139.6**  
Structural Grade: **0**  
O&M Grade: **1**  
Clock Start/From: **12**  
Clock To:  
1st Value:  
2nd Value:  
Value Percent:  
Continuous Index:  
Within 8" of Joint: **YES**  
Remarks:

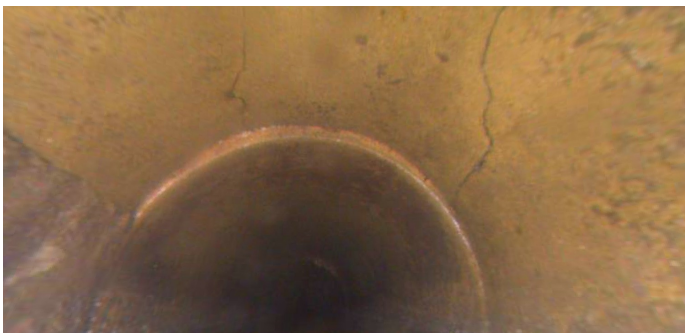
Code: **FM**  
Description: **Fracture Multiple**

Distance (ft): **149.1**  
Structural Grade: **4**  
O&M Grade: **0**  
Clock Start/From: **10**  
Clock To: **2**  
1st Value:  
2nd Value:  
Value Percent:  
Continuous Index:  
Within 8" of Joint: **YES**  
Remarks:

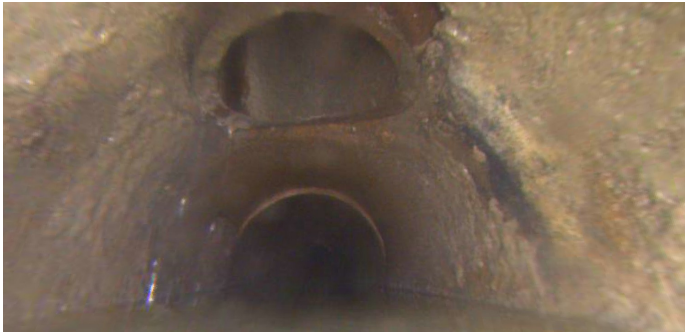
Code: **TBI**  
Description: **Tap Break-in Intruding**

Distance (ft): **150.3**  
Structural Grade: **0**  
O&M Grade: **2**  
Clock Start/From: **12**  
Clock To:  
1st Value: **4.000**  
2nd Value: **1.000**  
Value Percent:  
Continuous Index:  
Within 8" of Joint:  
Remarks:

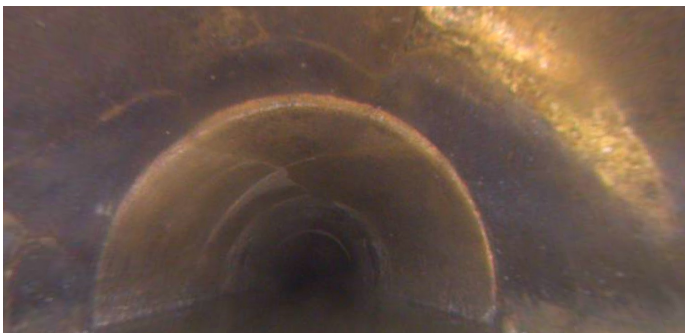
Code: **FM**  
Description: **Fracture Multiple**

Distance (ft): **152.0**  
Structural Grade: **4**  
O&M Grade: **0**  
Clock Start/From: **8**  
Clock To: **4**  
1st Value:  
2nd Value:  
Value Percent:  
Continuous Index: **S05**  
Within 8" of Joint: **YES**  
Remarks:

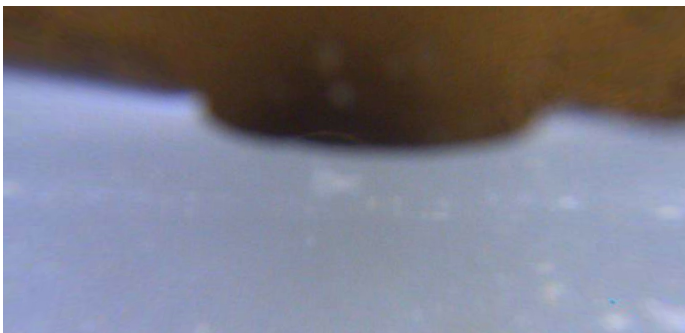
Code: **DAE**  
Description: **Deposits Attached Encrustation**

Distance (ft): **177.2**  
Structural Grade: **0**  
O&M Grade: **2**  
Clock Start/From: **8**  
Clock To: **4**  
1st Value:  
2nd Value:  
Value Percent: **5.000**  
Continuous Index: **F04**  
Within 8" of Joint: **YES**  
Remarks:

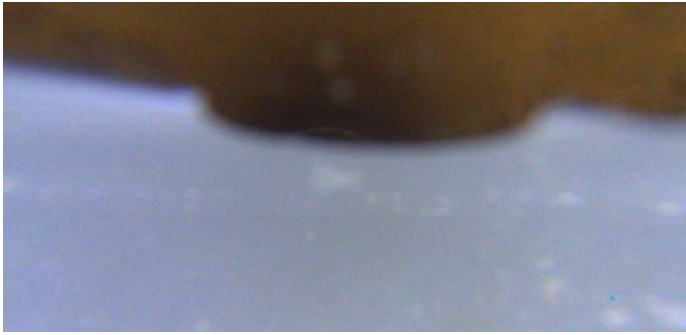
Code: **FM**  
Description: **Fracture Multiple**

Distance (ft): **177.2**  
Structural Grade: **4**  
O&M Grade: **0**  
Clock Start/From: **8**  
Clock To: **4**  
1st Value:  
2nd Value:  
Value Percent:  
Continuous Index: **F05**  
Within 8" of Joint: **YES**  
Remarks:

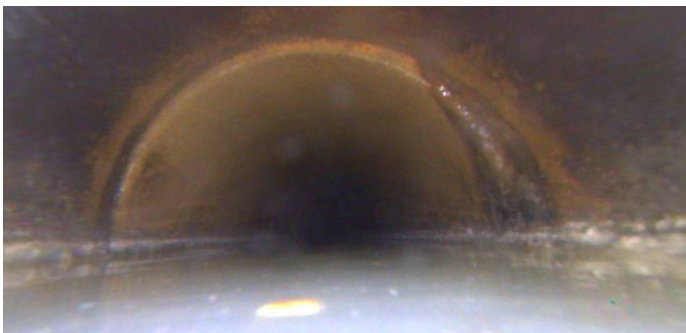
Code: **IW**  
Description: **Infil Weeper**

Distance (ft): **184.9**  
Structural Grade: **0**  
O&M Grade: **2**  
Clock Start/From: **9**  
Clock To: **11**  
1st Value:  
2nd Value:  
Value Percent:  
Continuous Index:  
Within 8" of Joint: **YES**  
Remarks:

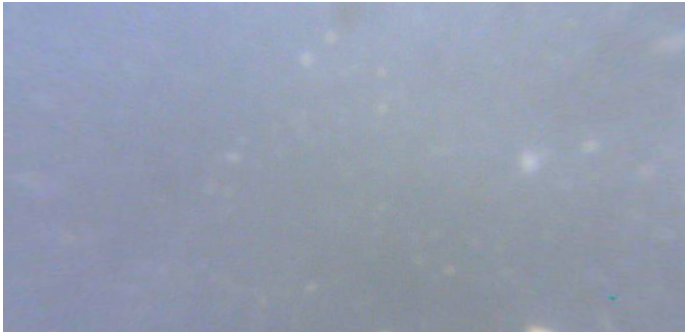
Code: **MCU**  
Description: **Camera Underwater**

Distance (ft): **189.0**  
Structural Grade: **0**  
O&M Grade: **4**  
Clock Start/From:  
Clock To:  
1st Value:  
2nd Value:  
Value Percent:  
Continuous Index: **S06**  
Within 8" of Joint: **NO**  
Remarks:

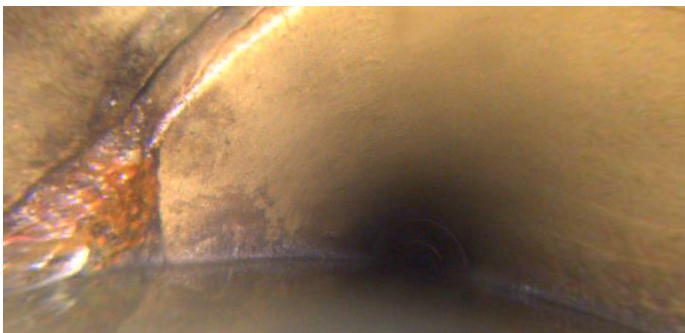
Code: **IW**  
Description: **Infil Weeper**

Distance (ft): **205.5**  
Structural Grade: **0**  
O&M Grade: **2**  
Clock Start/From: **3**  
Clock To:  
1st Value:  
2nd Value:  
Value Percent:  
Continuous Index:  
Within 8" of Joint: **YES**  
Remarks:

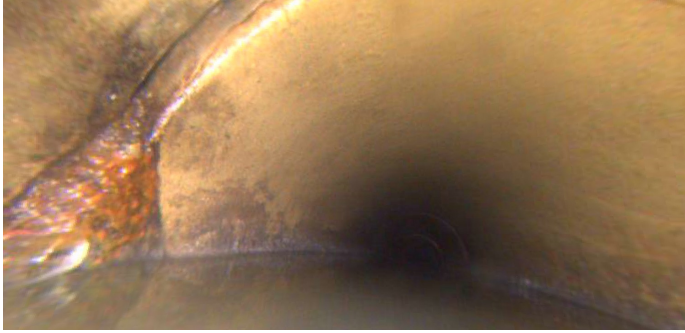
Code: **MCU**  
Description: **Camera Underwater**

Distance (ft): **205.5**  
Structural Grade: **0**  
O&M Grade: **4**  
Clock Start/From:  
Clock To:  
1st Value:  
2nd Value:  
Value Percent:  
Continuous Index: **F06**  
Within 8" of Joint: **NO**  
Remarks:

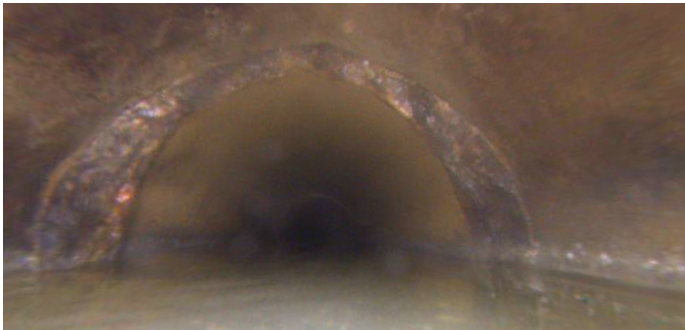
Code: **DAE**  
Description: **Deposits Attached Encrustation**

Distance (ft): **209.0**  
Structural Grade: **0**  
O&M Grade: **2**  
Clock Start/From: **8**  
Clock To: **4**  
1st Value:  
2nd Value:  
Value Percent: **10.000**  
Continuous Index:  
Within 8" of Joint: **YES**  
Remarks:

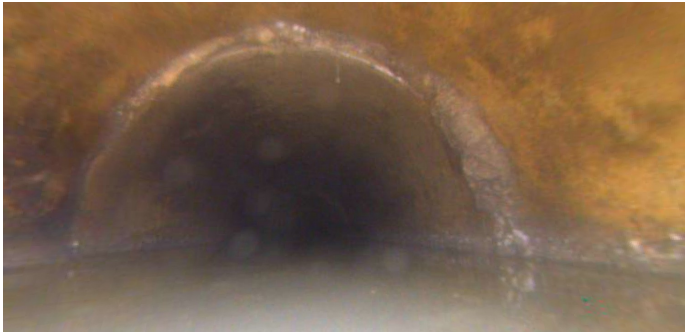
Code: **DAE**  
Description: **Deposits Attached Encrustation**

Distance (ft): **212.0**  
Structural Grade: **0**  
O&M Grade: **2**  
Clock Start/From: **8**  
Clock To: **4**  
1st Value:  
2nd Value:  
Value Percent: **5.000**  
Continuous Index:  
Within 8" of Joint: **YES**  
Remarks:

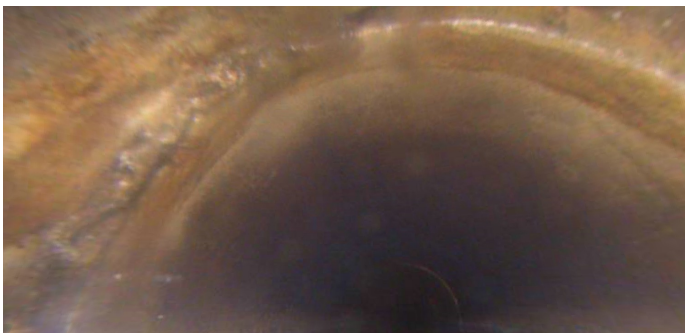
Code: **DAE**  
Description: **Deposits Attached Encrustation**

Distance (ft): **217.6**  
Structural Grade: **0**  
O&M Grade: **2**  
Clock Start/From: **12**  
Clock To: **4**  
1st Value:  
2nd Value:  
Value Percent: **5.000**  
Continuous Index:  
Within 8" of Joint: **YES**  
Remarks:

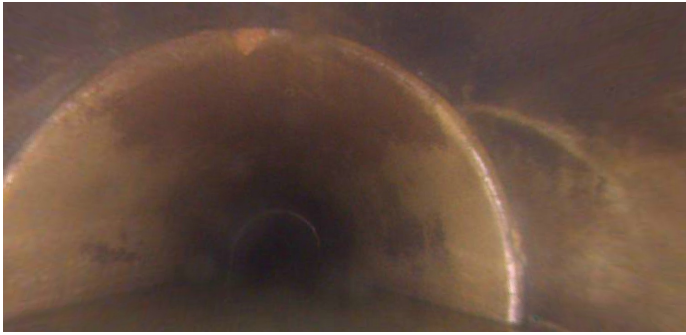
Code: **FS**  
Description: **Fracture Spiral**

Distance (ft): **223.8**  
Structural Grade: **3**  
O&M Grade: **0**  
Clock Start/From: **9**  
Clock To: **11**  
1st Value:  
2nd Value:  
Value Percent:  
Continuous Index:  
Within 8" of Joint: **YES**  
Remarks:

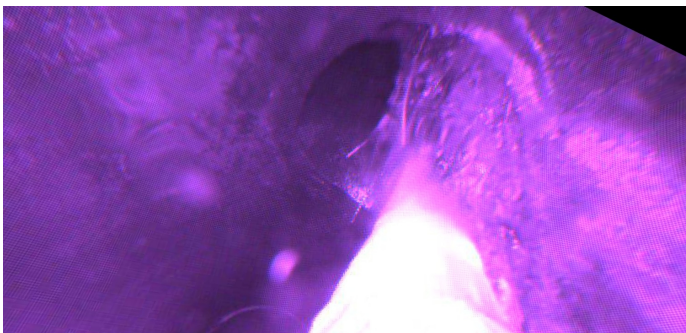
Code: **TFD**  
Description: **Tap Factory Defective**

Distance (ft): **247.5**  
Structural Grade: **0**  
O&M Grade: **2**  
Clock Start/From: **1**  
Clock To:  
1st Value: **4.000**  
2nd Value:  
Value Percent:  
Continuous Index:  
Within 8" of Joint:  
Remarks: **ROOTS**

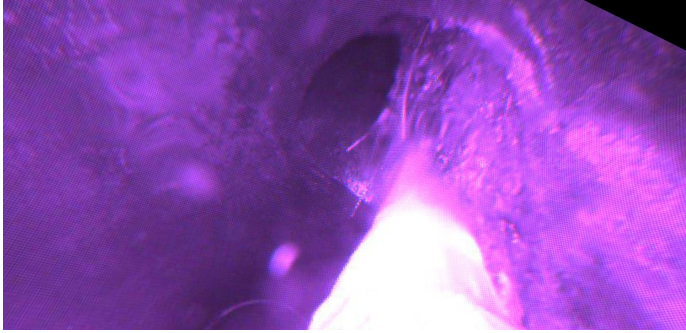
Code: **RML**  
Description: **Roots Medium Lateral**

Distance (ft): **247.5**  
Structural Grade: **0**  
O&M Grade: **3**  
Clock Start/From: **1**  
Clock To:  
1st Value:  
2nd Value:  
Value Percent: **20.000**  
Continuous Index:  
Within 8" of Joint: **NO**  
Remarks:
