Profile/Photo Observation Report

Street:	FOXCROFT STREET	Flow Control:	Not Controlled
City:	Hobart, IN	Year Renewed:	
Location:	Yard	Tape/Media #:	
Purpose:	Routine Assessment	Dia/Height:	12"
Use:	Sanitary	Material:	CP
Drain Area:	NA	Lining:	
Category:	NA		
Comment:	P_C at 247 ft debris		
Location Details:		Direction of Survey:	Downstream
US MH:	M-405-022	DS MH:	M-405-021
		Total Length Surveyed (ft):	249.0

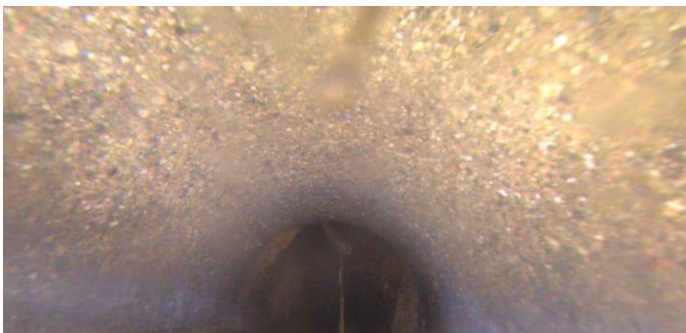
Code: **SAP**
Description: **Surface Aggregate Projecting**

Distance (ft): **1.2**
Structural Grade: **3**
O&M Grade: **0**
Clock Start/From: **8**
Clock To: **4**
1st Value:
2nd Value:
Value Percent:
Continuous Index: **S01**
Within 8" of Joint:
Remarks:

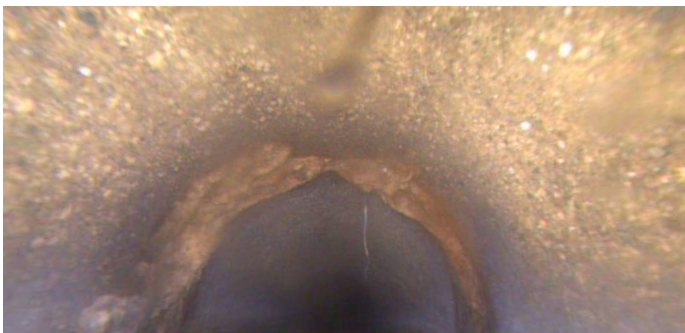
Code: **DAE**
Description: **Deposits Attached Encrustation**

Distance (ft): **4.4**
Structural Grade: **0**
O&M Grade: **2**
Clock Start/From: **8**
Clock To: **4**
1st Value:
2nd Value:
Value Percent: **10.000**
Continuous Index: **S02**
Within 8" of Joint: **YES**
Remarks:

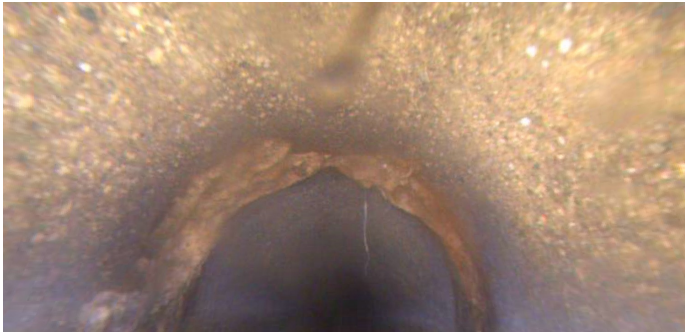
Code: **RFJ**
Description: **Roots Fine Joint**

Distance (ft): **4.4**
Structural Grade: **0**
O&M Grade: **1**
Clock Start/From: **12**
Clock To:
1st Value:
2nd Value:
Value Percent:
Continuous Index:
Within 8" of Joint: **YES**
Remarks:

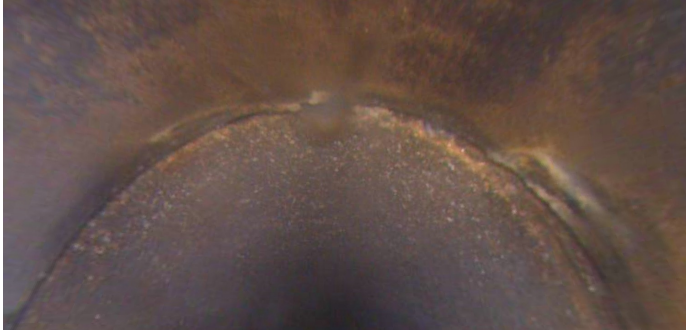
Code: **SAP**
Description: **Surface Aggregate Projecting**

Distance (ft): **19.9**
Structural Grade: **3**
O&M Grade: **0**
Clock Start/From: **8**
Clock To: **4**
1st Value:
2nd Value:
Value Percent:
Continuous Index: **F01**
Within 8" of Joint:
Remarks:

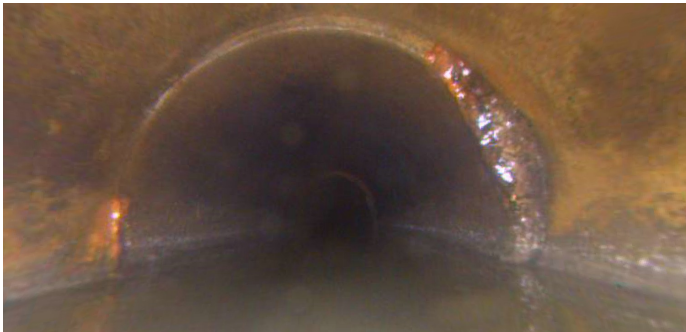
Code: **IW**
Description: **Infil Weeper**

Distance (ft): **41.0**
Structural Grade: **0**
O&M Grade: **2**
Clock Start/From: **8**
Clock To: **4**
1st Value:
2nd Value:
Value Percent:
Continuous Index:
Within 8" of Joint: **YES**
Remarks:

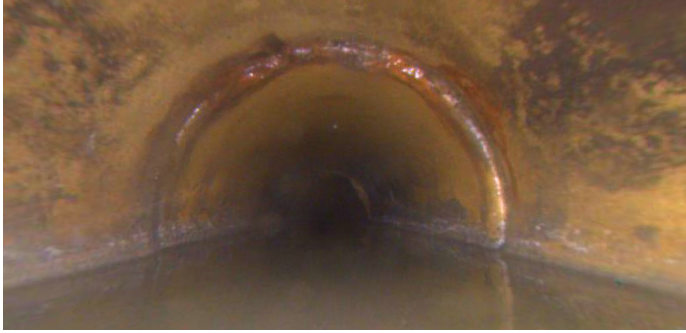
Code: **IW**
Description: **Infil Weeper**

Distance (ft): **50.1**
Structural Grade: **0**
O&M Grade: **2**
Clock Start/From: **8**
Clock To: **4**
1st Value:
2nd Value:
Value Percent:
Continuous Index:
Within 8" of Joint: **YES**
Remarks:

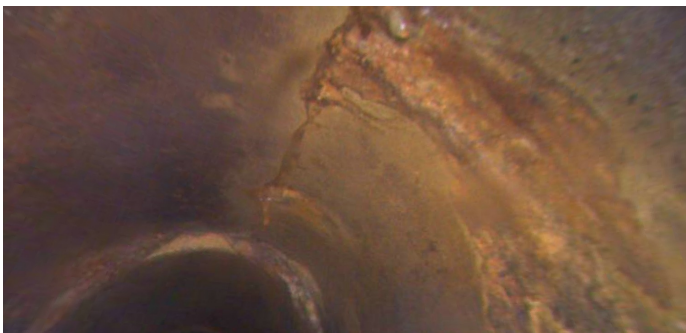
Code: **DAE**
Description: **Deposits Attached Encrustation**

Distance (ft): **59.6**
Structural Grade: **0**
O&M Grade: **2**
Clock Start/From: **9**
Clock To: **12**
1st Value:
2nd Value:
Value Percent: **5.000**
Continuous Index:
Within 8" of Joint: **NO**
Remarks:

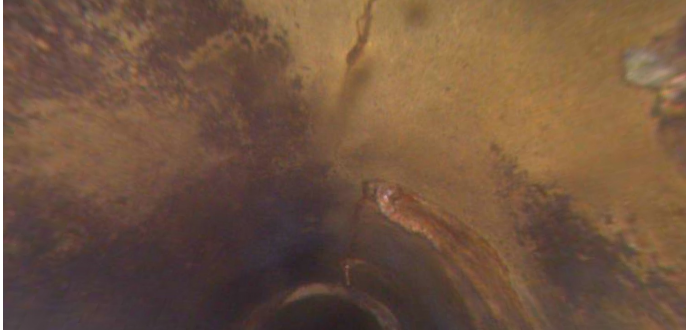
Code: **FL**
Description: **Fracture Longitudinal**

Distance (ft): **60.3**
Structural Grade: **3**
O&M Grade: **0**
Clock Start/From: **12**
Clock To:
1st Value:
2nd Value:
Value Percent:
Continuous Index: **S03**
Within 8" of Joint: **YES**
Remarks:

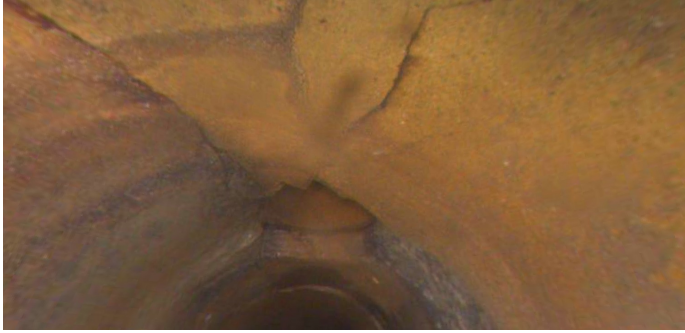
Code: **FM**
Description: **Fracture Multiple**

Distance (ft): **84.0**
Structural Grade: **4**
O&M Grade: **0**
Clock Start/From: **11**
Clock To: **1**
1st Value:
2nd Value:
Value Percent:
Continuous Index:
Within 8" of Joint:
Remarks:

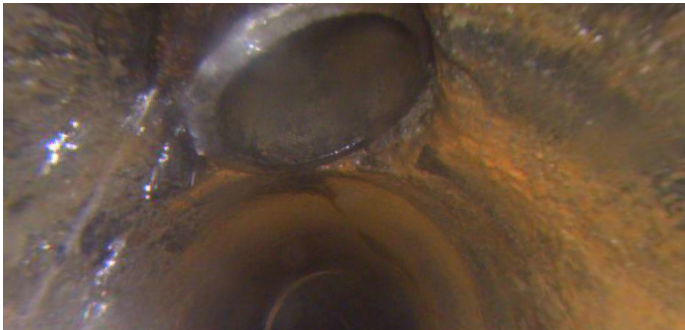
Code: **TBI**
Description: **Tap Break-in Intruding**

Distance (ft): **91.0**
Structural Grade: **0**
O&M Grade: **2**
Clock Start/From: **12**
Clock To:
1st Value: **4.000**
2nd Value: **1.000**
Value Percent:
Continuous Index:
Within 8" of Joint:
Remarks: **ACTIVE**

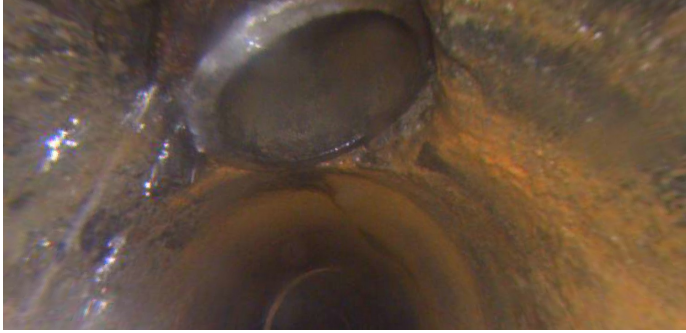
Code: **DAE**
Description: **Deposits Attached Encrustation**

Distance (ft): **91.0**
Structural Grade: **0**
O&M Grade: **2**
Clock Start/From: **8**
Clock To: **4**
1st Value:
2nd Value:
Value Percent: **10.000**
Continuous Index: **F02**
Within 8" of Joint: **YES**
Remarks:

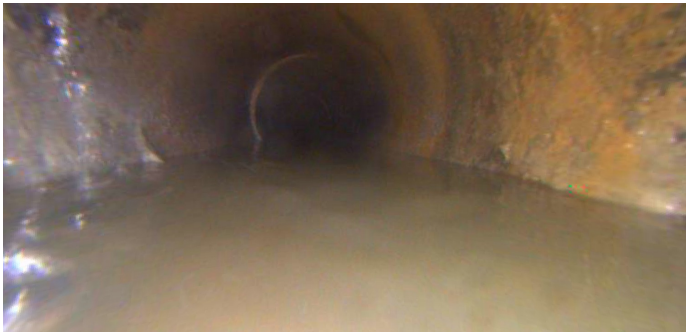
Code: **FL**
Description: **Fracture Longitudinal**

Distance (ft): **91.0**
Structural Grade: **3**
O&M Grade: **0**
Clock Start/From: **12**
Clock To:
1st Value:
2nd Value:
Value Percent:
Continuous Index: **F03**
Within 8" of Joint: **YES**
Remarks:

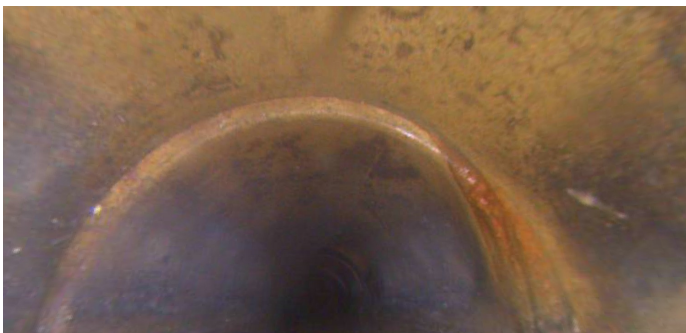
Code: **IW**
Description: **Infil Weeper**

Distance (ft): **97.9**
Structural Grade: **0**
O&M Grade: **2**
Clock Start/From: **9**
Clock To: **11**
1st Value:
2nd Value:
Value Percent:
Continuous Index:
Within 8" of Joint: **YES**
Remarks:

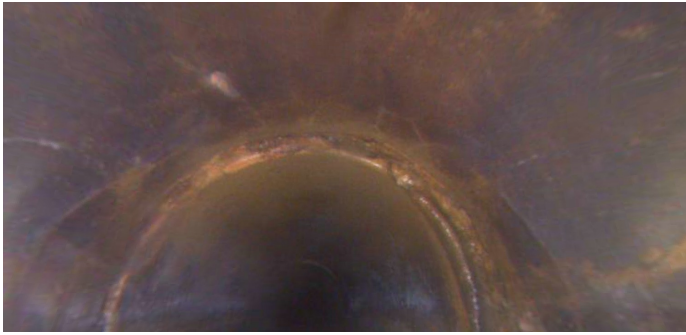
Code: **FM**
Description: **Fracture Multiple**

Distance (ft): **101.1**
Structural Grade: **4**
O&M Grade: **0**
Clock Start/From: **8**
Clock To: **4**
1st Value:
2nd Value:
Value Percent:
Continuous Index:
Within 8" of Joint: **YES**
Remarks:

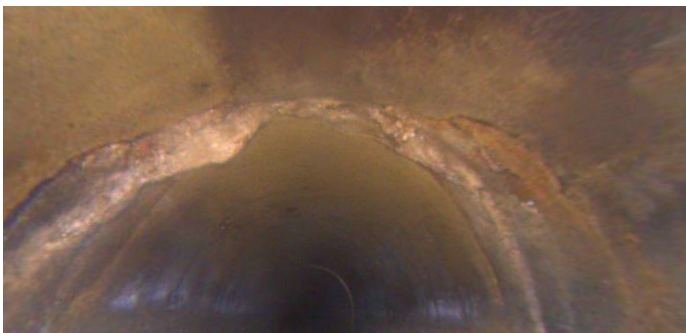
Code: **DAE**
Description: **Deposits Attached Encrustation**

Distance (ft): **106.9**
Structural Grade: **0**
O&M Grade: **2**
Clock Start/From: **8**
Clock To: **4**
1st Value:
2nd Value:
Value Percent: **5.000**
Continuous Index: **S04**
Within 8" of Joint: **YES**
Remarks:

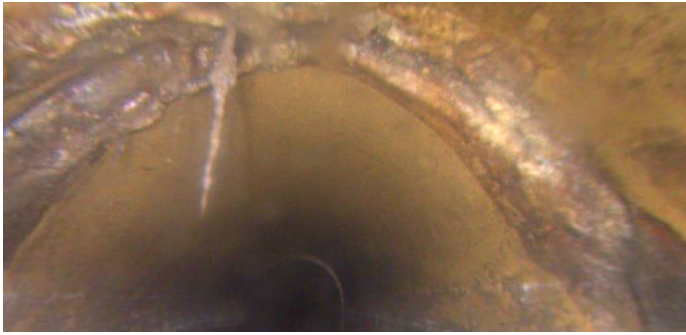
Code: **RFJ**
Description: **Roots Fine Joint**

Distance (ft): **139.6**
Structural Grade: **0**
O&M Grade: **1**
Clock Start/From: **12**
Clock To:
1st Value:
2nd Value:
Value Percent:
Continuous Index:
Within 8" of Joint: **YES**
Remarks:

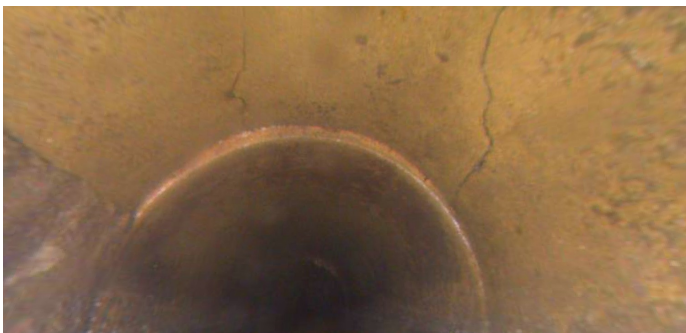
Code: **FM**
Description: **Fracture Multiple**

Distance (ft): **149.1**
Structural Grade: **4**
O&M Grade: **0**
Clock Start/From: **10**
Clock To: **2**
1st Value:
2nd Value:
Value Percent:
Continuous Index:
Within 8" of Joint: **YES**
Remarks:

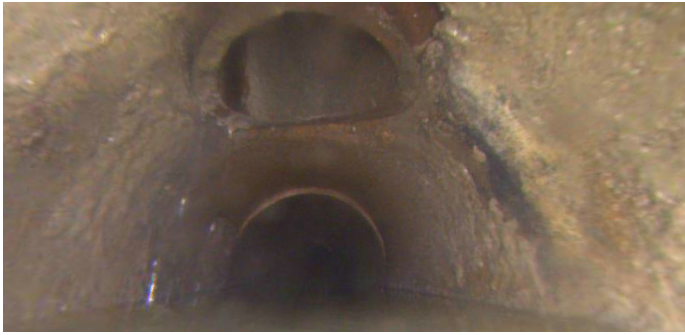
Code: **TBI**
Description: **Tap Break-in Intruding**

Distance (ft): **150.3**
Structural Grade: **0**
O&M Grade: **2**
Clock Start/From: **12**
Clock To:
1st Value: **4.000**
2nd Value: **1.000**
Value Percent:
Continuous Index:
Within 8" of Joint:
Remarks:

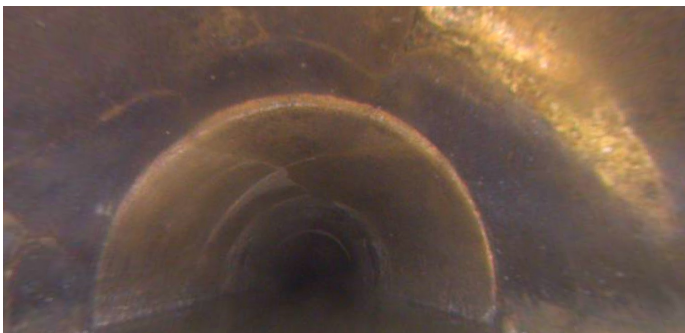
Code: **FM**
Description: **Fracture Multiple**

Distance (ft): **152.0**
Structural Grade: **4**
O&M Grade: **0**
Clock Start/From: **8**
Clock To: **4**
1st Value:
2nd Value:
Value Percent:
Continuous Index: **S05**
Within 8" of Joint: **YES**
Remarks:

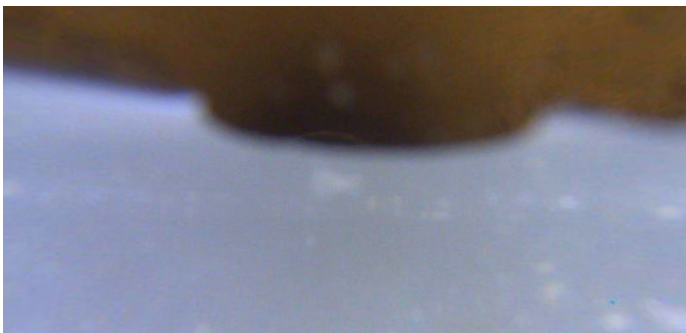
Code: **DAE**
Description: **Deposits Attached Encrustation**

Distance (ft): **177.2**
Structural Grade: **0**
O&M Grade: **2**
Clock Start/From: **8**
Clock To: **4**
1st Value:
2nd Value:
Value Percent: **5.000**
Continuous Index: **F04**
Within 8" of Joint: **YES**
Remarks:

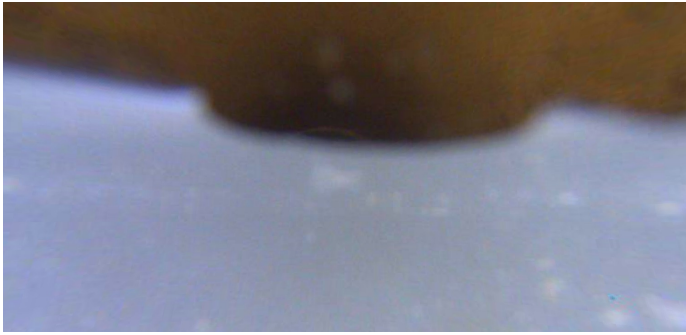
Code: **FM**
Description: **Fracture Multiple**

Distance (ft): **177.2**
Structural Grade: **4**
O&M Grade: **0**
Clock Start/From: **8**
Clock To: **4**
1st Value:
2nd Value:
Value Percent:
Continuous Index: **F05**
Within 8" of Joint: **YES**
Remarks:

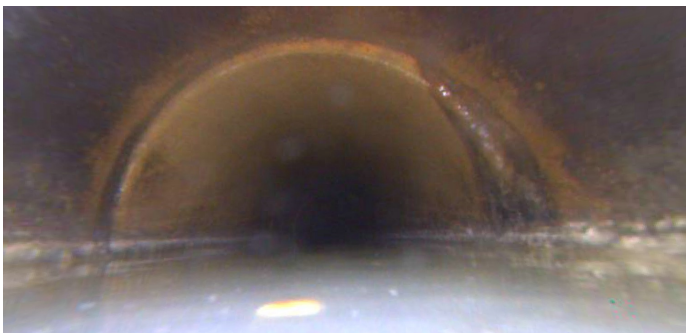
Code: **IW**
Description: **Infil Weeper**

Distance (ft): **184.9**
Structural Grade: **0**
O&M Grade: **2**
Clock Start/From: **9**
Clock To: **11**
1st Value:
2nd Value:
Value Percent:
Continuous Index:
Within 8" of Joint: **YES**
Remarks:

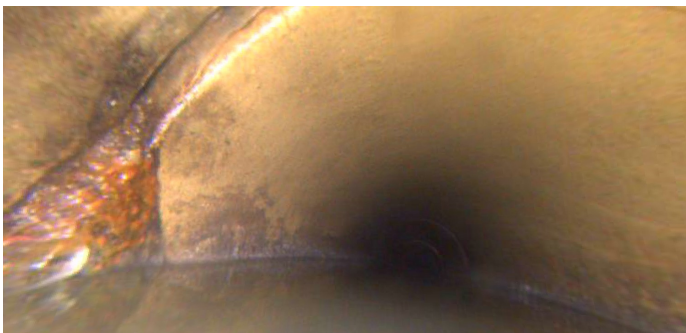
Code: **IW**
Description: **Infil Weeper**

Distance (ft): **205.5**
Structural Grade: **0**
O&M Grade: **2**
Clock Start/From: **3**
Clock To:
1st Value:
2nd Value:
Value Percent:
Continuous Index:
Within 8" of Joint: **YES**
Remarks:

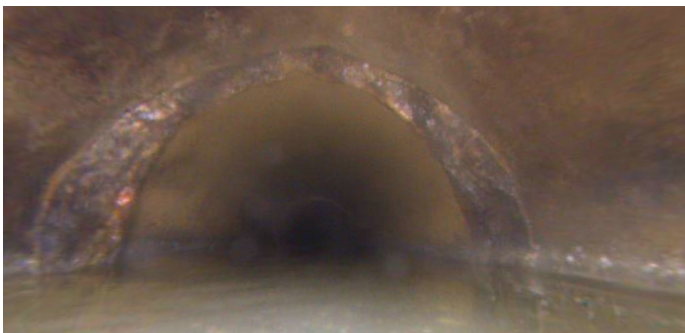
Code: **DAE**
Description: **Deposits Attached Encrustation**

Distance (ft): **209.0**
Structural Grade: **0**
O&M Grade: **2**
Clock Start/From: **8**
Clock To: **4**
1st Value:
2nd Value:
Value Percent: **10.000**
Continuous Index:
Within 8" of Joint: **YES**
Remarks:

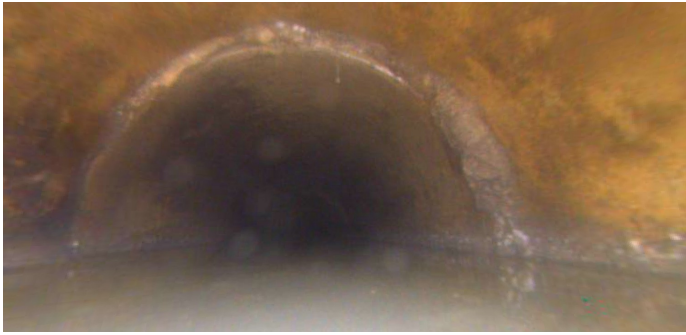
Code: **DAE**
Description: **Deposits Attached Encrustation**

Distance (ft): **212.0**
Structural Grade: **0**
O&M Grade: **2**
Clock Start/From: **8**
Clock To: **4**
1st Value:
2nd Value:
Value Percent: **5.000**
Continuous Index:
Within 8" of Joint: **YES**
Remarks:

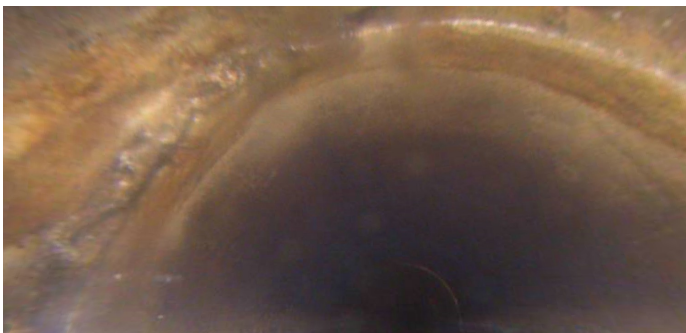
Code: **DAE**
Description: **Deposits Attached Encrustation**

Distance (ft): **217.6**
Structural Grade: **0**
O&M Grade: **2**
Clock Start/From: **12**
Clock To: **4**
1st Value:
2nd Value:
Value Percent: **5.000**
Continuous Index:
Within 8" of Joint: **YES**
Remarks:

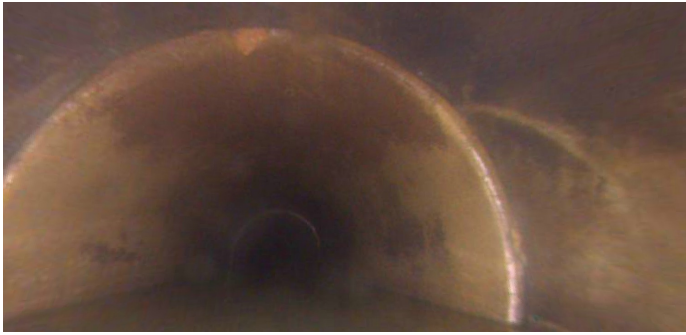
Code: **FS**
Description: **Fracture Spiral**

Distance (ft): **223.8**
Structural Grade: **3**
O&M Grade: **0**
Clock Start/From: **9**
Clock To: **11**
1st Value:
2nd Value:
Value Percent:
Continuous Index:
Within 8" of Joint: **YES**
Remarks:

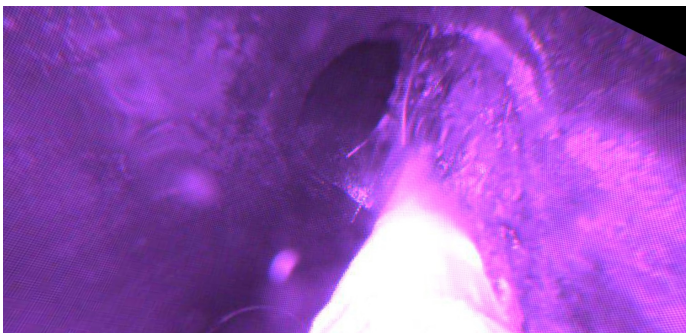
Code: **TFD**
Description: **Tap Factory Defective**

Distance (ft): **247.5**
Structural Grade: **0**
O&M Grade: **2**
Clock Start/From: **1**
Clock To:
1st Value: **4.000**
2nd Value:
Value Percent:
Continuous Index:
Within 8" of Joint:
Remarks: **ROOTS**

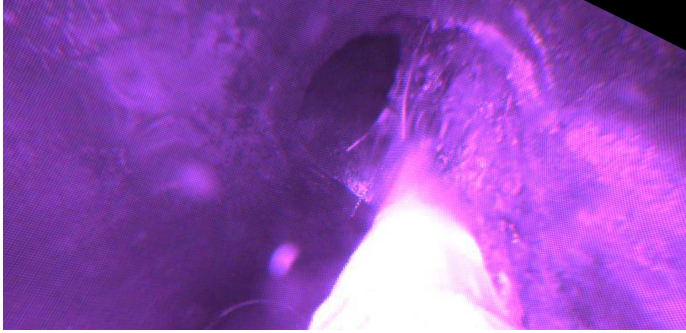
Code: **RML**
Description: **Roots Medium Lateral**

Distance (ft): **247.5**
Structural Grade: **0**
O&M Grade: **3**
Clock Start/From: **1**
Clock To:
1st Value:
2nd Value:
Value Percent: **20.000**
Continuous Index:
Within 8" of Joint: **NO**
Remarks:
