Profile/Photo Observation Report

Date:	04/24/2018	Weather:		Coding:	PACP 6.0
Pipe Length (ft):	262.5	Owner:	NA	Pre Clean:	No Pre-Cleaning
P.O.#:		Surveyor:	Jen Costello	PSR:	P-405-022-021
Customer:		Clean Date:	01/01/1900	Shape:	C

Street:	ALLEY BETWEEN DRIFTWOOD DR &	Flow Control:	Not Controlled
City:	Hobart, IN	Year Renewed:	
Location:	Yard	Tape/Media #:	
Purpose:	Routine Assessment	Dia/Height:	12"
Use:	Sanitary	Material:	PVC
Drain Area:	NA	Lining:	
Category:	NA		
Comment:	P_C at 11 ft roots

Location Details:		Direction of Survey:	Upstream
US MH:	M-405-022	DS MH:	M-405-021
		Total Length Surveyed (ft):	12.5

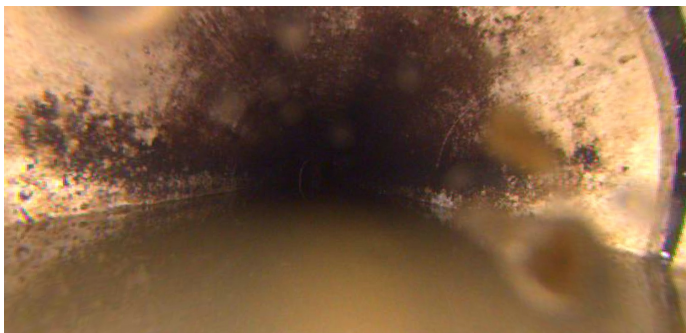
Code: **AMH**
Description: **Manhole**

Distance (ft): **.0**
Structural Grade: **0**
O&M Grade: **0**
Clock Start/From:
Clock To:
1st Value:
2nd Value:
Value Percent:
Continuous Index:
Within 8" of Joint: **NO**
Remarks: **M-405-021**

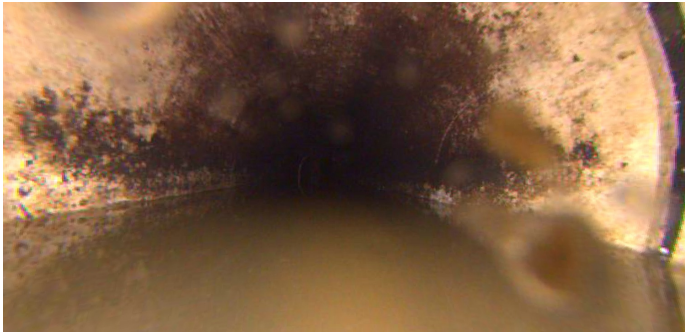
Code:	MWL
Description:	Water Level

Distance (ft):	.0
Structural Grade:	0
O&M Grade:	0
Clock Start/From:	
Clock To:	
1st Value:	
2nd Value:	
Value Percent:	30.000
Continuous Index:	
Within 8" of Joint:	NO
Remarks:

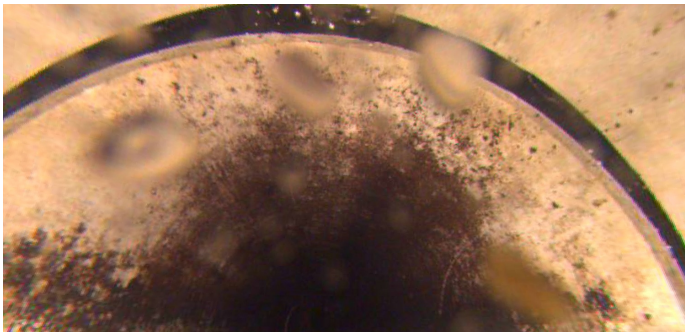
Code:	JOM
Description:	Joint Offset Medium

Distance (ft):	.0
Structural Grade:	1
O&M Grade:	0
Clock Start/From:	
Clock To:	
1st Value:	
2nd Value:	
Value Percent:	
Continuous Index:	
Within 8" of Joint:	NO
Remarks:

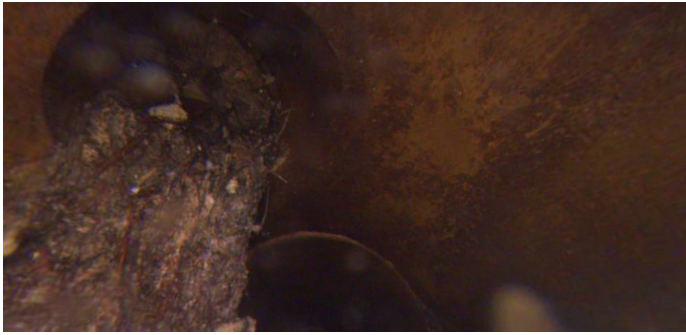
Code: **TFD**
Description: **Tap Factory Defective**

Distance (ft): **11.7**
Structural Grade: **0**
O&M Grade: **2**
Clock Start/From: **11**
Clock To:
1st Value: **4.000**
2nd Value:
Value Percent:
Continuous Index:
Within 8" of Joint:
Remarks: **rml**

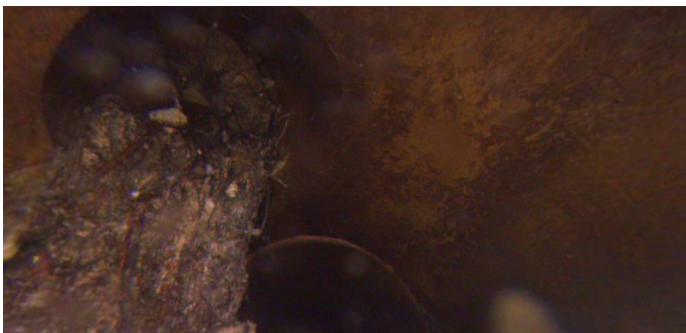
Code: **RML**
Description: **Roots Medium Lateral**

Distance (ft): **11.7**
Structural Grade: **0**
O&M Grade: **3**
Clock Start/From: **8**
Clock To: **11**
1st Value:
2nd Value:
Value Percent: **30.000**
Continuous Index:
Within 8" of Joint: **NO**
Remarks:

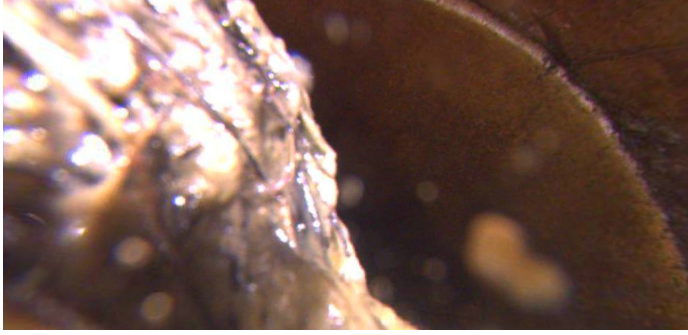
Code:	MSA
Description:	Abandoned Survey
Distance (ft):	12.5
Structural Grade:	0
O&M Grade:	0
Clock Start/From:	
Clock To:	
1st Value:	
2nd Value:	
Value Percent:	
Continuous Index:	
Within 8" of Joint:	NO
Remarks:	roots
