## Profile/Photo Observation Report

Street:	<b>FOXCROFT STREET</b>	Flow Control:	<b>Not Controlled</b>
City:	<b>Hobart, IN</b>	Year Renewed:	
Location:	<b>Yard</b>	Tape/Media #:	
Purpose:	<b>Routine Assessment</b>	Dia/Height:	<b>12"</b>
Use:	<b>Sanitary</b>	Material:	<b>PVC</b>
Drain Area:	<b>NA</b>	Lining:	
Category:	<b>NA</b>		
Comment:	<b>P_C at 11 ft roots</b>

Location Details:		Direction of Survey:	<b>Upstream</b>
US MH:	<b>M-405-022</b>	DS MH:	<b>M-405-021</b>
		Total Length Surveyed (ft):	<b>12.5</b>

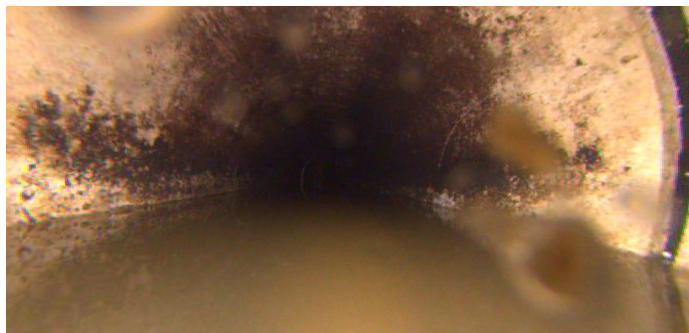
Code: **AMH**  
Description: **Manhole**

Distance (ft): **.0**  
Structural Grade: **0**  
O&M Grade: **0**  
Clock Start/From:  
Clock To:  
1st Value:  
2nd Value:  
Value Percent:  
Continuous Index:  
Within 8" of Joint: **NO**  
Remarks: **M-405-021**

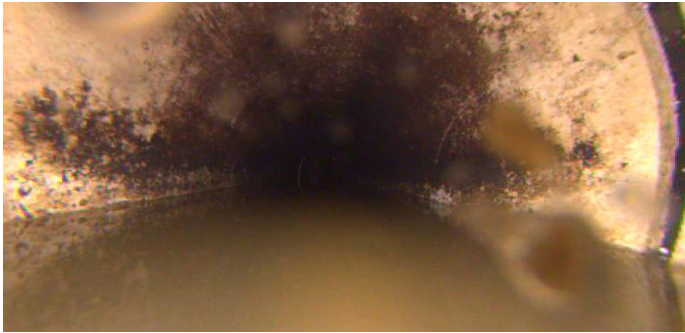
Code:	<b>MWL</b>
Description:	<b>Water Level</b>

Distance (ft):	<b>.0</b>
Structural Grade:	<b>0</b>
O&M Grade:	<b>0</b>
Clock Start/From:	
Clock To:	
1st Value:	
2nd Value:	
Value Percent:	<b>30.000</b>
Continuous Index:	
Within 8" of Joint:	<b>NO</b>
Remarks:

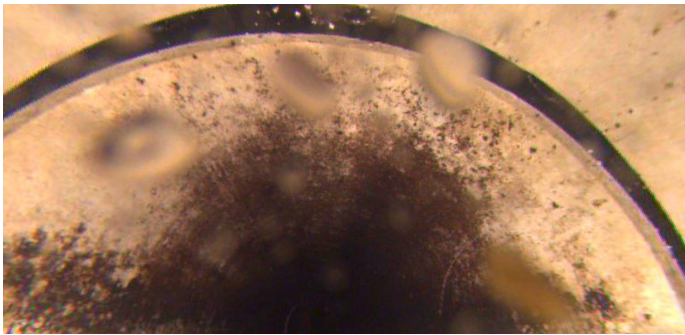
Code:	<b>JOM</b>
Description:	<b>Joint Offset Medium</b>

Distance (ft):	<b>.0</b>
Structural Grade:	<b>1</b>
O&M Grade:	<b>0</b>
Clock Start/From:	
Clock To:	
1st Value:	
2nd Value:	
Value Percent:	
Continuous Index:	
Within 8" of Joint:	<b>NO</b>
Remarks:

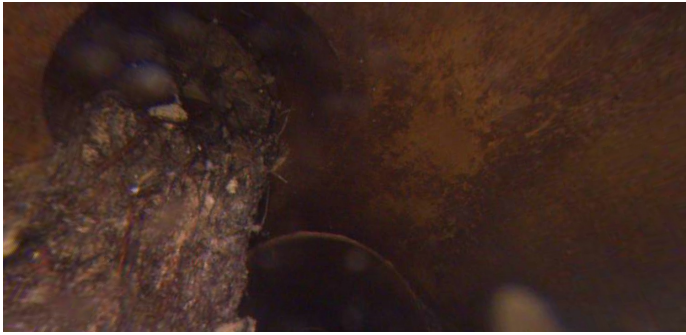
Code: **TFD**  
Description: **Tap Factory Defective**

Distance (ft): **11.7**  
Structural Grade: **0**  
O&M Grade: **2**  
Clock Start/From: **11**  
Clock To:  
1st Value: **4.000**  
2nd Value:  
Value Percent:  
Continuous Index:  
Within 8" of Joint:  
Remarks: **rml**

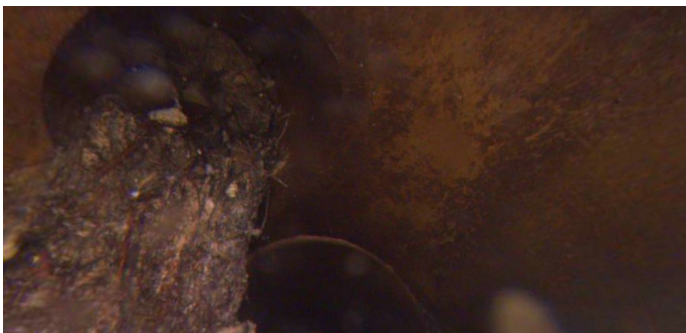
Code: **RML**  
Description: **Roots Medium Lateral**

Distance (ft): **11.7**  
Structural Grade: **0**  
O&M Grade: **3**  
Clock Start/From: **8**  
Clock To: **11**  
1st Value:  
2nd Value:  
Value Percent: **30.000**  
Continuous Index:  
Within 8" of Joint: **NO**  
Remarks:

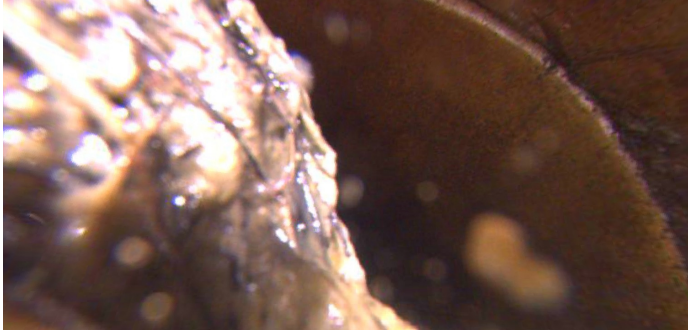
Code:	<b>MSA</b>
Description:	<b>Abandoned Survey</b>
Distance (ft):	<b>12.5</b>
Structural Grade:	<b>0</b>
O&M Grade:	<b>0</b>
Clock Start/From:	
Clock To:	
1st Value:	
2nd Value:	
Value Percent:	
Continuous Index:	
Within 8" of Joint:	<b>NO</b>
Remarks:	<b>roots</b>
