Profile/Ph	oto Observation	Report			RedZone
Date: Pipe Length (ft) P.O.#: Customer:	04/16/2018): 291.3	Weather: Owner: Surveyor: Clean Date:	NA Selasie Honu 01/01/1900	Coding: Pre Clean: PSR: Shape:	PACP 6.0 No Pre-Cleaning P-405-023-022 C
Street:	FOXCROFT STREET		Flow Control:	Not Controlled	
City:	Hobart, IN		Year Renewed:		
Location:	Yard		Tape/Media #:		
Purpose:	Routine Assessmen	nt	Dia/Height:	12"	
Use:	Sanitary		Material:	VCP	
Drain Area:	NA		Lining:		
Category:	NA				
Comment:					
Location Detail	s:		Direction of Surve	y: Upstream	
US MH:	M-405-023	DS MH:	M-405-022	Total Length Surveyed (ft)	: 6.2
0&M Index:	3.00	O&M Quick:	3100	O&M Rating:	3.00
Structural Index:	2.00	Structural Qui	ck: 2100	Structural Rating:	2.00
Overall Index:	2.50	Overall Quick:	3121	Overall Rating:	5.00

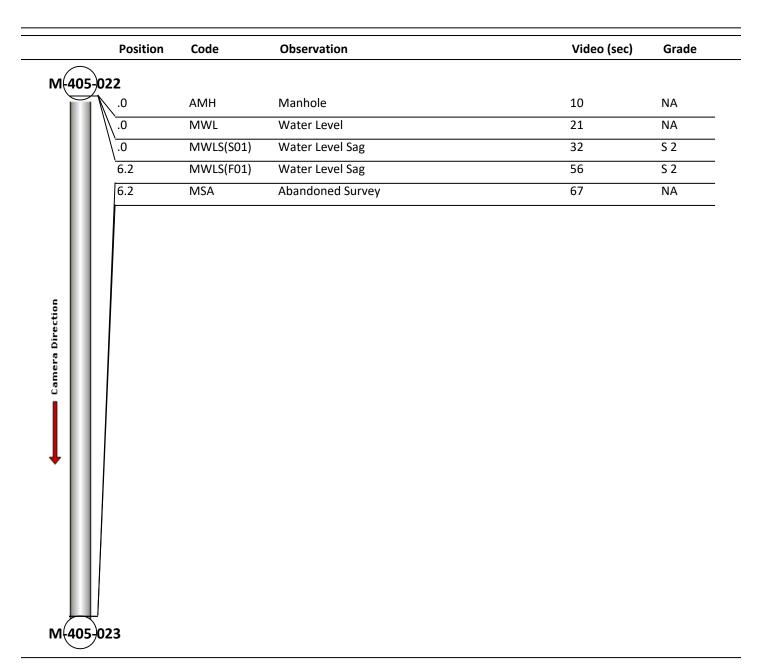
Code: Description:	AMH Manhole
Distance (ft):	.0
Structural Grade:	0
O&M Grade:	0
Clock Start/From:	
Clock To:	
1st Value:	
2nd Value:	
Value Percent:	
Continuous Index:	
Within 8" of Joint:	NO
Remarks:	M-405-022
