## Profile/Photo Observation Report

Street:	<b>OFF S LASALLE ST</b>	Flow Control:	<b>Not Controlled</b>
City:	<b>Hobart, IN</b>	Year Renewed:	
Location:	<b>Woods</b>	Tape/Media #:	
Purpose:	<b>Routine Assessment</b>	Dia/Height:	<b>12"</b>
Use:	<b>Sanitary</b>	Material:	<b>PVC</b>
Drain Area:	<b>NA</b>	Lining:	
Category:	<b>NA</b>		
Comment:	<b>P_C at 28 ft nothing visible</b>		
Location Details:		Direction of Survey:	<b>Upstream</b>
US MH:	<b>M-405-024</b>	DS MH:	<b>M-405-023</b>
		Total Length Surveyed (ft):	<b>29.6</b>

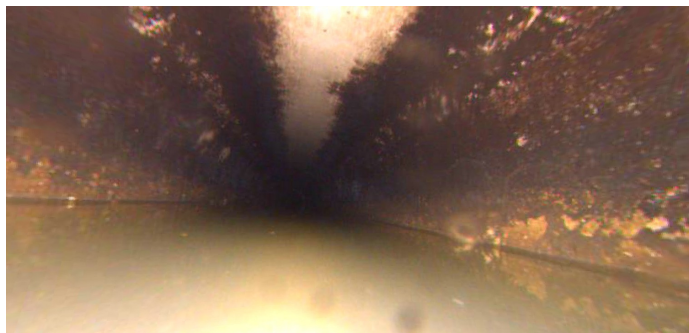
Code: **AMH**  
 Description: **Manhole**  
 Distance (ft): **.0**  
 Structural Grade: **0**  
 O&M Grade: **0**  
 Clock Start/From:  
 Clock To:  
 1st Value:  
 2nd Value:  
 Value Percent:  
 Continuous Index:  
 Within 8" of Joint: **NO**  
 Remarks: **M-405-023**

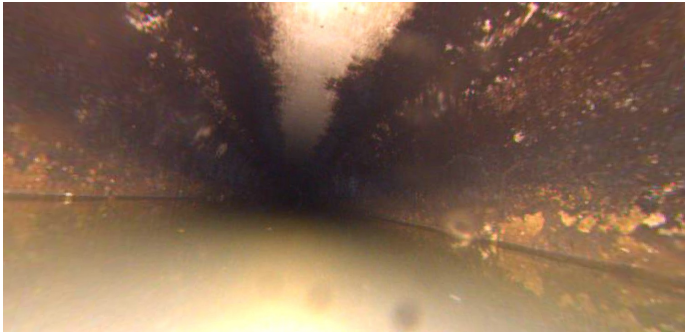
Code:	<b>MWL</b>
Description:	<b>Water Level</b>

Distance (ft):	<b>.0</b>
Structural Grade:	<b>0</b>
O&M Grade:	<b>0</b>
Clock Start/From:	
Clock To:	
1st Value:	
2nd Value:	
Value Percent:	<b>40.000</b>
Continuous Index:	
Within 8" of Joint:	<b>NO</b>
Remarks:

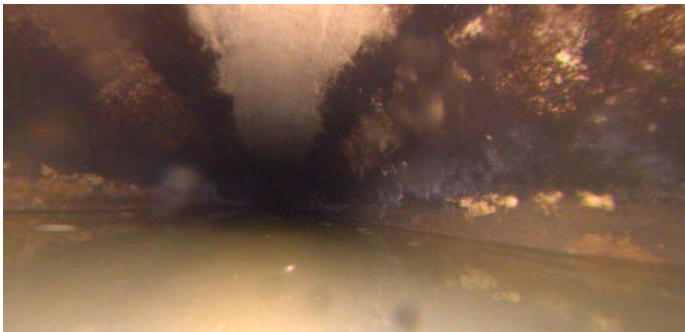
Code:	<b>MSA</b>
Description:	<b>Abandoned Survey</b>

Distance (ft):	<b>29.6</b>
Structural Grade:	<b>0</b>
O&M Grade:	<b>0</b>
Clock Start/From:	
Clock To:	
1st Value:	
2nd Value:	
Value Percent:	
Continuous Index:	
Within 8" of Joint:	<b>NO</b>
Remarks:	<b>debris under water</b>
