Profile/Photo Observation Report

| Street: | OFF S LASALLE ST | Flow Control: | Not Controlled |
| City: | Hobart, IN | Year Renewed: | |
| US MH: | M-405-025 | DS MH: | M-405-024 |

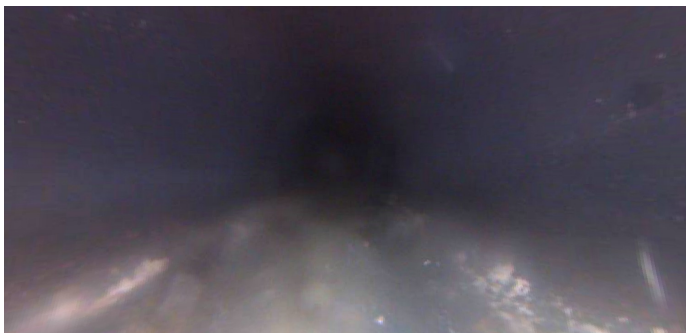
Code: **AMH**
Description: **Manhole**

Distance (ft): **.0**
Structural Grade: **0**
O&M Grade: **0**
Clock Start/From:
Clock To:
1st Value:
2nd Value:
Value Percent:
Continuous Index:
Within 8" of Joint: **NO**
Remarks: **M-405-025**

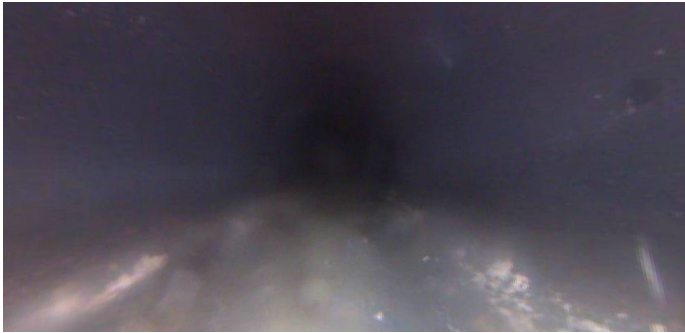
| Code: | MWL |

| Description: | Water Level |

| Value Percent: | 5.000 |

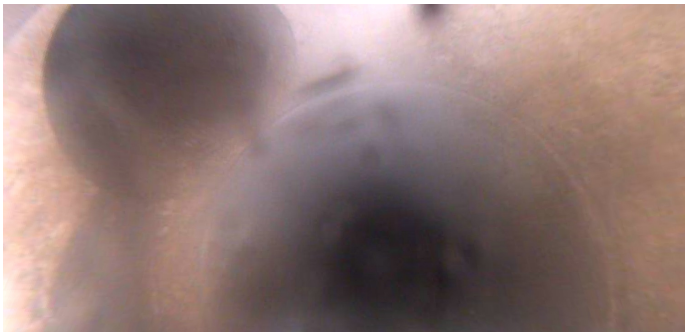
| Code: | TFA |

| Description: | Tap Factory Active |

| Distance (ft): | 11.6 |
| Clock Start/From: | 10 |
| 1st Value: | 4.000 |

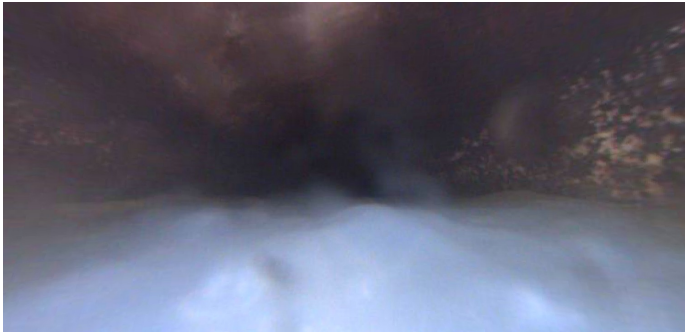
Code: **MWL**
Description: **Water Level**

Distance (ft): **95.3**
Structural Grade: **0**
O&M Grade: **0**
Clock Start/From:
Clock To:
1st Value:
2nd Value:
Value Percent: **40.000**
Continuous Index:
Within 8" of Joint: **NO**
Remarks:

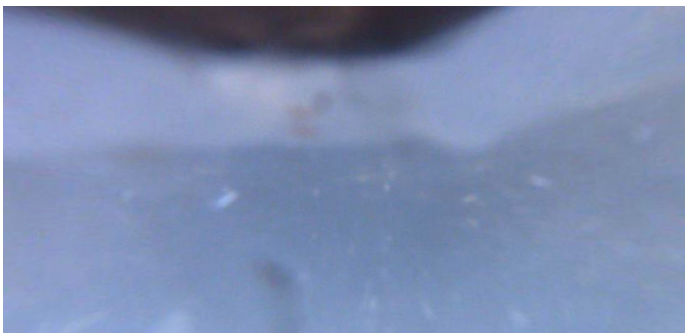
Code: **MCU**
Description: **Camera Underwater**

| | Position | Code | Observation | Video (sec) | Grade |
|--|---|---|---|---|---|
| | 98.2 | MCU(S01) | Camera Underwater | 252 | M 4 |

Distance (ft): **98.2**
Structural Grade: **0**
O&M Grade: **4**
Clock Start/From:
Clock To:
1st Value:
2nd Value:
Value Percent:
Continuous Index: **S01**
Within 8" of Joint: **NO**
Remarks:

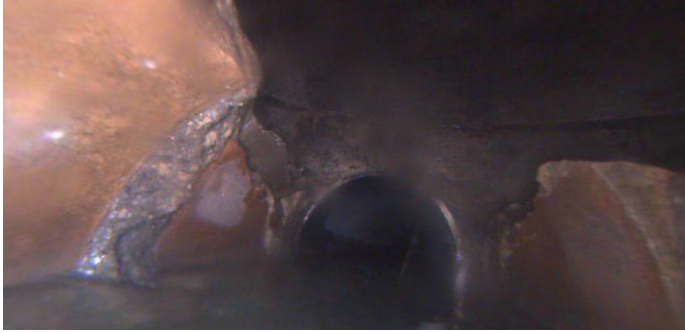
Code: **MCU**
Description: **Camera Underwater**

| | Position | Code | Observation | Video (sec) | Grade |
|--|---|---|---|---|---|
| | 107.2 | MCU(F01) | Camera Underwater | 282 | M 4 |

Distance (ft): **107.2**
Structural Grade: **0**
O&M Grade: **4**
Clock Start/From:
Clock To:
1st Value:
2nd Value:
Value Percent:
Continuous Index: **F01**
Within 8" of Joint: **NO**
Remarks:

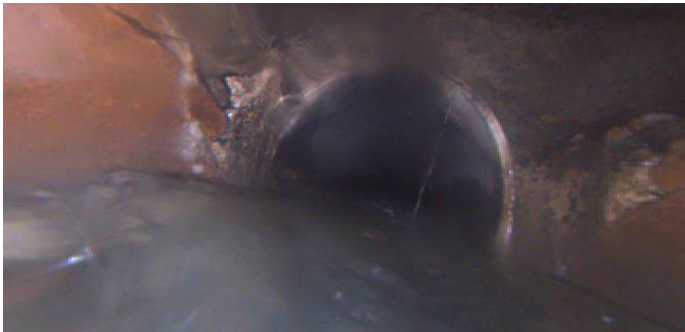
Code: **AMH**
Description: **Manhole**

Distance (ft): **107.8**
Structural Grade: **0**
O&M Grade: **0**
Clock Start/From:
Clock To:
1st Value:
2nd Value:
Value Percent:
Continuous Index:
Within 8" of Joint: **NO**
Remarks: **M-405-024**
