## Profile/Photo Observation Report

| P.O.#: | | Surveyor: | <b>Selasie Honu</b> | PSR: | <b>P-405-026-025</b> |

| Street: | <b>DRIFTWOOD DR</b> | Flow Control: | <b>Not Controlled</b> |

| US MH: | <b>M-405-026</b> | DS MH: | <b>M-405-025</b> |

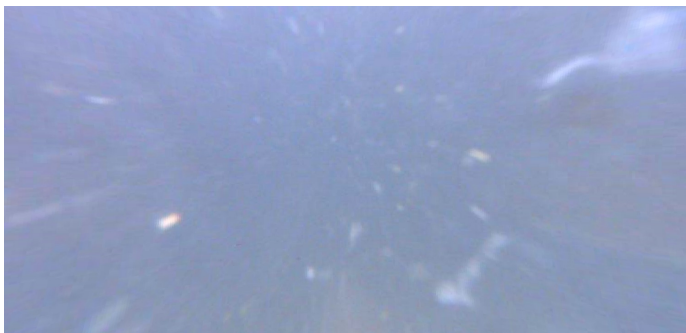
Code: **AMH**  
Description: **Manhole**

Distance (ft): **.0**  
Structural Grade: **0**  
O&M Grade: **0**  
Clock Start/From:  
Clock To:  
1st Value:  
2nd Value:  
Value Percent:  
Continuous Index:  
Within 8" of Joint: **NO**  
Remarks: **M-405-025**

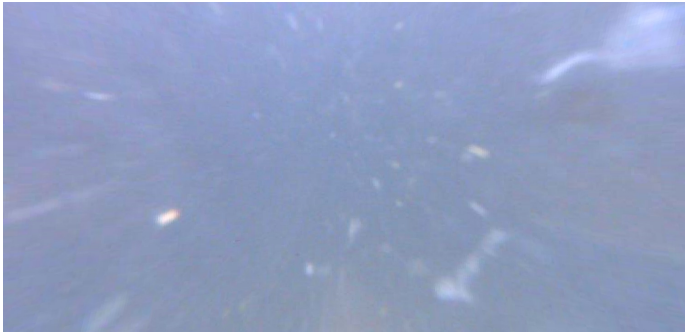
| Code: | <b>MWL</b> |
| Description: | <b>Water Level</b> |

| Value Percent: | <b>5.000</b> |

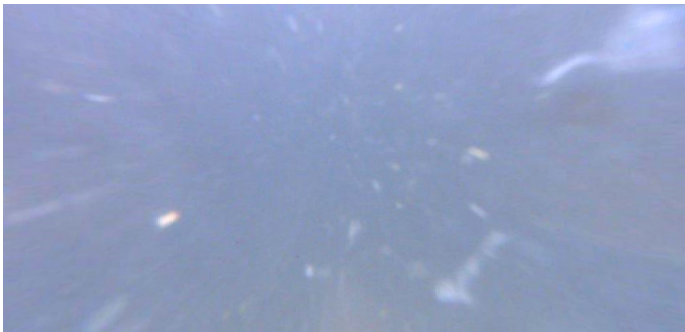
| Code: | <b>MWLS</b> |
| Description: | <b>Water Level Sag</b> |

| Structural Grade: | <b>2</b> |
| O&M Grade: | <b>3</b> |
| Value Percent: | <b>10.000</b> |

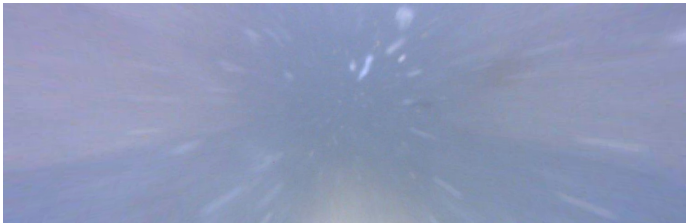
Code: **MWLS**  
Description: **Water Level Sag**

Distance (ft): **7.5**  
Structural Grade: **2**  
O&M Grade: **3**  
Clock Start/From:  
Clock To:  
1st Value:  
2nd Value:  
Value Percent: **10.000**  
Continuous Index: **F01**  
Within 8" of Joint: **NO**  
Remarks:

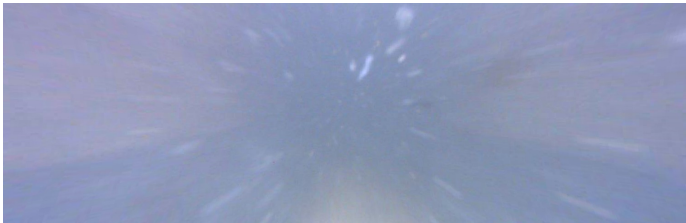
Code: **MSA**  
Description: **Abandoned Survey**

Distance (ft): **7.5**  
Structural Grade: **0**  
O&M Grade: **0**  
Clock Start/From:  
Clock To:  
1st Value:  
2nd Value:  
Value Percent:  
Continuous Index:  
Within 8" of Joint: **NO**  
Remarks: **camera underwater**
