Profile/Photo Observation Report

Date:	04/16/2018	Weather:		Coding:	PACP 6.0
Pipe Length (ft):	273.0	Owner:	NA	Pre Clean:	No Pre-Cleaning
P.O.#:		Surveyor:	Selasie Honu	PSR:	P-405-026-025
Customer:		Clean Date:	01/01/1900	Shape:	C

Street:	FOXCROFT STREET	Flow Control:	Not Controlled
City:	Hobart, IN	Year Renewed:	
Location:	Yard	Tape/Media #:	
Purpose:	Routine Assessment	Dia/Height:	12"
Use:	Sanitary	Material:	VCP
Drain Area:	NA	Lining:	
Category:	NA		
Comment:

Location Details:		Direction of Survey:	Upstream
US MH:	M-405-026	DS MH:	M-405-025
		Total Length Surveyed (ft):	7.5

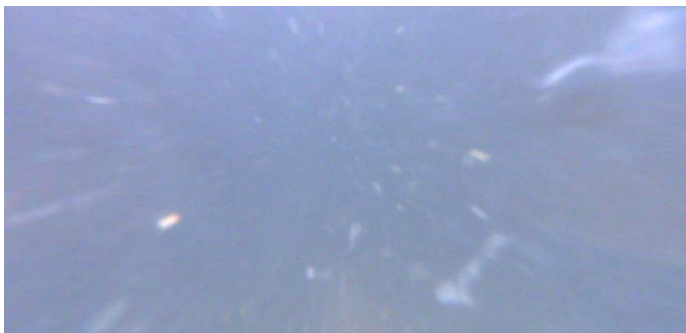
Code: **AMH**
Description: **Manhole**

Distance (ft): **.0**
Structural Grade: **0**
O&M Grade: **0**
Clock Start/From:
Clock To:
1st Value:
2nd Value:
Value Percent:
Continuous Index:
Within 8" of Joint: **NO**
Remarks: **M-405-025**

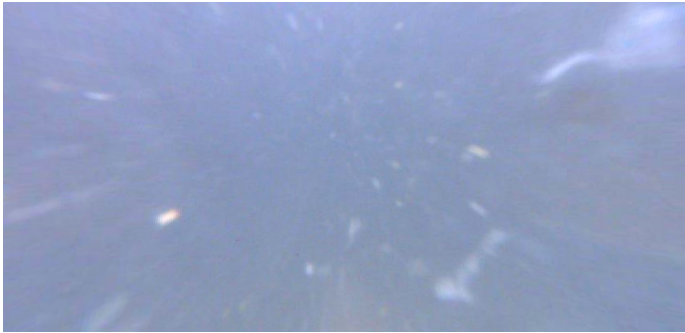
Code:	MWL
Description:	Water Level

Distance (ft):	.0
Structural Grade:	0
O&M Grade:	0
Clock Start/From:	
Clock To:	
1st Value:	
2nd Value:	
Value Percent:	5.000
Continuous Index:	
Within 8" of Joint:	NO
Remarks:

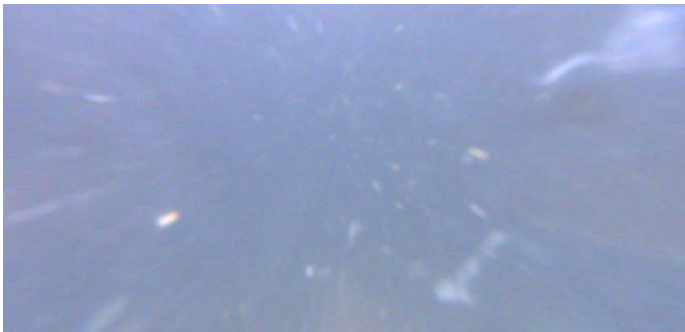
Code:	MWLS
Description:	Water Level Sag

Distance (ft):	.0
Structural Grade:	2
O&M Grade:	3
Clock Start/From:	
Clock To:	
1st Value:	
2nd Value:	
Value Percent:	10.000
Continuous Index:	S01
Within 8" of Joint:	NO
Remarks:

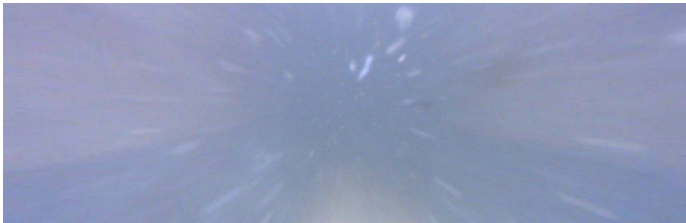
Code: **MWLS**
Description: **Water Level Sag**

Distance (ft): **7.5**
Structural Grade: **2**
O&M Grade: **3**
Clock Start/From:
Clock To:
1st Value:
2nd Value:
Value Percent: **10.000**
Continuous Index: **F01**
Within 8" of Joint: **NO**
Remarks:

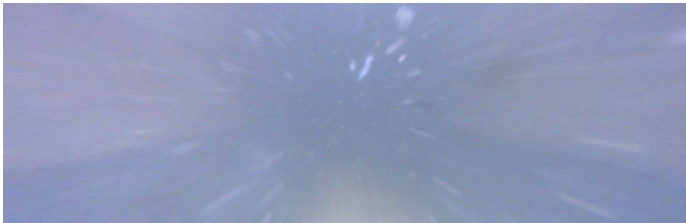
Code: **MSA**
Description: **Abandoned Survey**

Distance (ft): **7.5**
Structural Grade: **0**
O&M Grade: **0**
Clock Start/From:
Clock To:
1st Value:
2nd Value:
Value Percent:
Continuous Index:
Within 8" of Joint: **NO**
Remarks: **camera underwater**
