Profile/Photo Observation Report

Date:	04/20/2018	Weather:		Coding:	PACP 6.0
Pipe Length (ft):	273.0	Owner:	NA	Pre Clean:	No Pre-Cleaning
P.O.#:		Surveyor:	Byrd Fitzgerald	PSR:	P-405-026-025
Customer:		Clean Date:	01/01/1900	Shape:	C

Street:	DRIFTWOOD DR	Flow Control:	Not Controlled
City:	Hobart, IN	Year Renewed:	
Location:	Yard	Tape/Media #:	
Purpose:	Routine Assessment	Dia/Height:	10"
Use:	Sanitary	Material:	VCP
Drain Area:	NA	Lining:	
Category:	NA		
Comment:			
Location Details:		Direction of Survey:	Downstream
US MH:	M-405-026	DS MH:	M-405-025
		Total Length Surveyed (ft):	273.2

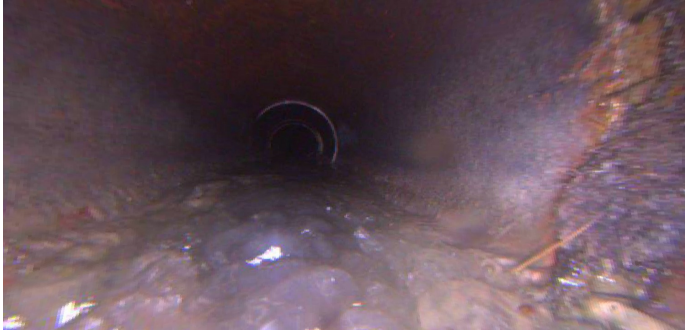
Code: **RMJ**
Description: **Roots Medium Joint**

Distance (ft): **3.6**
Structural Grade: **0**
O&M Grade: **3**
Clock Start/From: **3**
Clock To: **5**
1st Value:
2nd Value:
Value Percent: **5.000**
Continuous Index:
Within 8" of Joint: **YES**
Remarks:

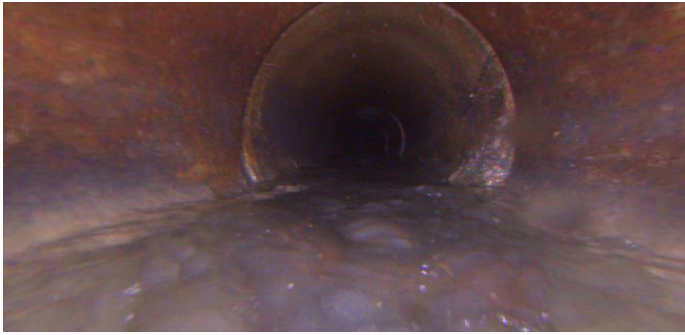
Code: **RMJ**
Description: **Roots Medium Joint**

Distance (ft): **20.7**
Structural Grade: **0**
O&M Grade: **3**
Clock Start/From: **3**
Clock To: **5**
1st Value:
2nd Value:
Value Percent: **5.000**
Continuous Index: **S01**
Within 8" of Joint: **YES**
Remarks: **wandering**

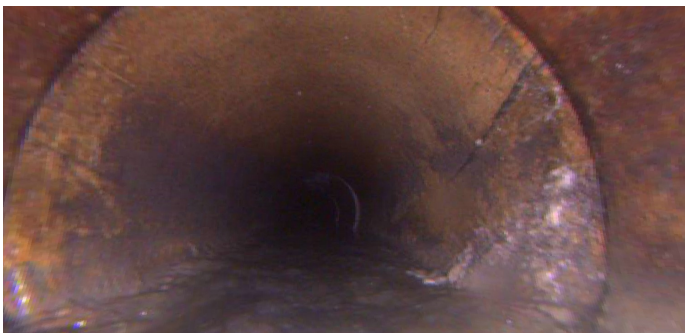
Code: **RFJ**
Description: **Roots Fine Joint**

Distance (ft): **21.4**
Structural Grade: **0**
O&M Grade: **1**
Clock Start/From: **7**
Clock To: **3**
1st Value:
2nd Value:
Value Percent:
Continuous Index: **S02**
Within 8" of Joint: **YES**
Remarks: **wandering**

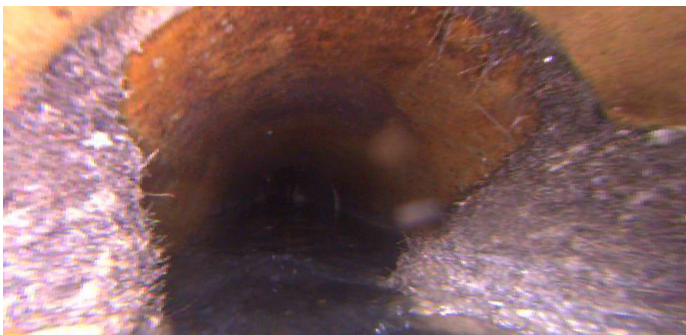
Code: **RMJ**
Description: **Roots Medium Joint**

Distance (ft): **45.5**
Structural Grade: **0**
O&M Grade: **3**
Clock Start/From: **7**
Clock To: **5**
1st Value:
2nd Value:
Value Percent: **40.000**
Continuous Index:
Within 8" of Joint: **YES**
Remarks:

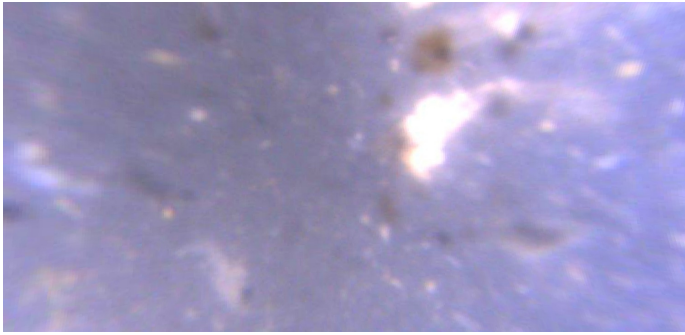
Code: **MCU**
Description: **Camera Underwater**

Distance (ft): **48.5**
Structural Grade: **0**
O&M Grade: **4**
Clock Start/From:
Clock To:
1st Value:
2nd Value:
Value Percent:
Continuous Index: **S03**
Within 8" of Joint: **NO**
Remarks:

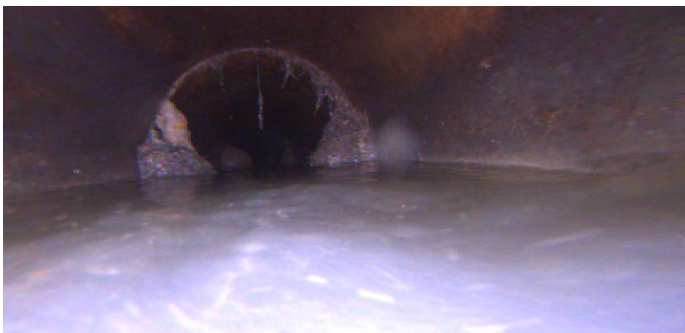
Code: **MCU**
Description: **Camera Underwater**

Distance (ft): **56.3**
Structural Grade: **0**
O&M Grade: **4**
Clock Start/From:
Clock To:
1st Value:
2nd Value:
Value Percent:
Continuous Index: **F03**
Within 8" of Joint: **NO**
Remarks:

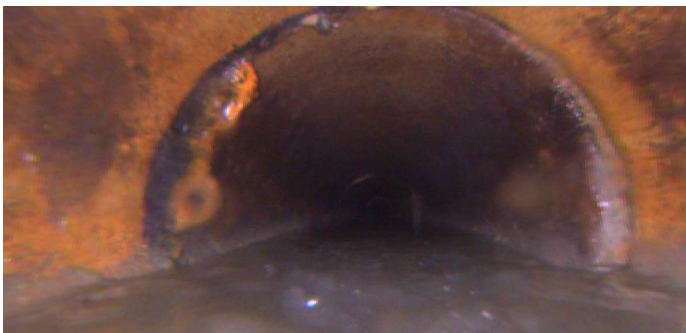
Code: **DAE**
Description: **Deposits Attached Encrustation**

Distance (ft): **162.4**
Structural Grade: **0**
O&M Grade: **2**
Clock Start/From: **8**
Clock To: **10**
1st Value:
2nd Value:
Value Percent: **5.000**
Continuous Index:
Within 8" of Joint: **YES**
Remarks:

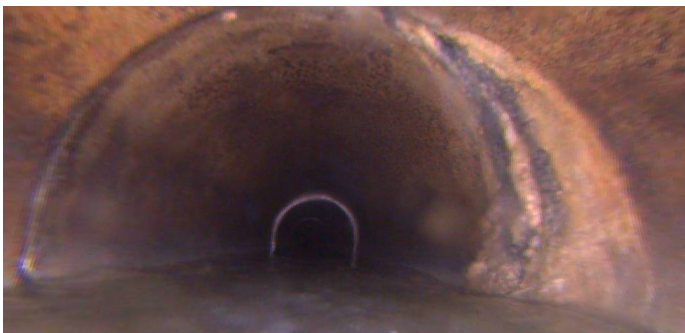
Code: **DAE**
Description: **Deposits Attached Encrustation**

Distance (ft): **171.6**
Structural Grade: **0**
O&M Grade: **2**
Clock Start/From: **1**
Clock To: **4**
1st Value:
2nd Value:
Value Percent: **5.000**
Continuous Index:
Within 8" of Joint: **YES**
Remarks:

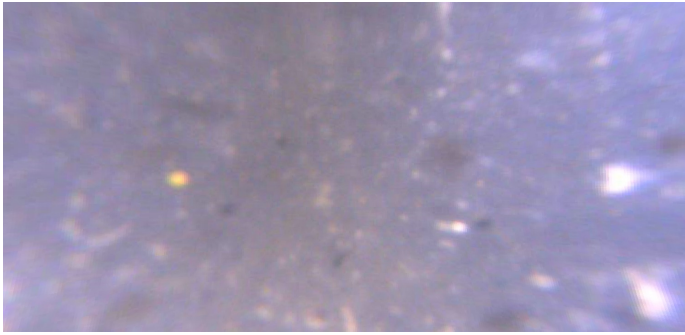
Code: **MCU**
Description: **Camera Underwater**

Distance (ft): **262.4**
Structural Grade: **0**
O&M Grade: **4**
Clock Start/From:
Clock To:
1st Value:
2nd Value:
Value Percent:
Continuous Index:
Within 8" of Joint: **NO**
Remarks:

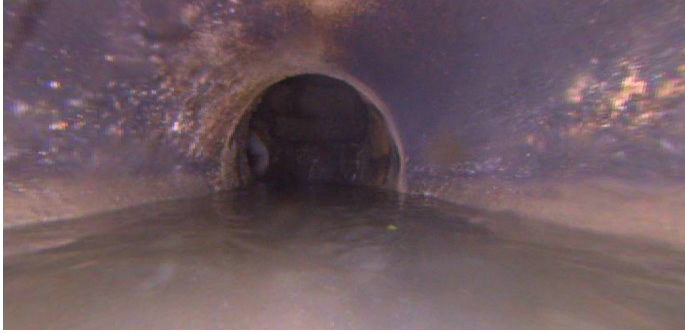
Code: **RFJ**
Description: **Roots Fine Joint**

Distance (ft): **269.6**
Structural Grade: **0**
O&M Grade: **1**
Clock Start/From: **7**
Clock To: **3**
1st Value:
2nd Value:
Value Percent:
Continuous Index: **F02**
Within 8" of Joint: **YES**
Remarks: **wandering**

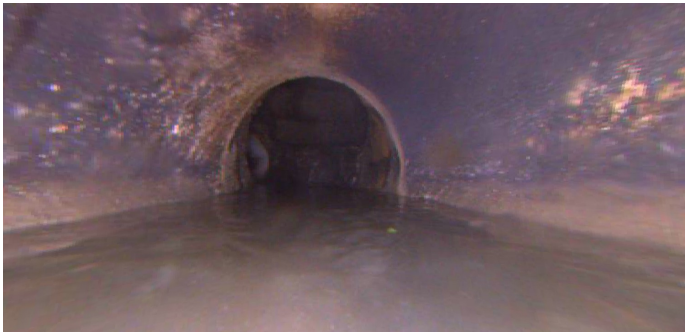
Code: **RMJ**
Description: **Roots Medium Joint**

Distance (ft): **269.6**
Structural Grade: **0**
O&M Grade: **3**
Clock Start/From: **3**
Clock To: **5**
1st Value:
2nd Value:
Value Percent: **5.000**
Continuous Index: **F01**
Within 8" of Joint: **YES**
Remarks: **wandering**
