## Profile/Photo Observation Report

Date:	<b>04/20/2018</b>	Weather:		Coding:	<b>PACP 6.0</b>
Pipe Length (ft):	<b>273.0</b>	Owner:	<b>NA</b>	Pre Clean:	<b>No Pre-Cleaning</b>
P.O.#:		Surveyor:	<b>Byrd Fitzgerald</b>	PSR:	<b>P-405-026-025</b>
Customer:		Clean Date:	<b>01/01/1900</b>	Shape:	<b>C</b>

Street:	<b>FOXCROFT STREET</b>	Flow Control:	<b>Not Controlled</b>
City:	<b>Hobart, IN</b>	Year Renewed:	
Location:	<b>Yard</b>	Tape/Media #:	
Purpose:	<b>Routine Assessment</b>	Dia/Height:	<b>10"</b>
Use:	<b>Sanitary</b>	Material:	<b>VCP</b>
Drain Area:	<b>NA</b>	Lining:	
Category:	<b>NA</b>		
Comment:

Location Details:		Direction of Survey:	<b>Downstream</b>
US MH:	<b>M-405-026</b>	DS MH:	<b>M-405-025</b>
		Total Length Surveyed (ft):	<b>273.2</b>

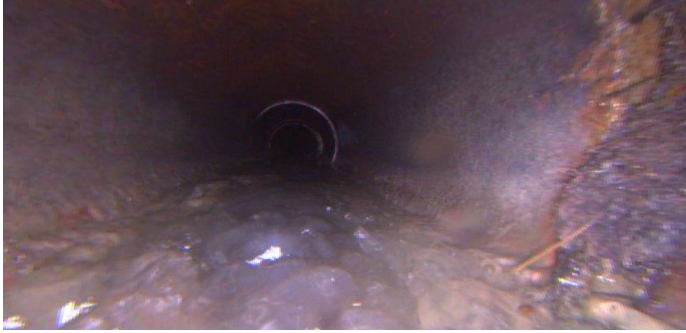
Code: **RMJ**  
Description: **Roots Medium Joint**

Distance (ft): **3.6**  
Structural Grade: **0**  
O&M Grade: **3**  
Clock Start/From: **3**  
Clock To: **5**  
1st Value:  
2nd Value:  
Value Percent: **5.000**  
Continuous Index:  
Within 8" of Joint: **YES**  
Remarks:

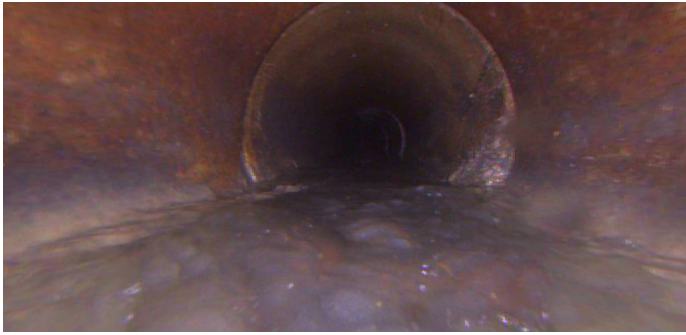
Code: **RMJ**  
Description: **Roots Medium Joint**

Distance (ft): **20.7**  
Structural Grade: **0**  
O&M Grade: **3**  
Clock Start/From: **3**  
Clock To: **5**  
1st Value:  
2nd Value:  
Value Percent: **5.000**  
Continuous Index: **S01**  
Within 8" of Joint: **YES**  
Remarks: **wandering**

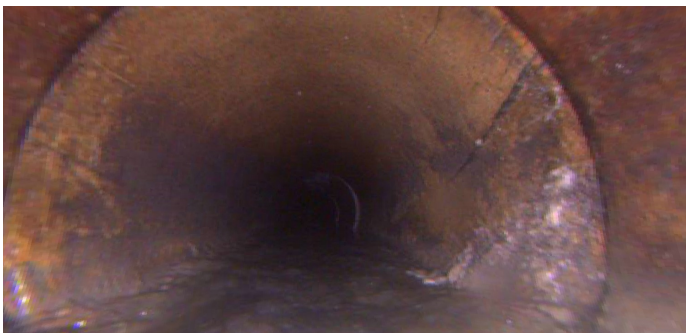
Code: **RFJ**  
Description: **Roots Fine Joint**

Distance (ft): **21.4**  
Structural Grade: **0**  
O&M Grade: **1**  
Clock Start/From: **7**  
Clock To: **3**  
1st Value:  
2nd Value:  
Value Percent:  
Continuous Index: **S02**  
Within 8" of Joint: **YES**  
Remarks: **wandering**

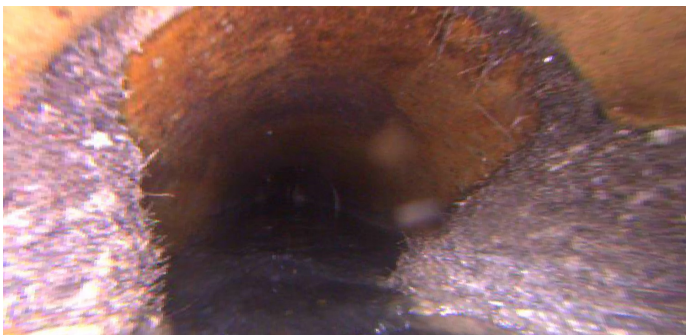
Code: **RMJ**  
Description: **Roots Medium Joint**

Distance (ft): **45.5**  
Structural Grade: **0**  
O&M Grade: **3**  
Clock Start/From: **7**  
Clock To: **5**  
1st Value:  
2nd Value:  
Value Percent: **40.000**  
Continuous Index:  
Within 8" of Joint: **YES**  
Remarks:

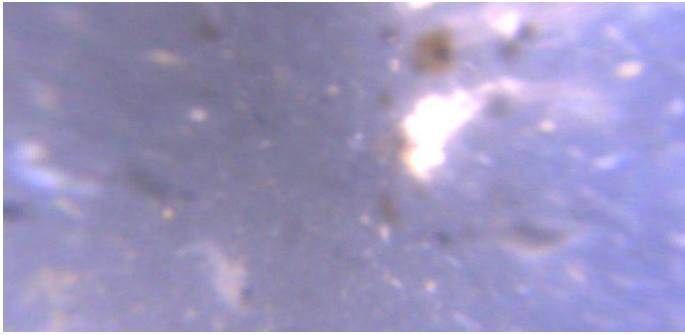
Code: **MCU**  
Description: **Camera Underwater**

Distance (ft): **48.5**  
Structural Grade: **0**  
O&M Grade: **4**  
Clock Start/From:  
Clock To:  
1st Value:  
2nd Value:  
Value Percent:  
Continuous Index: **S03**  
Within 8" of Joint: **NO**  
Remarks:

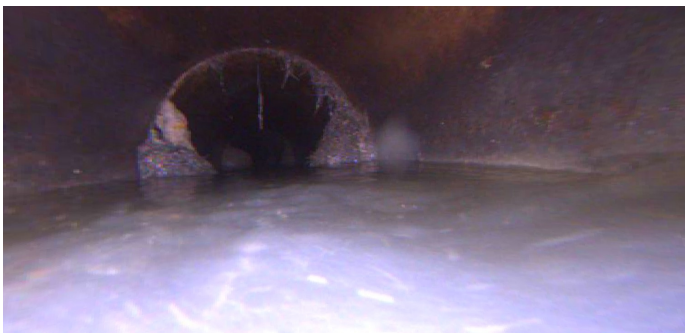
Code: **MCU**  
Description: **Camera Underwater**

Distance (ft): **56.3**  
Structural Grade: **0**  
O&M Grade: **4**  
Clock Start/From:  
Clock To:  
1st Value:  
2nd Value:  
Value Percent:  
Continuous Index: **F03**  
Within 8" of Joint: **NO**  
Remarks:

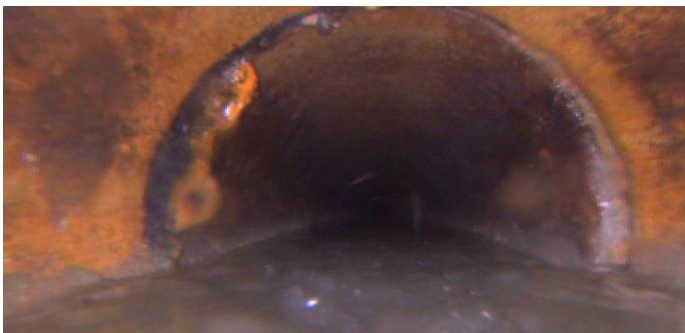
Code: **DAE**  
Description: **Deposits Attached Encrustation**

Distance (ft): **162.4**  
Structural Grade: **0**  
O&M Grade: **2**  
Clock Start/From: **8**  
Clock To: **10**  
1st Value:  
2nd Value:  
Value Percent: **5.000**  
Continuous Index:  
Within 8" of Joint: **YES**  
Remarks:

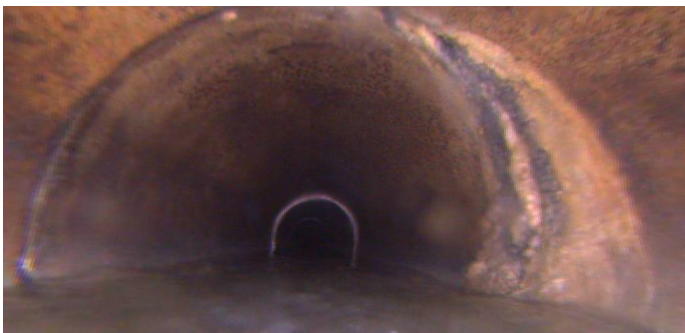
Code: **DAE**  
Description: **Deposits Attached Encrustation**

Distance (ft): **171.6**  
Structural Grade: **0**  
O&M Grade: **2**  
Clock Start/From: **1**  
Clock To: **4**  
1st Value:  
2nd Value:  
Value Percent: **5.000**  
Continuous Index:  
Within 8" of Joint: **YES**  
Remarks:

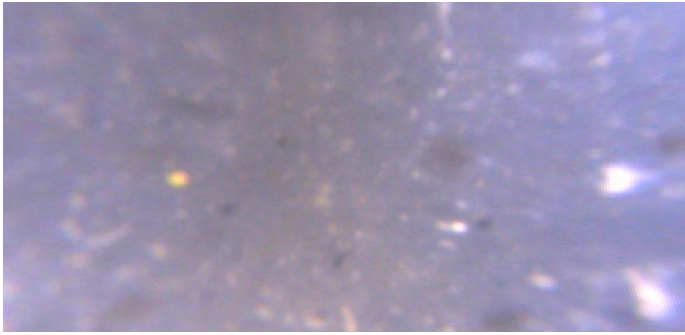
Code: **MCU**  
Description: **Camera Underwater**

Distance (ft): **262.4**  
Structural Grade: **0**  
O&M Grade: **4**  
Clock Start/From:  
Clock To:  
1st Value:  
2nd Value:  
Value Percent:  
Continuous Index:  
Within 8" of Joint: **NO**  
Remarks:

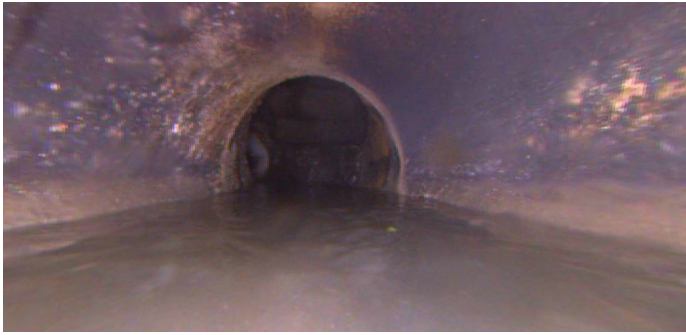
Code: **RFJ**  
Description: **Roots Fine Joint**

Distance (ft): **269.6**  
Structural Grade: **0**  
O&M Grade: **1**  
Clock Start/From: **7**  
Clock To: **3**  
1st Value:  
2nd Value:  
Value Percent:  
Continuous Index: **F02**  
Within 8" of Joint: **YES**  
Remarks: **wandering**

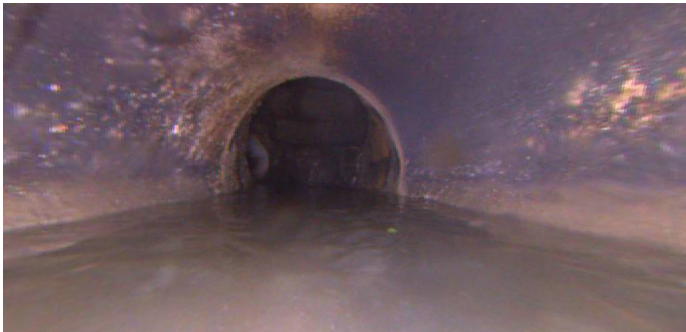
Code: **RMJ**  
Description: **Roots Medium Joint**

Distance (ft): **269.6**  
Structural Grade: **0**  
O&M Grade: **3**  
Clock Start/From: **3**  
Clock To: **5**  
1st Value:  
2nd Value:  
Value Percent: **5.000**  
Continuous Index: **F01**  
Within 8" of Joint: **YES**  
Remarks: **wandering**
