## Profile/Photo Observation Report

Street:	<b>SOFTWOOD DR</b>	Flow Control:	<b>Not Controlled</b>
City:	<b>Hobart, IN</b>	Year Renewed:	
Location:	<b>Yard</b>	Tape/Media #:	
Purpose:	<b>Routine Assessment</b>	Dia/Height:	<b>10"</b>
Use:	<b>Sanitary</b>	Material:	<b>PVC</b>
Drain Area:	<b>NA</b>	Lining:	
Category:	<b>NA</b>		
Comment:	<b>Flow direction wrong</b>

Location Details:		Direction of Survey:	<b>Downstream</b>
US MH:	<b>M-405-026</b>	DS MH:	<b>M-405-027</b>
		Total Length Surveyed (ft):	<b>217.7</b>

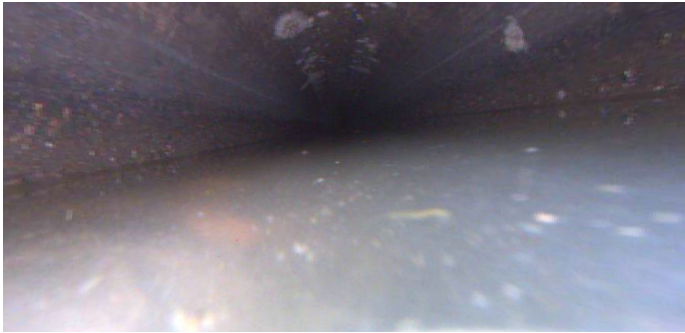
Code:	<b>MWL</b>
Description:	<b>Water Level</b>

Distance (ft):	<b>.0</b>
Structural Grade:	<b>0</b>
O&M Grade:	<b>0</b>
Clock Start/From:	
Clock To:	
1st Value:	
2nd Value:	
Value Percent:	<b>25.000</b>
Continuous Index:	
Within 8" of Joint:	<b>NO</b>
Remarks:

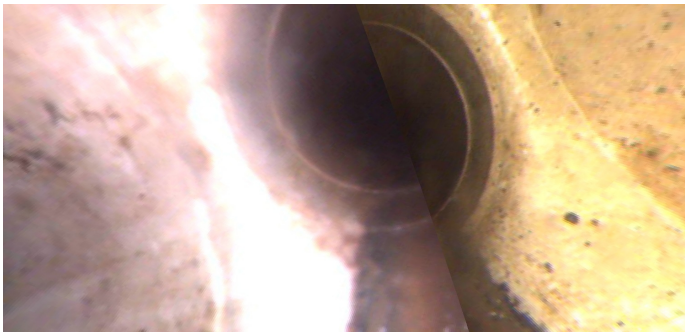
Code:	<b>TF</b>
Description:	<b>Tap Factory</b>

Distance (ft):	<b>87.1</b>
Structural Grade:	<b>0</b>
O&M Grade:	<b>0</b>
Clock Start/From:	<b>2</b>
Clock To:	
1st Value:	<b>4.000</b>
2nd Value:	
Value Percent:	
Continuous Index:	
Within 8" of Joint:	<b>YES</b>
Remarks:

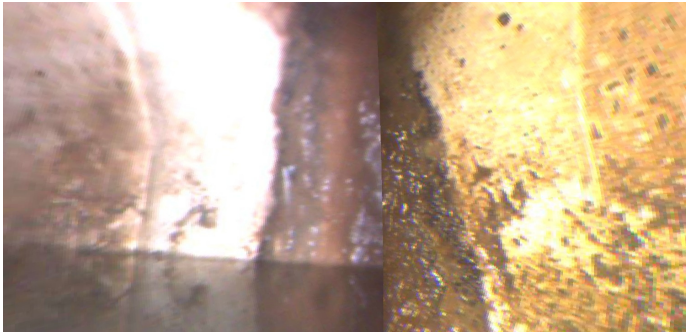
Code: **DAZ**  
Description: **Deposits Attached Other**

Distance (ft): **87.1**  
Structural Grade: **0**  
O&M Grade: **2**  
Clock Start/From: **2**  
Clock To: **5**  
1st Value:  
2nd Value:  
Value Percent: **5.000**  
Continuous Index:  
Within 8" of Joint: **NO**  
Remarks:

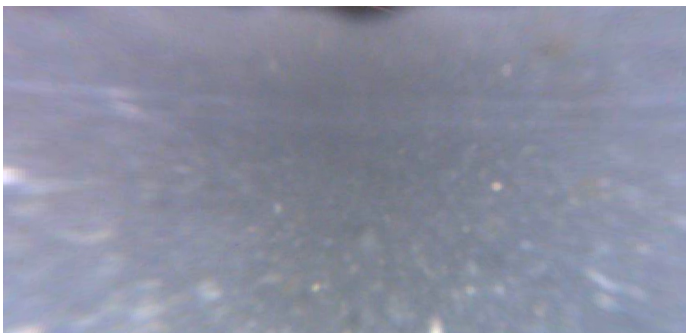
Code: **MCU**  
Description: **Camera Underwater**

Distance (ft): **206.1**  
Structural Grade: **0**  
O&M Grade: **4**  
Clock Start/From:  
Clock To:  
1st Value:  
2nd Value:  
Value Percent:  
Continuous Index: **S01**  
Within 8" of Joint: **NO**  
Remarks:

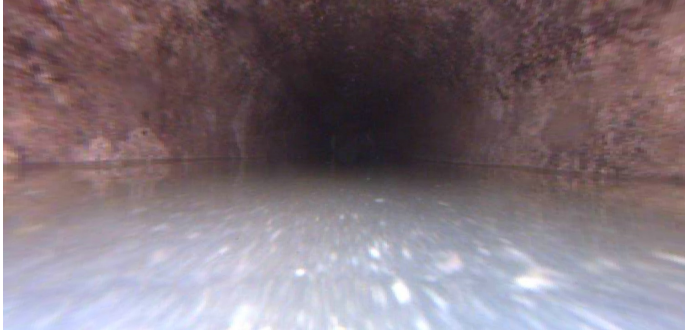
Code: **MCU**  
Description: **Camera Underwater**

Distance (ft): **210.1**  
Structural Grade: **0**  
O&M Grade: **4**  
Clock Start/From:  
Clock To:  
1st Value:  
2nd Value:  
Value Percent:  
Continuous Index: **F01**  
Within 8" of Joint: **NO**  
Remarks:

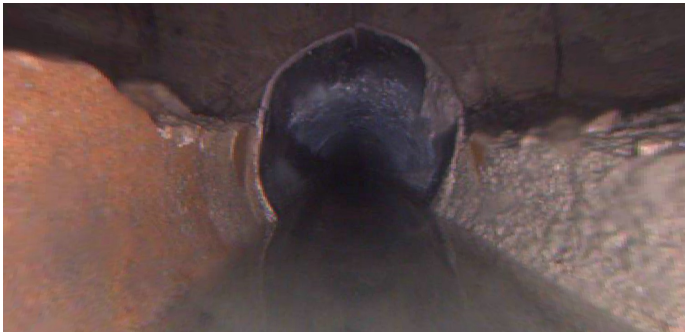
Code: **AMH**  
Description: **Manhole**

Distance (ft): **217.7**  
Structural Grade: **0**  
O&M Grade: **0**  
Clock Start/From:  
Clock To:  
1st Value:  
2nd Value:  
Value Percent:  
Continuous Index:  
Within 8" of Joint: **NO**  
Remarks: **M-405-027**
