## Profile/Photo Observation Report

Date:	<b>04/20/2018</b>	Weather:		Coding:	<b>PACP 6.0</b>
Pipe Length (ft):	<b>196.2</b>	Owner:	<b>NA</b>	Pre Clean:	<b>No Pre-Cleaning</b>
P.O.#:		Surveyor:	<b>Byrd Fitzgerald</b>	PSR:	<b>P-405-027-026</b>
Customer:		Clean Date:	<b>01/01/1900</b>	Shape:	<b>C</b>

Street:	<b>FOXCROFT STREET</b>	Flow Control:	<b>Not Controlled</b>
City:	<b>Hobart, IN</b>	Year Renewed:	
Location:	<b>Yard</b>	Tape/Media #:	
Purpose:	<b>Routine Assessment</b>	Dia/Height:	<b>10"</b>
Use:	<b>Sanitary</b>	Material:	<b>PVC</b>
Drain Area:	<b>NA</b>	Lining:	
Category:	<b>NA</b>		
Comment:	<b>Flow direction wrong</b>

Location Details:		Direction of Survey:	<b>Downstream</b>
US MH:	<b>M-405-026</b>	DS MH:	<b>M-405-027</b>
		Total Length Surveyed (ft):	<b>217.7</b>

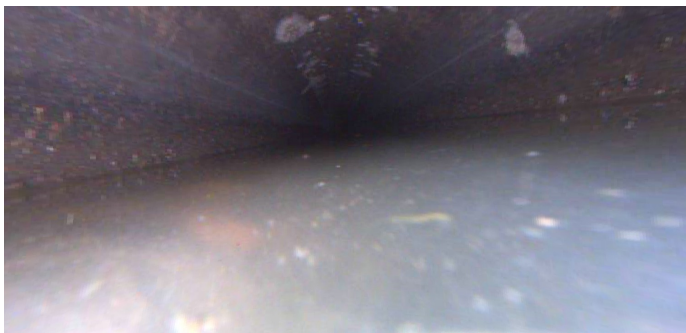
Code: **AMH**  
Description: **Manhole**

Distance (ft): **.0**  
Structural Grade: **0**  
O&M Grade: **0**  
Clock Start/From:  
Clock To:  
1st Value:  
2nd Value:  
Value Percent:  
Continuous Index:  
Within 8" of Joint: **NO**  
Remarks: **M-405-026**

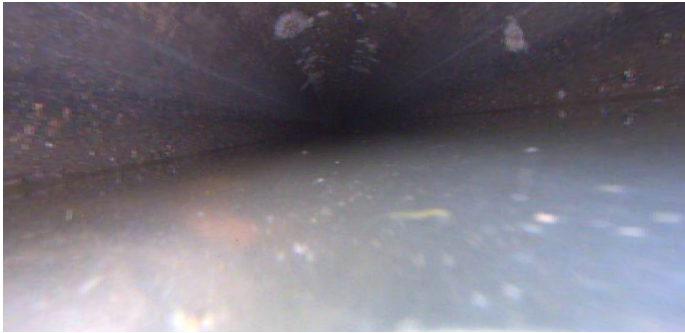
Code:	<b>MWL</b>
Description:	<b>Water Level</b>

Distance (ft):	<b>.0</b>
Structural Grade:	<b>0</b>
O&M Grade:	<b>0</b>
Clock Start/From:	
Clock To:	
1st Value:	
2nd Value:	
Value Percent:	<b>25.000</b>
Continuous Index:	
Within 8" of Joint:	<b>NO</b>
Remarks:

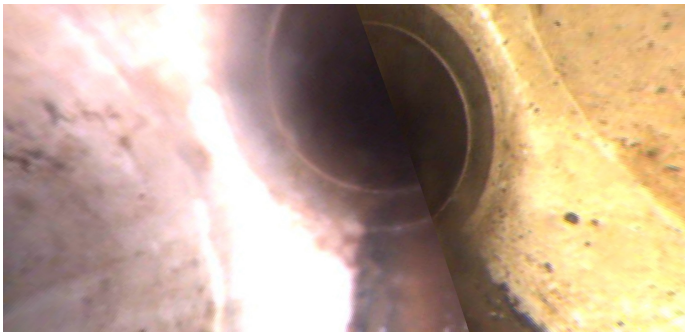
Code:	<b>TF</b>
Description:	<b>Tap Factory</b>

Distance (ft):	<b>87.1</b>
Structural Grade:	<b>0</b>
O&M Grade:	<b>0</b>
Clock Start/From:	<b>2</b>
Clock To:	
1st Value:	<b>4.000</b>
2nd Value:	
Value Percent:	
Continuous Index:	
Within 8" of Joint:	<b>YES</b>
Remarks:

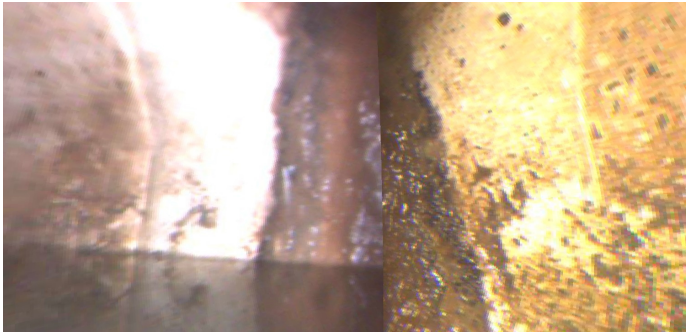
Code: **DAZ**  
Description: **Deposits Attached Other**

Distance (ft): **87.1**  
Structural Grade: **0**  
O&M Grade: **2**  
Clock Start/From: **2**  
Clock To: **5**  
1st Value:  
2nd Value:  
Value Percent: **5.000**  
Continuous Index:  
Within 8" of Joint: **NO**  
Remarks:

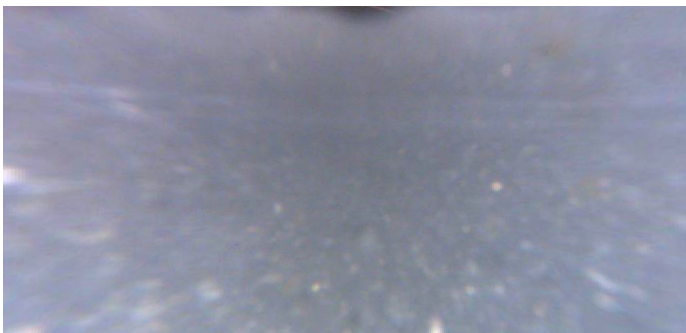
Code: **MCU**  
Description: **Camera Underwater**

Distance (ft): **206.1**  
Structural Grade: **0**  
O&M Grade: **4**  
Clock Start/From:  
Clock To:  
1st Value:  
2nd Value:  
Value Percent:  
Continuous Index: **S01**  
Within 8" of Joint: **NO**  
Remarks:

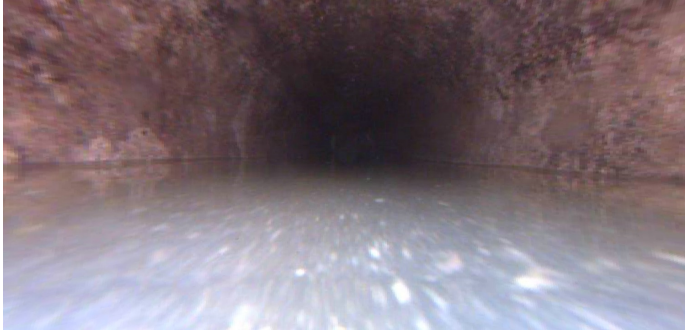
Code: **MCU**  
Description: **Camera Underwater**

Distance (ft): **210.1**  
Structural Grade: **0**  
O&M Grade: **4**  
Clock Start/From:  
Clock To:  
1st Value:  
2nd Value:  
Value Percent:  
Continuous Index: **F01**  
Within 8" of Joint: **NO**  
Remarks:

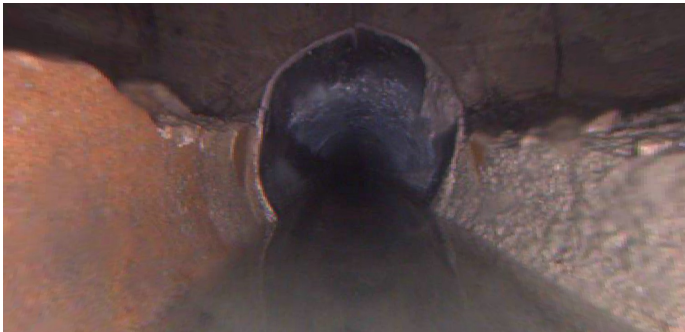
Code: **AMH**  
Description: **Manhole**

Distance (ft): **217.7**  
Structural Grade: **0**  
O&M Grade: **0**  
Clock Start/From:  
Clock To:  
1st Value:  
2nd Value:  
Value Percent:  
Continuous Index:  
Within 8" of Joint: **NO**  
Remarks: **M-405-027**
