Profile/Photo Observation Report

Date:	03/16/2024	Weather:		Coding:	PACP 7.0
Pipe Length (ft):	133.0	Owner:	City of Hobart	Pre Clean:	Heavy Cleaning
P.O.#:		Surveyor:	S. Bucklin	PSR:	P-405-028-027
Customer:	City of Hobart	Clean Date:	10/25/2023	Shape:	C

Street:	W 3RD PL	Flow Control:	Not Controlled
City:	Hobart, IN	Year Renewed:	
Location:	Easement/Right of Way	Tape/Media #:	
Purpose:	Sewer System Evaluation Survey (SS)	Dia/Height:	10"
Use:	Sanitary Sewage Pipe	Material:	VCP
Drain Area:		Lining:	Cured-In-Place Pipe
Category:	NA		
Comment:

Location Details:		Direction of Survey:	Downstream
US MH:	M-405-027	DS MH:	M-405-028
		Total Length Surveyed (ft):	104.7

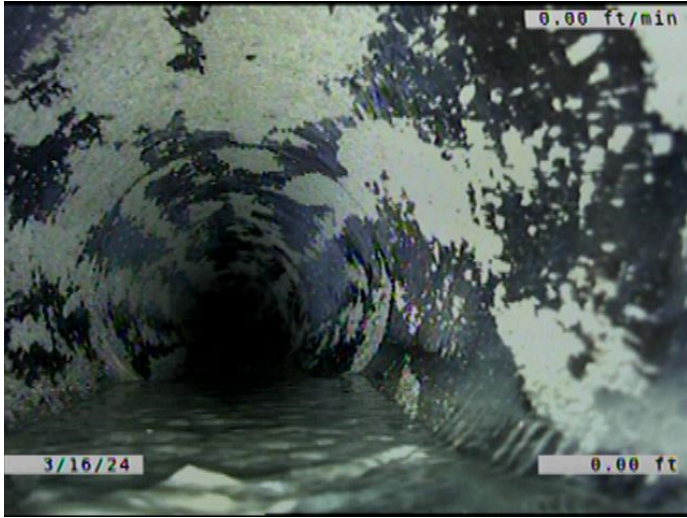
Code: **MWL**
Description: **Miscellaneous Water Level**

Distance (ft): **.0**
Structural Grade: **0**
O&M Grade: **0**
Clock Start/From:
Clock To:
1st Value:
2nd Value:
Value Percent: **10.000**
Continuous Index:
Within 8" of Joint: **NO**
Remarks:

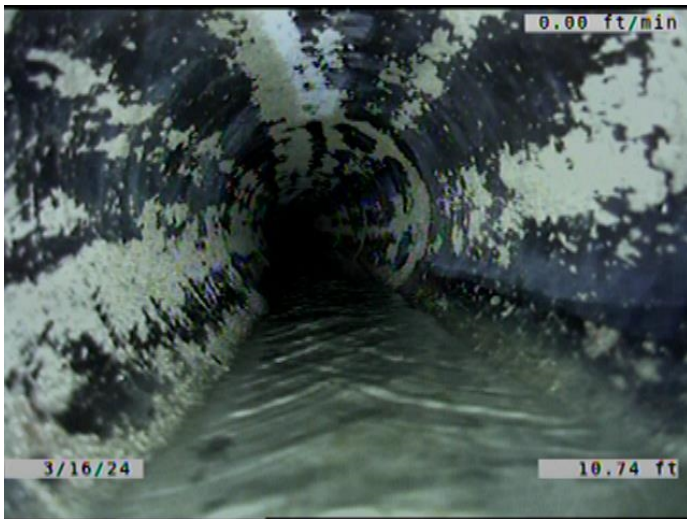
Code: **LL**
Description: **Line Left**

Distance (ft): **10.7**
Structural Grade: **0**
O&M Grade: **1**
Clock Start/From:
Clock To:
1st Value:
2nd Value:
Value Percent: **10.000**
Continuous Index:
Within 8" of Joint: **NO**
Remarks:

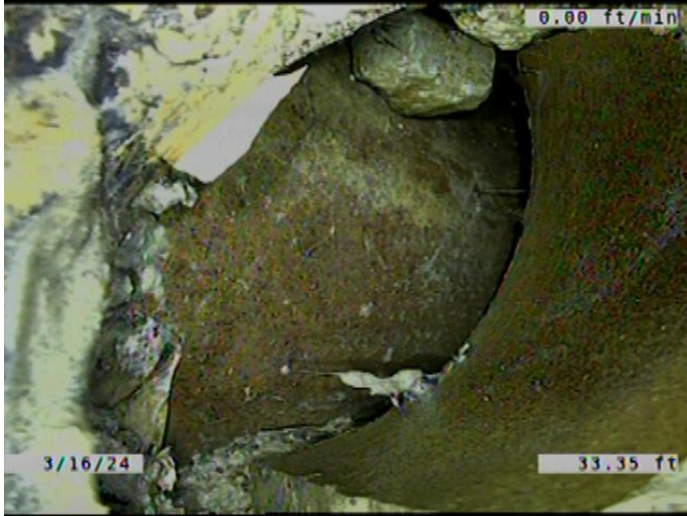
Code: **TBI**
Description: **Tap Break-in Intruding**

Distance (ft): **33.4**
Structural Grade: **0**
O&M Grade: **2**
Clock Start/From: **10**
Clock To:
1st Value: **6.000**
2nd Value: **1.000**
Value Percent:
Continuous Index:
Within 8" of Joint: **NO**
Remarks: **SERVICE COLLAPSED. SOIL AND GRAVEL VISIBLE.**

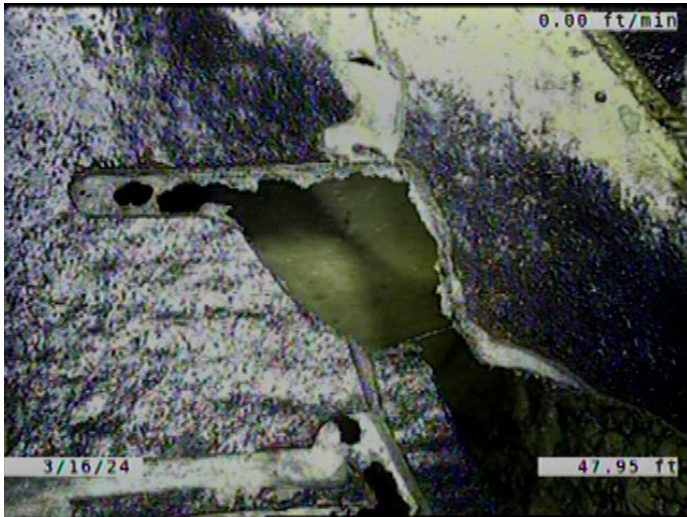
Code: **LFUC**
Description: **Lining Feature Undercut Service**

Distance (ft): **47.9**
Structural Grade: **3**
O&M Grade: **0**
Clock Start/From: **1**
Clock To: **3**
1st Value:
2nd Value:
Value Percent:
Continuous Index:
Within 8" of Joint: **NO**
Remarks:

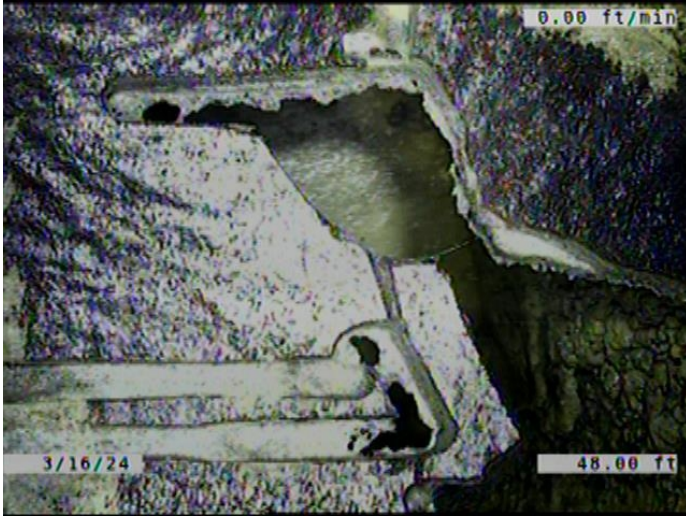
Code:	TBD
Description:	Tap Break-in/Hammer Defective
Distance (ft):	48.0
Structural Grade:	0
O&M Grade:	3
Clock Start/From:	2
Clock To:	
1st Value:	6.000
2nd Value:	
Value Percent:	
Continuous Index:	
Within 8" of Joint:	NO
Remarks:	Defective

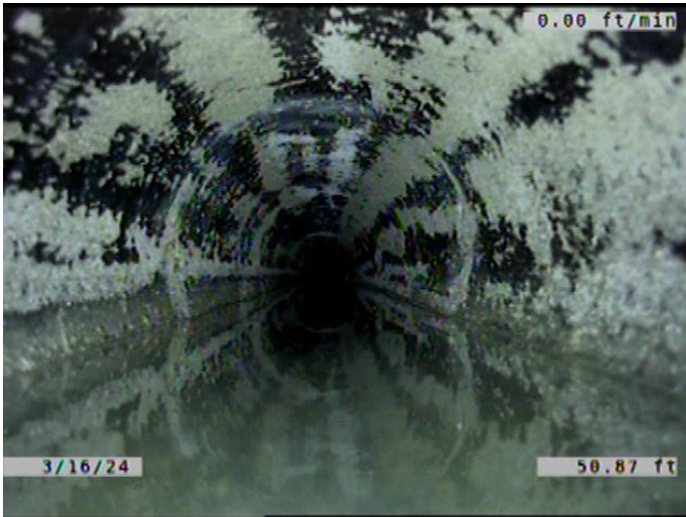
Code:	MWL
Description:	Miscellaneous Water Level
Distance (ft):	50.9
Structural Grade:	0
O&M Grade:	0
Clock Start/From:	
Clock To:	
1st Value:	
2nd Value:	
Value Percent:	20.000
Continuous Index:	
Within 8" of Joint:	NO
Remarks:

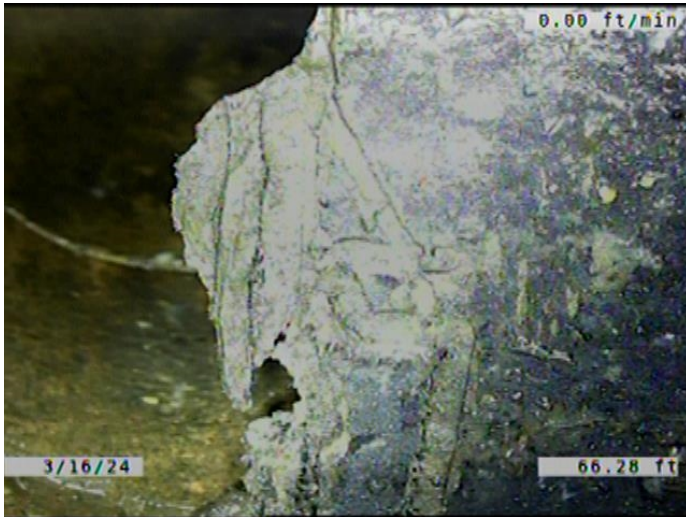
Code: **LFUC**
 Description: **Lining Feature Undercut Service**

Distance (ft): **66.3**
 Structural Grade: **3**
 O&M Grade: **0**
 Clock Start/From: **10**
 Clock To: **11**
 1st Value:
 2nd Value:
 Value Percent:
 Continuous Index:
 Within 8" of Joint: **NO**
 Remarks:

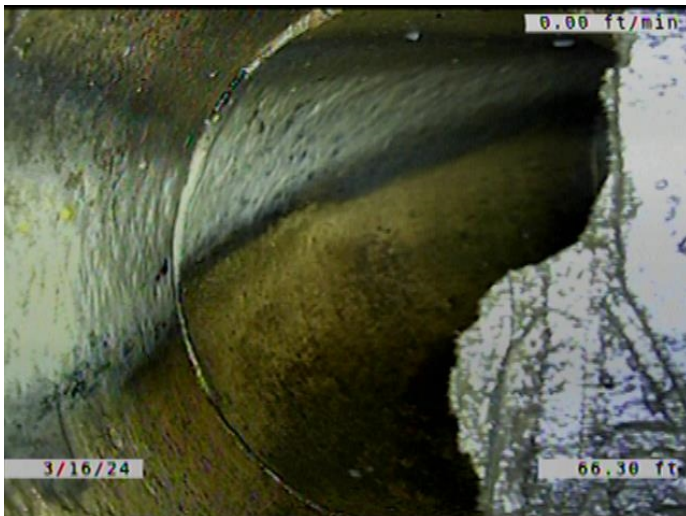
Code: **TBD**
 Description: **Tap Break-in/Hammer Defective**

Distance (ft): **66.3**
 Structural Grade: **0**
 O&M Grade: **3**
 Clock Start/From: **10**
 Clock To:
 1st Value: **6.000**
 2nd Value:
 Value Percent:
 Continuous Index:
 Within 8" of Joint: **NO**
 Remarks: **CONSTANTLY RUNNING WATER.**

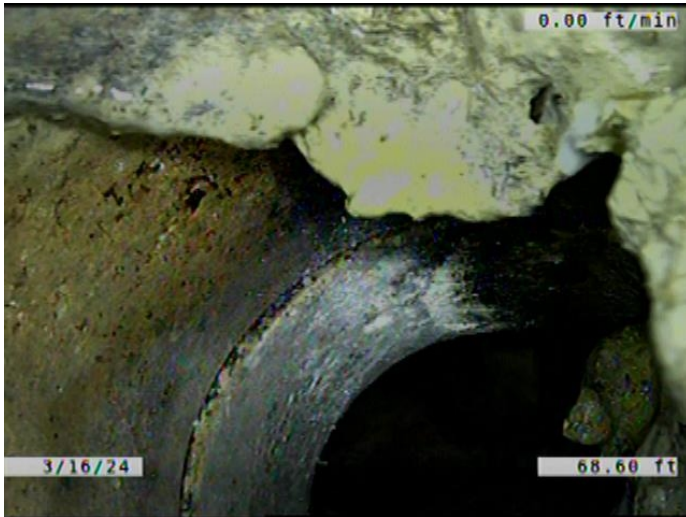
Code: **LFUC**
Description: **Lining Feature Undercut Service**

Distance (ft): **68.6**
Structural Grade: **3**
O&M Grade: **0**
Clock Start/From: **2**
Clock To: **3**
1st Value:
2nd Value:
Value Percent:
Continuous Index:
Within 8" of Joint: **NO**
Remarks:

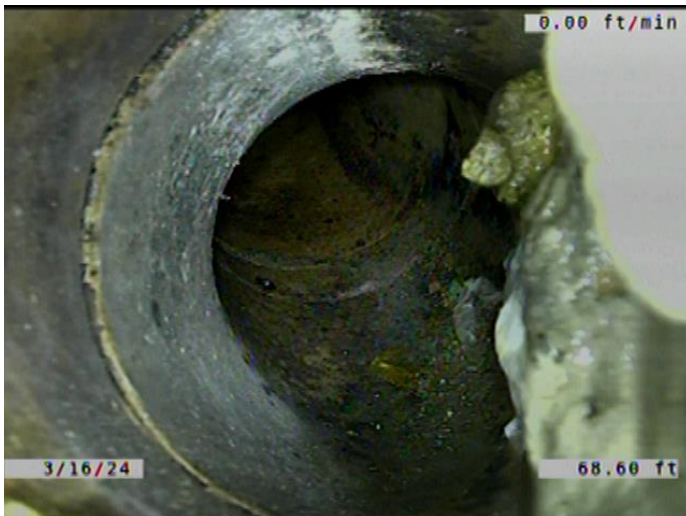
Code: **TBD**
Description: **Tap Break-in/Hammer Defective**

Distance (ft): **68.6**
Structural Grade: **0**
O&M Grade: **3**
Clock Start/From: **3**
Clock To:
1st Value: **6.000**
2nd Value:
Value Percent:
Continuous Index:
Within 8" of Joint: **YES**
Remarks: **CONSTANTLY RUNNING WATER.**

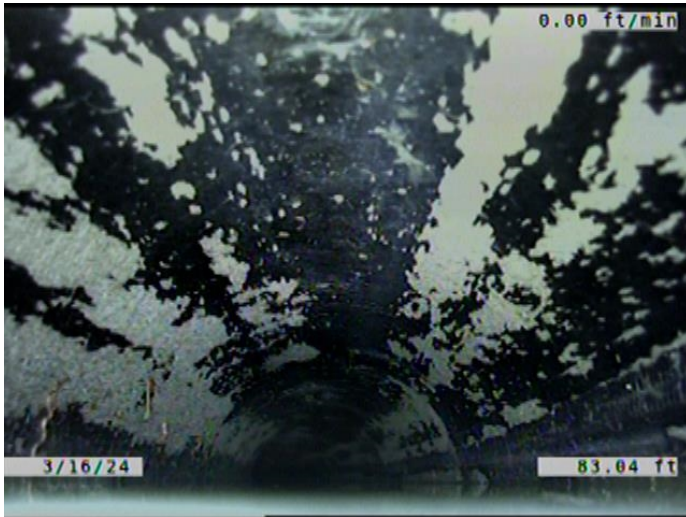
Code: **MWLS**
Description: **Miscellaneous Water Level Sag**

Distance (ft): **83.0**
Structural Grade: **3**
O&M Grade: **0**
Clock Start/From:
Clock To:
1st Value:
2nd Value:
Value Percent: **40.000**
Continuous Index: **S01**
Within 8" of Joint: **NO**
Remarks:

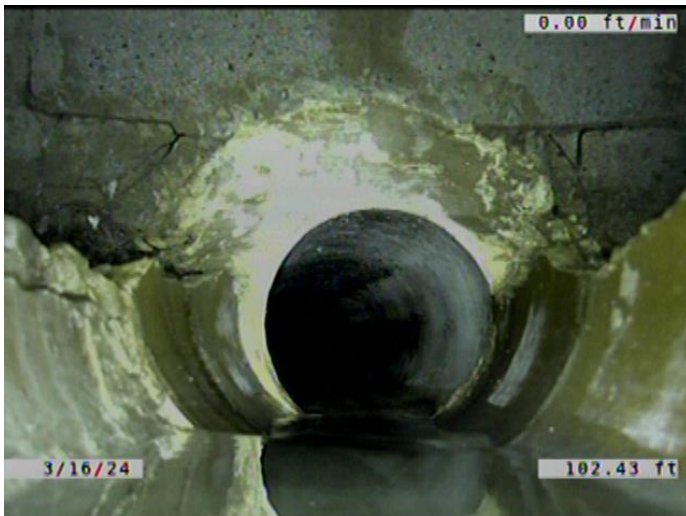
Code: **MWLS**
Description: **Miscellaneous Water Level Sag**

Distance (ft): **102.4**
Structural Grade: **3**
O&M Grade: **0**
Clock Start/From:
Clock To:
1st Value:
2nd Value:
Value Percent: **40.000**
Continuous Index: **F01**
Within 8" of Joint: **NO**
Remarks:
