Profile/Photo Observation Report

Date: 03/16/2024 Weather: **PACP 7.0** Coding: Pipe Length (ft): 179.0 Owner: **City of Hobart** Pre Clean: **Heavy Cleaning** P.O.#: S. Bucklin PSR: P-405-029-028 Surveyor:

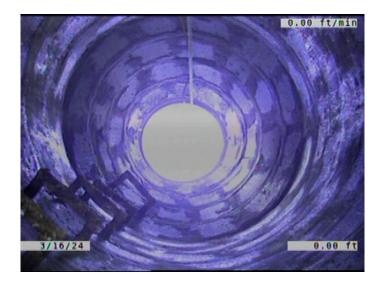
Code: AMH
Description: Manhole

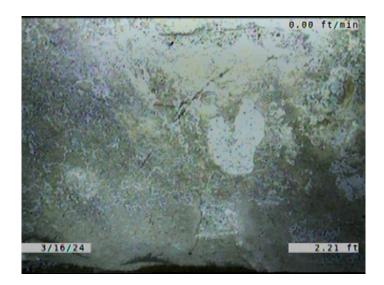
Code: RPP
Description: Point Repair Patch

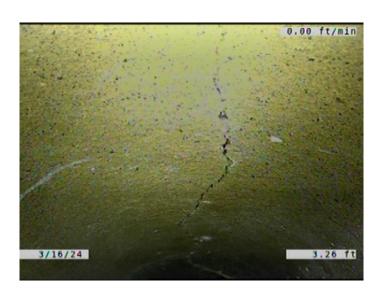
Code: B
Description: Broken

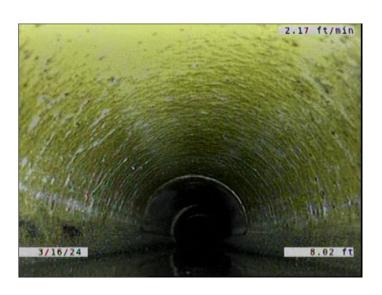
Code: B
Description: Broken

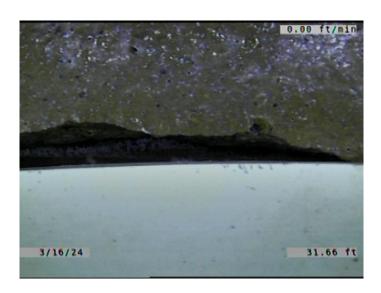
Remarks: CONSTANTLY RUNNING WATER.

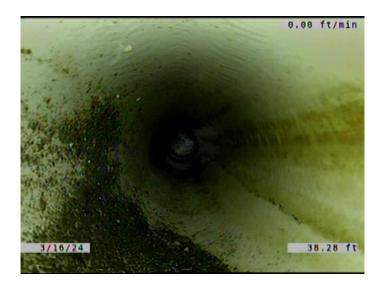
Remarks: **REPLACED WITH PVC.**

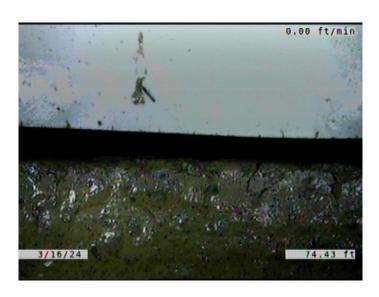
Remarks: CONSTANTLY RUNNING WATER.

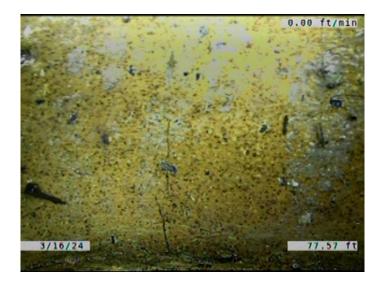
Remarks: **REPLACED WITH PVC.**

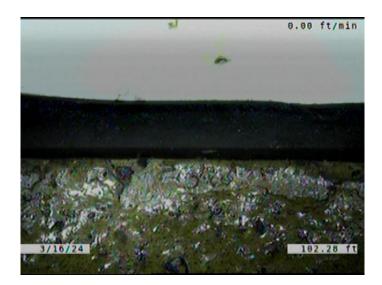
Remarks: **REPLACED WITH PVC.**

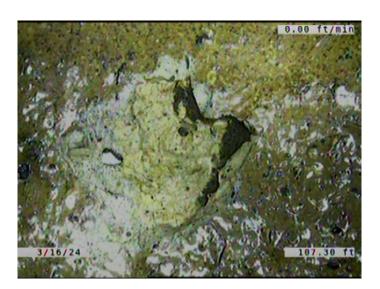
Remarks: **REPLACED WITH PVC.**

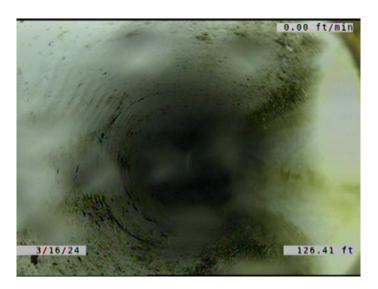
Remarks: **REPLACED WITH PVC.**

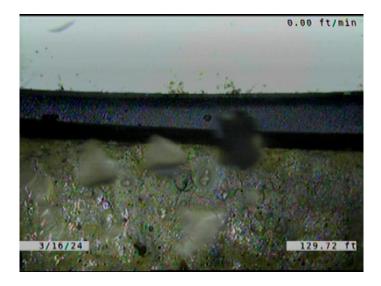
Remarks: CONSTANTLY RUNNING WATER.

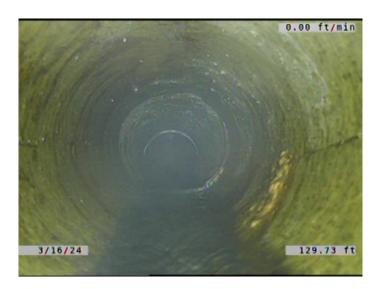
Remarks: **REPLACED WITH PVC.**

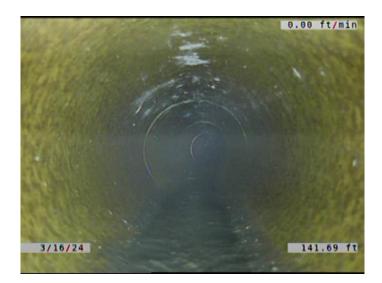
Remarks: CAPPED. ENCRUSTATION COMING AROUND THE CAP INTO THE MAIN.

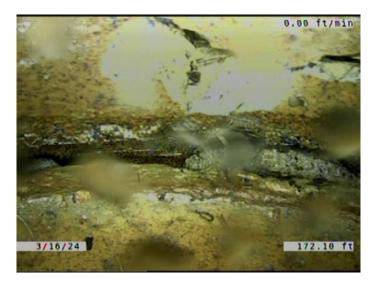
Remarks: ACTIVITY. SERVICE BROKEN. ROOTS
GROWING IN THE JOINTS. CONSTAN
