Profile/Photo Observation Report

Date:	04/24/2018	Weather:		Coding:	PACP 6.0
Pipe Length (ft):	257.7	Owner:	NA	Pre Clean:	No Pre-Cleaning
P.O.#:		Surveyor:	Jen Costello	PSR:	P-405-030-029
Customer:		Clean Date:	01/01/1900	Shape:	C

Street:	ALLEY BETWEEN DRIFTWOOD DR &	Flow Control:	Not Controlled
City:	Hobart, IN	Year Renewed:	
Location:	Yard	Tape/Media #:	
Purpose:	Routine Assessment	Dia/Height:	8"
Use:	Sanitary	Material:	VCP
Drain Area:	NA	Lining:	
Category:	NA		
Comment:	P_C at 36 ft nothing visible. Flow direction wrong		
Location Details:		Direction of Survey:	Downstream
US MH:	M-405-029	DS MH:	M-405-030
		Total Length Surveyed (ft):	37.5

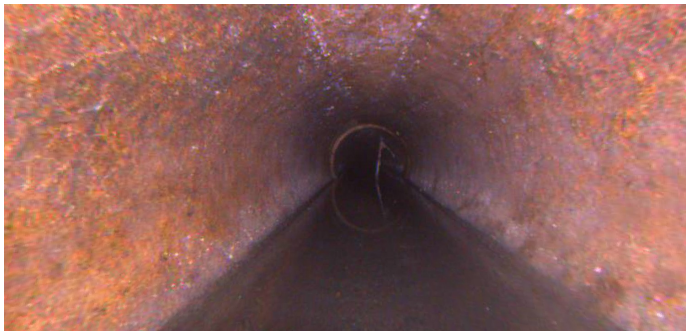
Code: **AMH**
Description: **Manhole**

Distance (ft): **.0**
Structural Grade: **0**
O&M Grade: **0**
Clock Start/From:
Clock To:
1st Value:
2nd Value:
Value Percent:
Continuous Index:
Within 8" of Joint: **NO**
Remarks: **M-405-029**

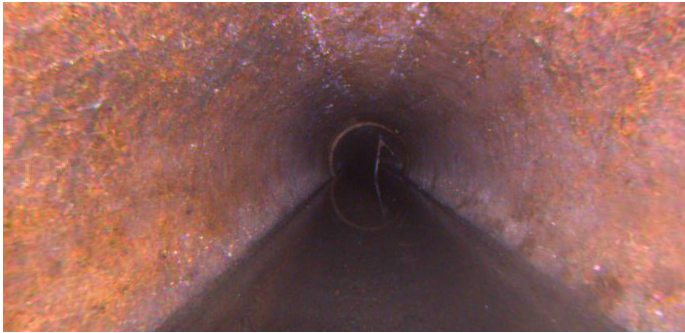
Code:	MWL
Description:	Water Level

Distance (ft):	.0
Structural Grade:	0
O&M Grade:	0
Clock Start/From:	
Clock To:	
1st Value:	
2nd Value:	
Value Percent:	10.000
Continuous Index:	
Within 8" of Joint:	NO
Remarks:

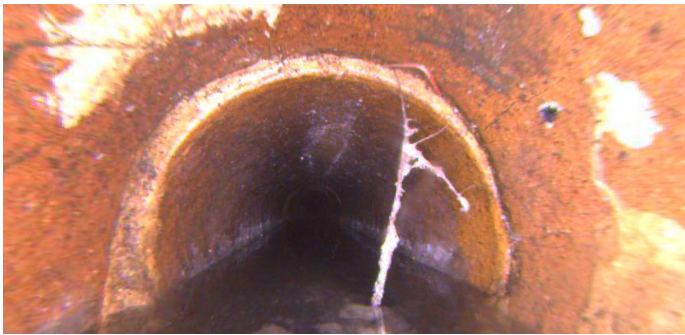
Code:	FL
Description:	Fracture Longitudinal

Distance (ft):	3.2
Structural Grade:	3
O&M Grade:	0
Clock Start/From:	2
Clock To:	
1st Value:	
2nd Value:	
Value Percent:	
Continuous Index:	
Within 8" of Joint:	YES
Remarks:

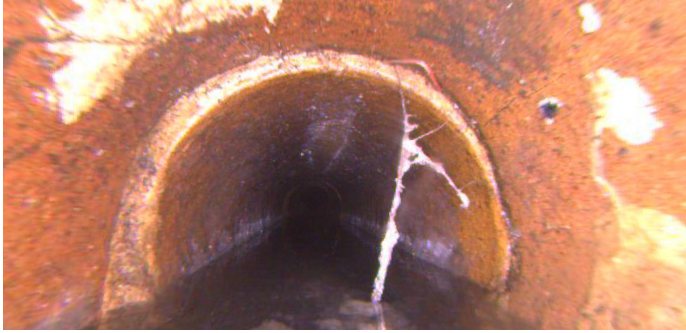
Code: **RFJ**
Description: **Roots Fine Joint**

Distance (ft): **3.2**
Structural Grade: **0**
O&M Grade: **1**
Clock Start/From: **8**
Clock To: **4**
1st Value:
2nd Value:
Value Percent:
Continuous Index:
Within 8" of Joint: **YES**
Remarks:

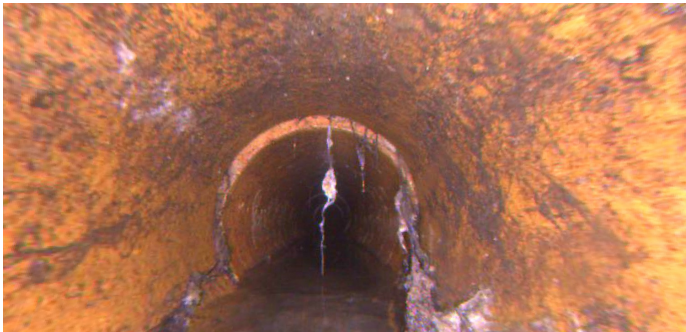
Code: **RMJ**
Description: **Roots Medium Joint**

Distance (ft): **11.7**
Structural Grade: **0**
O&M Grade: **3**
Clock Start/From: **8**
Clock To: **4**
1st Value:
2nd Value:
Value Percent: **5.000**
Continuous Index:
Within 8" of Joint: **YES**
Remarks:

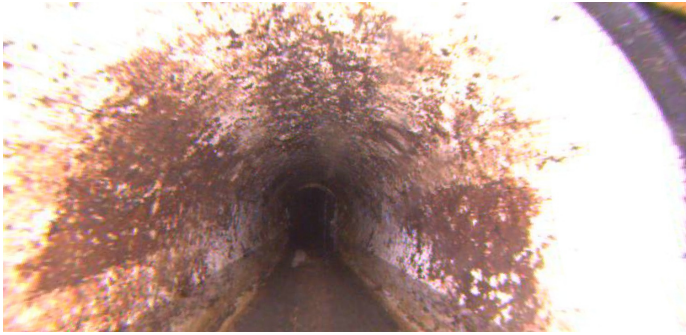
Code: **MMC**
Description: **Material Change**

Distance (ft): **18.2**
Structural Grade: **0**
O&M Grade: **0**
Clock Start/From:
Clock To:
1st Value:
2nd Value:
Value Percent:
Continuous Index:
Within 8" of Joint: **NO**
Remarks: **PVC**

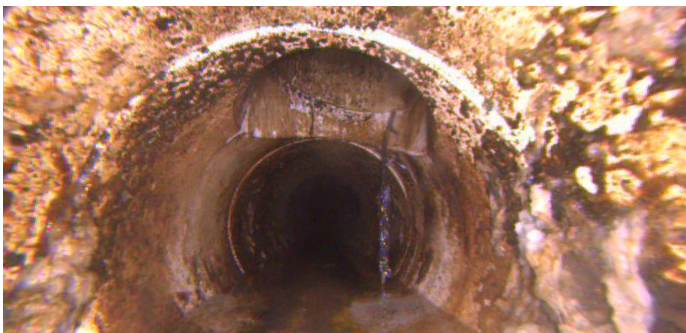
Code: **DAGS**
Description: **Deposits Attached Grease**

Distance (ft): **21.5**
Structural Grade: **0**
O&M Grade: **2**
Clock Start/From: **8**
Clock To: **4**
1st Value:
2nd Value:
Value Percent: **5.000**
Continuous Index:
Within 8" of Joint: **NO**
Remarks:

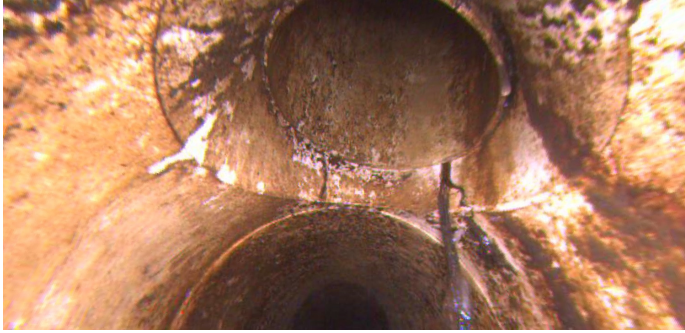
Code: **TFD**
Description: **Tap Factory Defective**

Distance (ft): **22.0**
Structural Grade: **0**
O&M Grade: **2**
Clock Start/From: **12**
Clock To:
1st Value: **4.000**
2nd Value:
Value Percent:
Continuous Index:
Within 8" of Joint:
Remarks: **ROOTS**

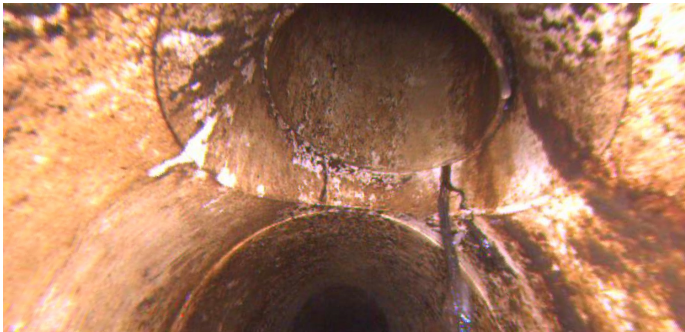
Code: **RFL**
Description: **Roots Fine Lateral**

Distance (ft): **22.0**
Structural Grade: **0**
O&M Grade: **1**
Clock Start/From: **12**
Clock To:
1st Value:
2nd Value:
Value Percent:
Continuous Index:
Within 8" of Joint: **NO**
Remarks:

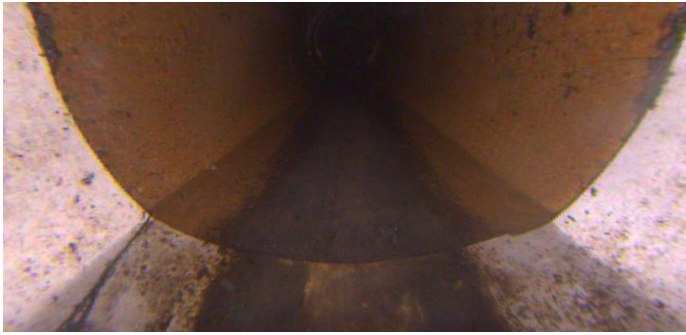
Code: **RFJ**
Description: **Roots Fine Joint**

Distance (ft): **27.3**
Structural Grade: **0**
O&M Grade: **1**
Clock Start/From: **8**
Clock To:
1st Value:
2nd Value:
Value Percent:
Continuous Index:
Within 8" of Joint: **YES**
Remarks:

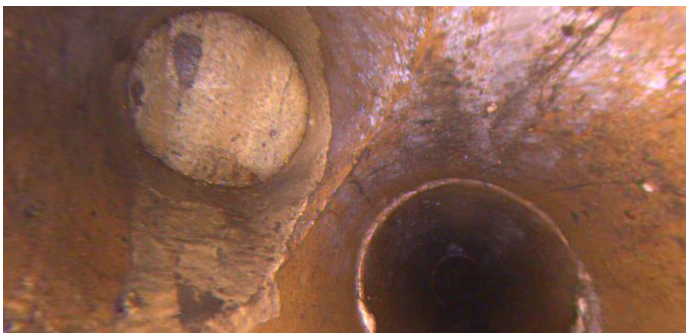
Code: **TFC**
Description: **Tap Factory Capped**

Distance (ft): **29.5**
Structural Grade: **0**
O&M Grade: **0**
Clock Start/From: **10**
Clock To:
1st Value: **4.000**
2nd Value:
Value Percent:
Continuous Index:
Within 8" of Joint:
Remarks:

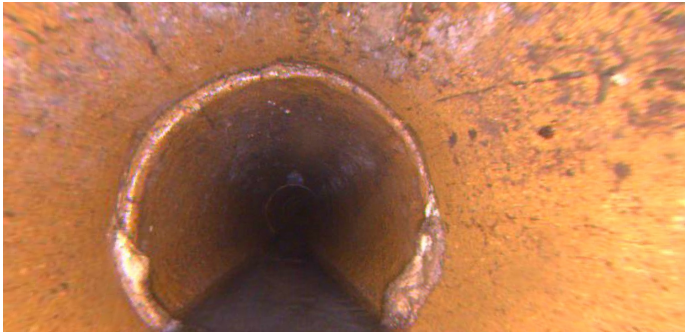
Code: **DAE**
Description: **Deposits Attached Encrustation**

Distance (ft): **30.0**
Structural Grade: **0**
O&M Grade: **2**
Clock Start/From: **8**
Clock To: **4**
1st Value:
2nd Value:
Value Percent: **5.000**
Continuous Index:
Within 8" of Joint: **YES**
Remarks:

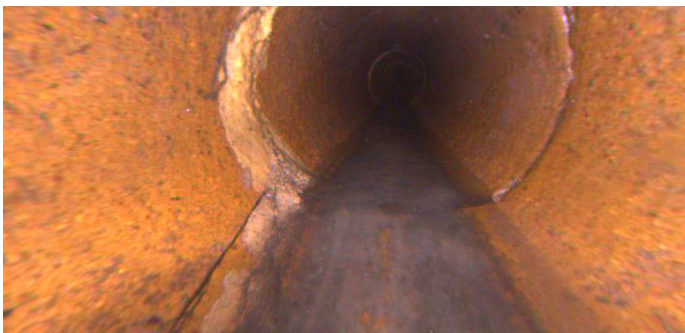
Code: **RFJ**
Description: **Roots Fine Joint**

Distance (ft): **32.9**
Structural Grade: **0**
O&M Grade: **1**
Clock Start/From: **8**
Clock To:
1st Value:
2nd Value:
Value Percent:
Continuous Index:
Within 8" of Joint: **YES**
Remarks:

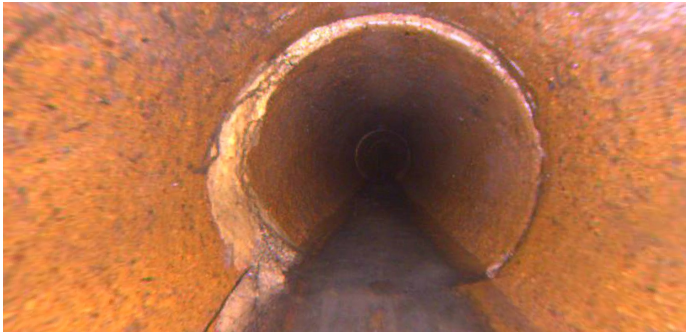
Code: **DAE**
Description: **Deposits Attached Encrustation**

Distance (ft): **32.9**
Structural Grade: **0**
O&M Grade: **2**
Clock Start/From: **7**
Clock To: **11**
1st Value:
2nd Value:
Value Percent: **5.000**
Continuous Index:
Within 8" of Joint: **YES**
Remarks:

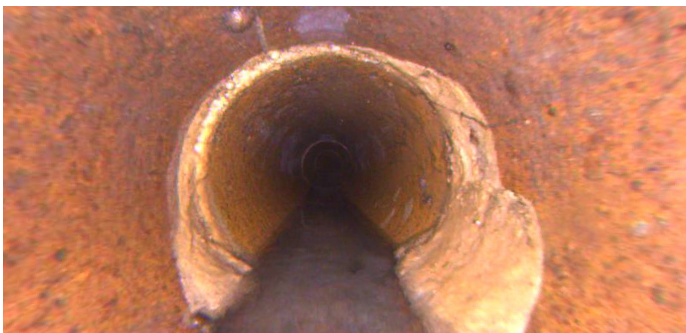
Code: **DAE**
Description: **Deposits Attached Encrustation**

Distance (ft): **35.8**
Structural Grade: **0**
O&M Grade: **2**
Clock Start/From: **8**
Clock To: **4**
1st Value:
2nd Value:
Value Percent: **5.000**
Continuous Index:
Within 8" of Joint: **YES**
Remarks:

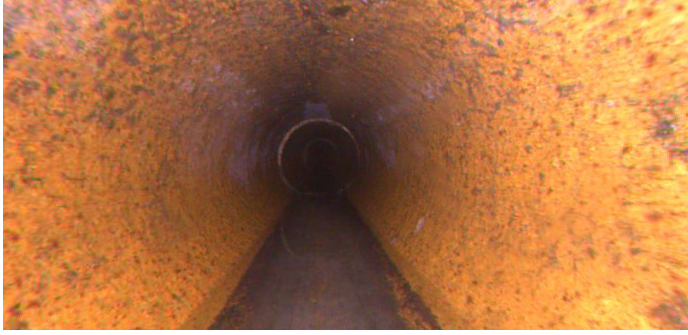
Code:	MSA
Description:	Abandoned Survey
Distance (ft):	37.5
Structural Grade:	0
O&M Grade:	0
Clock Start/From:	
Clock To:	
1st Value:	
2nd Value:	
Value Percent:	
Continuous Index:	
Within 8" of Joint:	NO
Remarks:	DAE
