Profile/Photo Observation Report

Date:	04/24/2018	Weather:		Coding:	PACP 6.0
Pipe Length (ft):	257.7	Owner:	NA	Pre Clean:	No Pre-Cleaning
P.O.#:		Surveyor:	Jen Costello	PSR:	P-405-030-029
Customer:		Clean Date:	01/01/1900	Shape:	C

Street:	FOXCROFT STREET	Flow Control:	Not Controlled
City:	Hobart, IN	Year Renewed:	
Location:	Yard	Tape/Media #:	
Purpose:	Routine Assessment	Dia/Height:	8"
Use:	Sanitary	Material:	VCP
Drain Area:	NA	Lining:	
Category:	NA		
Comment:	P_C at 36 ft nothing visible. Flow direction wrong		
Location Details:		Direction of Survey:	Downstream
US MH:	M-405-029	DS MH:	M-405-030
		Total Length Surveyed (ft):	37.5

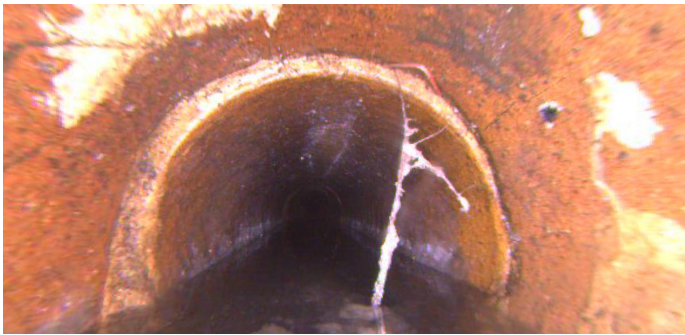
Code:	FL
Description:	Fracture Longitudinal

Distance (ft):	3.2
Structural Grade:	3
O&M Grade:	0
Clock Start/From:	2
Clock To:	
1st Value:	
2nd Value:	
Value Percent:	
Continuous Index:	
Within 8" of Joint:	YES
Remarks:

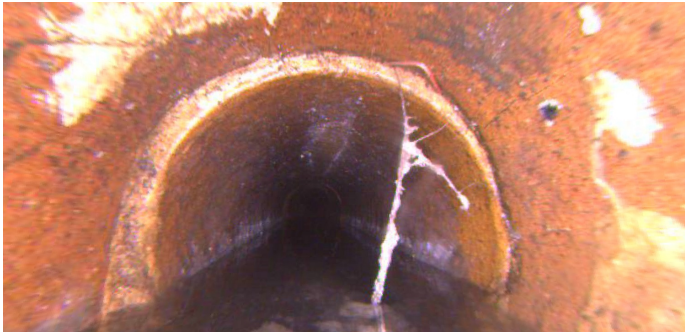
Code: **RFJ**
Description: **Roots Fine Joint**

Distance (ft): **3.2**
Structural Grade: **0**
O&M Grade: **1**
Clock Start/From: **8**
Clock To: **4**
1st Value:
2nd Value:
Value Percent:
Continuous Index:
Within 8" of Joint: **YES**
Remarks:

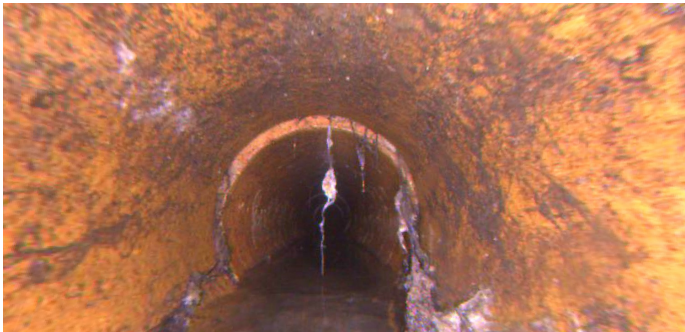
Code: **RMJ**
Description: **Roots Medium Joint**

Distance (ft): **11.7**
Structural Grade: **0**
O&M Grade: **3**
Clock Start/From: **8**
Clock To: **4**
1st Value:
2nd Value:
Value Percent: **5.000**
Continuous Index:
Within 8" of Joint: **YES**
Remarks:

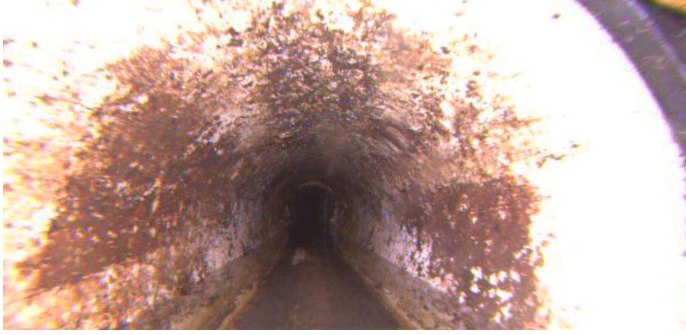
Code:	MMC
Description:	Material Change
Distance (ft):	18.2
Structural Grade:	0
O&M Grade:	0
Clock Start/From:	
Clock To:	
1st Value:	
2nd Value:	
Value Percent:	
Continuous Index:	
Within 8" of Joint:	NO
Remarks:	PVC

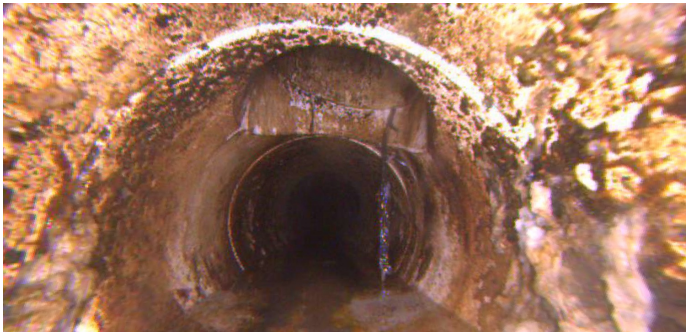
Code:	DAGS
Description:	Deposits Attached Grease
Distance (ft):	21.5
Structural Grade:	0
O&M Grade:	2
Clock Start/From:	8
Clock To:	4
1st Value:	
2nd Value:	
Value Percent:	5.000
Continuous Index:	
Within 8" of Joint:	NO
Remarks:

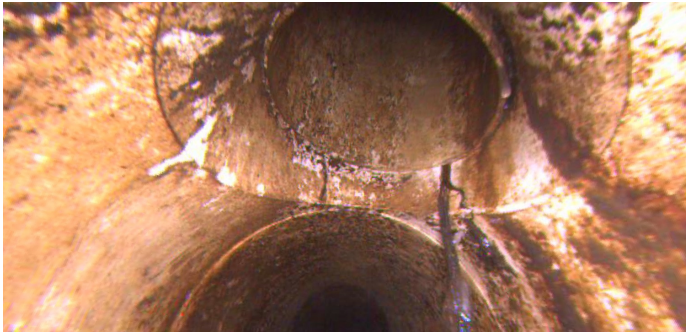
Code: **TFD**
Description: **Tap Factory Defective**

Distance (ft): **22.0**
Structural Grade: **0**
O&M Grade: **2**
Clock Start/From: **12**
Clock To:
1st Value: **4.000**
2nd Value:
Value Percent:
Continuous Index:
Within 8" of Joint:
Remarks: **ROOTS**

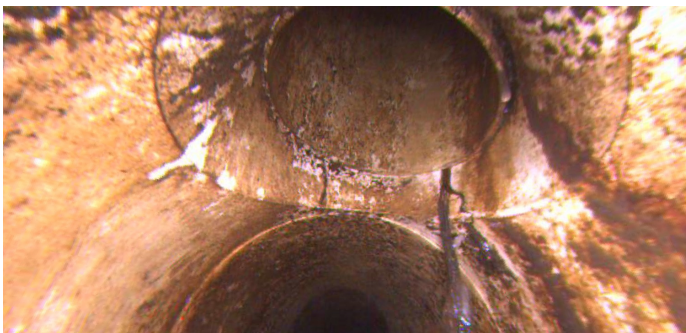
Code: **RFL**
Description: **Roots Fine Lateral**

Distance (ft): **22.0**
Structural Grade: **0**
O&M Grade: **1**
Clock Start/From: **12**
Clock To:
1st Value:
2nd Value:
Value Percent:
Continuous Index:
Within 8" of Joint: **NO**
Remarks:

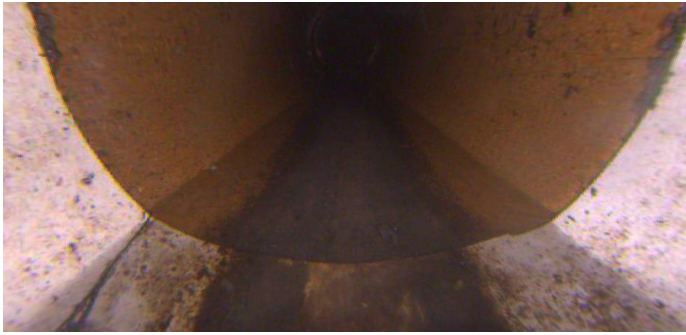
Code: **RFJ**
Description: **Roots Fine Joint**

Distance (ft): **27.3**
Structural Grade: **0**
O&M Grade: **1**
Clock Start/From: **8**
Clock To:
1st Value:
2nd Value:
Value Percent:
Continuous Index:
Within 8" of Joint: **YES**
Remarks:

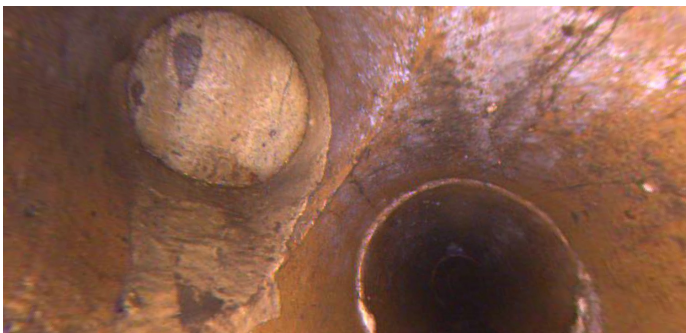
Code: **TFC**
Description: **Tap Factory Capped**

Distance (ft): **29.5**
Structural Grade: **0**
O&M Grade: **0**
Clock Start/From: **10**
Clock To:
1st Value: **4.000**
2nd Value:
Value Percent:
Continuous Index:
Within 8" of Joint:
Remarks:

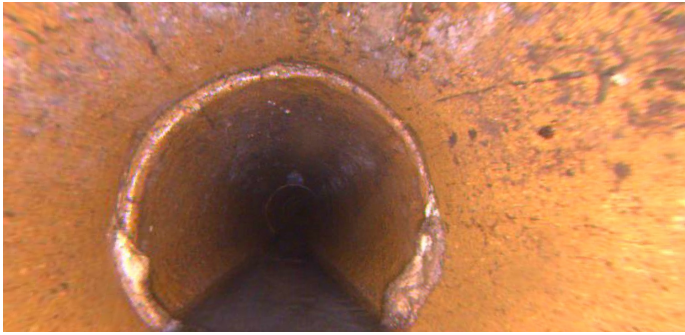
Code: **DAE**
Description: **Deposits Attached Encrustation**

Distance (ft): **30.0**
Structural Grade: **0**
O&M Grade: **2**
Clock Start/From: **8**
Clock To: **4**
1st Value:
2nd Value:
Value Percent: **5.000**
Continuous Index:
Within 8" of Joint: **YES**
Remarks:

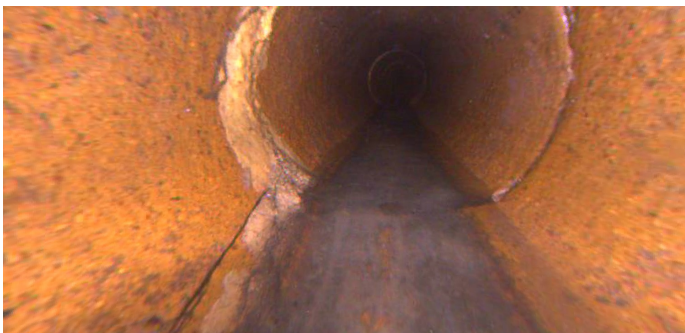
Code: **RFJ**
Description: **Roots Fine Joint**

Distance (ft): **32.9**
Structural Grade: **0**
O&M Grade: **1**
Clock Start/From: **8**
Clock To:
1st Value:
2nd Value:
Value Percent:
Continuous Index:
Within 8" of Joint: **YES**
Remarks:

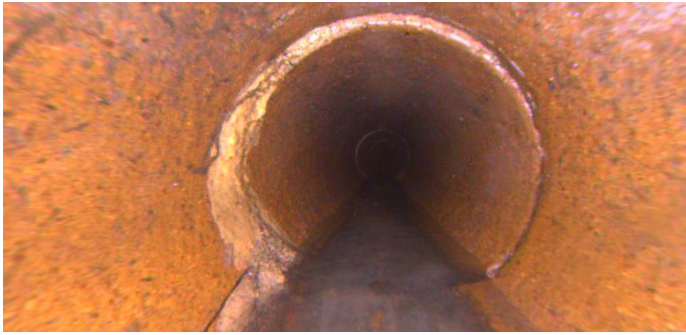
Code: **DAE**
Description: **Deposits Attached Encrustation**

Distance (ft): **32.9**
Structural Grade: **0**
O&M Grade: **2**
Clock Start/From: **7**
Clock To: **11**
1st Value:
2nd Value:
Value Percent: **5.000**
Continuous Index:
Within 8" of Joint: **YES**
Remarks:

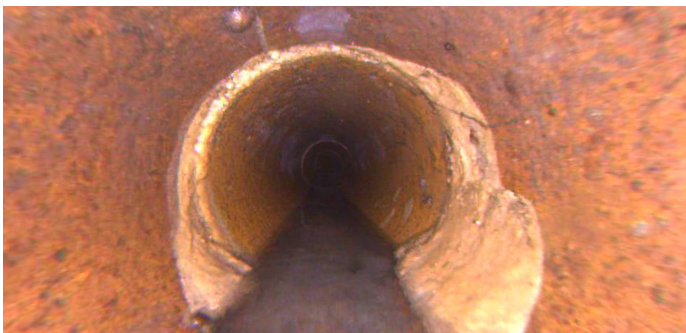
Code: **DAE**
Description: **Deposits Attached Encrustation**

Distance (ft): **35.8**
Structural Grade: **0**
O&M Grade: **2**
Clock Start/From: **8**
Clock To: **4**
1st Value:
2nd Value:
Value Percent: **5.000**
Continuous Index:
Within 8" of Joint: **YES**
Remarks:

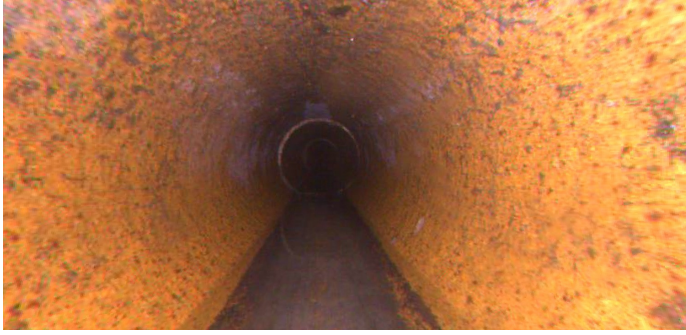
Code:	MSA
Description:	Abandoned Survey
Distance (ft):	37.5
Structural Grade:	0
O&M Grade:	0
Clock Start/From:	
Clock To:	
1st Value:	
2nd Value:	
Value Percent:	
Continuous Index:	
Within 8" of Joint:	NO
Remarks:	DAE
