Profile/Photo Observation Report

Date:	04/24/2018	Weather:		Coding:	PACP 6.0
Pipe Length (ft):	257.7	Owner:	NA	Pre Clean:	No Pre-Cleaning
P.O.#:		Surveyor:	Jen Costello	PSR:	P-405-030-029
Customer:		Clean Date:	01/01/1900	Shape:	C

Street:	ALLEY BETWEEN DRIFTWOOD DR &	Flow Control:	Not Controlled
City:	Hobart, IN	Year Renewed:	
Location:	Yard	Tape/Media #:	
Purpose:	Routine Assessment	Dia/Height:	8"
Use:	Sanitary	Material:	VCP
Drain Area:	NA	Lining:	
Category:	NA		
Comment:	P_C at 21 ft Flow direction wrong		
Location Details:		Direction of Survey:	Upstream
US MH:	M-405-029	DS MH:	M-405-030
		Total Length Surveyed (ft):	23.0

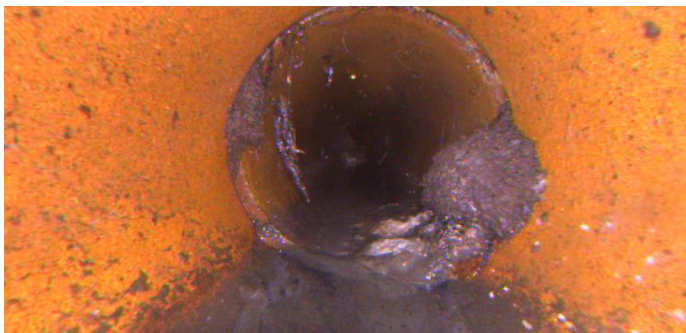
Code: **AMH**
Description: **Manhole**

Distance (ft): **.0**
Structural Grade: **0**
O&M Grade: **0**
Clock Start/From:
Clock To:
1st Value:
2nd Value:
Value Percent:
Continuous Index:
Within 8" of Joint: **NO**
Remarks: **M-405-030**

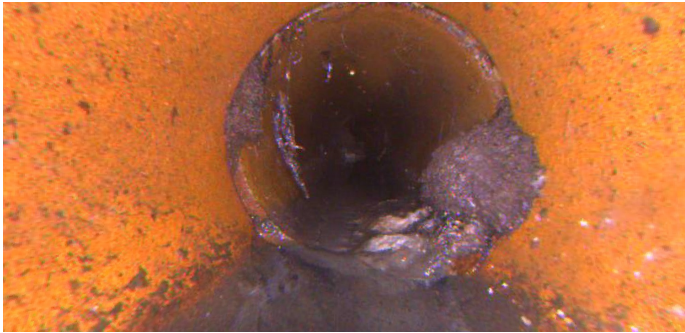
Code:	MWL
Description:	Water Level

Distance (ft):	.0
Structural Grade:	0
O&M Grade:	0
Clock Start/From:	
Clock To:	
1st Value:	
2nd Value:	
Value Percent:	5.000
Continuous Index:	
Within 8" of Joint:	NO
Remarks:

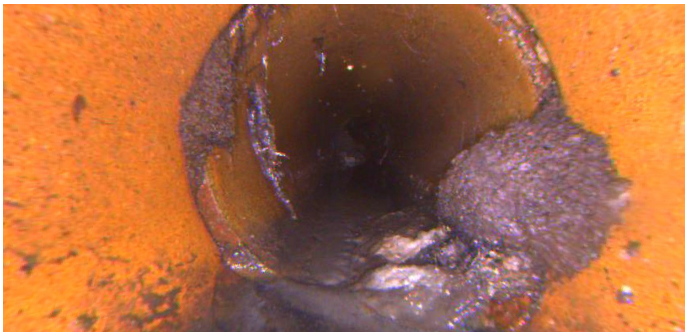
Code:	RMJ
Description:	Roots Medium Joint

Distance (ft):	.3
Structural Grade:	0
O&M Grade:	3
Clock Start/From:	8
Clock To:	4
1st Value:	
2nd Value:	
Value Percent:	10.000
Continuous Index:	
Within 8" of Joint:	YES
Remarks:

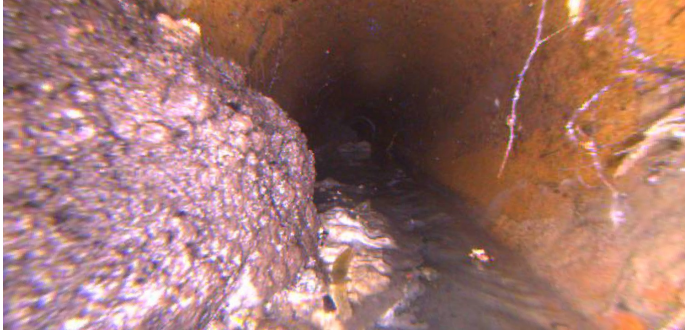
Code: **RMJ**
Description: **Roots Medium Joint**

Distance (ft): **4.6**
Structural Grade: **0**
O&M Grade: **3**
Clock Start/From: **7**
Clock To: **5**
1st Value:
2nd Value:
Value Percent: **40.000**
Continuous Index:
Within 8" of Joint: **YES**
Remarks:

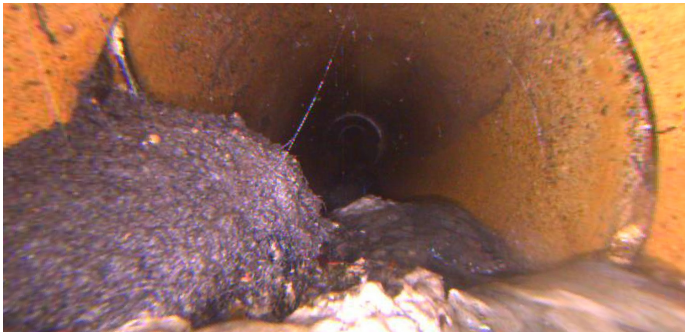
Code: **RMJ**
Description: **Roots Medium Joint**

Distance (ft): **7.4**
Structural Grade: **0**
O&M Grade: **3**
Clock Start/From: **7**
Clock To: **9**
1st Value:
2nd Value:
Value Percent: **30.000**
Continuous Index:
Within 8" of Joint: **YES**
Remarks:

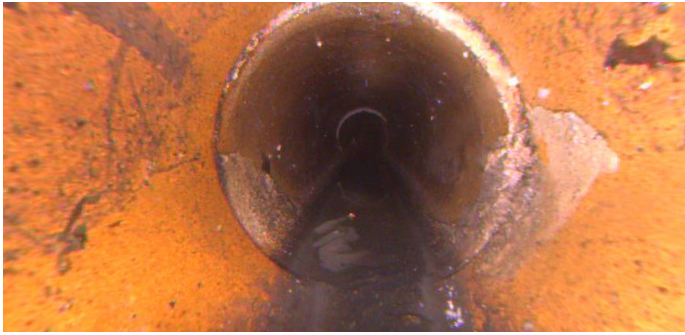
Code: **FM**
Description: **Fracture Multiple**

Distance (ft): **10.1**
Structural Grade: **4**
O&M Grade: **0**
Clock Start/From: **8**
Clock To: **4**
1st Value:
2nd Value:
Value Percent:
Continuous Index:
Within 8" of Joint: **YES**
Remarks:

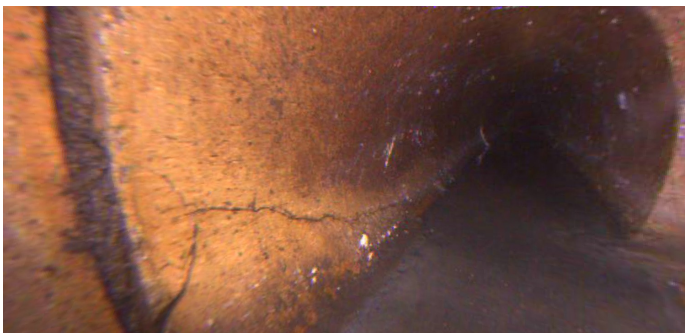
Code: **FM**
Description: **Fracture Multiple**

Distance (ft): **13.6**
Structural Grade: **4**
O&M Grade: **0**
Clock Start/From: **8**
Clock To: **9**
1st Value:
2nd Value:
Value Percent:
Continuous Index:
Within 8" of Joint: **YES**
Remarks:

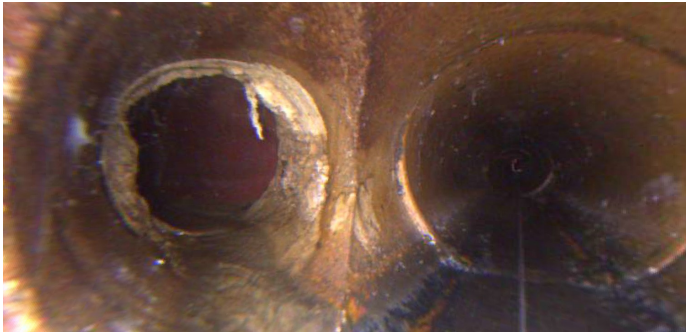
Code: **TFA**
Description: **Tap Factory Active**

Distance (ft): **14.6**
Structural Grade: **0**
O&M Grade: **0**
Clock Start/From: **3**
Clock To:
1st Value: **4.000**
2nd Value:
Value Percent:
Continuous Index:
Within 8" of Joint:
Remarks:

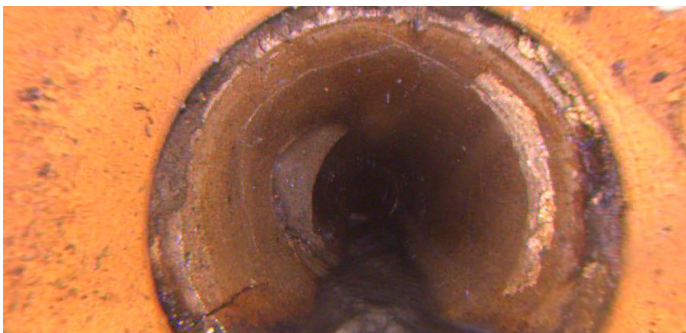
Code: **FM**
Description: **Fracture Multiple**

Distance (ft): **19.2**
Structural Grade: **4**
O&M Grade: **0**
Clock Start/From: **8**
Clock To: **4**
1st Value:
2nd Value:
Value Percent:
Continuous Index:
Within 8" of Joint: **YES**
Remarks:

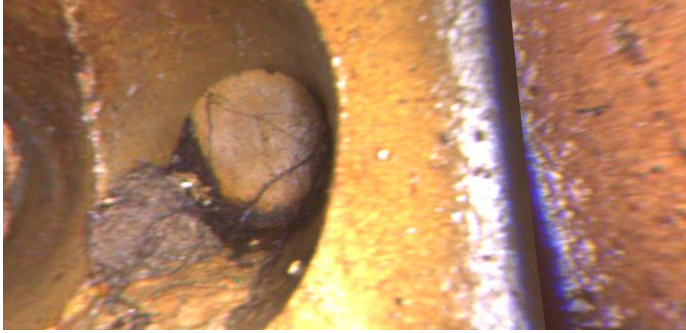
Code: **TF**
Description: **Tap Factory**

Distance (ft): **20.8**
Structural Grade: **0**
O&M Grade: **0**
Clock Start/From: **9**
Clock To:
1st Value: **4.000**
2nd Value:
Value Percent:
Continuous Index:
Within 8" of Joint:
Remarks:

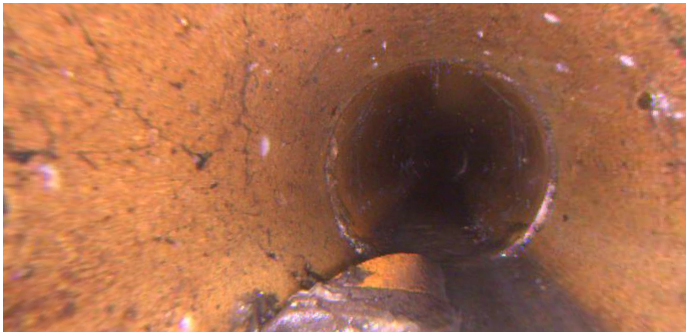
Code: **OBM**
Description: **Obstacle Pipe Material**

Distance (ft): **21.7**
Structural Grade: **0**
O&M Grade: **2**
Clock Start/From: **6**
Clock To: **7**
1st Value:
2nd Value:
Value Percent: **5.000**
Continuous Index:
Within 8" of Joint: **NO**
Remarks:

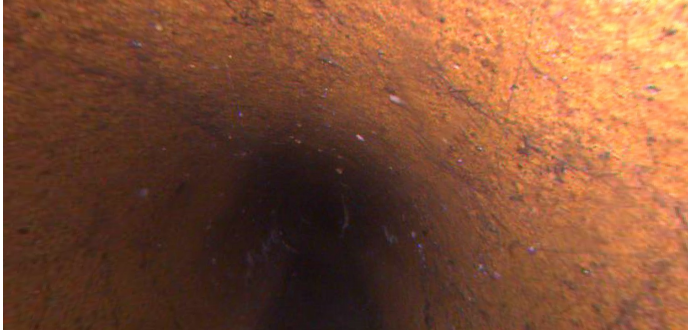
Code:	MSA
Description:	Abandoned Survey
Distance (ft):	23.0
Structural Grade:	0
O&M Grade:	0
Clock Start/From:	
Clock To:	
1st Value:	
2nd Value:	
Value Percent:	
Continuous Index:	
Within 8" of Joint:	NO
Remarks:	OBP
