Profile/Photo Observation Report

Date:	04/24/2018	Weather:		Coding:	PACP 6.0
Pipe Length (ft):	257.7	Owner:	NA	Pre Clean:	No Pre-Cleaning
P.O.#:		Surveyor:	Jen Costello	PSR:	P-405-030-029
Customer:		Clean Date:	01/01/1900	Shape:	C

Street:	FOXCROFT STREET	Flow Control:	Not Controlled
City:	Hobart, IN	Year Renewed:	
Location:	Yard	Tape/Media #:	
Purpose:	Routine Assessment	Dia/Height:	8"
Use:	Sanitary	Material:	VCP
Drain Area:	NA	Lining:	
Category:	NA		
Comment:	P_C at 21 ft Flow direction wrong		
Location Details:		Direction of Survey:	Upstream
US MH:	M-405-029	DS MH:	M-405-030
		Total Length Surveyed (ft):	23.0

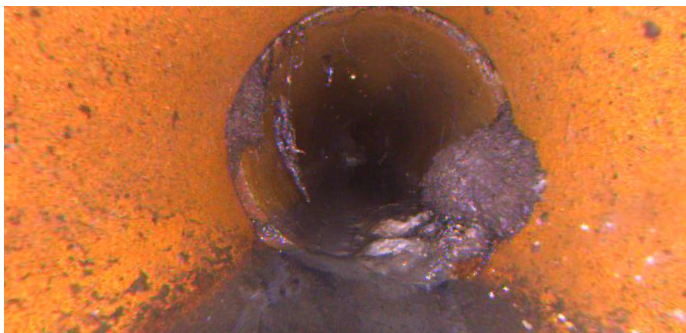
Code: **AMH**
Description: **Manhole**

Distance (ft): **.0**
Structural Grade: **0**
O&M Grade: **0**
Clock Start/From:
Clock To:
1st Value:
2nd Value:
Value Percent:
Continuous Index:
Within 8" of Joint: **NO**
Remarks: **M-405-030**

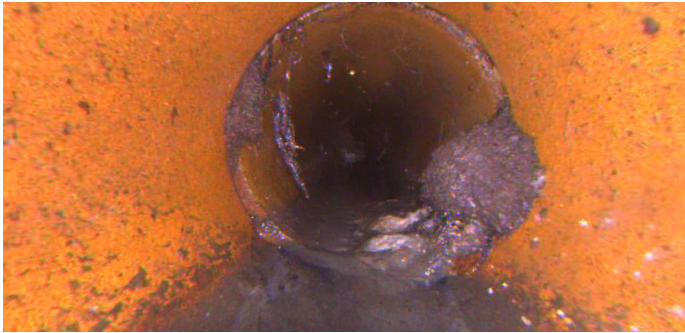
Code:	MWL
Description:	Water Level

Distance (ft):	.0
Structural Grade:	0
O&M Grade:	0
Clock Start/From:	
Clock To:	
1st Value:	
2nd Value:	
Value Percent:	5.000
Continuous Index:	
Within 8" of Joint:	NO
Remarks:

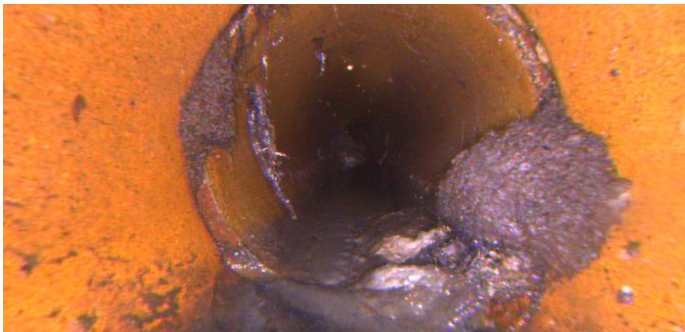
Code:	RMJ
Description:	Roots Medium Joint

Distance (ft):	.3
Structural Grade:	0
O&M Grade:	3
Clock Start/From:	8
Clock To:	4
1st Value:	
2nd Value:	
Value Percent:	10.000
Continuous Index:	
Within 8" of Joint:	YES
Remarks:

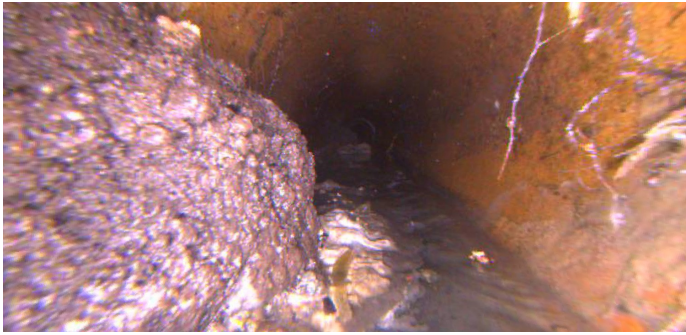
Code: **RMJ**
Description: **Roots Medium Joint**

Distance (ft): **4.6**
Structural Grade: **0**
O&M Grade: **3**
Clock Start/From: **7**
Clock To: **5**
1st Value:
2nd Value:
Value Percent: **40.000**
Continuous Index:
Within 8" of Joint: **YES**
Remarks:

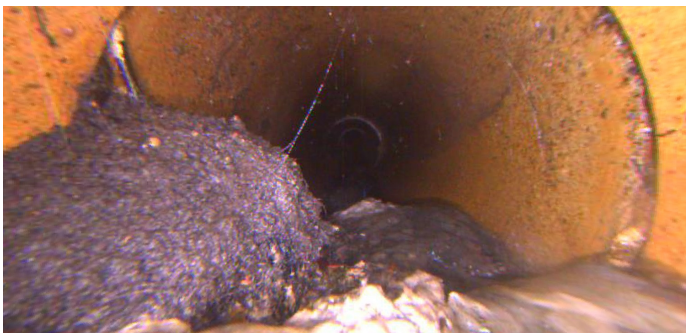
Code: **RMJ**
Description: **Roots Medium Joint**

Distance (ft): **7.4**
Structural Grade: **0**
O&M Grade: **3**
Clock Start/From: **7**
Clock To: **9**
1st Value:
2nd Value:
Value Percent: **30.000**
Continuous Index:
Within 8" of Joint: **YES**
Remarks:

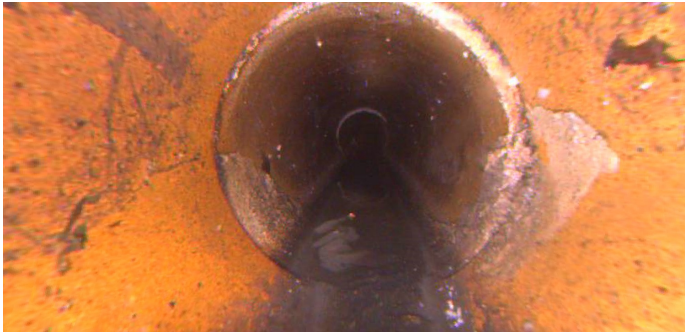
Code: **FM**
Description: **Fracture Multiple**

Distance (ft): **10.1**
Structural Grade: **4**
O&M Grade: **0**
Clock Start/From: **8**
Clock To: **4**
1st Value:
2nd Value:
Value Percent:
Continuous Index:
Within 8" of Joint: **YES**
Remarks:

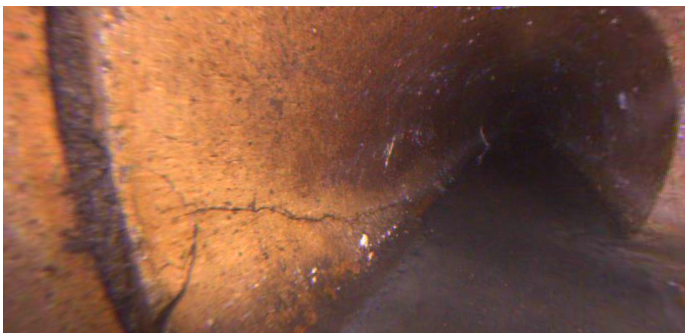
Code: **FM**
Description: **Fracture Multiple**

Distance (ft): **13.6**
Structural Grade: **4**
O&M Grade: **0**
Clock Start/From: **8**
Clock To: **9**
1st Value:
2nd Value:
Value Percent:
Continuous Index:
Within 8" of Joint: **YES**
Remarks:

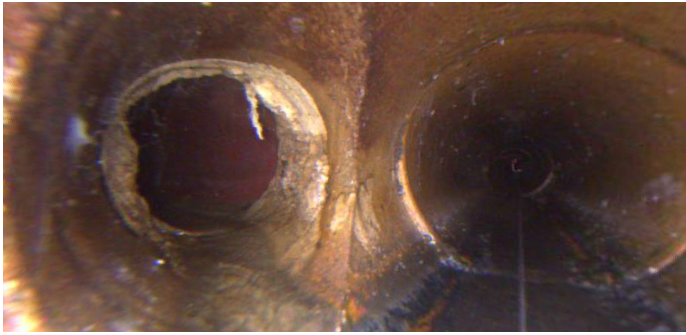
Code: **TFA**
Description: **Tap Factory Active**

Distance (ft): **14.6**
Structural Grade: **0**
O&M Grade: **0**
Clock Start/From: **3**
Clock To:
1st Value: **4.000**
2nd Value:
Value Percent:
Continuous Index:
Within 8" of Joint:
Remarks:

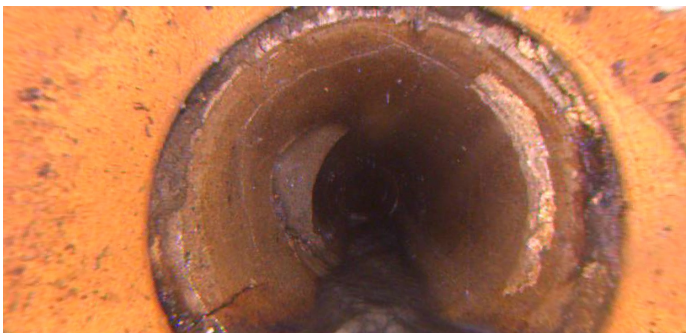
Code: **FM**
Description: **Fracture Multiple**

Distance (ft): **19.2**
Structural Grade: **4**
O&M Grade: **0**
Clock Start/From: **8**
Clock To: **4**
1st Value:
2nd Value:
Value Percent:
Continuous Index:
Within 8" of Joint: **YES**
Remarks:

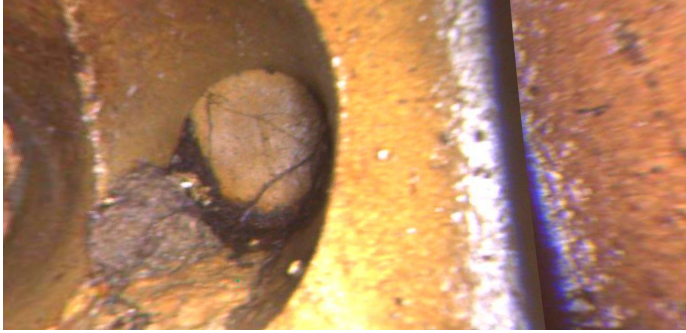
Code: **TF**
Description: **Tap Factory**

Distance (ft): **20.8**
Structural Grade: **0**
O&M Grade: **0**
Clock Start/From: **9**
Clock To:
1st Value: **4.000**
2nd Value:
Value Percent:
Continuous Index:
Within 8" of Joint:
Remarks:

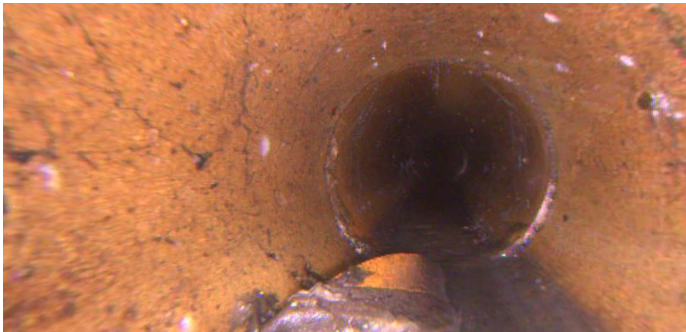
Code: **OBM**
Description: **Obstacle Pipe Material**

Distance (ft): **21.7**
Structural Grade: **0**
O&M Grade: **2**
Clock Start/From: **6**
Clock To: **7**
1st Value:
2nd Value:
Value Percent: **5.000**
Continuous Index:
Within 8" of Joint: **NO**
Remarks:

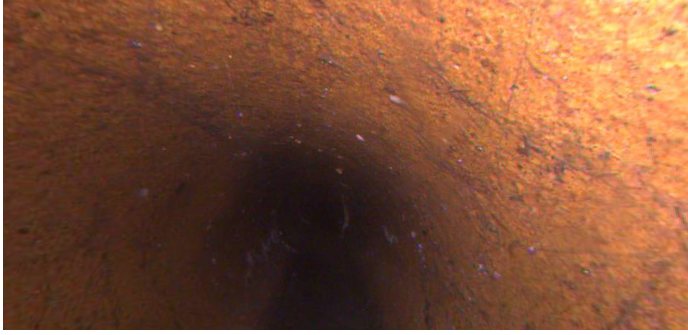
Code:	MSA
Description:	Abandoned Survey
Distance (ft):	23.0
Structural Grade:	0
O&M Grade:	0
Clock Start/From:	
Clock To:	
1st Value:	
2nd Value:	
Value Percent:	
Continuous Index:	
Within 8" of Joint:	NO
Remarks:	OBP
