Profile/Photo Observation Report

Date:	03/16/2024	Weather:		Coding:	PACP 7.0
Pipe Length (ft):	258.0	Owner:	City of Hobart	Pre Clean:	Heavy Cleaning
P.O.#:		Surveyor:	S. Bucklin	PSR:	P-405-030-029
Customer:	City of Hobart	Clean Date:	10/27/2023	Shape:	C

Street:	W 3RD ST	Flow Control:	Not Controlled
City:	Hobart, IN	Year Renewed:	
Location:	Easement/Right of Way	Tape/Media #:	
Purpose:	Sewer System Evaluation Survey (SS)	Dia/Height:	8"
Use:	Sanitary Sewage Pipe	Material:	VCP
Drain Area:		Lining:	None
Category:	NA		
Comment:			
Location Details:		Direction of Survey:	Upstream
US MH:	M-405-029	DS MH:	M-405-030
		Total Length Surveyed (ft):	255.7

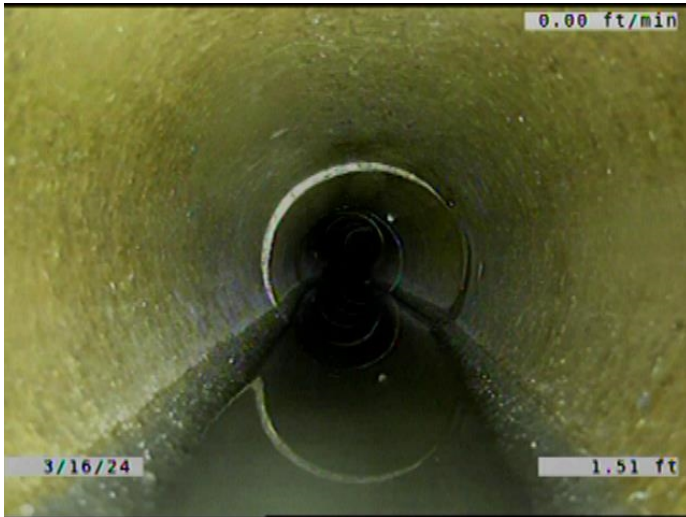
Code: **MWLS**
Description: **Miscellaneous Water Level Sag**

Distance (ft): **1.5**
Structural Grade: **2**
O&M Grade: **0**
Clock Start/From:
Clock To:
1st Value:
2nd Value:
Value Percent: **10.000**
Continuous Index: **S02**
Within 8" of Joint: **NO**
Remarks:

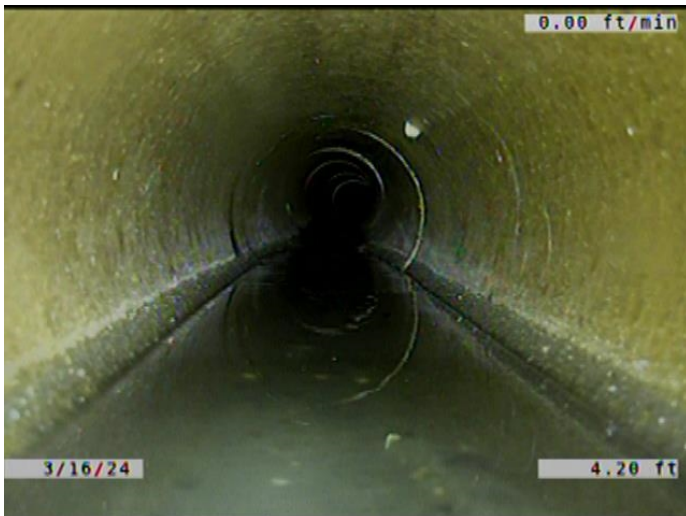
Code: **DSF**
Description: **Deposits Settled Fine**

Distance (ft): **4.2**
Structural Grade: **0**
O&M Grade: **2**
Clock Start/From: **5**
Clock To: **7**
1st Value:
2nd Value:
Value Percent: **5.000**
Continuous Index: **S03**
Within 8" of Joint: **YES**
Remarks:

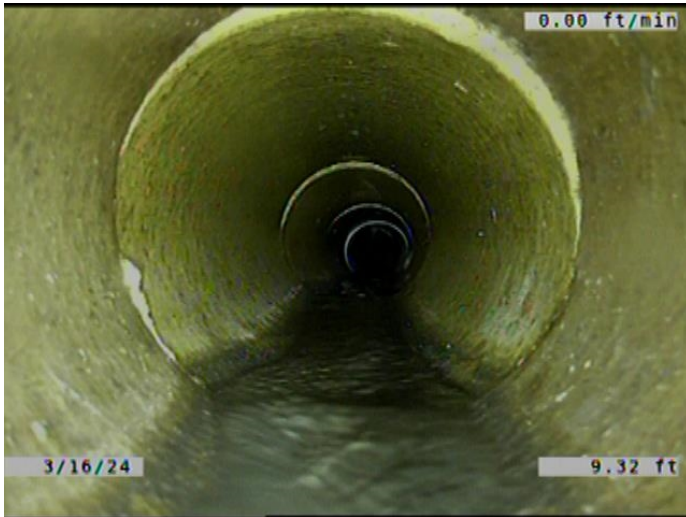
Code: **MWLS**
Description: **Miscellaneous Water Level Sag**

Distance (ft): **9.3**
Structural Grade: **2**
O&M Grade: **0**
Clock Start/From:
Clock To:
1st Value:
2nd Value:
Value Percent: **10.000**
Continuous Index: **F02**
Within 8" of Joint: **NO**
Remarks:

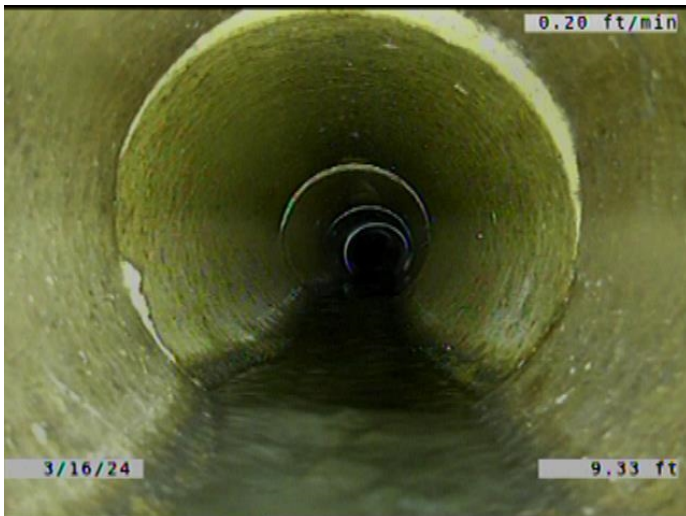
Code: **DSF**
Description: **Deposits Settled Fine**

Distance (ft): **9.3**
Structural Grade: **0**
O&M Grade: **2**
Clock Start/From: **5**
Clock To: **7**
1st Value:
2nd Value:
Value Percent: **5.000**
Continuous Index: **F03**
Within 8" of Joint: **YES**
Remarks:

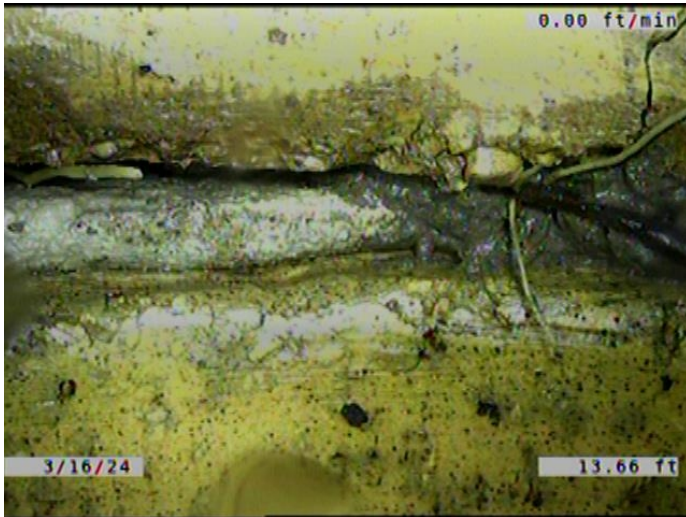
Code: **RFJ**
 Description: **Roots Fine Joint**

Distance (ft): **13.7**
 Structural Grade: **0**
 O&M Grade: **1**
 Clock Start/From: **8**
 Clock To: **4**
 1st Value:
 2nd Value:
 Value Percent:
 Continuous Index:
 Within 8" of Joint: **YES**
 Remarks:

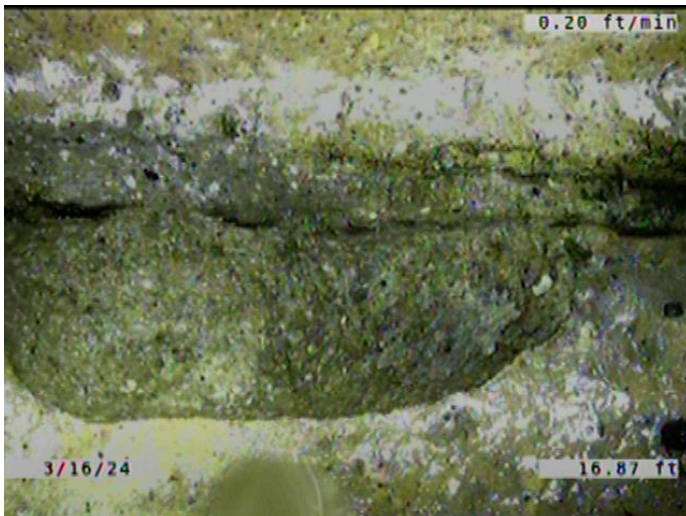
Code: **DAE**
 Description: **Deposits Attached Encrustation**

Distance (ft): **16.9**
 Structural Grade: **0**
 O&M Grade: **2**
 Clock Start/From: **7**
 Clock To: **5**
 1st Value:
 2nd Value:
 Value Percent: **5.000**
 Continuous Index:
 Within 8" of Joint: **YES**
 Remarks:

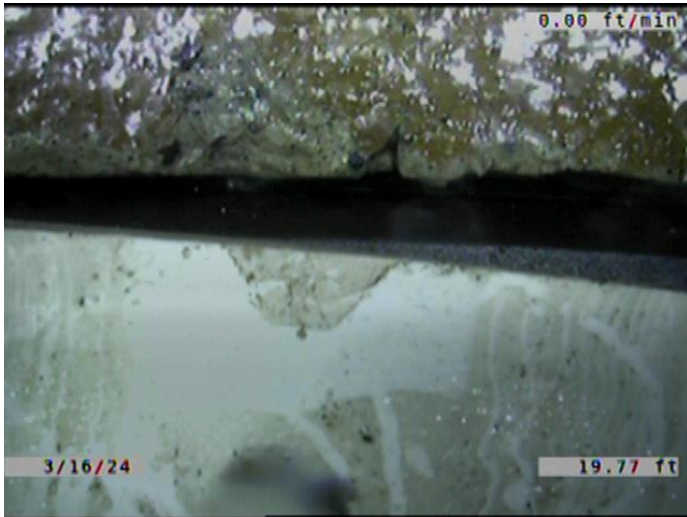
Code: **RPR**
Description: **Point Repair Replacement**

Distance (ft): **19.8**
Structural Grade: **0**
O&M Grade: **0**
Clock Start/From:
Clock To:
1st Value:
2nd Value:
Value Percent:
Continuous Index: **S04**
Within 8" of Joint: **YES**
Remarks: **REPLACED WITH PVC.**

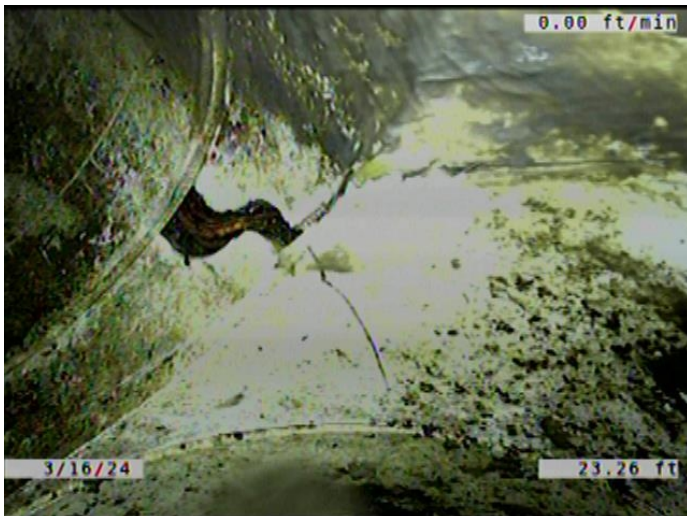
Code: **B**
Description: **Broken**

Distance (ft): **23.3**
Structural Grade: **4**
O&M Grade: **0**
Clock Start/From: **1**
Clock To: **3**
1st Value:
2nd Value:
Value Percent:
Continuous Index:
Within 8" of Joint: **YES**
Remarks: **ROOTS VISIBLE IN THE BROKEN TAP.**

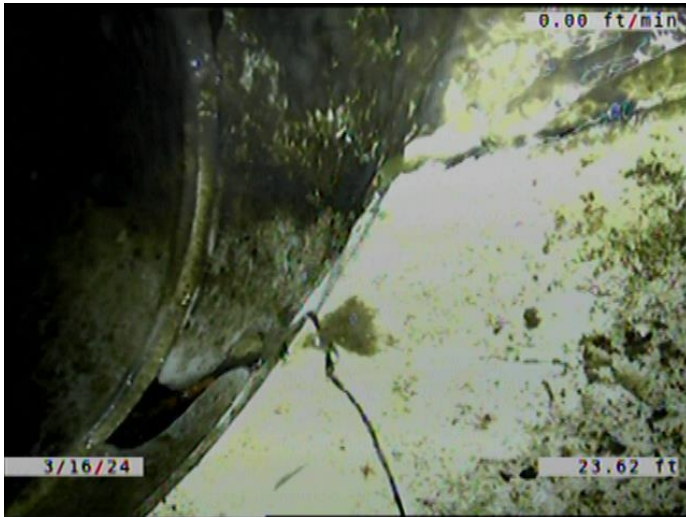
Code: **IRC**
 Description: **Infiltration Runner Connection**

Distance (ft): **23.6**
 Structural Grade: **0**
 O&M Grade: **4**
 Clock Start/From: **1**
 Clock To: **2**
 1st Value:
 2nd Value:
 Value Percent:
 Continuous Index:
 Within 8" of Joint: **YES**
 Remarks:

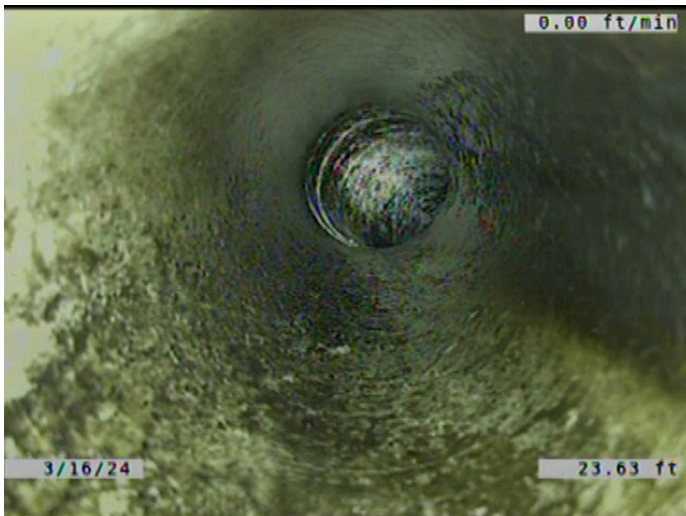
Code: **TFD**
 Description: **Tap Factory Defective**

Distance (ft): **23.6**
 Structural Grade: **0**
 O&M Grade: **3**
 Clock Start/From: **12**
 Clock To:
 1st Value: **6.000**
 2nd Value:
 Value Percent:
 Continuous Index:
 Within 8" of Joint: **YES**
 Remarks: **ACTIVITY. CONSTANTLY RUNNING WATER. TAP BROKEN. ROOTS VISIBL**

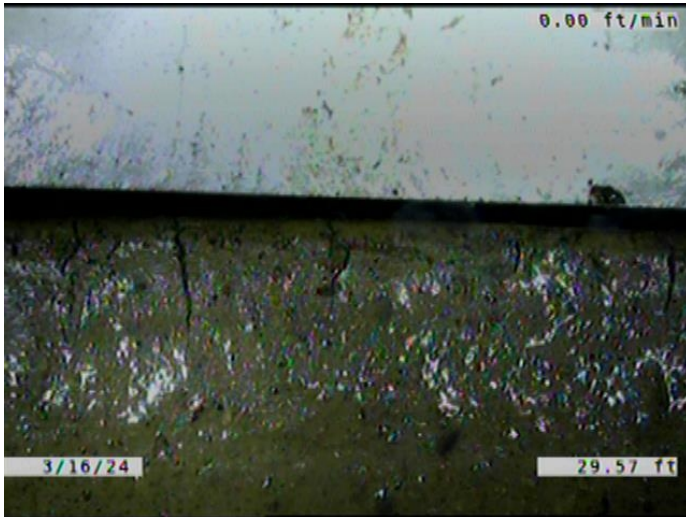
Code: **RPR**
 Description: **Point Repair Replacement**

Distance (ft): **29.6**
 Structural Grade: **0**
 O&M Grade: **0**
 Clock Start/From:
 Clock To:
 1st Value:
 2nd Value:
 Value Percent:
 Continuous Index: **F04**
 Within 8" of Joint: **YES**
 Remarks: **REPLACED WITH PVC.**

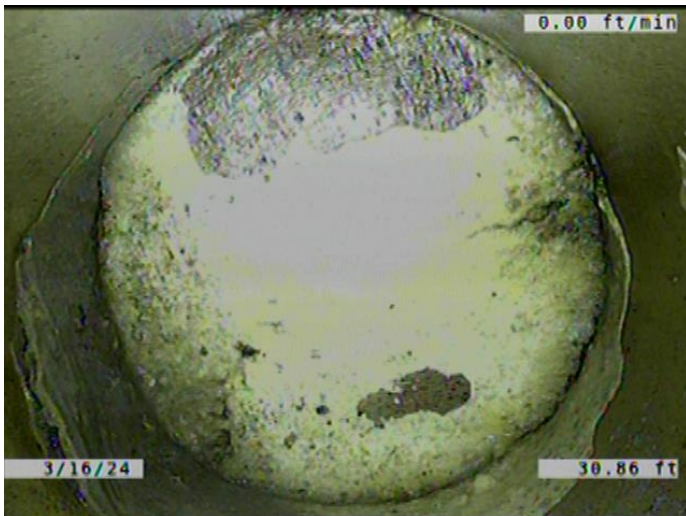
Code: **TFD**
 Description: **Tap Factory Defective**

Distance (ft): **30.9**
 Structural Grade: **0**
 O&M Grade: **3**
 Clock Start/From: **10**
 Clock To:
 1st Value: **6.000**
 2nd Value:
 Value Percent:
 Continuous Index:
 Within 8" of Joint: **YES**
 Remarks: **CAPPED. ENCRUSTATION COMING AROUND THE CAP INTO THE MAIN.**

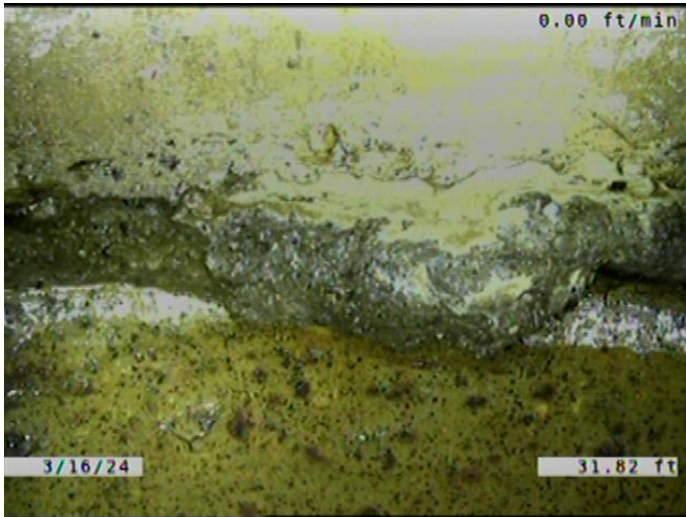
Code: **DAE**
Description: **Deposits Attached Encrustation**

Distance (ft): **31.8**
Structural Grade: **0**
O&M Grade: **2**
Clock Start/From: **7**
Clock To: **5**
1st Value:
2nd Value:
Value Percent: **5.000**
Continuous Index: **S05**
Within 8" of Joint: **YES**
Remarks:

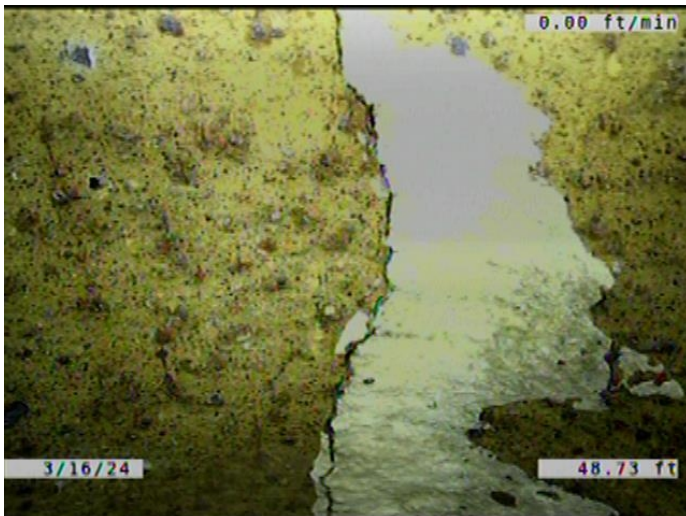
Code: **FS**
Description: **Fracture Spiral**

Distance (ft): **48.7**
Structural Grade: **3**
O&M Grade: **0**
Clock Start/From: **11**
Clock To: **1**
1st Value:
2nd Value:
Value Percent:
Continuous Index:
Within 8" of Joint: **YES**
Remarks:

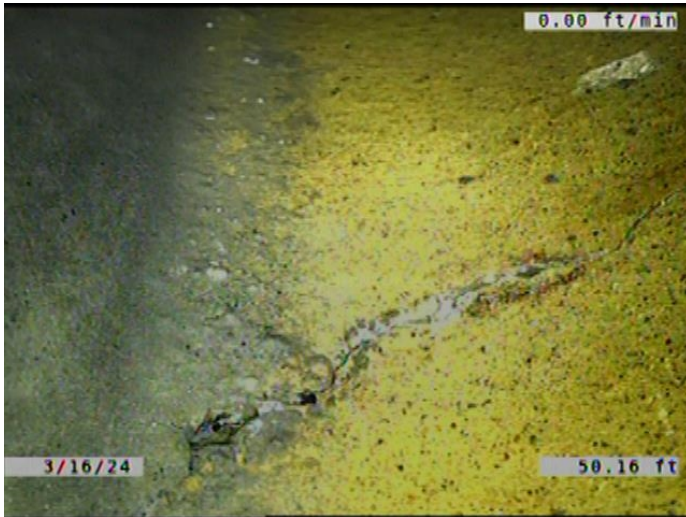
Code: **FS**
Description: **Fracture Spiral**

Distance (ft): **50.2**
Structural Grade: **3**
O&M Grade: **0**
Clock Start/From: **3**
Clock To: **5**
1st Value:
2nd Value:
Value Percent:
Continuous Index:
Within 8" of Joint: **YES**
Remarks:

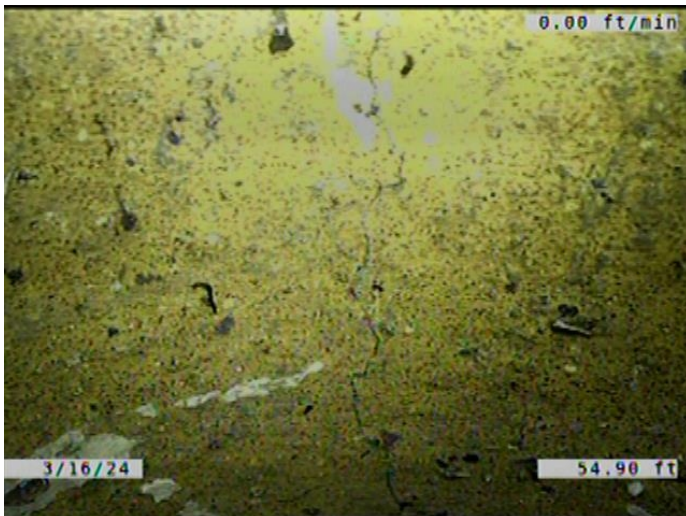
Code: **FM**
Description: **Fracture Multiple**

Distance (ft): **54.9**
Structural Grade: **4**
O&M Grade: **0**
Clock Start/From: **8**
Clock To: **4**
1st Value:
2nd Value:
Value Percent:
Continuous Index: **S06**
Within 8" of Joint: **YES**
Remarks:

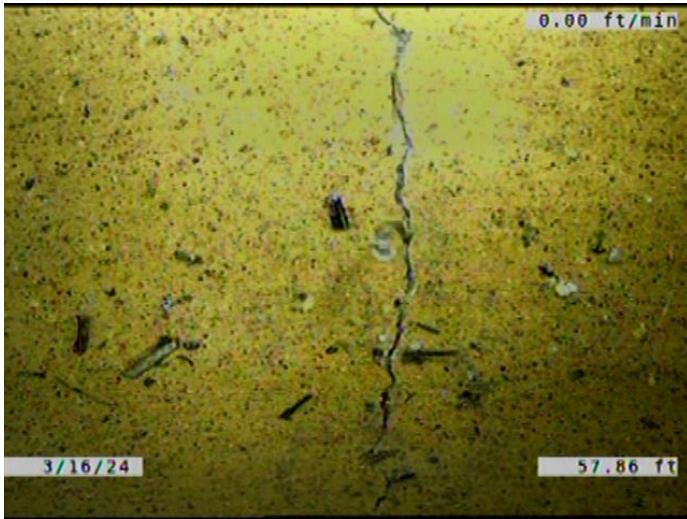
Code: **IWB**
Description: **Infiltration Weeper Barrel**

Distance (ft): **57.9**
Structural Grade: **0**
O&M Grade: **2**
Clock Start/From: **12**
Clock To:
1st Value:
2nd Value:
Value Percent:
Continuous Index:
Within 8" of Joint: **NO**
Remarks:

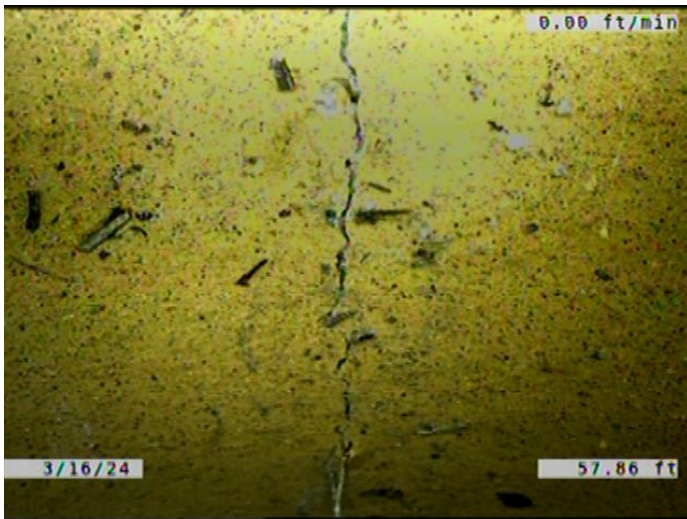
Code: **RFB**
Description: **Roots Fine Barrel**

Distance (ft): **57.9**
Structural Grade: **0**
O&M Grade: **2**
Clock Start/From: **12**
Clock To:
1st Value:
2nd Value:
Value Percent:
Continuous Index:
Within 8" of Joint: **NO**
Remarks:

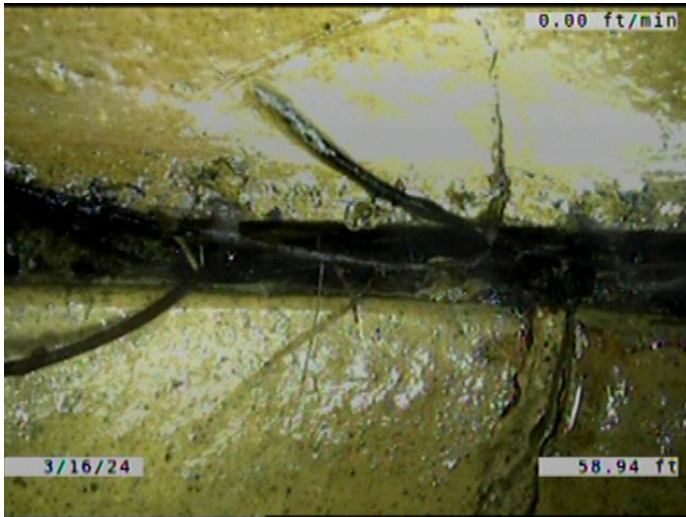
Code: **RFJ**
Description: **Roots Fine Joint**

Distance (ft): **58.9**
Structural Grade: **0**
O&M Grade: **1**
Clock Start/From: **8**
Clock To: **4**
1st Value:
2nd Value:
Value Percent:
Continuous Index: **S07**
Within 8" of Joint: **YES**
Remarks:

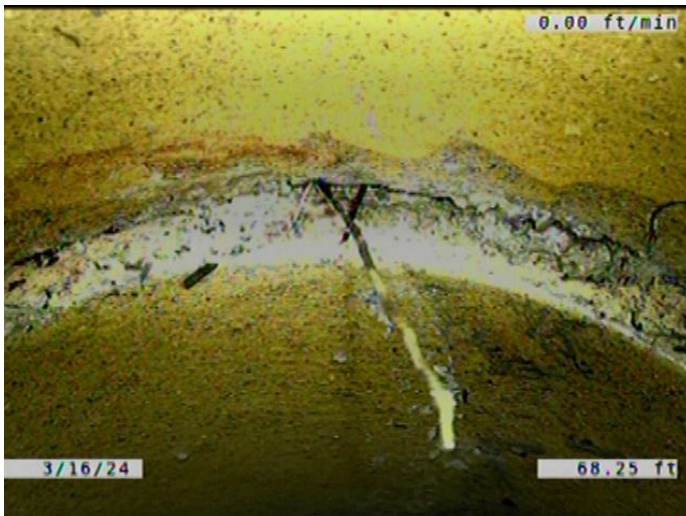
Code: **JOMD**
Description: **Joint Offset Medium Defective**

Distance (ft): **68.3**
Structural Grade: **3**
O&M Grade: **0**
Clock Start/From:
Clock To:
1st Value:
2nd Value:
Value Percent:
Continuous Index:
Within 8" of Joint: **NO**
Remarks:

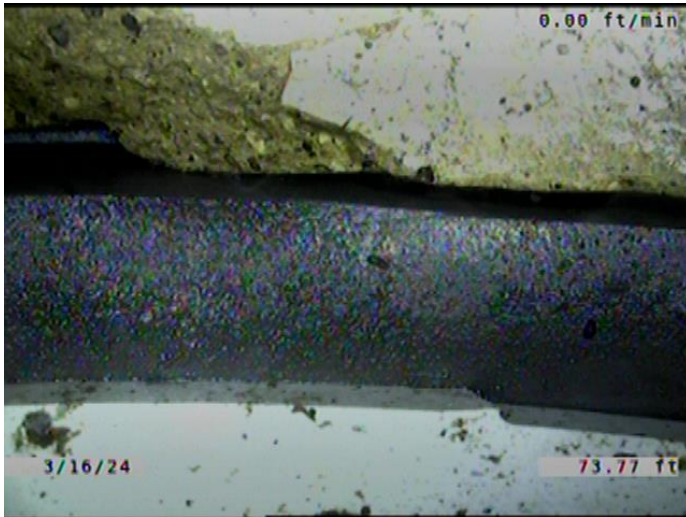
Code: **RPR**
Description: **Point Repair Replacement**

Distance (ft): **73.8**
Structural Grade: **0**
O&M Grade: **0**
Clock Start/From:
Clock To:
1st Value:
2nd Value:
Value Percent:
Continuous Index: **S08**
Within 8" of Joint: **YES**
Remarks: **REPLACED WITH PVC.**

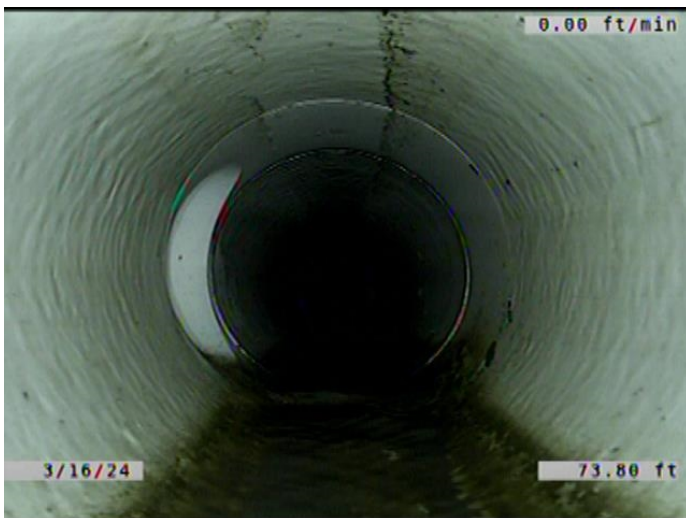
Code: **DAE**
Description: **Deposits Attached Encrustation**

Distance (ft): **73.8**
Structural Grade: **0**
O&M Grade: **2**
Clock Start/From: **7**
Clock To: **5**
1st Value:
2nd Value:
Value Percent: **5.000**
Continuous Index: **F05**
Within 8" of Joint: **YES**
Remarks:

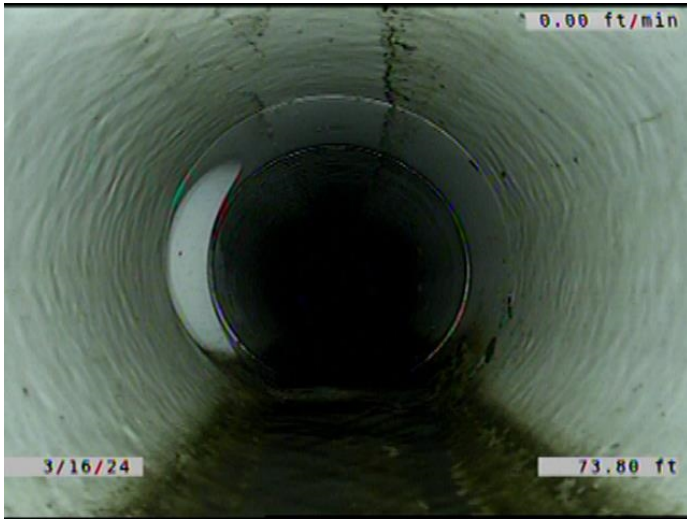
Code: **FM**
Description: **Fracture Multiple**

Distance (ft): **73.8**
Structural Grade: **4**
O&M Grade: **0**
Clock Start/From: **8**
Clock To: **4**
1st Value:
2nd Value:
Value Percent:
Continuous Index: **F06**
Within 8" of Joint: **YES**
Remarks:

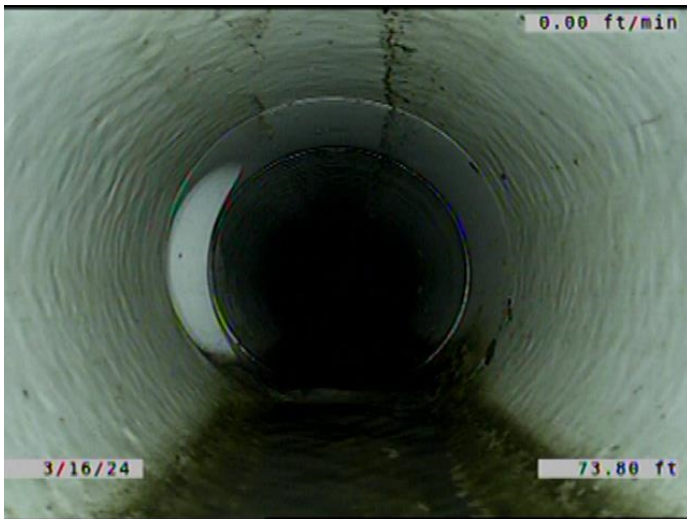
Code: **RFJ**
Description: **Roots Fine Joint**

Distance (ft): **73.8**
Structural Grade: **0**
O&M Grade: **1**
Clock Start/From: **8**
Clock To: **4**
1st Value:
2nd Value:
Value Percent:
Continuous Index: **F07**
Within 8" of Joint: **YES**
Remarks:

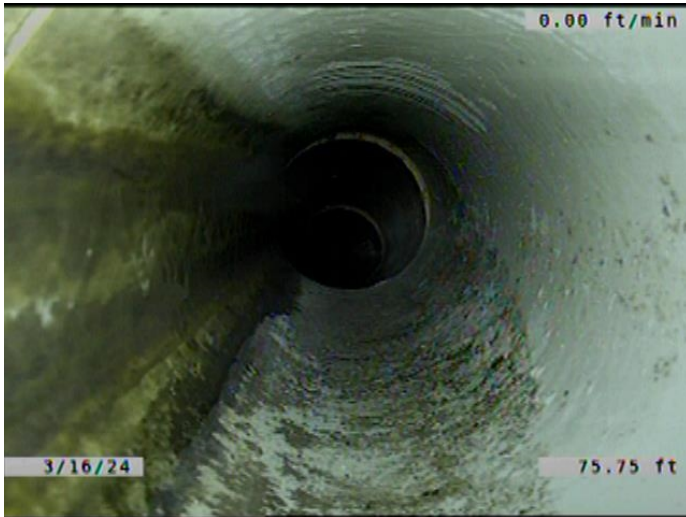
Code:	TF
Description:	Tap Factory
Distance (ft):	75.8
Structural Grade:	0
O&M Grade:	0
Clock Start/From:	9
Clock To:	
1st Value:	6.000
2nd Value:	
Value Percent:	
Continuous Index:	
Within 8" of Joint:	YES
Remarks:	TAP IS PVC. SERVICE IS VCP. CONSTANTLY RUNNING WATER.

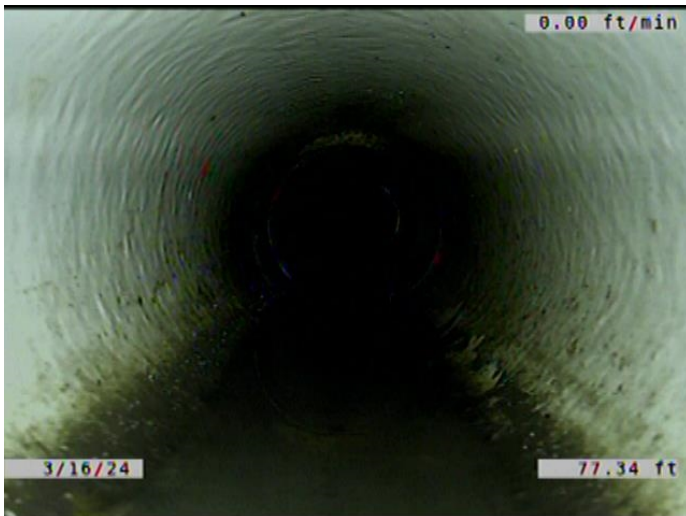
Code:	MWLS
Description:	Miscellaneous Water Level Sag
Distance (ft):	77.3
Structural Grade:	2
O&M Grade:	0
Clock Start/From:	
Clock To:	
1st Value:	
2nd Value:	
Value Percent:	5.000
Continuous Index:	S09
Within 8" of Joint:	NO
Remarks:

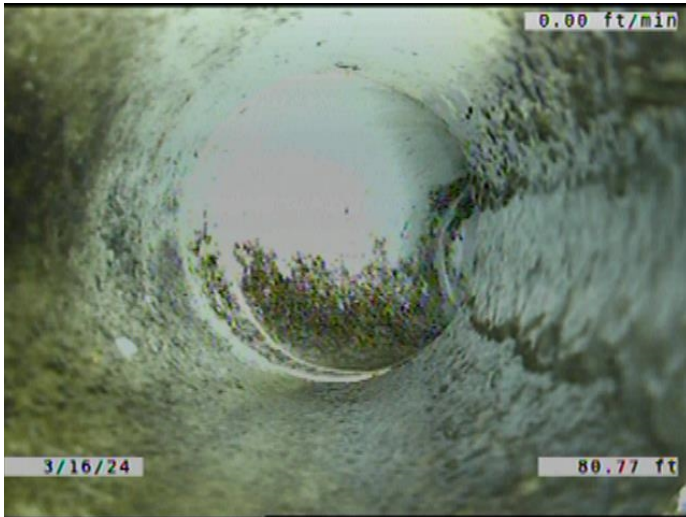
Code: **TF**
Description: **Tap Factory**

Distance (ft): **80.8**
Structural Grade: **0**
O&M Grade: **0**
Clock Start/From: **12**
Clock To:
1st Value: **6.000**
2nd Value:
Value Percent:
Continuous Index:
Within 8" of Joint: **YES**

Remarks: **CONSTANTLY RUNNING WATER. LINE GOES TO THE RIGHT (EAST).**

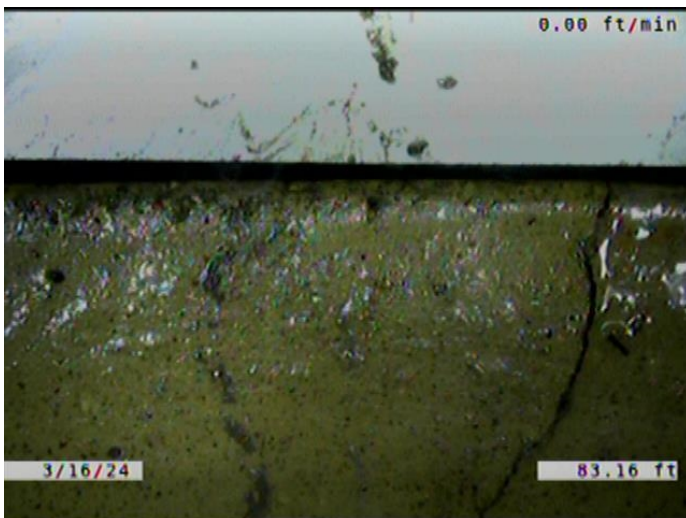
Code: **RPR**
Description: **Point Repair Replacement**

Distance (ft): **83.2**
Structural Grade: **0**
O&M Grade: **0**
Clock Start/From:
Clock To:
1st Value:
2nd Value:
Value Percent:
Continuous Index: **F08**
Within 8" of Joint: **YES**
Remarks: **REPLACED WITH PVC.**

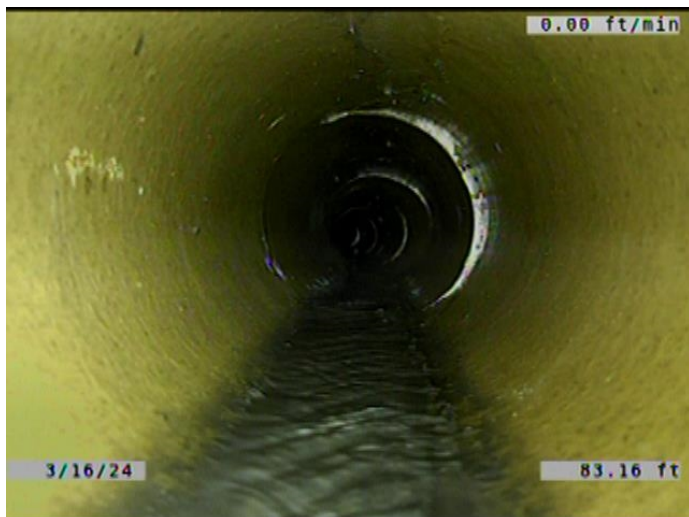
Code: **FM**
Description: **Fracture Multiple**

Distance (ft): **83.2**
Structural Grade: **4**
O&M Grade: **0**
Clock Start/From: **7**
Clock To: **5**
1st Value:
2nd Value:
Value Percent:
Continuous Index: **S10**
Within 8" of Joint: **YES**
Remarks:

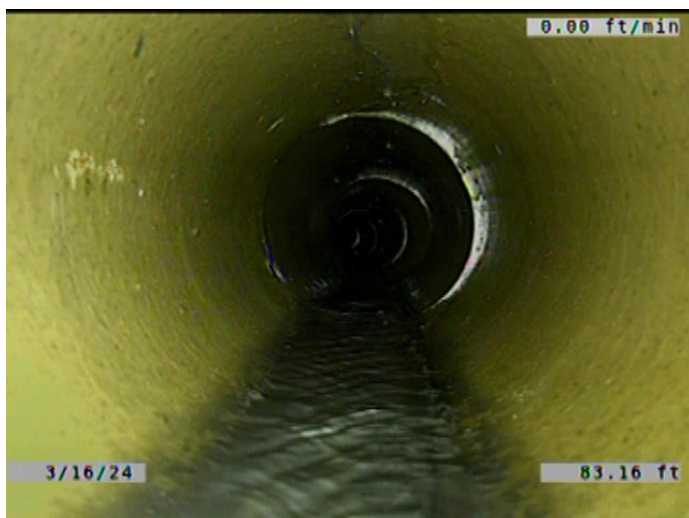
Code: **MWLS**
Description: **Miscellaneous Water Level Sag**

Distance (ft): **83.2**
Structural Grade: **2**
O&M Grade: **0**
Clock Start/From:
Clock To:
1st Value:
2nd Value:
Value Percent: **5.000**
Continuous Index: **F09**
Within 8" of Joint: **NO**
Remarks:

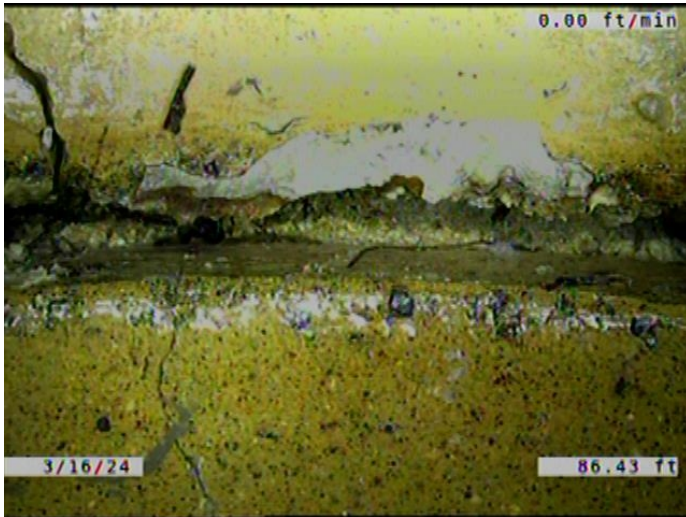
Code: **DAE**
Description: **Deposits Attached Encrustation**

Distance (ft): **86.4**
Structural Grade: **0**
O&M Grade: **2**
Clock Start/From: **7**
Clock To: **5**
1st Value:
2nd Value:
Value Percent: **5.000**
Continuous Index: **S11**
Within 8" of Joint: **YES**
Remarks:

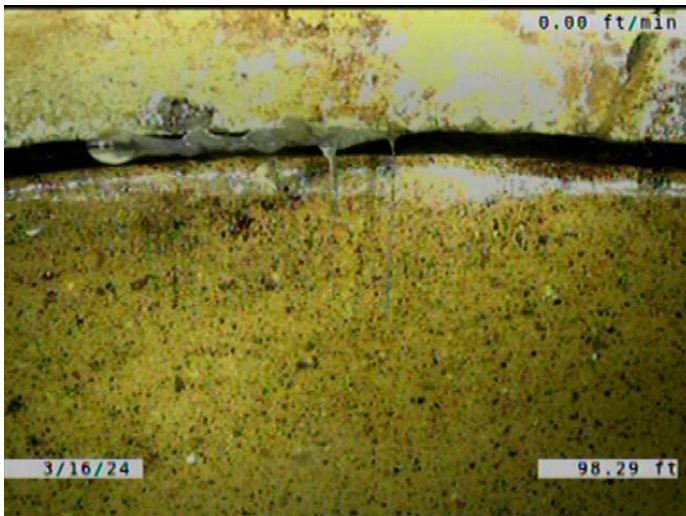
Code: **RFJ**
Description: **Roots Fine Joint**

Distance (ft): **98.3**
Structural Grade: **0**
O&M Grade: **1**
Clock Start/From: **10**
Clock To:
1st Value:
2nd Value:
Value Percent:
Continuous Index:
Within 8" of Joint: **YES**
Remarks:

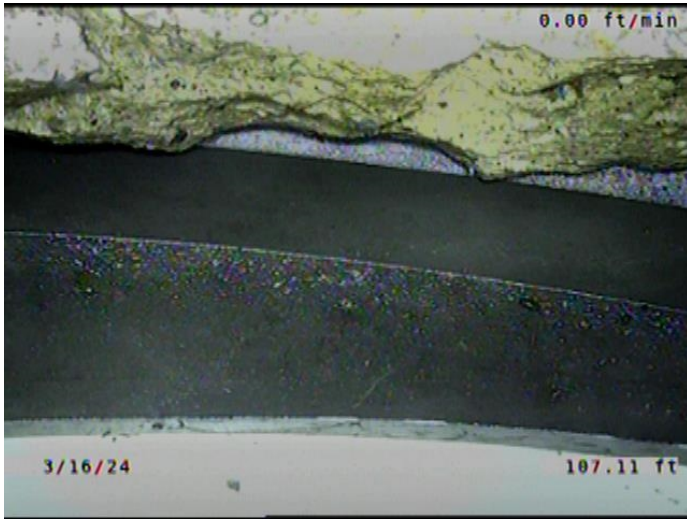
Code:	RPR
Description:	Point Repair Replacement
Distance (ft):	107.1
Structural Grade:	0
O&M Grade:	0
Clock Start/From:	
Clock To:	
1st Value:	
2nd Value:	
Value Percent:	
Continuous Index:	S12
Within 8" of Joint:	YES
Remarks:	REPLACED WITH PVC.

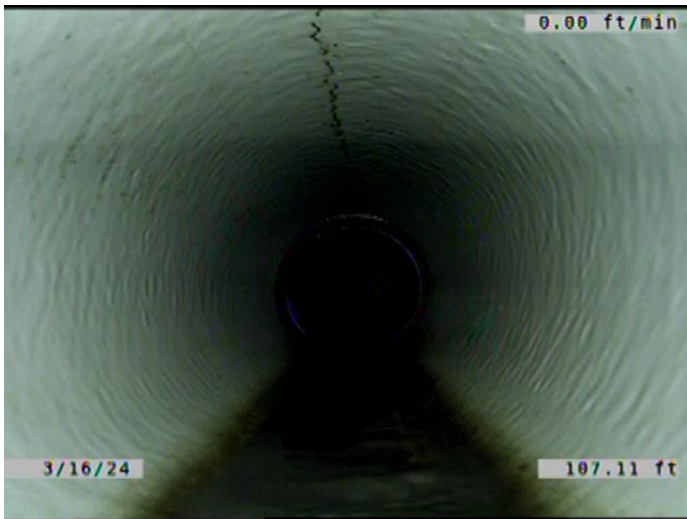
Code:	FM
Description:	Fracture Multiple
Distance (ft):	107.1
Structural Grade:	4
O&M Grade:	0
Clock Start/From:	7
Clock To:	5
1st Value:	
2nd Value:	
Value Percent:	
Continuous Index:	F10
Within 8" of Joint:	YES
Remarks:

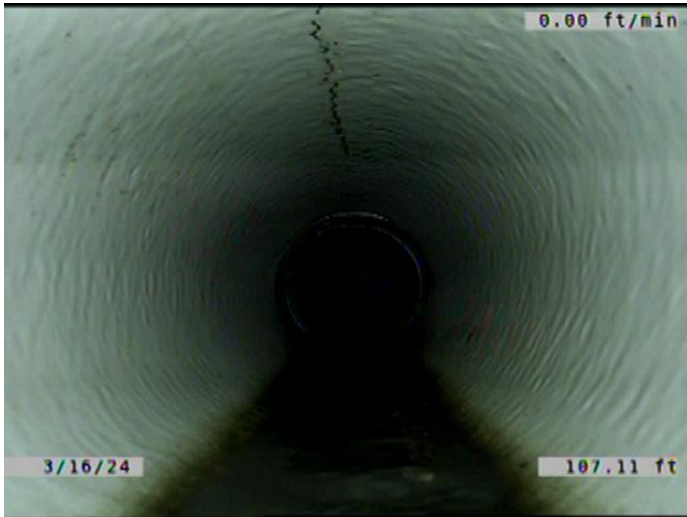
Code: **DAE**
Description: **Deposits Attached Encrustation**

Distance (ft): **107.1**
Structural Grade: **0**
O&M Grade: **2**
Clock Start/From: **7**
Clock To: **5**
1st Value:
2nd Value:
Value Percent: **5.000**
Continuous Index: **F11**
Within 8" of Joint: **YES**
Remarks:

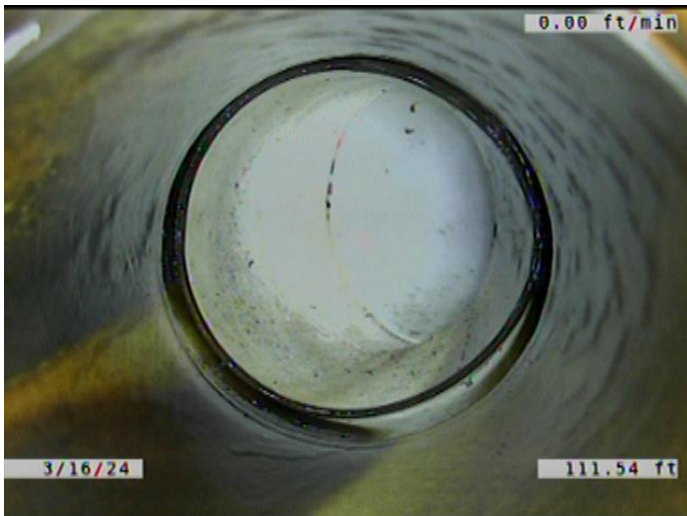
Code: **TF**
Description: **Tap Factory**

Distance (ft): **111.5**
Structural Grade: **0**
O&M Grade: **0**
Clock Start/From: **12**
Clock To:
1st Value: **6.000**
2nd Value:
Value Percent:
Continuous Index:
Within 8" of Joint: **YES**
Remarks: **LINE GOES TO THE RIGHT (EAST).
CONSTANTLY RUNNING A LARGE A**

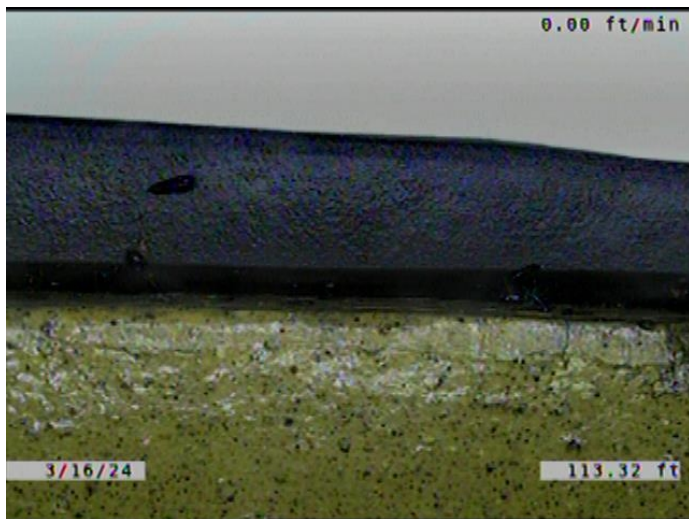
Code: **RPR**
Description: **Point Repair Replacement**

Distance (ft): **113.3**
Structural Grade: **0**
O&M Grade: **0**
Clock Start/From:
Clock To:
1st Value:
2nd Value:
Value Percent:
Continuous Index: **F12**
Within 8" of Joint: **YES**
Remarks: **REPLACED WITH PVC.**

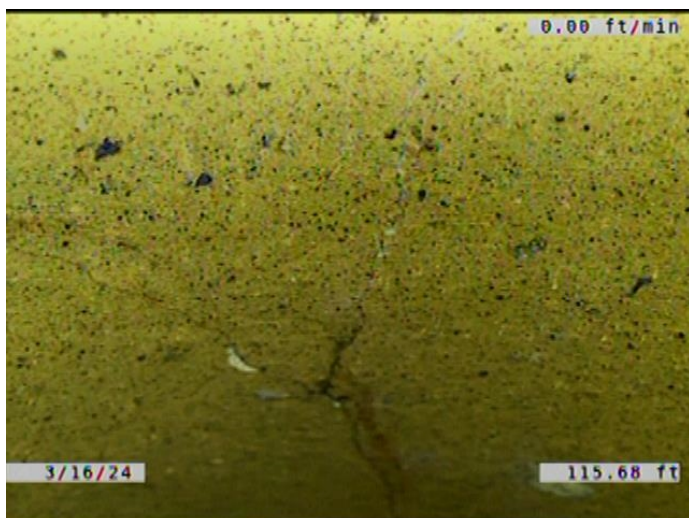
Code: **CM**
Description: **Crack Multiple**

Distance (ft): **115.7**
Structural Grade: **3**
O&M Grade: **0**
Clock Start/From: **8**
Clock To: **11**
1st Value:
2nd Value:
Value Percent:
Continuous Index:
Within 8" of Joint: **YES**
Remarks:

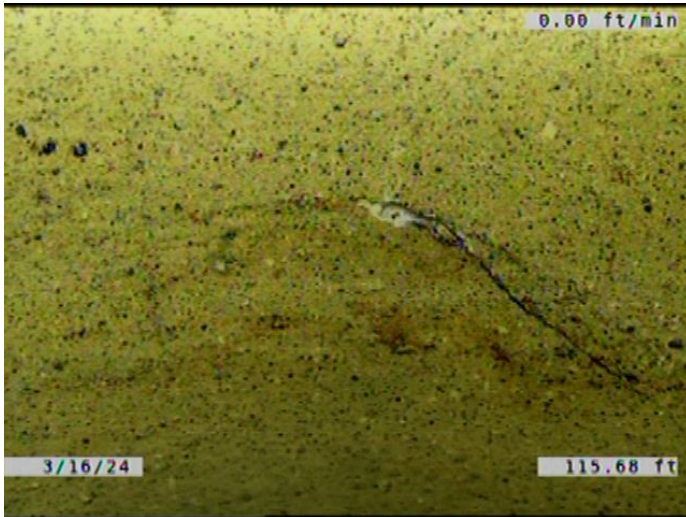
Code: **ISB**
Description: **Infiltration Stain Barrel**

Distance (ft): **115.7**
Structural Grade: **0**
O&M Grade: **1**
Clock Start/From: **7**
Clock To: **11**
1st Value:
2nd Value:
Value Percent:
Continuous Index:
Within 8" of Joint: **YES**
Remarks:

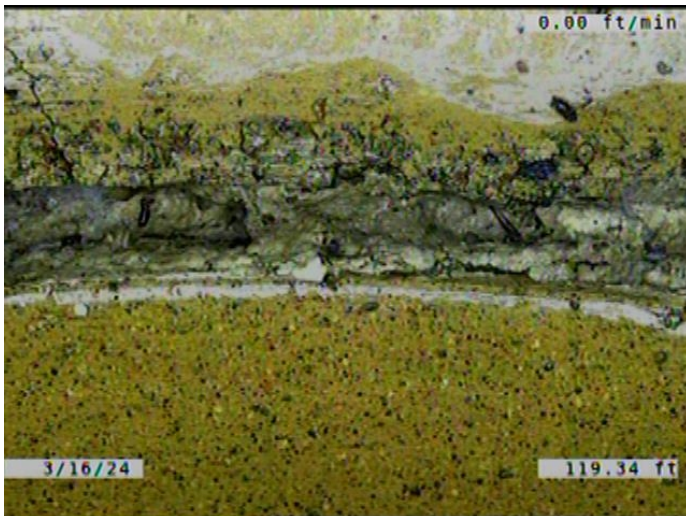
Code: **DAE**
Description: **Deposits Attached Encrustation**

Distance (ft): **119.3**
Structural Grade: **0**
O&M Grade: **2**
Clock Start/From: **7**
Clock To: **5**
1st Value:
2nd Value:
Value Percent: **5.000**
Continuous Index: **S13**
Within 8" of Joint: **YES**
Remarks:

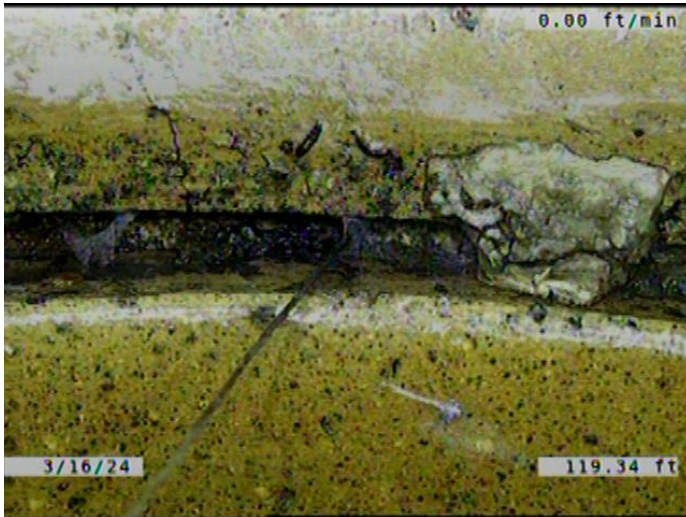
Code: **RFJ**
Description: **Roots Fine Joint**

Distance (ft): **119.3**
Structural Grade: **0**
O&M Grade: **1**
Clock Start/From: **1**
Clock To:
1st Value:
2nd Value:
Value Percent:
Continuous Index:
Within 8" of Joint: **YES**
Remarks:

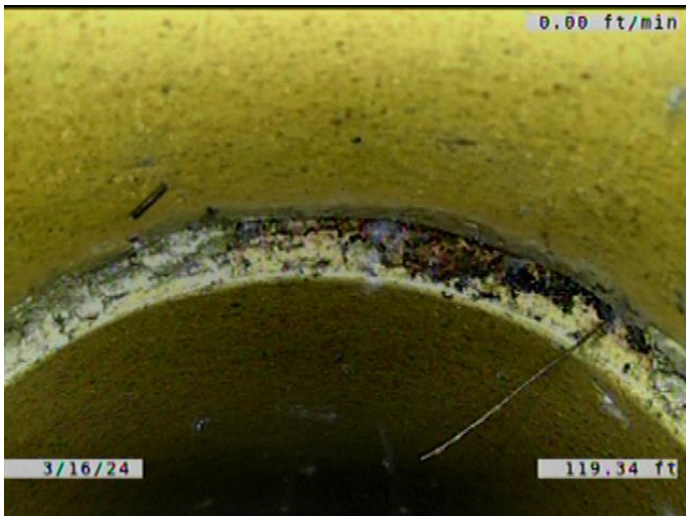
Code: **JOMD**
Description: **Joint Offset Medium Defective**

Distance (ft): **119.3**
Structural Grade: **3**
O&M Grade: **0**
Clock Start/From:
Clock To:
1st Value:
2nd Value:
Value Percent:
Continuous Index:
Within 8" of Joint: **NO**
Remarks:

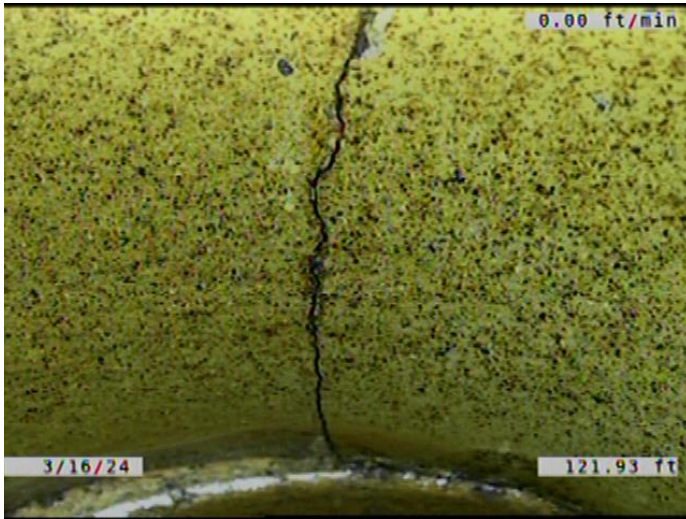
Code: **CL**
Description: **Crack Longitudinal**

Distance (ft): **121.9**
Structural Grade: **2**
O&M Grade: **0**
Clock Start/From: **3**
Clock To:
1st Value:
2nd Value:
Value Percent:
Continuous Index:
Within 8" of Joint: **YES**
Remarks:

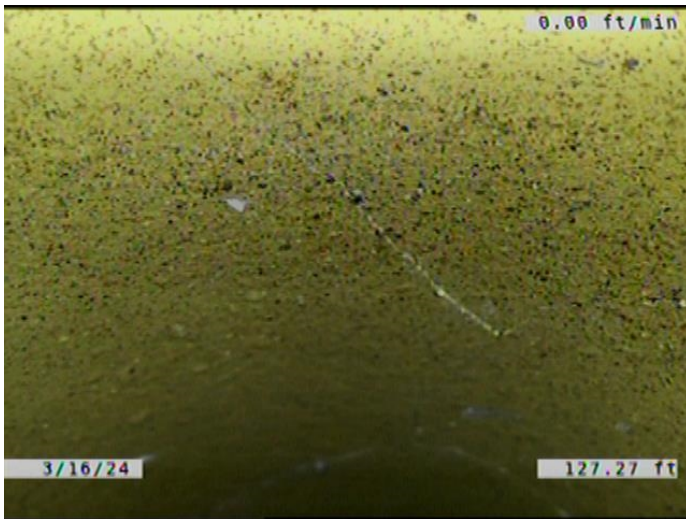
Code: **CM**
Description: **Crack Multiple**

Distance (ft): **127.3**
Structural Grade: **3**
O&M Grade: **0**
Clock Start/From: **7**
Clock To: **5**
1st Value:
2nd Value:
Value Percent:
Continuous Index: **S14**
Within 8" of Joint: **YES**
Remarks:

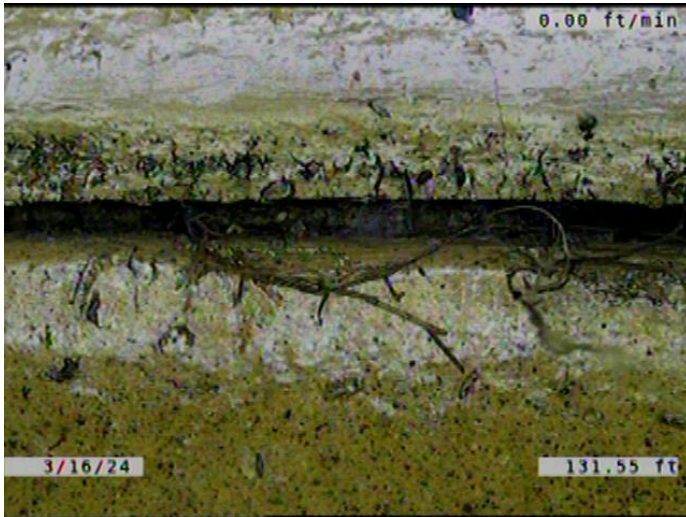
Code: **RFJ**
 Description: **Roots Fine Joint**

Distance (ft): **131.5**
 Structural Grade: **0**
 O&M Grade: **1**
 Clock Start/From: **12**
 Clock To: **3**
 1st Value:
 2nd Value:
 Value Percent:
 Continuous Index:
 Within 8" of Joint: **YES**
 Remarks:

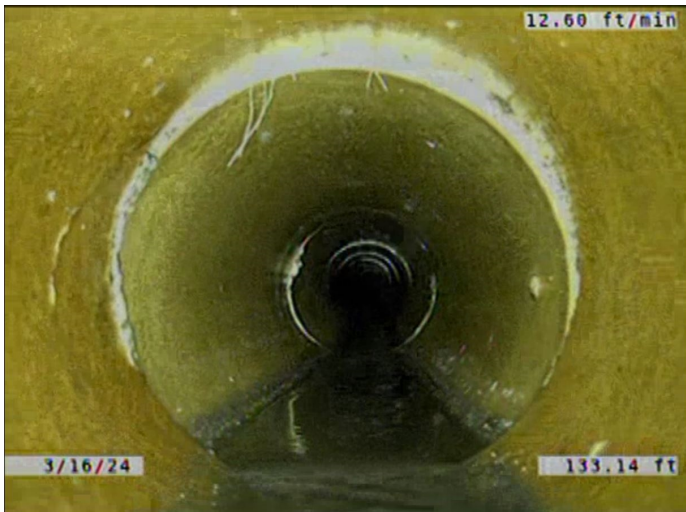
Code: **CM**
 Description: **Crack Multiple**

Distance (ft): **133.1**
 Structural Grade: **3**
 O&M Grade: **0**
 Clock Start/From: **7**
 Clock To: **5**
 1st Value:
 2nd Value:
 Value Percent:
 Continuous Index: **F14**
 Within 8" of Joint: **YES**
 Remarks:

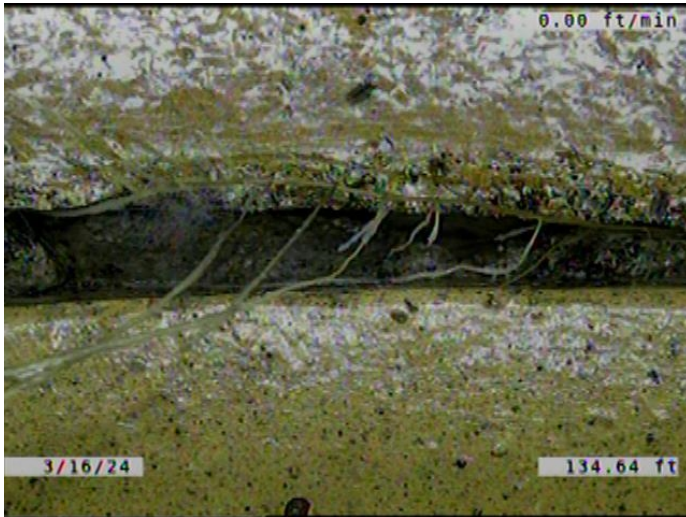
Code: **RFJ**
Description: **Roots Fine Joint**

Distance (ft): **134.6**
Structural Grade: **0**
O&M Grade: **1**
Clock Start/From: **10**
Clock To: **1**
1st Value:
2nd Value:
Value Percent:
Continuous Index:
Within 8" of Joint: **YES**
Remarks:

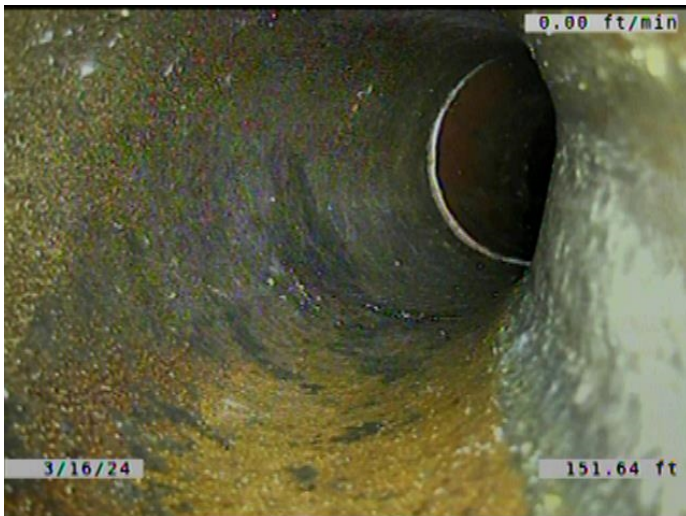
Code: **TBI**
Description: **Tap Break-in Intruding**

Distance (ft): **151.6**
Structural Grade: **0**
O&M Grade: **2**
Clock Start/From: **1**
Clock To:
1st Value: **4.000**
2nd Value: **2.000**
Value Percent:
Continuous Index:
Within 8" of Joint: **YES**
Remarks:

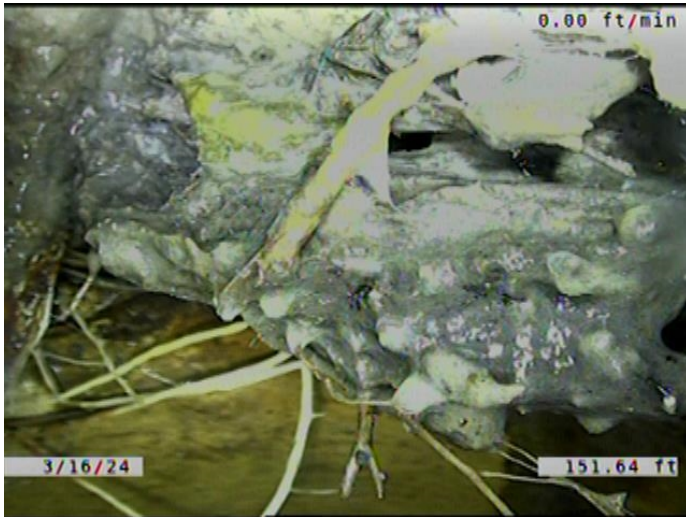
Code: **RMC**
 Description: **Roots Medium Connection**

Distance (ft): **151.6**
 Structural Grade: **0**
 O&M Grade: **3**
 Clock Start/From: **12**
 Clock To: **4**
 1st Value:
 2nd Value:
 Value Percent: **5.000**
 Continuous Index:
 Within 8" of Joint: **NO**
 Remarks:

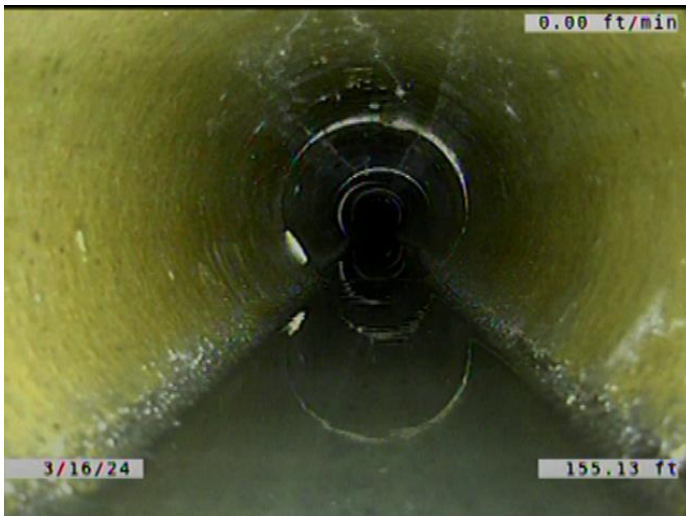
Code: **MWLS**
 Description: **Miscellaneous Water Level Sag**

Distance (ft): **155.1**
 Structural Grade: **2**
 O&M Grade: **0**
 Clock Start/From:
 Clock To:
 1st Value:
 2nd Value:
 Value Percent: **10.000**
 Continuous Index: **S15**
 Within 8" of Joint: **NO**
 Remarks:

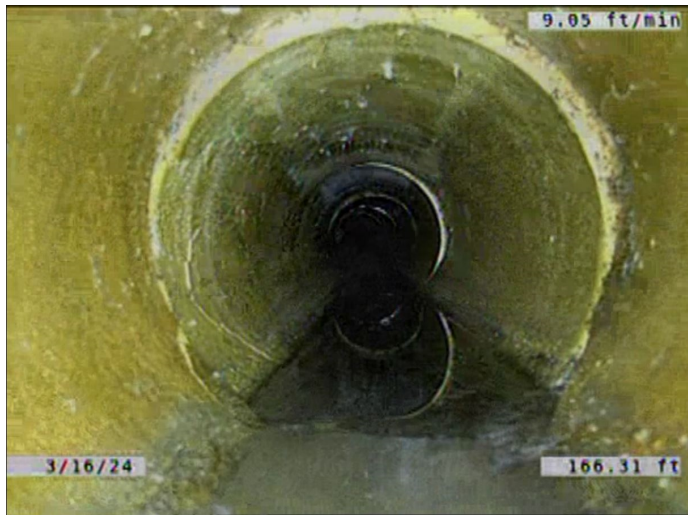
Code: **B**
Description: **Broken**

Distance (ft): **166.3**
Structural Grade: **4**
O&M Grade: **0**
Clock Start/From: **8**
Clock To: **4**
1st Value:
2nd Value:
Value Percent:
Continuous Index:
Within 8" of Joint: **YES**
Remarks:

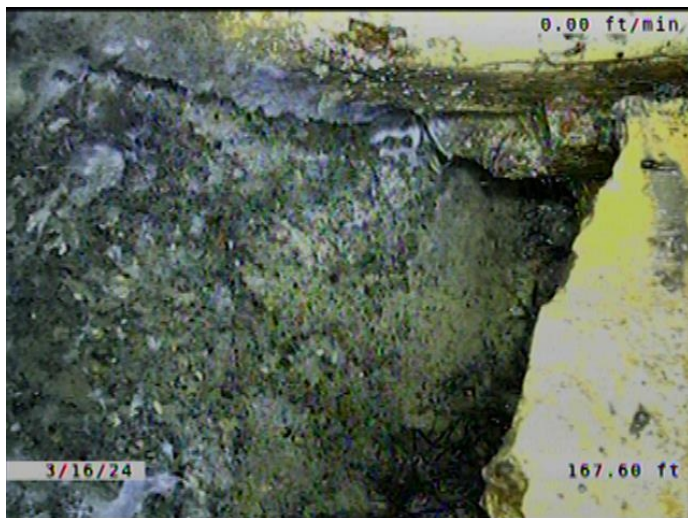
Code: **HSV**
Description: **Hole Soil Visible**

Distance (ft): **167.6**
Structural Grade: **5**
O&M Grade: **0**
Clock Start/From: **4**
Clock To: **8**
1st Value:
2nd Value:
Value Percent:
Continuous Index:
Within 8" of Joint: **YES**
Remarks: **VOID AND SOIL VISIBLE. WATER EXITING THE PIPE.**

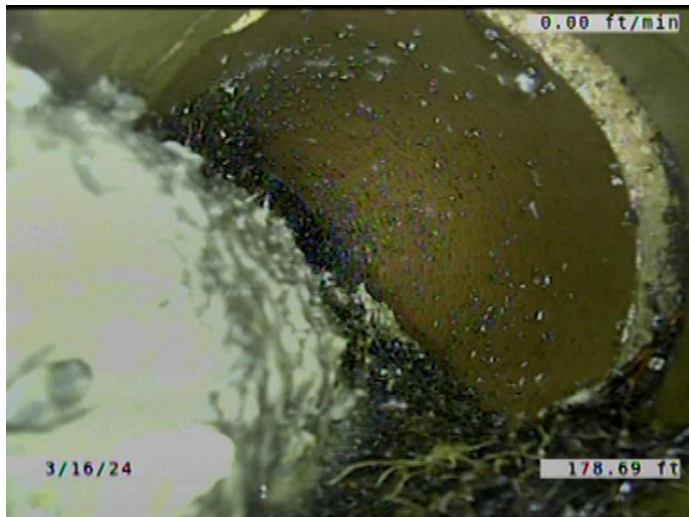
Code:	TFD
Description:	Tap Factory Defective
Distance (ft):	178.7
Structural Grade:	0
O&M Grade:	3
Clock Start/From:	11
Clock To:	
1st Value:	6.000
2nd Value:	
Value Percent:	
Continuous Index:	
Within 8" of Joint:	YES
Remarks:	TAP BROKEN. 95% PLUGGED WITH ROOTS. CONSTANTLY RUNNING WA
