Profile/Photo Observation Report

Date:	03/16/2024	Weather:		Coding:	PACP 7.0
Pipe Length (ft):	258.0	Owner:	City of Hobart	Pre Clean:	Heavy Cleaning
P.O.#:		Surveyor:	S. Bucklin	PSR:	P-405-030-029
Customer:	City of Hobart	Clean Date:	10/27/2023	Shape:	C

Street:	W 3RD ST	Flow Control:	Not Controlled
City:	Hobart, IN	Year Renewed:	
Location:	Easement/Right of Way	Tape/Media #:	
Purpose:	Sewer System Evaluation Survey (SS)	Dia/Height:	8"
Use:	Sanitary Sewage Pipe	Material:	VCP
Drain Area:		Lining:	None
Category:	NA		
Comment:			
Location Details:		Direction of Survey:	Upstream
US MH:	M-405-029	DS MH:	M-405-030
		Total Length Surveyed (ft):	255.7

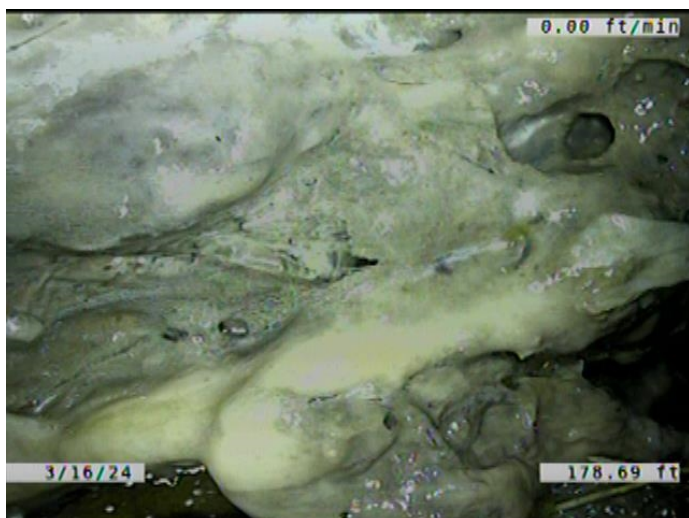
Code:	RML
Description:	Roots Medium Lateral
Distance (ft):	178.7
Structural Grade:	0
O&M Grade:	3
Clock Start/From:	9
Clock To:	11
1st Value:	
2nd Value:	
Value Percent:	5.000
Continuous Index:	
Within 8" of Joint:	NO
Remarks:

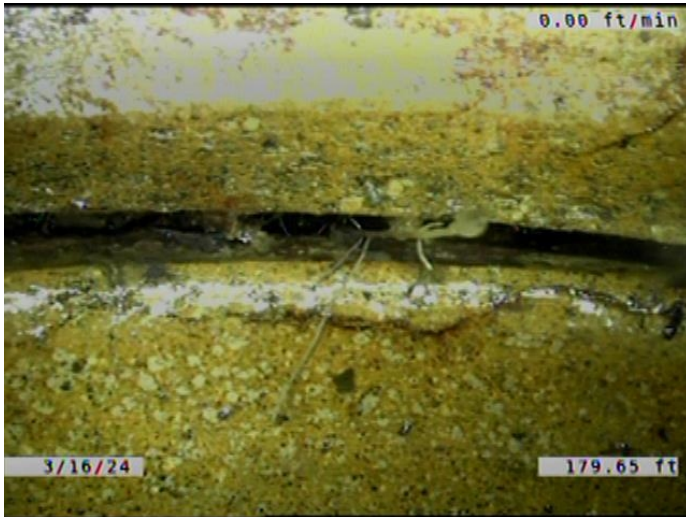
Code: **RFJ**
Description: **Roots Fine Joint**

Distance (ft): **179.7**
Structural Grade: **0**
O&M Grade: **1**
Clock Start/From: **2**
Clock To: **3**
1st Value:
2nd Value:
Value Percent:
Continuous Index:
Within 8" of Joint: **YES**
Remarks:

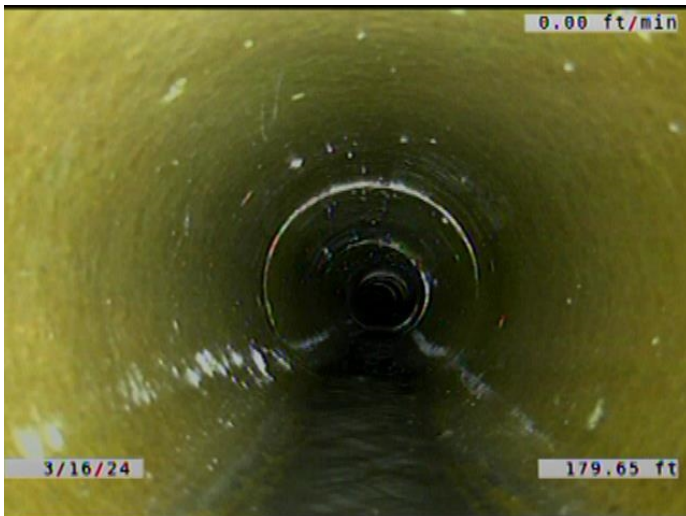
Code: **MWLS**
Description: **Miscellaneous Water Level Sag**

Distance (ft): **179.7**
Structural Grade: **2**
O&M Grade: **0**
Clock Start/From:
Clock To:
1st Value:
2nd Value:
Value Percent: **10.000**
Continuous Index: **F15**
Within 8" of Joint: **NO**
Remarks:

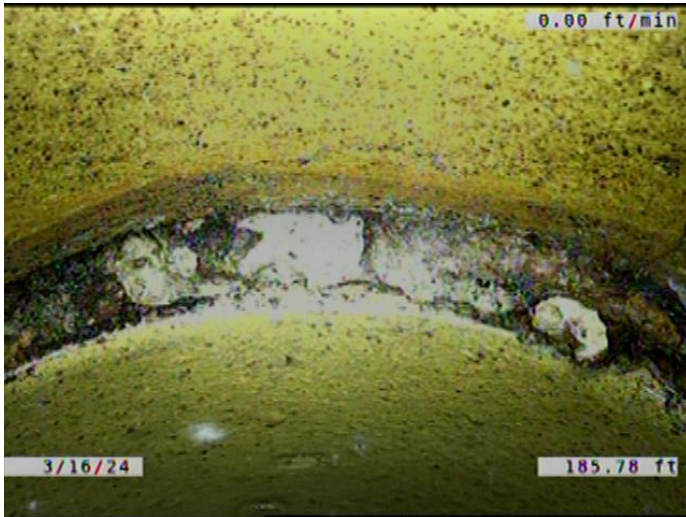
Code: **JOMD**
 Description: **Joint Offset Medium Defective**

Distance (ft): **185.8**
 Structural Grade: **3**
 O&M Grade: **0**
 Clock Start/From:
 Clock To:
 1st Value:
 2nd Value:
 Value Percent:
 Continuous Index:
 Within 8" of Joint: **NO**
 Remarks:

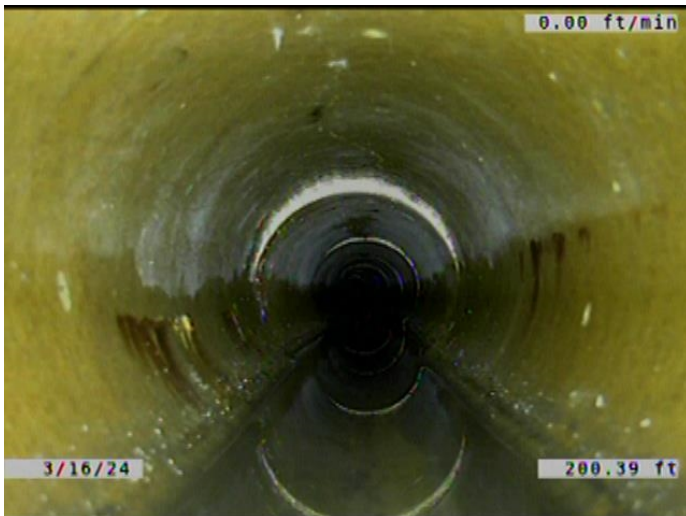
Code: **MWLS**
 Description: **Miscellaneous Water Level Sag**

Distance (ft): **200.4**
 Structural Grade: **2**
 O&M Grade: **0**
 Clock Start/From:
 Clock To:
 1st Value:
 2nd Value:
 Value Percent: **10.000**
 Continuous Index: **S16**
 Within 8" of Joint: **NO**
 Remarks:

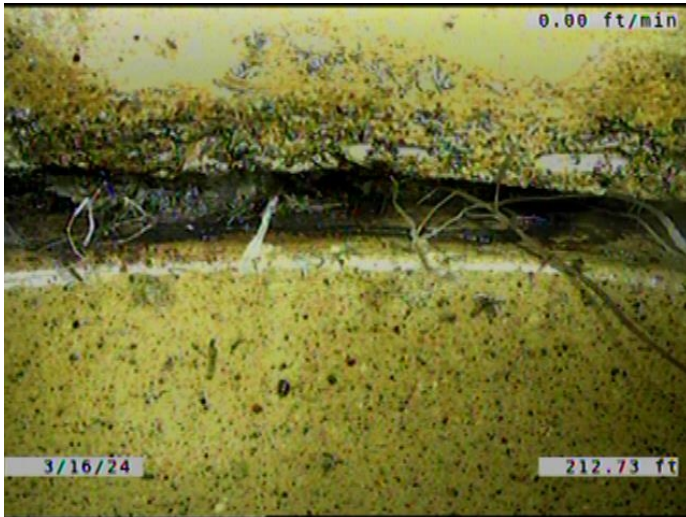
Code: **RFJ**
Description: **Roots Fine Joint**

Distance (ft): **212.7**
Structural Grade: **0**
O&M Grade: **1**
Clock Start/From: **2**
Clock To: **4**
1st Value:
2nd Value:
Value Percent:
Continuous Index:
Within 8" of Joint: **YES**
Remarks:

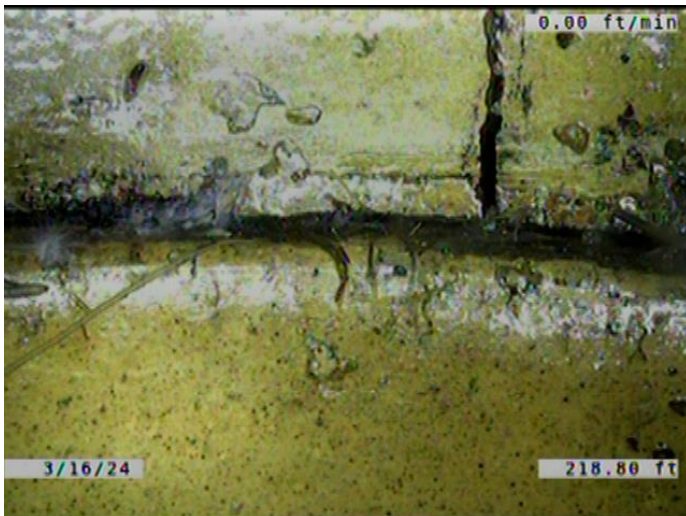
Code: **RFJ**
Description: **Roots Fine Joint**

Distance (ft): **218.8**
Structural Grade: **0**
O&M Grade: **1**
Clock Start/From: **1**
Clock To: **3**
1st Value:
2nd Value:
Value Percent:
Continuous Index:
Within 8" of Joint: **YES**
Remarks:

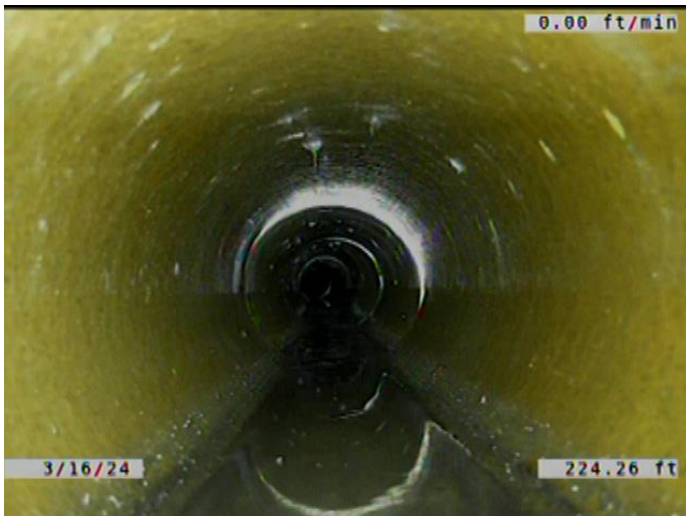
Code: **MWLS**
Description: **Miscellaneous Water Level Sag**

Distance (ft): **224.2**
Structural Grade: **2**
O&M Grade: **0**
Clock Start/From:
Clock To:
1st Value:
2nd Value:
Value Percent: **5.000**
Continuous Index: **S17**
Within 8" of Joint: **NO**
Remarks:

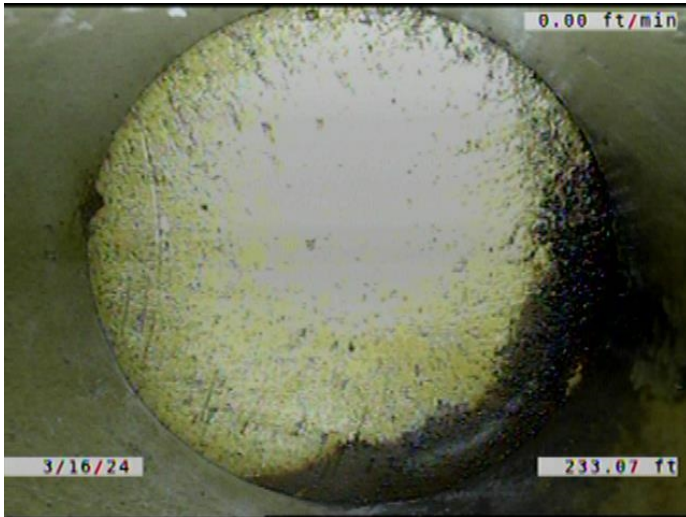
Code: **TFD**
Description: **Tap Factory Defective**

Distance (ft): **233.1**
Structural Grade: **0**
O&M Grade: **3**
Clock Start/From: **2**
Clock To:
1st Value: **6.000**
2nd Value:
Value Percent:
Continuous Index:
Within 8" of Joint: **YES**
Remarks: **CAPPED. INFILTRATION STAINS
AROUND THE CAP INTO THE MAIN.**

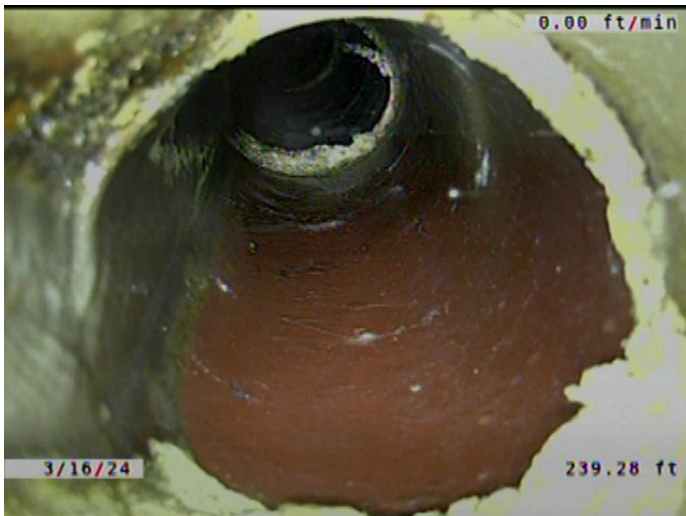
Code: **TFD**
Description: **Tap Factory Defective**

Distance (ft): **239.3**
Structural Grade: **0**
O&M Grade: **3**
Clock Start/From: **9**
Clock To:
1st Value: **6.000**
2nd Value:
Value Percent:
Continuous Index:
Within 8" of Joint: **YES**
Remarks: **CONSTANTLY RUNNING A LARGE
AMOUNT OF WATER. ENCRUSTATIO**

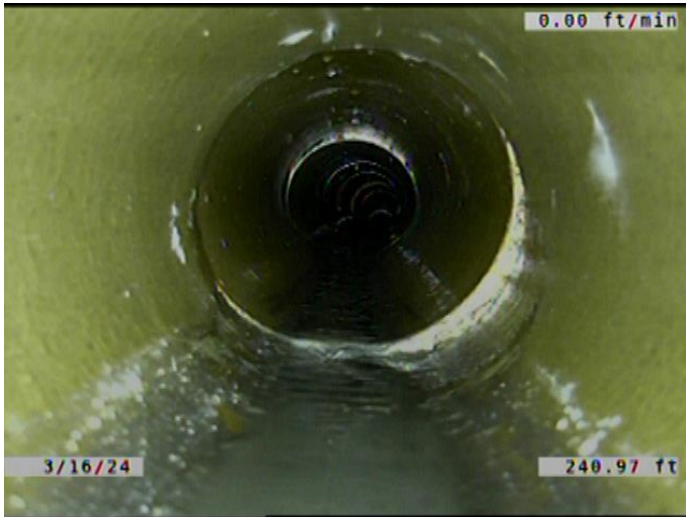
Code: **MWLS**
Description: **Miscellaneous Water Level Sag**

Distance (ft): **241.0**
Structural Grade: **2**
O&M Grade: **0**
Clock Start/From:
Clock To:
1st Value:
2nd Value:
Value Percent: **5.000**
Continuous Index: **F17**
Within 8" of Joint: **NO**
Remarks:

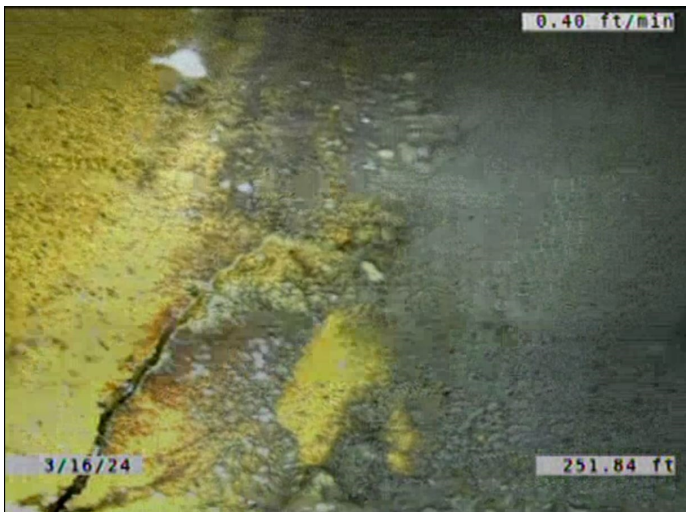
Code: **FM**
Description: **Fracture Multiple**

Distance (ft): **251.8**
Structural Grade: **4**
O&M Grade: **0**
Clock Start/From: **4**
Clock To: **8**
1st Value:
2nd Value:
Value Percent:
Continuous Index:
Within 8" of Joint: **YES**
Remarks:

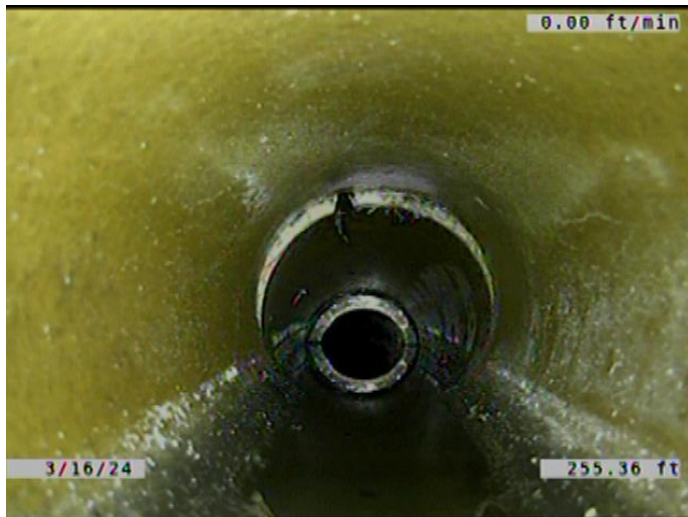
Code: **DAE**
 Description: **Deposits Attached Encrustation**

Distance (ft): **255.4**
 Structural Grade: **0**
 O&M Grade: **2**
 Clock Start/From: **7**
 Clock To: **5**
 1st Value:
 2nd Value:
 Value Percent: **5.000**
 Continuous Index: **F13**
 Within 8" of Joint: **YES**
 Remarks:
