Profile/Photo Observation Report

Date:	04/19/2018	Weather:		Coding:	PACP 6.0
Pipe Length (ft):	332.8	Owner:	NA	Pre Clean:	No Pre-Cleaning
P.O.#:		Surveyor:	Byrd Fitzgerald	PSR:	P-405-035-031
Customer:		Clean Date:	01/01/1900	Shape:	C

Street:	FOXCROFT STREET	Flow Control:	Not Controlled
City:	Hobart, IN	Year Renewed:	
Location:	Yard	Tape/Media #:	
Purpose:	Routine Assessment	Dia/Height:	8"
Use:	Sanitary	Material:	PVC
Drain Area:	NA	Lining:	
Category:	NA		
Comment:	P_C at 168 ft roots		
Location Details:		Direction of Survey:	Downstream
US MH:	M-405-031	DS MH:	M-405-035
		Total Length Surveyed (ft):	169.7

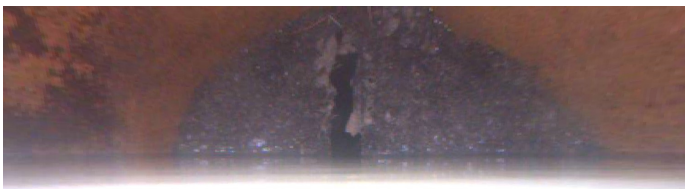
Code: **RBJ**
Description: **Roots Ball Joint**

Distance (ft): **3.7**
Structural Grade: **0**
O&M Grade: **4**
Clock Start/From: **9**
Clock To: **3**
1st Value:
2nd Value:
Value Percent: **90.000**
Continuous Index:
Within 8" of Joint: **YES**
Remarks:

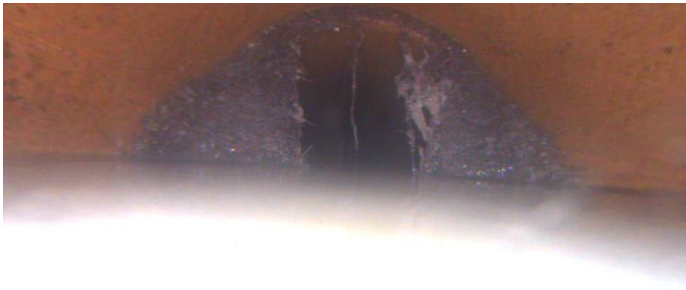
Code: **RBJ**
Description: **Roots Ball Joint**

Distance (ft): **6.7**
Structural Grade: **0**
O&M Grade: **4**
Clock Start/From: **9**
Clock To: **3**
1st Value:
2nd Value:
Value Percent: **55.000**
Continuous Index: **S01**
Within 8" of Joint: **YES**
Remarks:

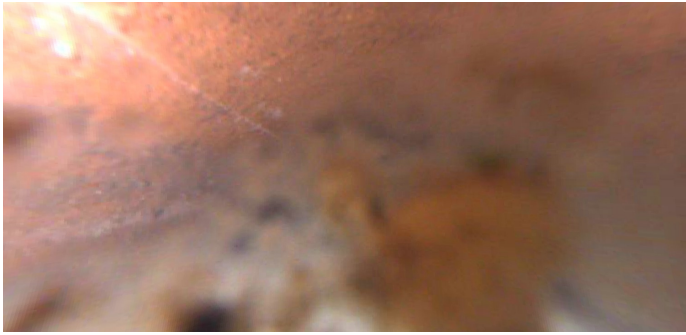
Code: **RBJ**
Description: **Roots Ball Joint**

Distance (ft): **24.1**
Structural Grade: **0**
O&M Grade: **4**
Clock Start/From: **9**
Clock To: **3**
1st Value:
2nd Value:
Value Percent: **55.000**
Continuous Index: **F01**
Within 8" of Joint: **YES**
Remarks:

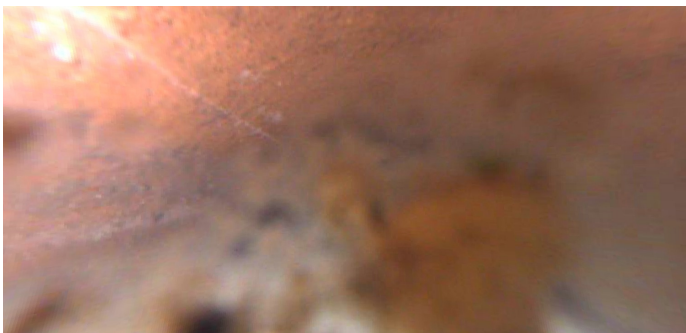
Code: **MCU**
Description: **Camera Underwater**

Distance (ft): **24.1**
Structural Grade: **0**
O&M Grade: **4**
Clock Start/From:
Clock To:
1st Value:
2nd Value:
Value Percent:
Continuous Index: **F02**
Within 8" of Joint: **NO**
Remarks:

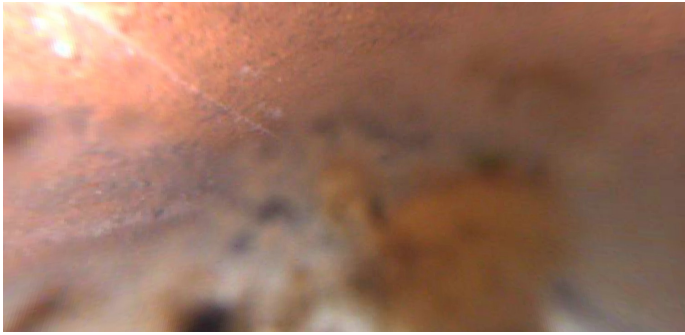
Code: **MGO**
Description: **General Observation**

Distance (ft): **24.1**
Structural Grade: **0**
O&M Grade: **0**
Clock Start/From:
Clock To:
1st Value:
2nd Value:
Value Percent:
Continuous Index:
Within 8" of Joint: **NO**
Remarks: **lense dirty front and rear**

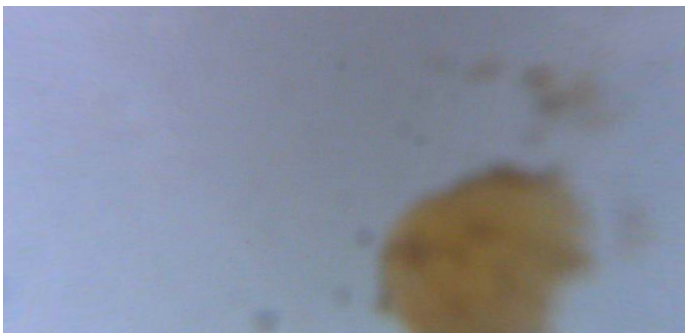
Code: **MCU**
Description: **Camera Underwater**

Distance (ft): **47.6**
Structural Grade: **0**
O&M Grade: **4**
Clock Start/From:
Clock To:
1st Value:
2nd Value:
Value Percent:
Continuous Index: **S03**
Within 8" of Joint: **NO**
Remarks:

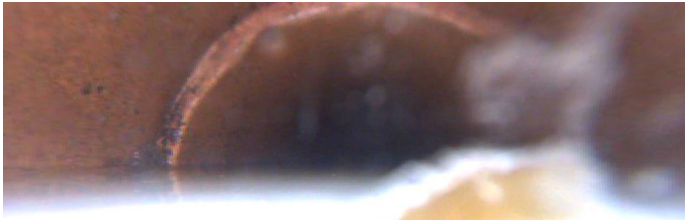
Code: **MCU**
Description: **Camera Underwater**

Distance (ft): **52.0**
Structural Grade: **0**
O&M Grade: **4**
Clock Start/From:
Clock To:
1st Value:
2nd Value:
Value Percent:
Continuous Index: **F03**
Within 8" of Joint: **NO**
Remarks:

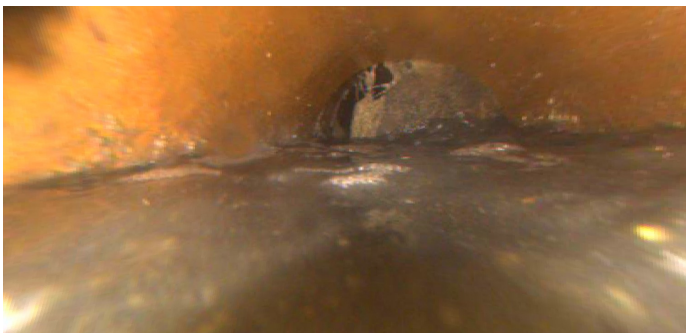
Code: **RBJ**
Description: **Roots Ball Joint**

Distance (ft): **65.4**
Structural Grade: **0**
O&M Grade: **4**
Clock Start/From: **9**
Clock To: **3**
1st Value:
2nd Value:
Value Percent: **80.000**
Continuous Index:
Within 8" of Joint: **YES**
Remarks:

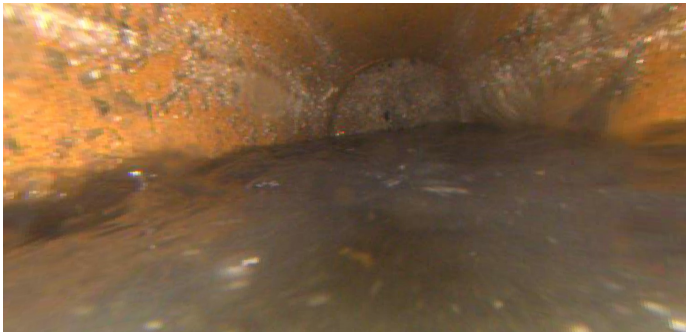
Code: **RBJ**
Description: **Roots Ball Joint**

Distance (ft): **71.8**
Structural Grade: **0**
O&M Grade: **4**
Clock Start/From: **9**
Clock To: **3**
1st Value:
2nd Value:
Value Percent: **100.000**
Continuous Index:
Within 8" of Joint: **YES**
Remarks:

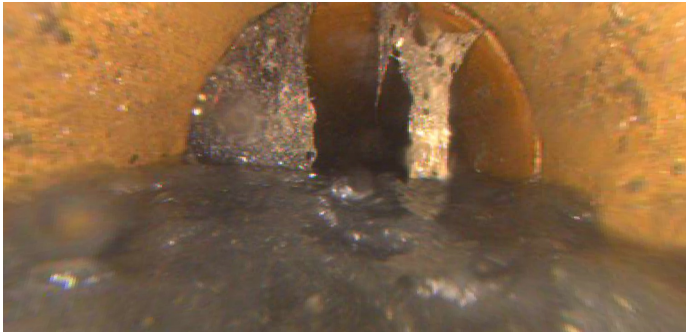
Code: **RMJ**
Description: **Roots Medium Joint**

Distance (ft): **74.0**
Structural Grade: **0**
O&M Grade: **3**
Clock Start/From: **8**
Clock To: **4**
1st Value:
2nd Value:
Value Percent: **20.000**
Continuous Index: **S04**
Within 8" of Joint: **YES**
Remarks: **wandering**

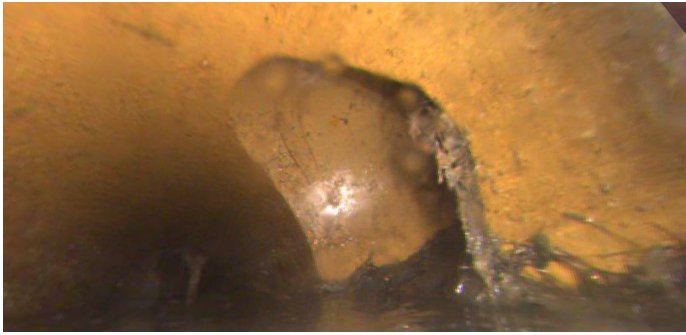
Code: **RFC**
Description: **Roots Fine Connection**

Distance (ft): **76.2**
Structural Grade: **0**
O&M Grade: **1**
Clock Start/From: **10**
Clock To:
1st Value:
2nd Value:
Value Percent:
Continuous Index:
Within 8" of Joint: **NO**
Remarks:

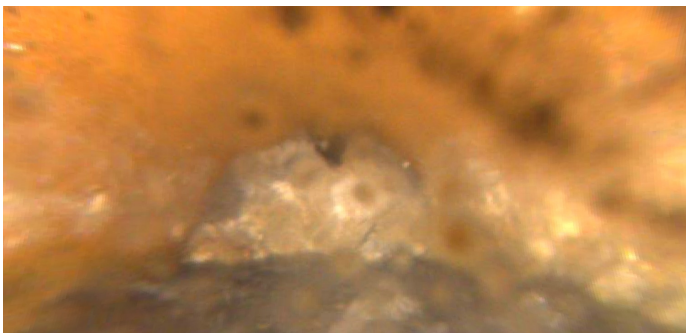
Code: **RBJ**
Description: **Roots Ball Joint**

Distance (ft): **80.2**
Structural Grade: **0**
O&M Grade: **4**
Clock Start/From: **9**
Clock To: **3**
1st Value:
2nd Value:
Value Percent: **100.000**
Continuous Index:
Within 8" of Joint: **YES**
Remarks: **also grease**

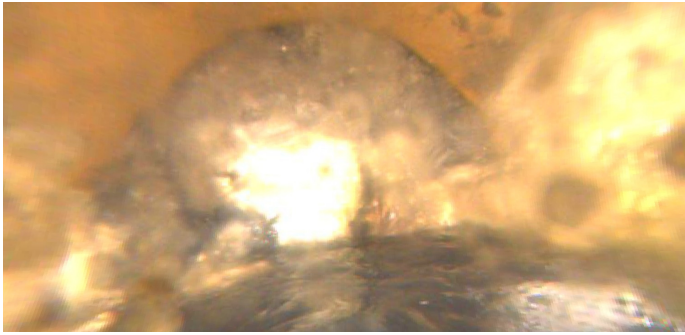
Code: **RBJ**
Description: **Roots Ball Joint**

Distance (ft): **85.9**
Structural Grade: **0**
O&M Grade: **4**
Clock Start/From: **7**
Clock To: **5**
1st Value:
2nd Value:
Value Percent: **100.000**
Continuous Index: **S05**
Within 8" of Joint: **YES**
Remarks: **percentages may change**

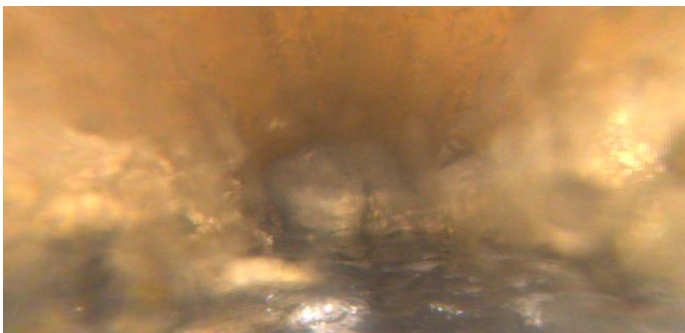
Code: **DAGS**
Description: **Deposits Attached Grease**

Distance (ft): **86.6**
Structural Grade: **0**
O&M Grade: **2**
Clock Start/From: **9**
Clock To: **3**
1st Value:
2nd Value:
Value Percent: **5.000**
Continuous Index: **S06**
Within 8" of Joint: **NO**
Remarks:

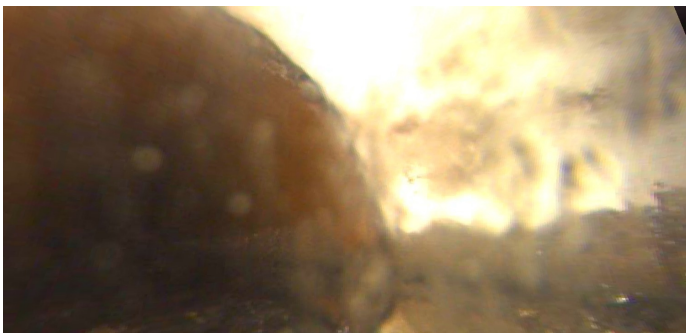
Code: **RBJ**
Description: **Roots Ball Joint**

Distance (ft): **112.7**
Structural Grade: **0**
O&M Grade: **4**
Clock Start/From: **7**
Clock To: **5**
1st Value:
2nd Value:
Value Percent: **100.000**
Continuous Index: **F05**
Within 8" of Joint: **YES**
Remarks: **percentages may change**

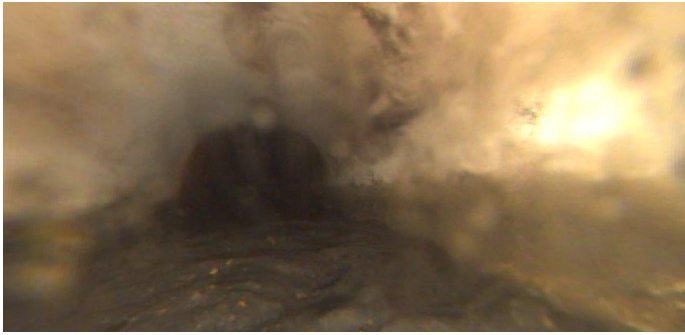
Code: **DAGS**
Description: **Deposits Attached Grease**

Distance (ft): **113.8**
Structural Grade: **0**
O&M Grade: **2**
Clock Start/From: **9**
Clock To: **3**
1st Value:
2nd Value:
Value Percent: **5.000**
Continuous Index: **F06**
Within 8" of Joint: **NO**
Remarks:

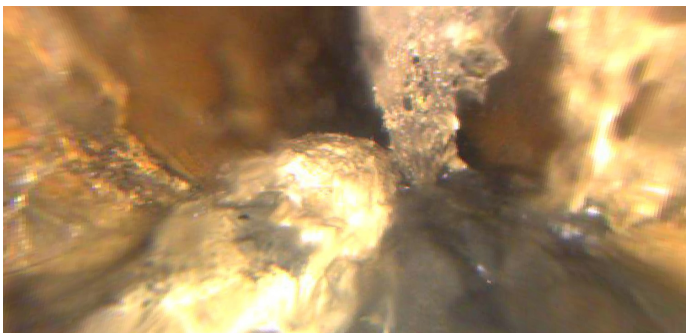
Code: **DSZ**
Description: **Deposits Settled Other**

Distance (ft): **127.6**
Structural Grade: **0**
O&M Grade: **3**
Clock Start/From: **6**
Clock To:
1st Value:
2nd Value:
Value Percent: **15.000**
Continuous Index:
Within 8" of Joint: **NO**
Remarks: **ball of grease?**

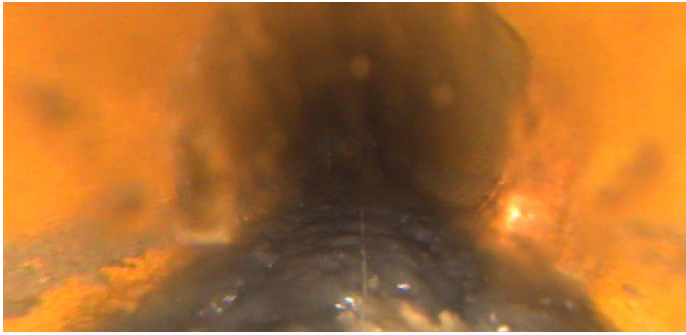
Code: **DAE**
Description: **Deposits Attached Encrustation**

Distance (ft): **134.0**
Structural Grade: **0**
O&M Grade: **2**
Clock Start/From: **7**
Clock To: **9**
1st Value:
2nd Value:
Value Percent: **5.000**
Continuous Index:
Within 8" of Joint: **YES**
Remarks:
