# Profile/Photo Observation Report

Date: **02/17/2024**      Weather:      Coding: **PACP 7.0**  
 Pipe Length (ft): **333.0**      Owner: **City of Hobart**      Pre Clean: **Heavy Cleaning**  
 P.O.#: **YES502259**      Surveyor: **S. Bucklin**      PSR: **P-405-035-031**  
 Customer: **City of Hobart**      Clean Date: **10/13/2023**      Shape: **C**

Street: **SOFTWOOD DR**      Flow Control: **Not Controlled**  
 City: **Hobart, IN**      Year Renewed:  
 Location: **Easement/Right of Way**      Tape/Media #:  
 Purpose: **Routine Assessment**      Dia/Height: **8"**  
 Use: **Sanitary Sewage Pipe**      Material: **VCP**  
 Drain Area:      Lining: **None**  
 Category: **NA**  
 Comment:  
 Location Details:      Direction of Survey: **Downstream**  
 US MH: **M-405-031**      DS MH: **M-405-035**      Total Length Surveyed (ft): **327.9**

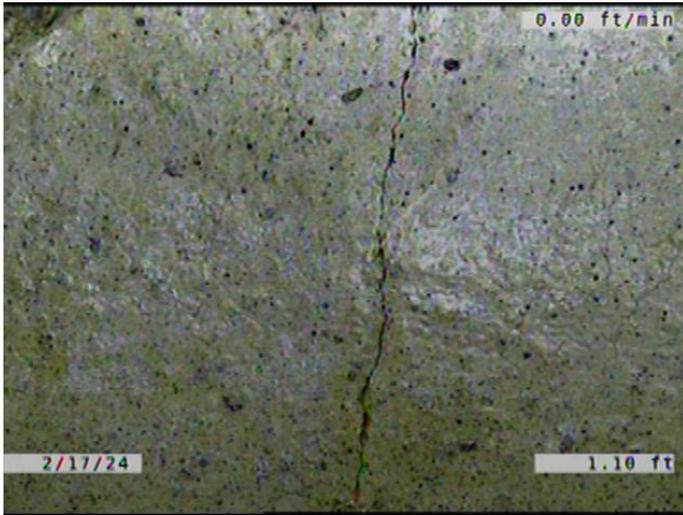
Code: **CM**  
Description: **Crack Multiple**

Distance (ft): **1.1**  
Structural Grade: **3**  
O&M Grade: **0**  
Clock Start/From: **10**  
Clock To: **2**  
1st Value:  
2nd Value:  
Value Percent:  
Continuous Index:  
Within 8" of Joint: **YES**  
Remarks:

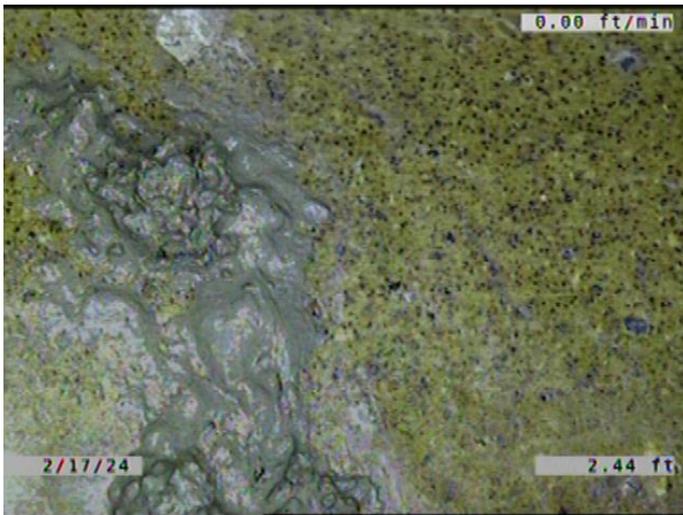
Code: **FM**  
Description: **Fracture Multiple**

Distance (ft): **2.4**  
Structural Grade: **4**  
O&M Grade: **0**  
Clock Start/From: **12**  
Clock To: **12**  
1st Value:  
2nd Value:  
Value Percent:  
Continuous Index:  
Within 8" of Joint: **YES**  
Remarks:

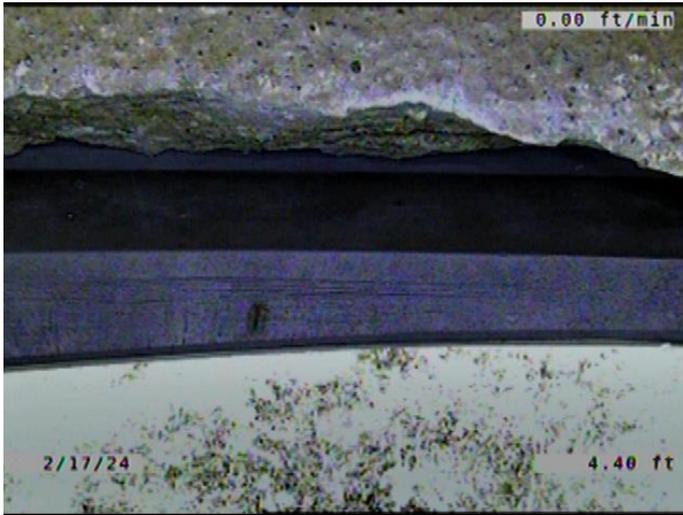
Code: **RPR**  
 Description: **Point Repair Replacement**

Distance (ft): **4.4**  
 Structural Grade: **0**  
 O&M Grade: **0**  
 Clock Start/From:  
 Clock To:  
 1st Value:  
 2nd Value:  
 Value Percent:  
 Continuous Index:  
 Within 8" of Joint: **YES**  
 Remarks: **REPLACED WITH PVC.**

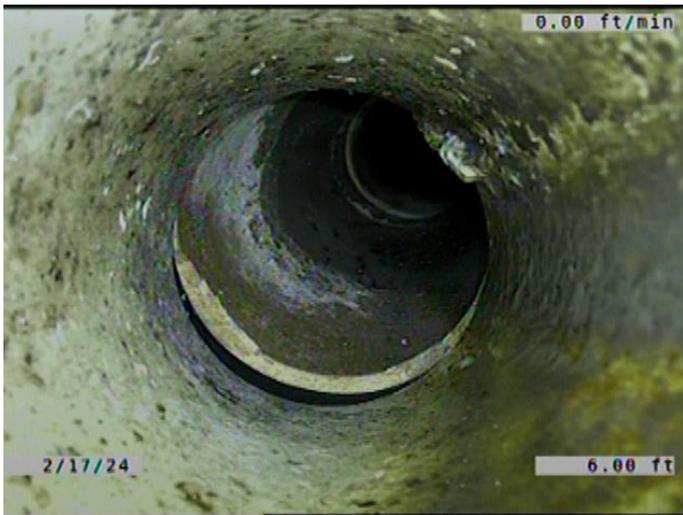
Code: **TF**  
 Description: **Tap Factory**

Distance (ft): **6.0**  
 Structural Grade: **0**  
 O&M Grade: **0**  
 Clock Start/From: **2**  
 Clock To:  
 1st Value: **6.000**  
 2nd Value:  
 Value Percent:  
 Continuous Index:  
 Within 8" of Joint: **YES**  
 Remarks: **PVC T. SERVICE IS VCP.**

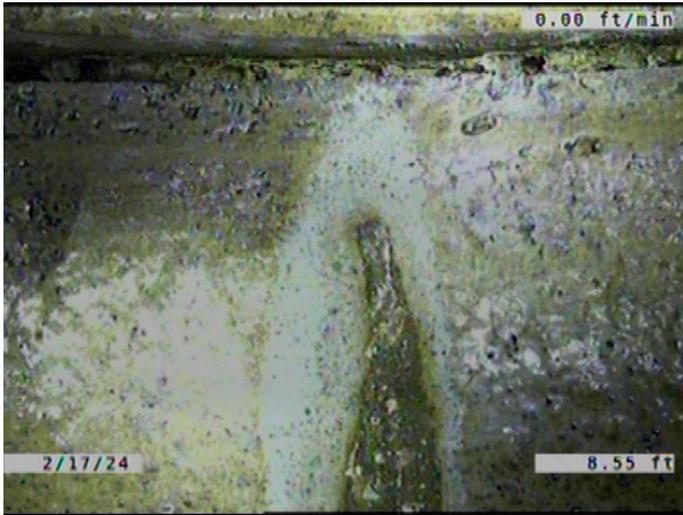
Code: **DAE**  
 Description: **Deposits Attached Encrustation**

Distance (ft): **8.6**  
 Structural Grade: **0**  
 O&M Grade: **2**  
 Clock Start/From: **7**  
 Clock To: **5**  
 1st Value:  
 2nd Value:  
 Value Percent: **5.000**  
 Continuous Index: **S01**  
 Within 8" of Joint: **YES**  
 Remarks:

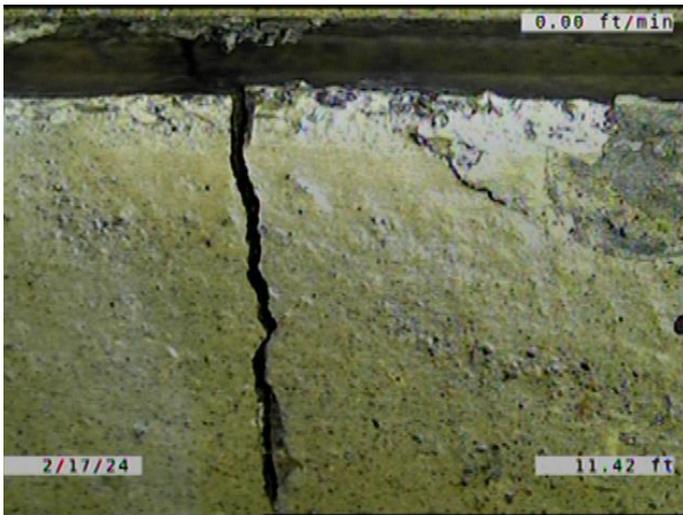
Code: **B**  
 Description: **Broken**

Distance (ft): **11.4**  
 Structural Grade: **4**  
 O&M Grade: **0**  
 Clock Start/From: **7**  
 Clock To: **5**  
 1st Value:  
 2nd Value:  
 Value Percent:  
 Continuous Index:  
 Within 8" of Joint: **YES**  
 Remarks:

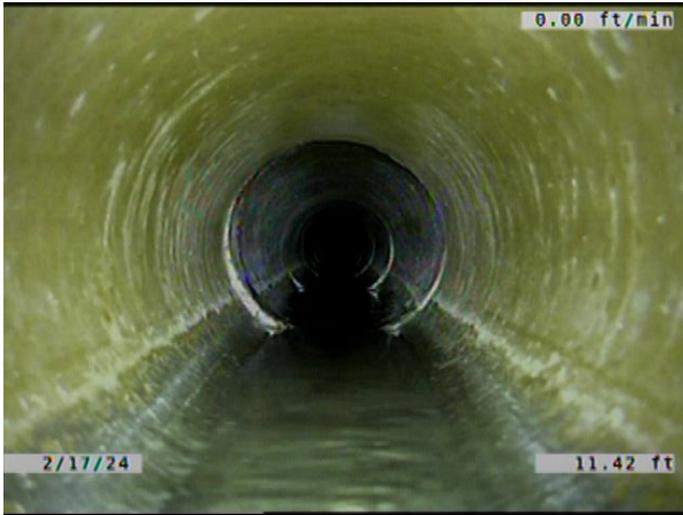
Code: **MWLS**  
 Description: **Miscellaneous Water Level Sag**

Distance (ft): **11.4**  
 Structural Grade: **2**  
 O&M Grade: **0**  
 Clock Start/From:  
 Clock To:  
 1st Value:  
 2nd Value:  
 Value Percent: **5.000**  
 Continuous Index: **S02**  
 Within 8" of Joint: **NO**  
 Remarks:

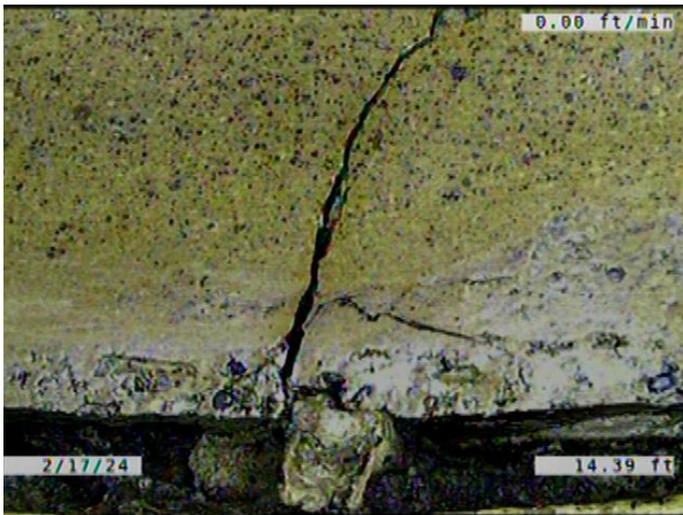
Code: **B**  
 Description: **Broken**

Distance (ft): **14.4**  
 Structural Grade: **4**  
 O&M Grade: **0**  
 Clock Start/From: **7**  
 Clock To: **10**  
 1st Value:  
 2nd Value:  
 Value Percent:  
 Continuous Index:  
 Within 8" of Joint: **YES**  
 Remarks:

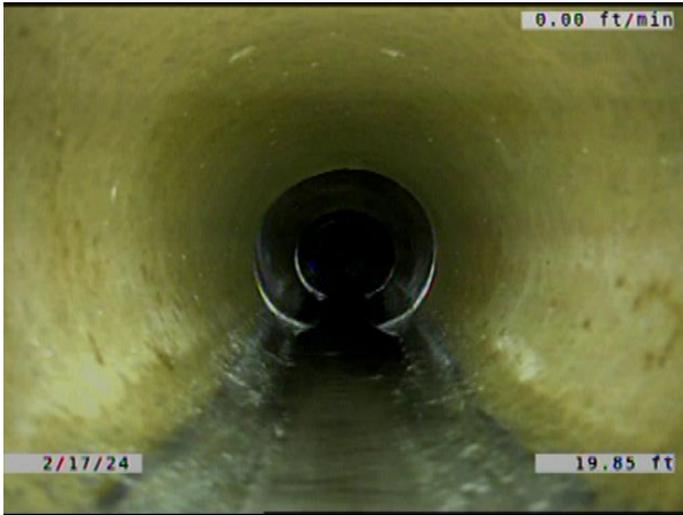
Code: **MWLS**  
Description: **Miscellaneous Water Level Sag**

Distance (ft): **19.8**  
Structural Grade: **2**  
O&M Grade: **0**  
Clock Start/From:  
Clock To:  
1st Value:  
2nd Value:  
Value Percent: **5.000**  
Continuous Index: **F02**  
Within 8" of Joint: **NO**  
Remarks:

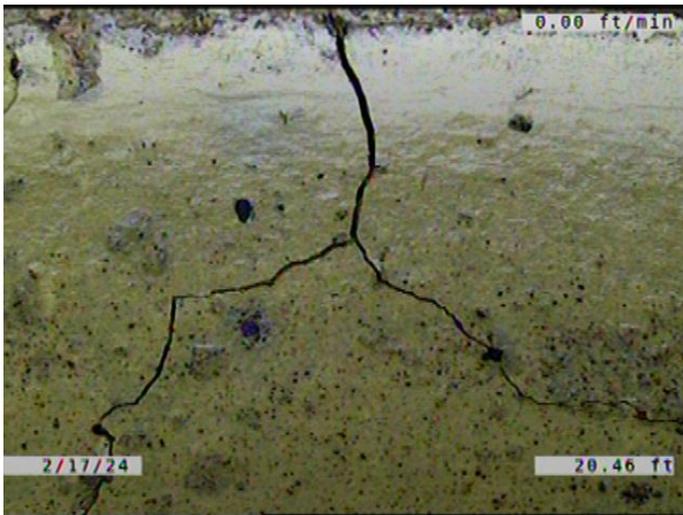
Code: **FM**  
Description: **Fracture Multiple**

Distance (ft): **20.5**  
Structural Grade: **4**  
O&M Grade: **0**  
Clock Start/From: **10**  
Clock To: **6**  
1st Value:  
2nd Value:  
Value Percent:  
Continuous Index: **S03**  
Within 8" of Joint: **YES**  
Remarks:

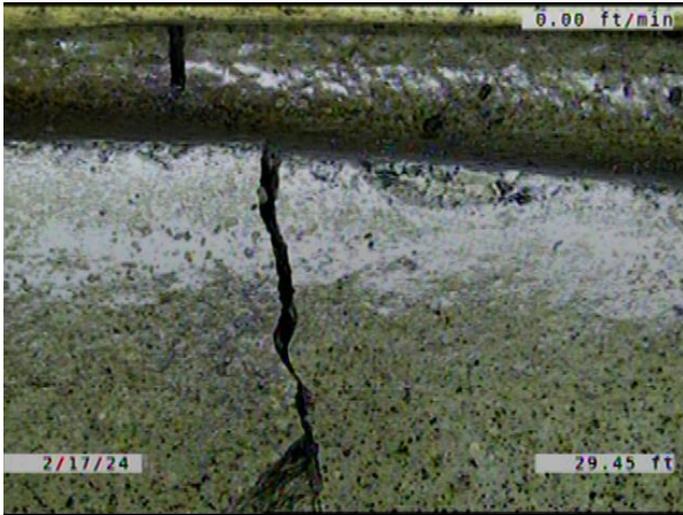
Code: **B**  
Description: **Broken**

Distance (ft): **29.4**  
Structural Grade: **4**  
O&M Grade: **0**  
Clock Start/From: **9**  
Clock To: **11**  
1st Value:  
2nd Value:  
Value Percent:  
Continuous Index:  
Within 8" of Joint: **YES**  
Remarks:

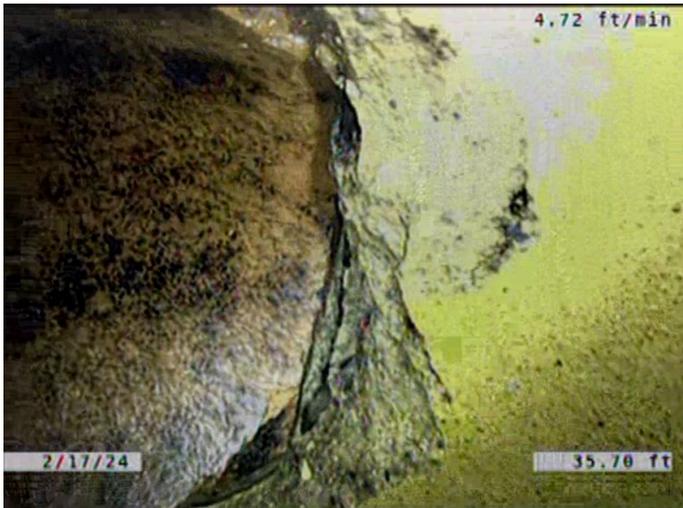
Code: **SSS**  
Description: **Surface Damage Surface Spalling**

Distance (ft): **35.7**  
Structural Grade: **2**  
O&M Grade: **0**  
Clock Start/From: **9**  
Clock To: **11**  
1st Value:  
2nd Value:  
Value Percent:  
Continuous Index:  
Within 8" of Joint: **NO**  
Remarks:

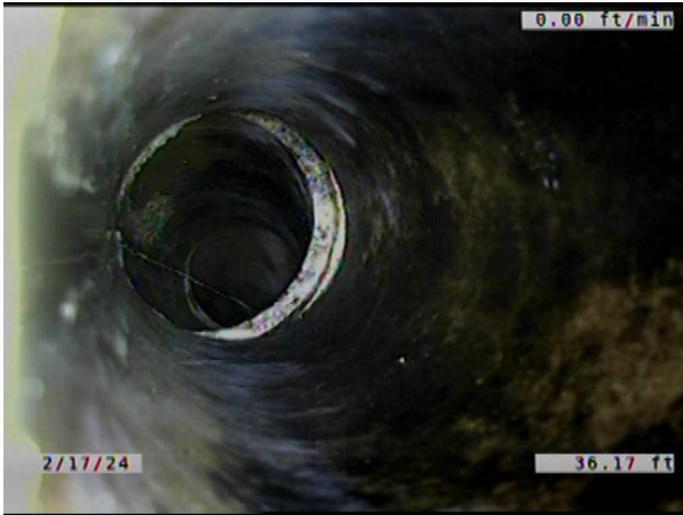
Code: **TBI**  
Description: **Tap Break-in Intruding**

Distance (ft): **36.2**  
Structural Grade: **0**  
O&M Grade: **2**  
Clock Start/From: **10**  
Clock To:  
1st Value: **6.000**  
2nd Value: **2.000**  
Value Percent:  
Continuous Index:  
Within 8" of Joint: **YES**  
Remarks: **SERVICE JOINTS OFFSET.  
CONSTANTLY DRIPPING WATER.**

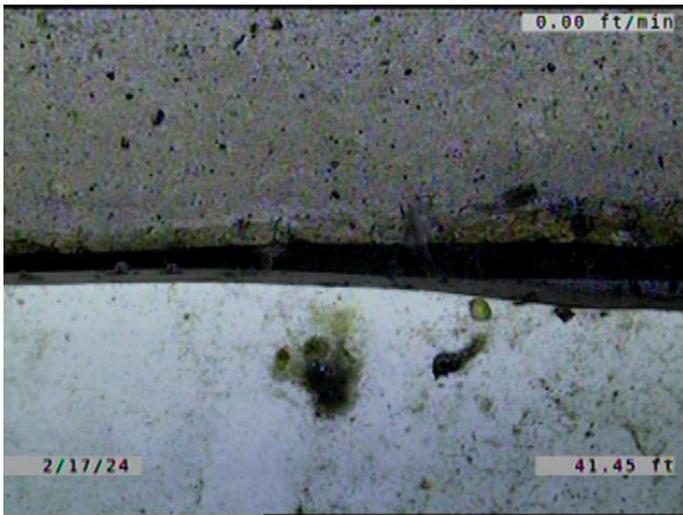
Code: **RPR**  
Description: **Point Repair Replacement**

Distance (ft): **41.4**  
Structural Grade: **0**  
O&M Grade: **0**  
Clock Start/From:  
Clock To:  
1st Value:  
2nd Value:  
Value Percent:  
Continuous Index: **S04**  
Within 8" of Joint: **YES**  
Remarks: **REPLACED WITH PVC.**

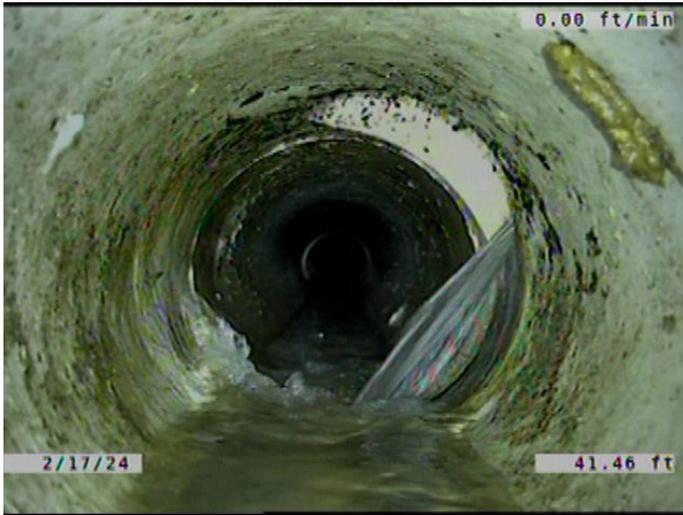
Code: **DAE**  
Description: **Deposits Attached Encrustation**

Distance (ft): **41.5**  
Structural Grade: **0**  
O&M Grade: **2**  
Clock Start/From: **7**  
Clock To: **5**  
1st Value:  
2nd Value:  
Value Percent: **5.000**  
Continuous Index: **F01**  
Within 8" of Joint: **YES**  
Remarks:

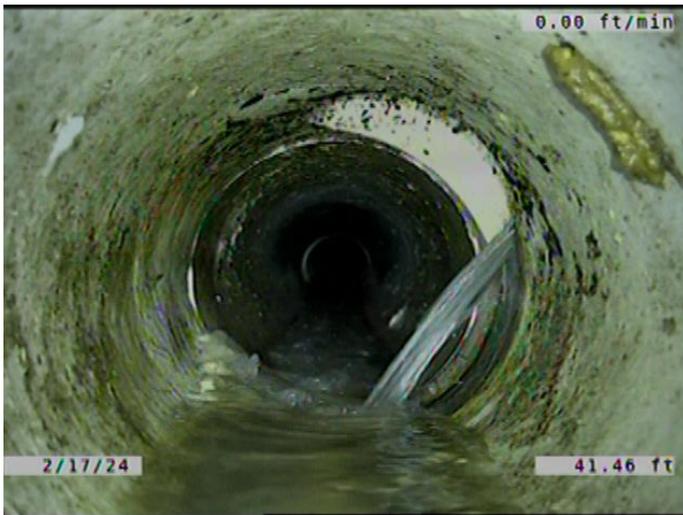
Code: **FM**  
Description: **Fracture Multiple**

Distance (ft): **41.5**  
Structural Grade: **4**  
O&M Grade: **0**  
Clock Start/From: **10**  
Clock To: **6**  
1st Value:  
2nd Value:  
Value Percent:  
Continuous Index: **F03**  
Within 8" of Joint: **YES**  
Remarks: **Wandering 8 - 6**

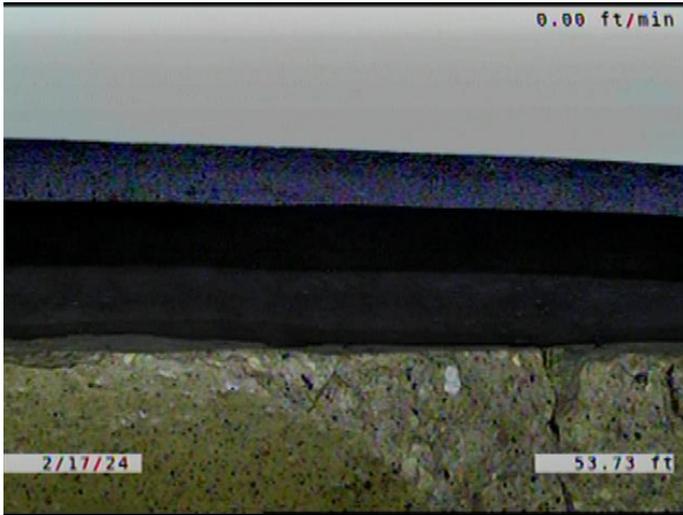
Code: **RPR**  
 Description: **Point Repair Replacement**

Distance (ft): **53.7**  
 Structural Grade: **0**  
 O&M Grade: **0**  
 Clock Start/From:  
 Clock To:  
 1st Value:  
 2nd Value:  
 Value Percent:  
 Continuous Index: **F04**  
 Within 8" of Joint: **YES**  
 Remarks: **REPLACED WITH PVC.**

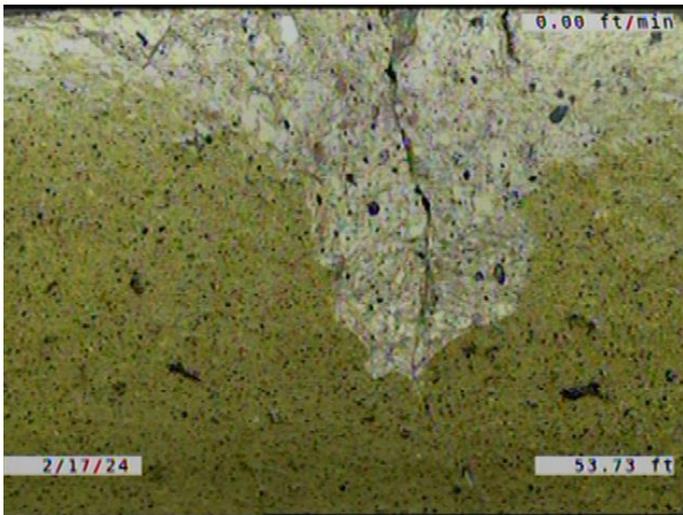
Code: **CM**  
 Description: **Crack Multiple**

Distance (ft): **53.7**  
 Structural Grade: **3**  
 O&M Grade: **0**  
 Clock Start/From: **11**  
 Clock To: **1**  
 1st Value:  
 2nd Value:  
 Value Percent:  
 Continuous Index:  
 Within 8" of Joint: **YES**  
 Remarks:

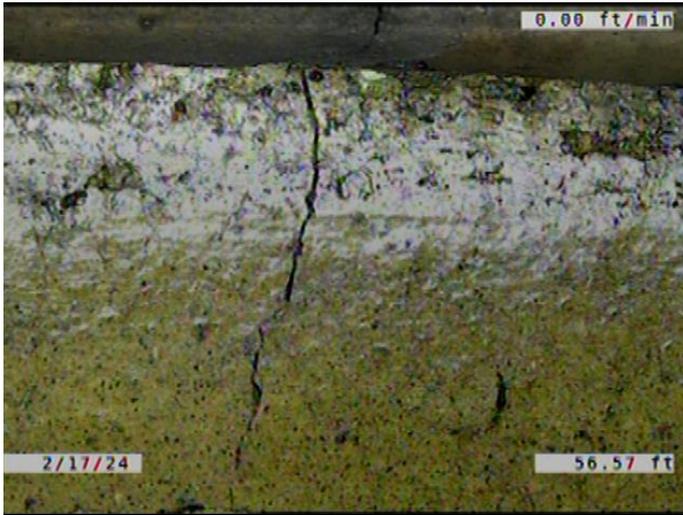
Code: **FM**  
Description: **Fracture Multiple**

Distance (ft): **56.6**  
Structural Grade: **4**  
O&M Grade: **0**  
Clock Start/From: **7**  
Clock To: **5**  
1st Value:  
2nd Value:  
Value Percent:  
Continuous Index:  
Within 8" of Joint: **YES**  
Remarks:

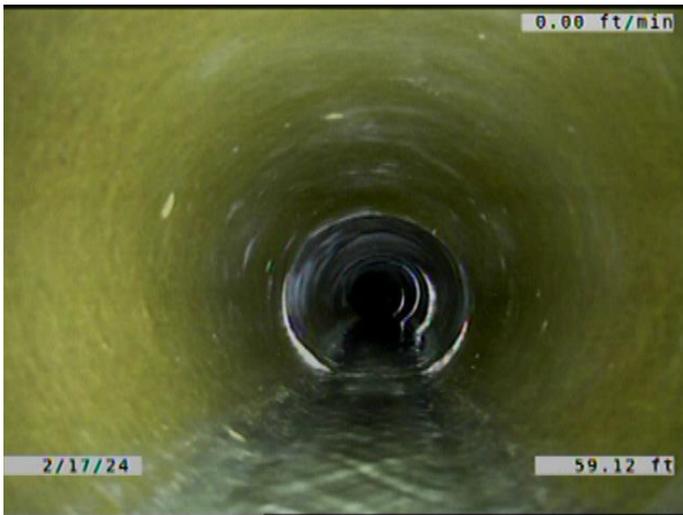
Code: **MWLS**  
Description: **Miscellaneous Water Level Sag**

Distance (ft): **59.1**  
Structural Grade: **2**  
O&M Grade: **0**  
Clock Start/From:  
Clock To:  
1st Value:  
2nd Value:  
Value Percent: **10.000**  
Continuous Index: **F05**  
Within 8" of Joint: **NO**  
Remarks:

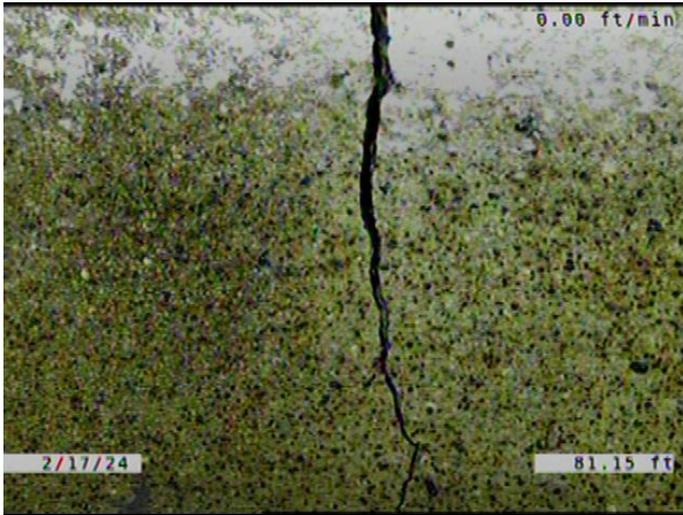
Code: **FM**  
 Description: **Fracture Multiple**

Distance (ft): **81.2**  
 Structural Grade: **4**  
 O&M Grade: **0**  
 Clock Start/From: **10**  
 Clock To: **4**  
 1st Value:  
 2nd Value:  
 Value Percent:  
 Continuous Index:  
 Within 8" of Joint: **YES**  
 Remarks:

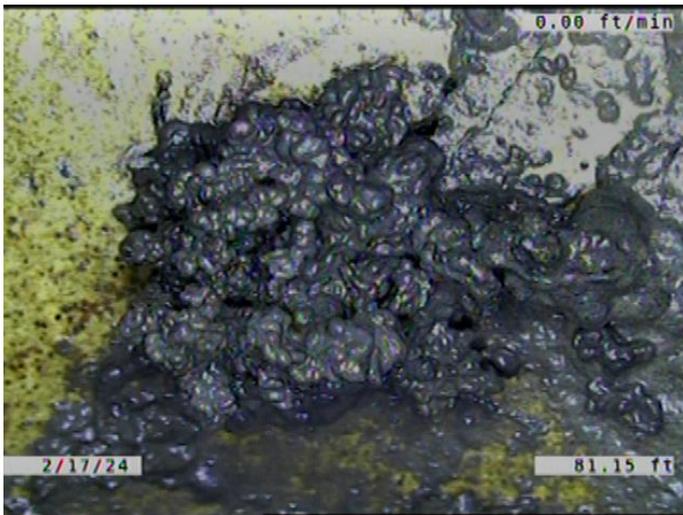
Code: **DAE**  
 Description: **Deposits Attached Encrustation**

Distance (ft): **81.2**  
 Structural Grade: **0**  
 O&M Grade: **2**  
 Clock Start/From: **7**  
 Clock To: **5**  
 1st Value:  
 2nd Value:  
 Value Percent: **5.000**  
 Continuous Index:  
 Within 8" of Joint: **YES**  
 Remarks:

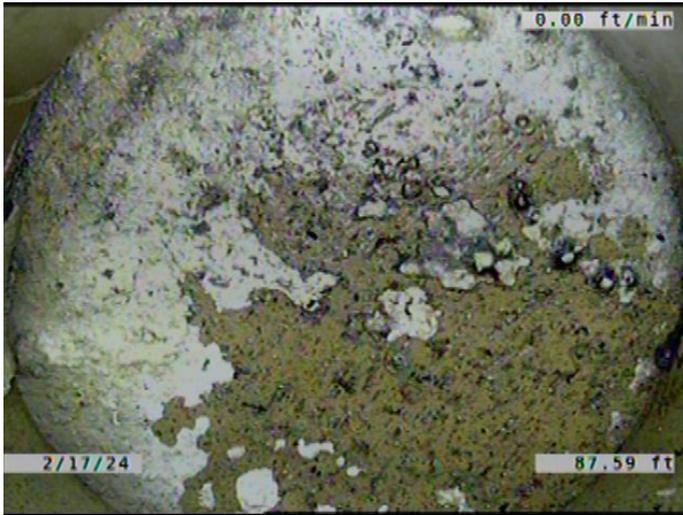
Code: **TFD**  
Description: **Tap Factory Defective**

Distance (ft): **87.6**  
Structural Grade: **0**  
O&M Grade: **3**  
Clock Start/From: **10**  
Clock To:  
1st Value: **6.000**  
2nd Value:  
Value Percent:  
Continuous Index:  
Within 8" of Joint: **YES**  
Remarks: **CAPPED. TAP BROKEN.  
ENCrustATION COMING AROUND T**

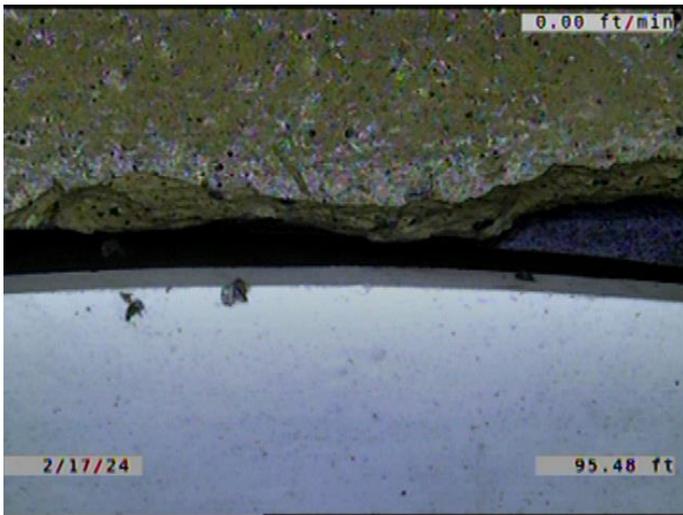
Code: **RPR**  
Description: **Point Repair Replacement**

Distance (ft): **95.5**  
Structural Grade: **0**  
O&M Grade: **0**  
Clock Start/From:  
Clock To:  
1st Value:  
2nd Value:  
Value Percent:  
Continuous Index: **S07**  
Within 8" of Joint: **YES**  
Remarks: **REPLACED WITH PVC.**

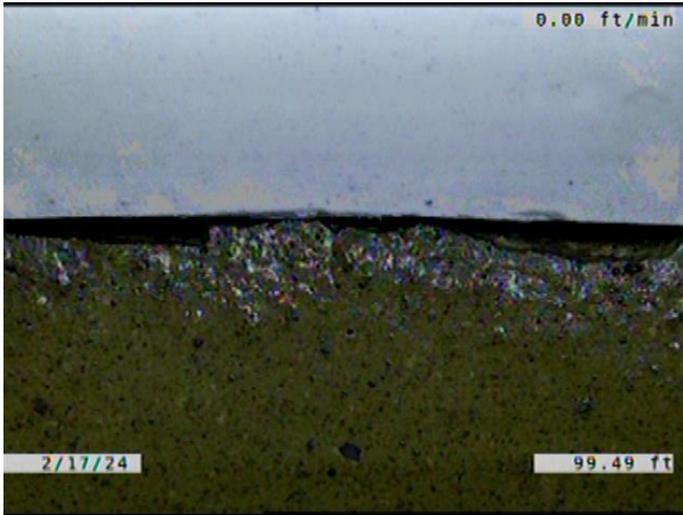
Code: **RPR**  
 Description: **Point Repair Replacement**

Distance (ft): **99.5**  
 Structural Grade: **0**  
 O&M Grade: **0**  
 Clock Start/From:  
 Clock To:  
 1st Value:  
 2nd Value:  
 Value Percent:  
 Continuous Index: **F07**  
 Within 8" of Joint: **YES**  
 Remarks: **REPLACED WITH PVC.**

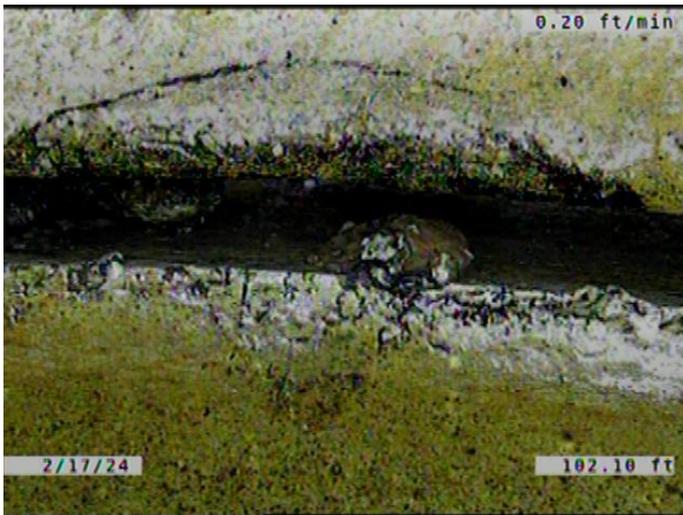
Code: **DAE**  
 Description: **Deposits Attached Encrustation**

Distance (ft): **102.1**  
 Structural Grade: **0**  
 O&M Grade: **2**  
 Clock Start/From: **7**  
 Clock To: **5**  
 1st Value:  
 2nd Value:  
 Value Percent: **5.000**  
 Continuous Index: **S08**  
 Within 8" of Joint: **YES**  
 Remarks:

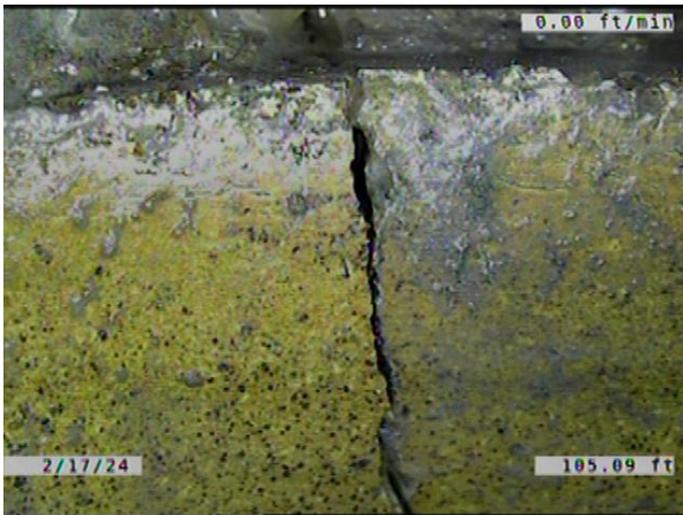
Code: **FM**  
 Description: **Fracture Multiple**

Distance (ft): **105.1**  
 Structural Grade: **4**  
 O&M Grade: **0**  
 Clock Start/From: **8**  
 Clock To: **11**  
 1st Value:  
 2nd Value:  
 Value Percent:  
 Continuous Index:  
 Within 8" of Joint: **YES**  
 Remarks:

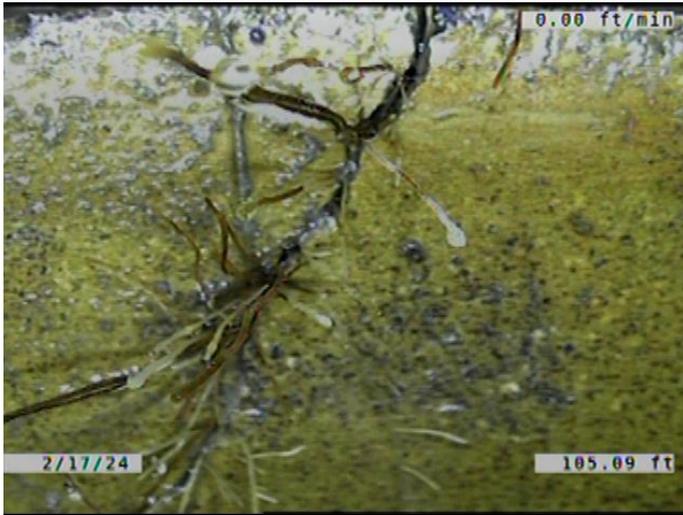
Code: **RFB**  
 Description: **Roots Fine Barrel**

Distance (ft): **105.1**  
 Structural Grade: **0**  
 O&M Grade: **2**  
 Clock Start/From: **10**  
 Clock To: **11**  
 1st Value:  
 2nd Value:  
 Value Percent:  
 Continuous Index:  
 Within 8" of Joint: **NO**  
 Remarks:

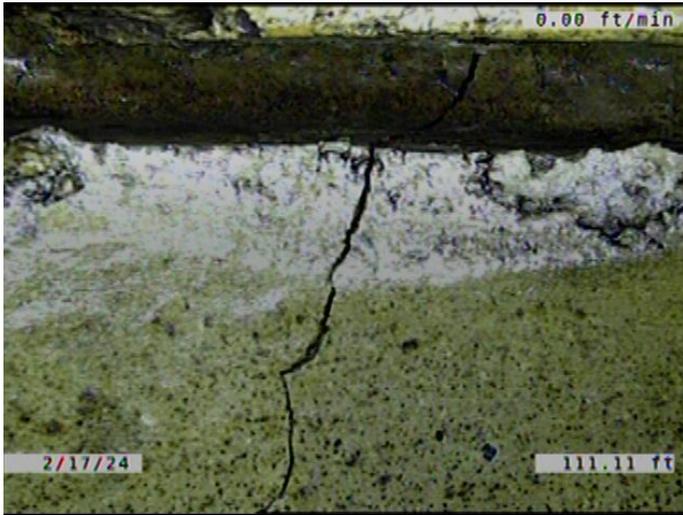
Code: **FM**  
 Description: **Fracture Multiple**

Distance (ft): **111.1**  
 Structural Grade: **4**  
 O&M Grade: **0**  
 Clock Start/From: **8**  
 Clock To: **10**  
 1st Value:  
 2nd Value:  
 Value Percent:  
 Continuous Index:  
 Within 8" of Joint: **YES**  
 Remarks:

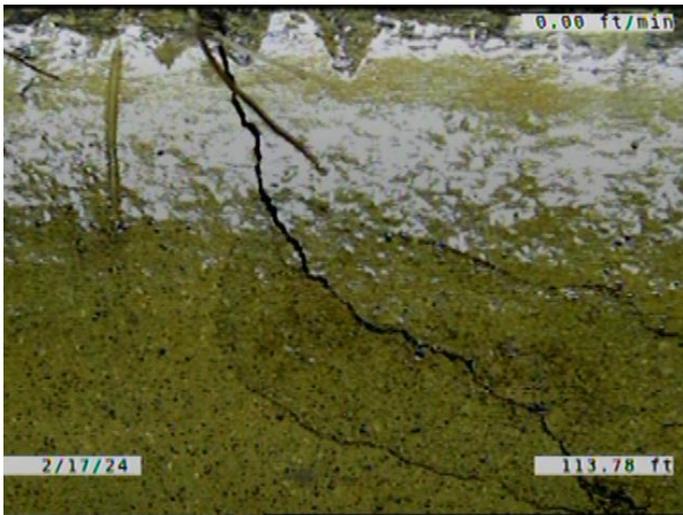
Code: **CM**  
 Description: **Crack Multiple**

Distance (ft): **113.8**  
 Structural Grade: **3**  
 O&M Grade: **0**  
 Clock Start/From: **12**  
 Clock To: **5**  
 1st Value:  
 2nd Value:  
 Value Percent:  
 Continuous Index:  
 Within 8" of Joint: **YES**  
 Remarks:

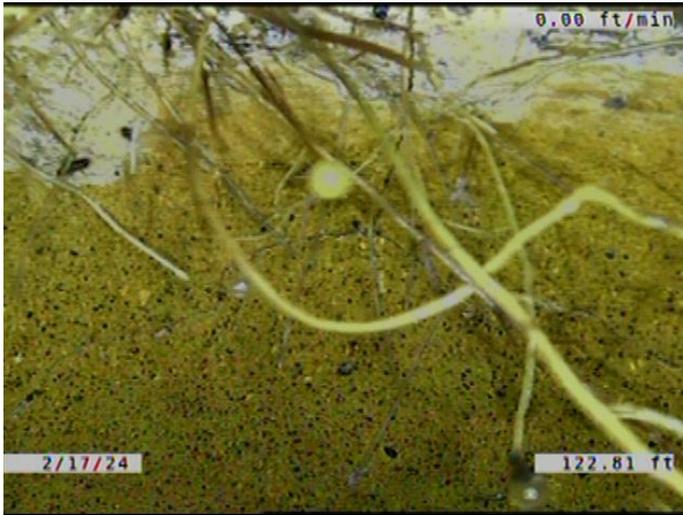
Code: **CM**  
Description: **Crack Multiple**

Distance (ft): **122.8**  
Structural Grade: **3**  
O&M Grade: **0**  
Clock Start/From: **10**  
Clock To: **5**  
1st Value:  
2nd Value:  
Value Percent:  
Continuous Index:  
Within 8" of Joint: **YES**  
Remarks:

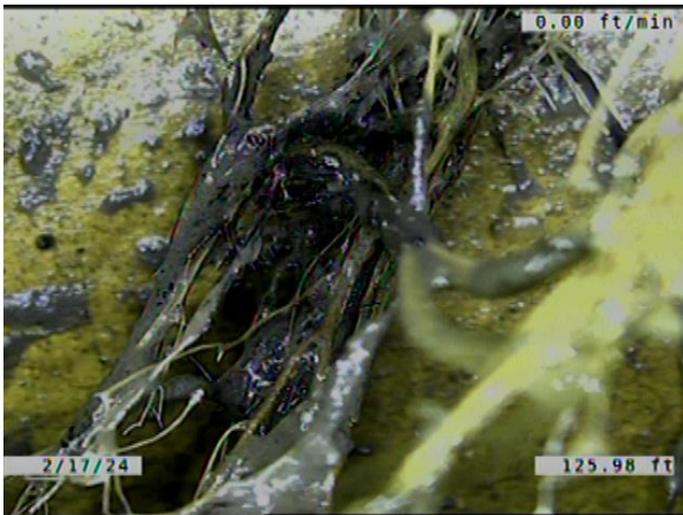
Code: **RFB**  
Description: **Roots Fine Barrel**

Distance (ft): **126.0**  
Structural Grade: **0**  
O&M Grade: **2**  
Clock Start/From: **11**  
Clock To: **1**  
1st Value:  
2nd Value:  
Value Percent:  
Continuous Index:  
Within 8" of Joint: **NO**  
Remarks:

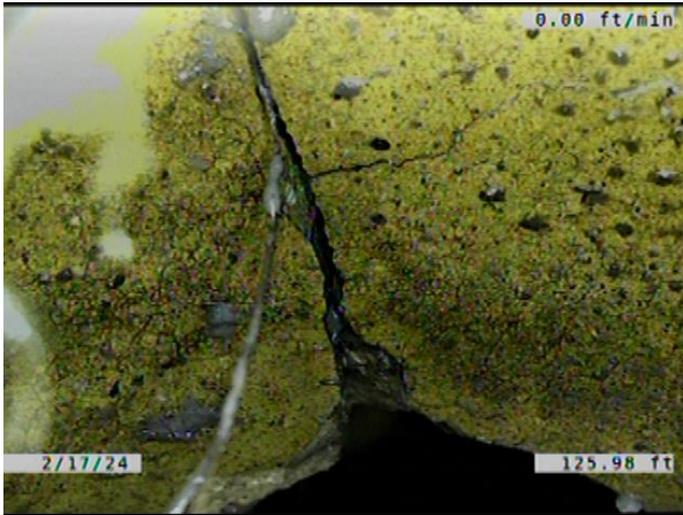
Code: **B**  
 Description: **Broken**

Distance (ft): **126.0**  
 Structural Grade: **4**  
 O&M Grade: **0**  
 Clock Start/From: **9**  
 Clock To: **1**  
 1st Value:  
 2nd Value:  
 Value Percent:  
 Continuous Index:  
 Within 8" of Joint: **YES**  
 Remarks:

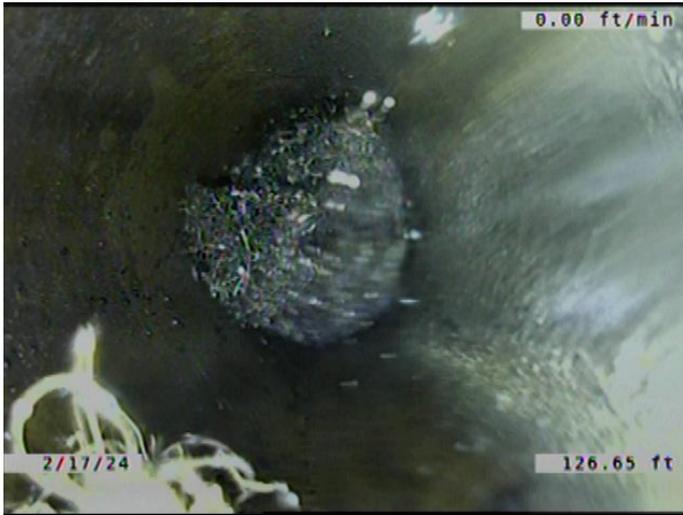
Code: **TBD**  
 Description: **Tap Break-in/Hammer Defective**

Distance (ft): **126.6**  
 Structural Grade: **0**  
 O&M Grade: **3**  
 Clock Start/From: **12**  
 Clock To:  
 1st Value: **6.000**  
 2nd Value:  
 Value Percent:  
 Continuous Index:  
 Within 8" of Joint: **YES**  
 Remarks: **SERVICE LOOKS LIKE IT GOES TO THE RIGHT (WEST). CONSTANTLY DRIPPI**

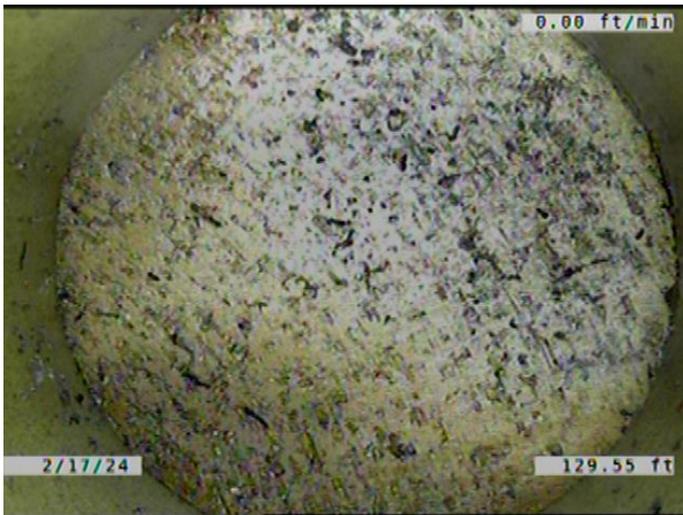
Code: **TFD**  
 Description: **Tap Factory Defective**

Distance (ft): **129.5**  
 Structural Grade: **0**  
 O&M Grade: **3**  
 Clock Start/From: **2**  
 Clock To:  
 1st Value: **6.000**  
 2nd Value:  
 Value Percent:  
 Continuous Index:  
 Within 8" of Joint: **YES**  
 Remarks: **CAPPED. TAP BROKEN.**

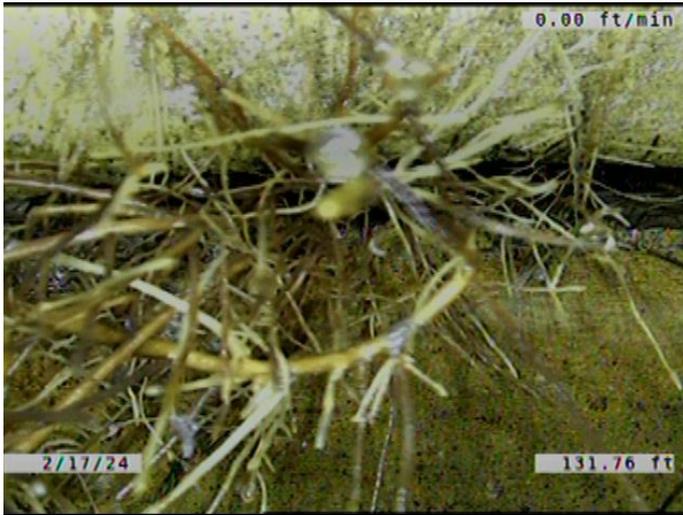
Code: **RMJ**  
Description: **Roots Medium Joint**

Distance (ft): **131.8**  
Structural Grade: **0**  
O&M Grade: **3**  
Clock Start/From: **7**  
Clock To: **5**  
1st Value:  
2nd Value:  
Value Percent: **5.000**  
Continuous Index:  
Within 8" of Joint: **YES**  
Remarks:

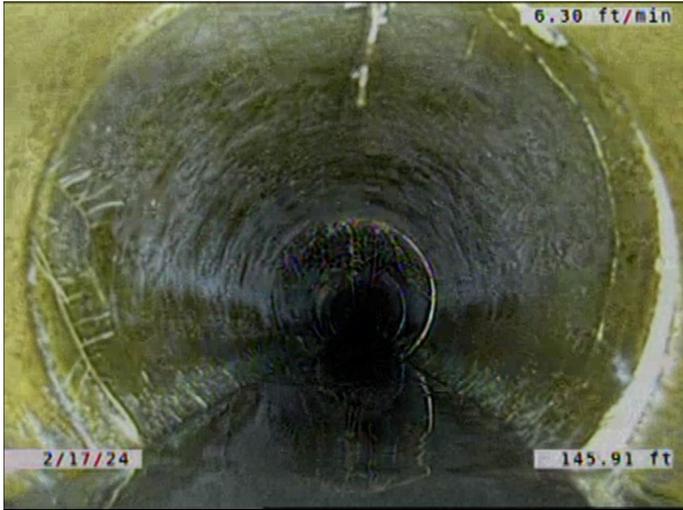
Code: **FM**  
Description: **Fracture Multiple**

Distance (ft): **145.9**  
Structural Grade: **4**  
O&M Grade: **0**  
Clock Start/From: **12**  
Clock To: **4**  
1st Value:  
2nd Value:  
Value Percent:  
Continuous Index: **S06**  
Within 8" of Joint: **YES**  
Remarks:

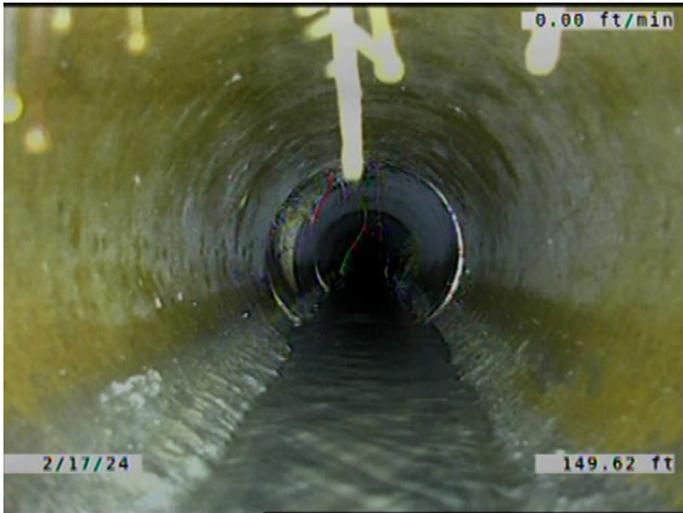
Code: **MWLS**  
Description: **Miscellaneous Water Level Sag**

Distance (ft): **149.6**  
Structural Grade: **2**  
O&M Grade: **0**  
Clock Start/From:  
Clock To:  
1st Value:  
2nd Value:  
Value Percent: **10.000**  
Continuous Index: **F11**  
Within 8" of Joint: **NO**  
Remarks:

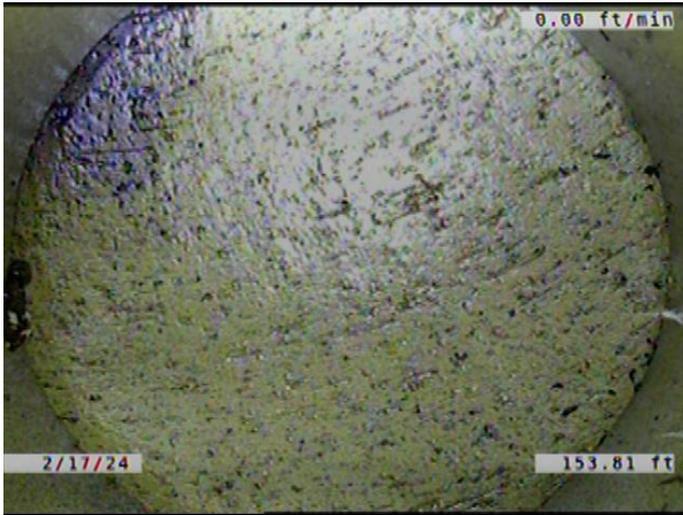
Code: **TFD**  
 Description: **Tap Factory Defective**

Distance (ft): **153.8**  
 Structural Grade: **0**  
 O&M Grade: **3**  
 Clock Start/From: **10**  
 Clock To:  
 1st Value: **6.000**  
 2nd Value:  
 Value Percent:  
 Continuous Index:  
 Within 8" of Joint: **YES**  
 Remarks: **CAPPED. TAP BROKEN.**

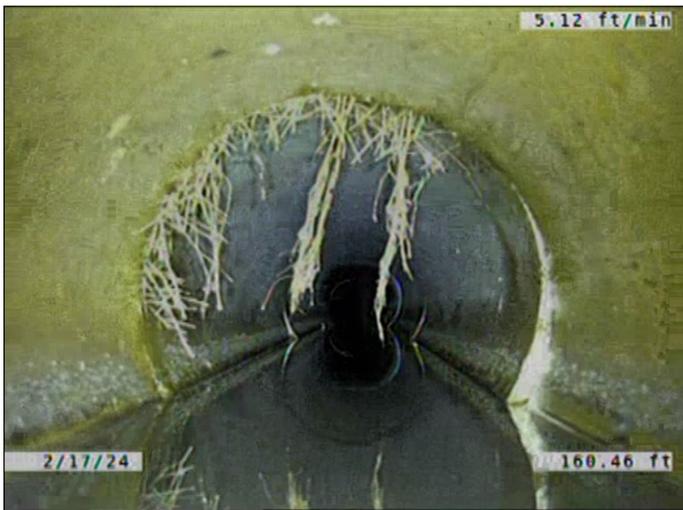
Code: **FM**  
 Description: **Fracture Multiple**

Distance (ft): **160.5**  
 Structural Grade: **4**  
 O&M Grade: **0**  
 Clock Start/From: **12**  
 Clock To: **4**  
 1st Value:  
 2nd Value:  
 Value Percent:  
 Continuous Index: **F06**  
 Within 8" of Joint: **YES**  
 Remarks:

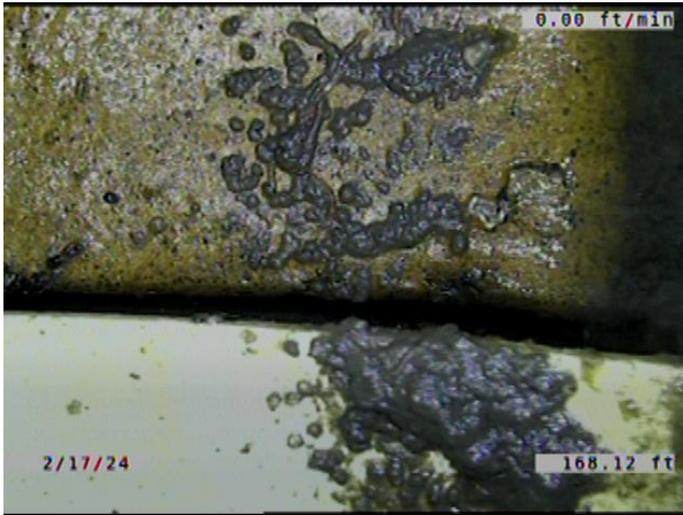
Code: **RPR**  
Description: **Point Repair Replacement**

Distance (ft): **168.1**  
Structural Grade: **0**  
O&M Grade: **0**  
Clock Start/From:  
Clock To:  
1st Value:  
2nd Value:  
Value Percent:  
Continuous Index: **S12**  
Within 8" of Joint: **YES**  
Remarks: **REPLACED WITH PVC.**

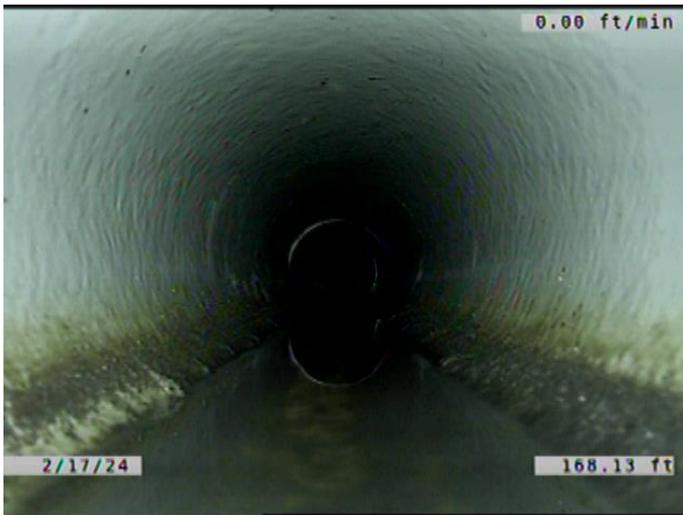
Code: **DAE**  
Description: **Deposits Attached Encrustation**

Distance (ft): **168.1**  
Structural Grade: **0**  
O&M Grade: **2**  
Clock Start/From: **7**  
Clock To: **5**  
1st Value:  
2nd Value:  
Value Percent: **5.000**  
Continuous Index: **F08**  
Within 8" of Joint: **YES**  
Remarks:

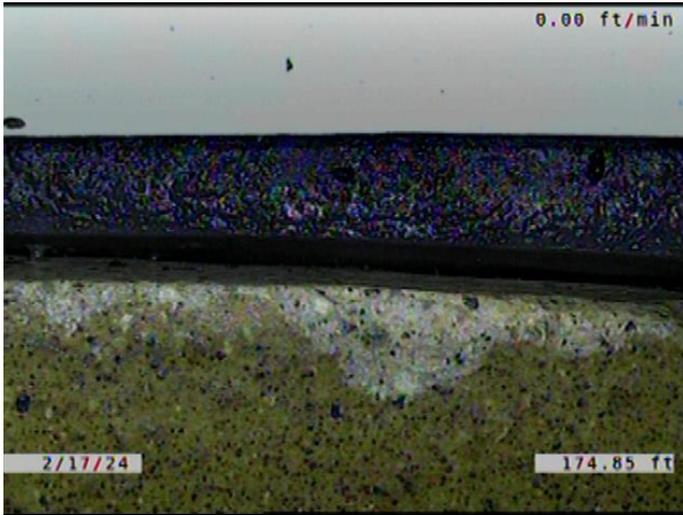
Code: **RPR**  
 Description: **Point Repair Replacement**

Distance (ft): **174.8**  
 Structural Grade: **0**  
 O&M Grade: **0**  
 Clock Start/From:  
 Clock To:  
 1st Value:  
 2nd Value:  
 Value Percent:  
 Continuous Index: **F12**  
 Within 8" of Joint: **YES**  
 Remarks: **REPLACED WITH PVC.**

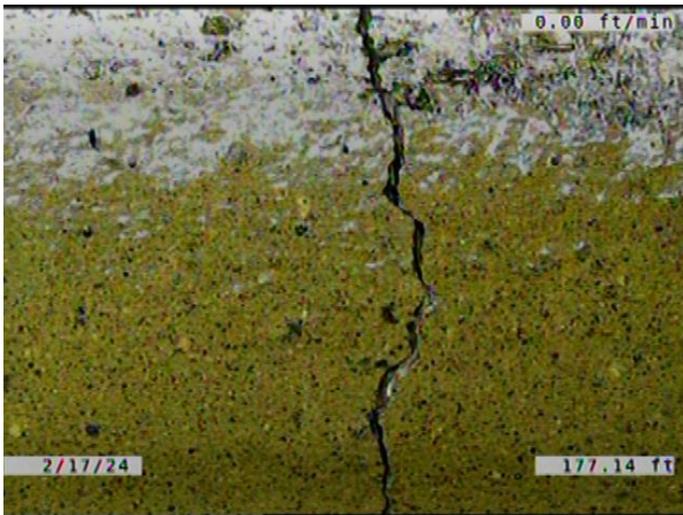
Code: **B**  
 Description: **Broken**

Distance (ft): **177.1**  
 Structural Grade: **4**  
 O&M Grade: **0**  
 Clock Start/From: **7**  
 Clock To: **5**  
 1st Value:  
 2nd Value:  
 Value Percent:  
 Continuous Index:  
 Within 8" of Joint: **YES**  
 Remarks:

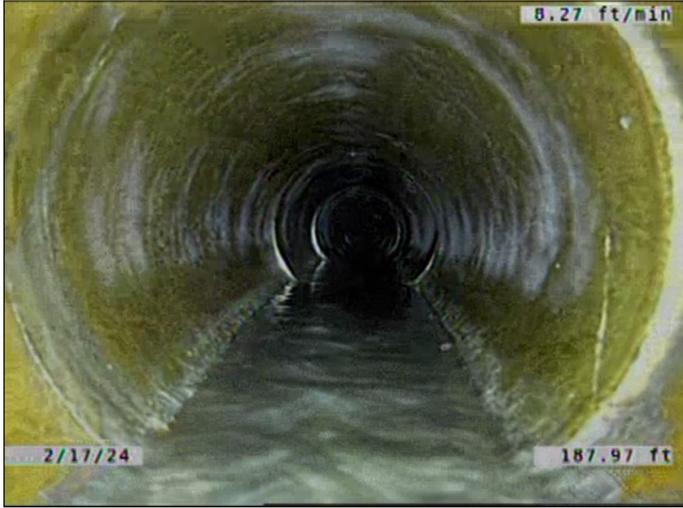
Code: **FM**  
 Description: **Fracture Multiple**

Distance (ft): **188.0**  
 Structural Grade: **4**  
 O&M Grade: **0**  
 Clock Start/From: **8**  
 Clock To: **4**  
 1st Value:  
 2nd Value:  
 Value Percent:  
 Continuous Index:  
 Within 8" of Joint: **YES**  
 Remarks:

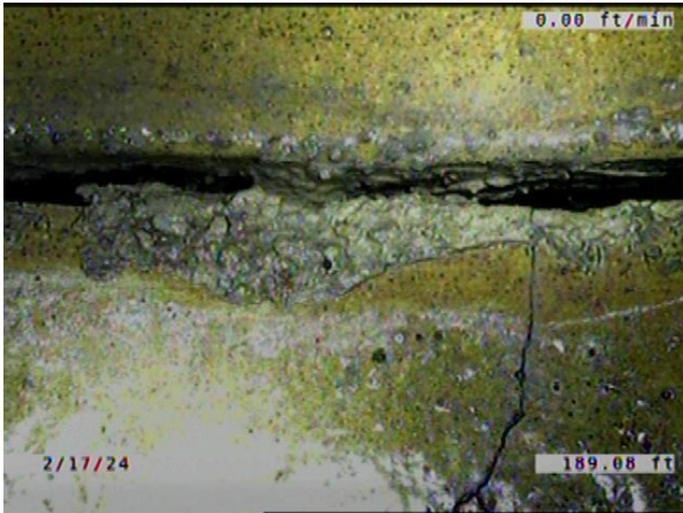
Code: **DAE**  
 Description: **Deposits Attached Encrustation**

Distance (ft): **189.1**  
 Structural Grade: **0**  
 O&M Grade: **2**  
 Clock Start/From: **7**  
 Clock To: **5**  
 1st Value:  
 2nd Value:  
 Value Percent: **5.000**  
 Continuous Index: **S14**  
 Within 8" of Joint: **NO**  
 Remarks:

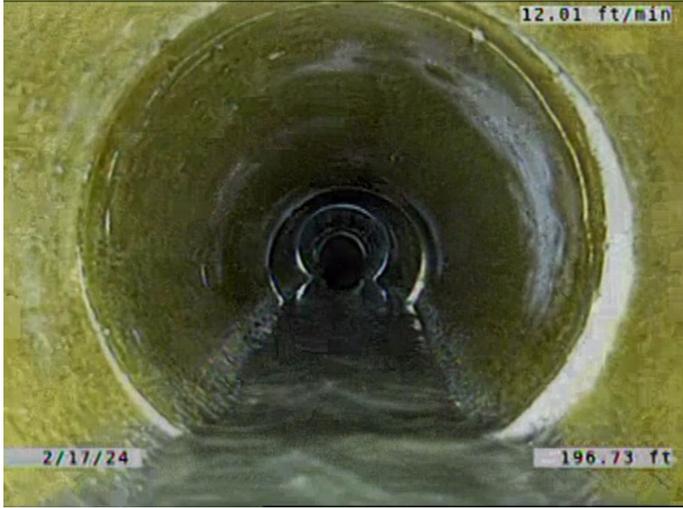
Code: **FM**  
 Description: **Fracture Multiple**

Distance (ft): **196.7**  
 Structural Grade: **4**  
 O&M Grade: **0**  
 Clock Start/From: **9**  
 Clock To: **3**  
 1st Value:  
 2nd Value:  
 Value Percent:  
 Continuous Index:  
 Within 8" of Joint: **YES**  
 Remarks:

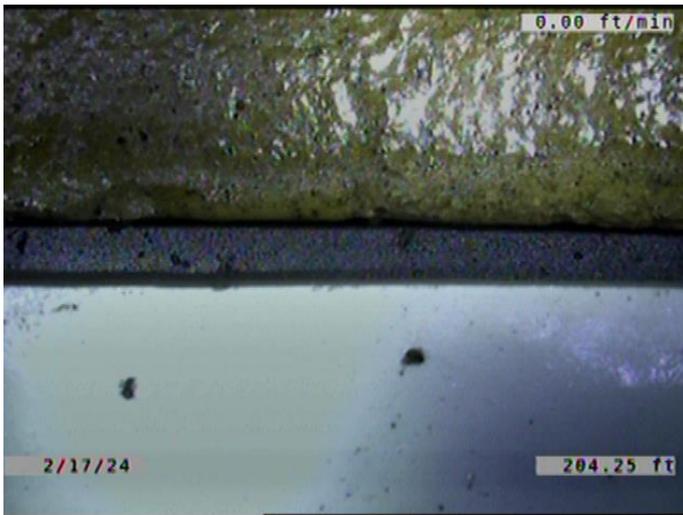
Code: **RPR**  
Description: **Point Repair Replacement**

Distance (ft): **204.2**  
Structural Grade: **0**  
O&M Grade: **0**  
Clock Start/From:  
Clock To:  
1st Value:  
2nd Value:  
Value Percent:  
Continuous Index: **S16**  
Within 8" of Joint: **YES**  
Remarks: **REPLACED WITH PVC.**

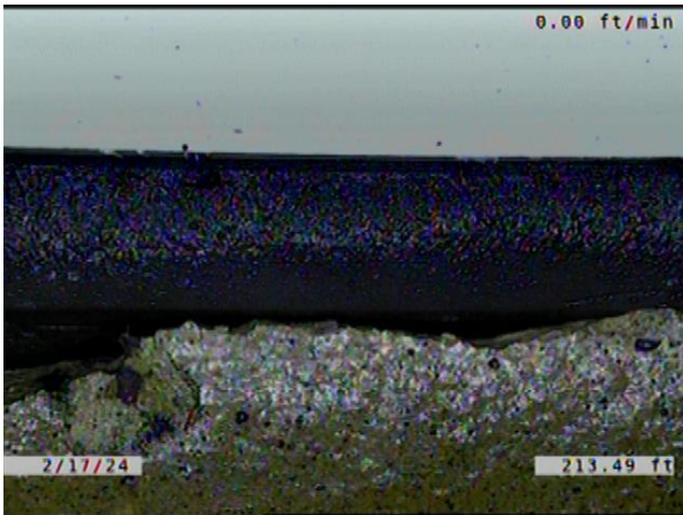
Code: **RPR**  
 Description: **Point Repair Replacement**

Within 8" of Joint: **YES**  
 Remarks: **REPLACED WITH PVC.**

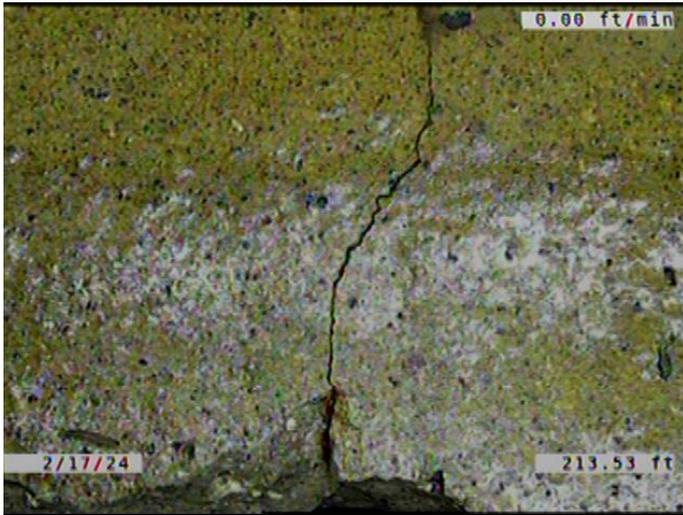
Code: **FM**  
Description: **Fracture Multiple**

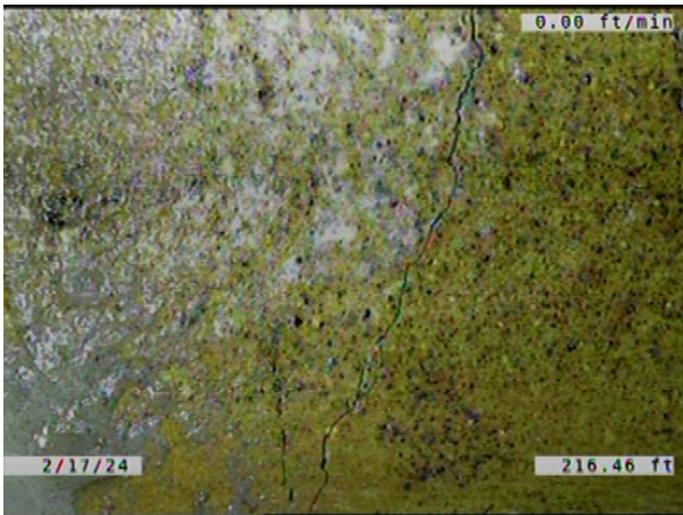
Code: **CM**  
Description: **Crack Multiple**

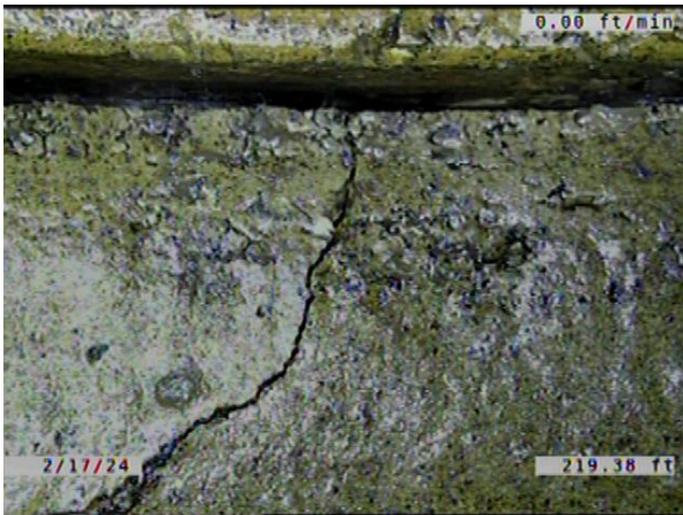
Code: **FM**  
Description: **Fracture Multiple**

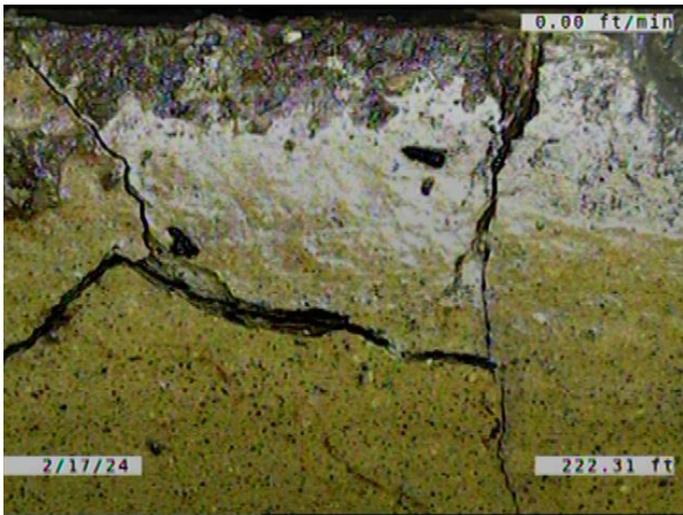
Code: **B**  
Description: **Broken**
