# Profile/Photo Observation Report

Date: **02/17/2024**      Weather:      Coding: **PACP 7.0**  
 Pipe Length (ft): **333.0**      Owner: **City of Hobart**      Pre Clean: **Heavy Cleaning**  
 P.O.#: **YES502259**      Surveyor: **S. Bucklin**      PSR: **P-405-035-031**  
 Customer: **City of Hobart**      Clean Date: **10/13/2023**      Shape: **C**

Street: **SOFTWOOD DR**      Flow Control: **Not Controlled**  
 City: **Hobart, IN**      Year Renewed:  
 Location: **Easement/Right of Way**      Tape/Media #:  
 Purpose: **Routine Assessment**      Dia/Height: **8"**  
 Use: **Sanitary Sewage Pipe**      Material: **VCP**  
 Drain Area:      Lining: **None**  
 Category: **NA**  
 Comment:  
 Location Details:      Direction of Survey: **Downstream**  
 US MH: **M-405-031**      DS MH: **M-405-035**      Total Length Surveyed (ft): **327.9**

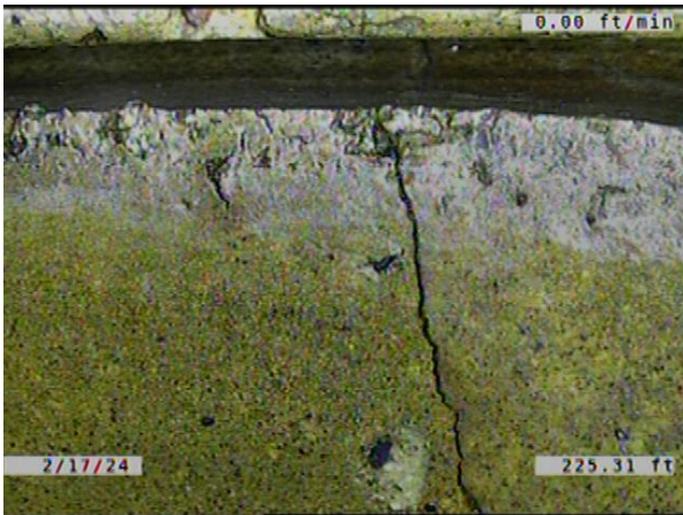
Code: **CS**  
 Description: **Crack Spiral**

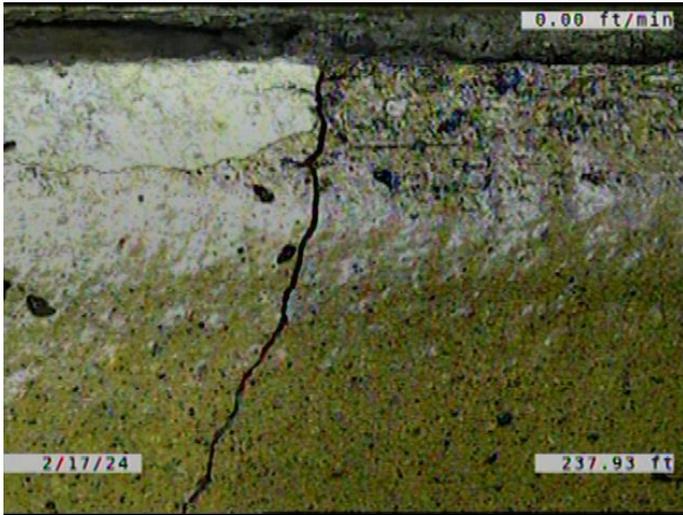
Code: **FM**  
 Description: **Fracture Multiple**

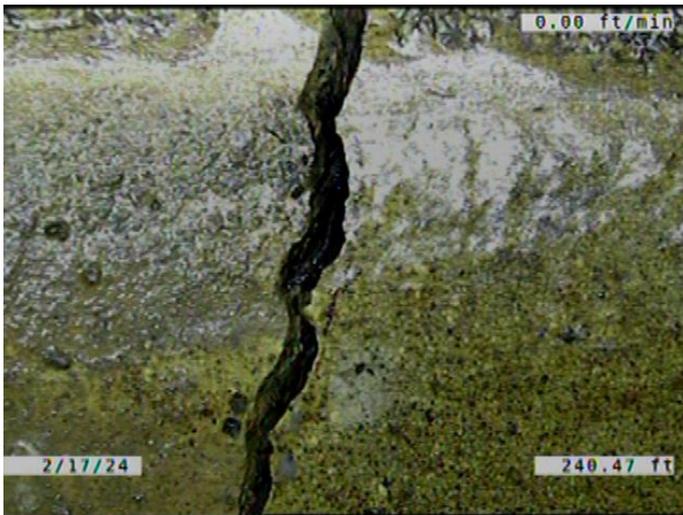
Code: **B**  
 Description: **Broken**

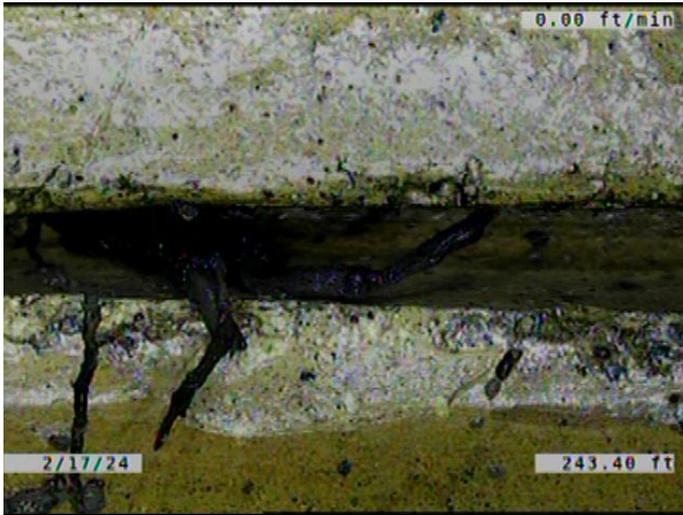
Code: **RFJ**  
Description: **Roots Fine Joint**

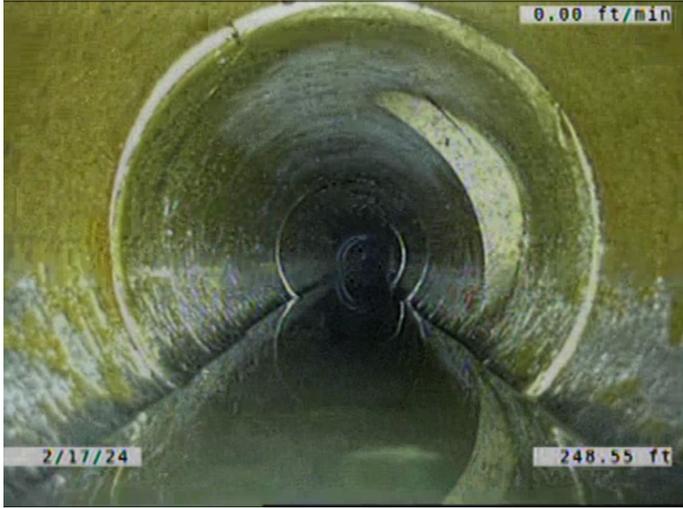
Code: **B**  
Description: **Broken**

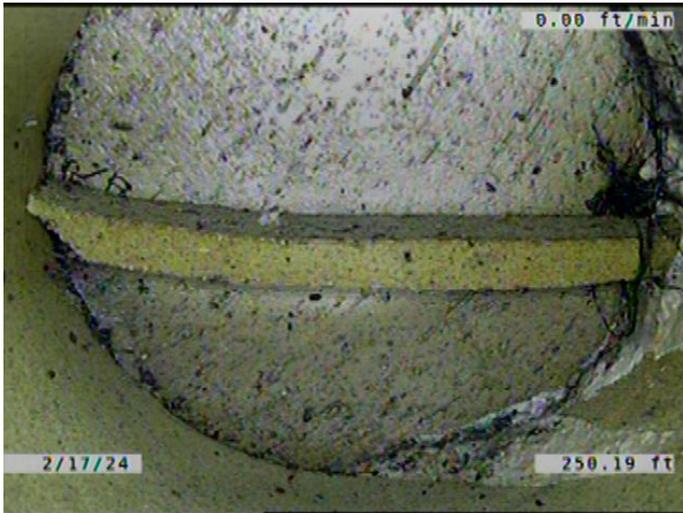
Code: **TFD**  
Description: **Tap Factory Defective**

Distance (ft): **250.2**  
Structural Grade: **0**  
O&M Grade: **3**  
Clock Start/From: **2**  
Clock To:  
1st Value: **6.000**  
2nd Value:  
Value Percent:  
Continuous Index:  
Within 8" of Joint: **YES**  
Remarks: **CAPPED. TAP BROKEN. ROOTS AND ENCRUSTATION CIMING AROUND T**

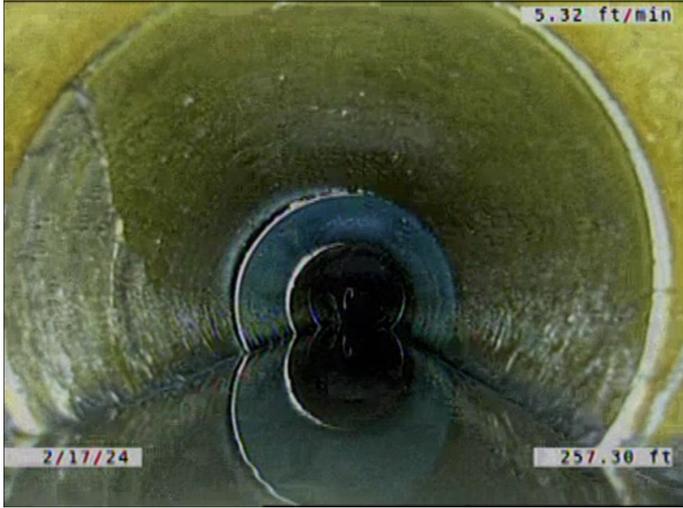
Code: **FM**  
Description: **Fracture Multiple**

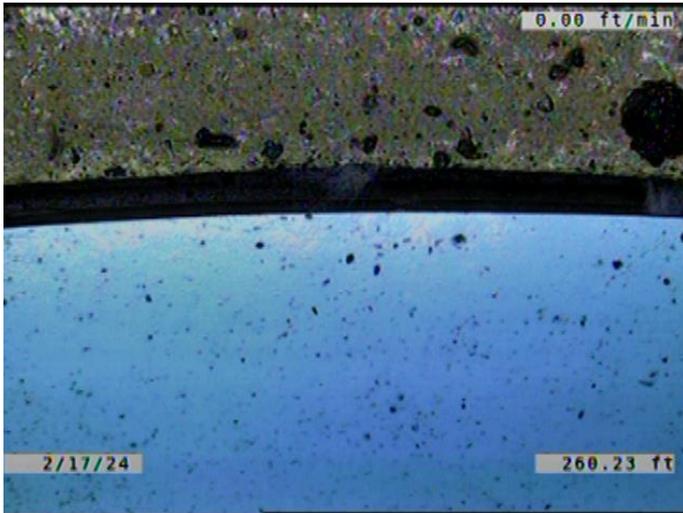
Code: **RPR**  
Description: **Point Repair Replacement**

Distance (ft): **260.2**  
Structural Grade: **0**  
O&M Grade: **0**  
Clock Start/From:  
Clock To:  
1st Value:  
2nd Value:  
Value Percent:  
Continuous Index:  
Within 8" of Joint: **YES**  
Remarks: **REPLACED WITH PVC BY H&G OCT 2023.**

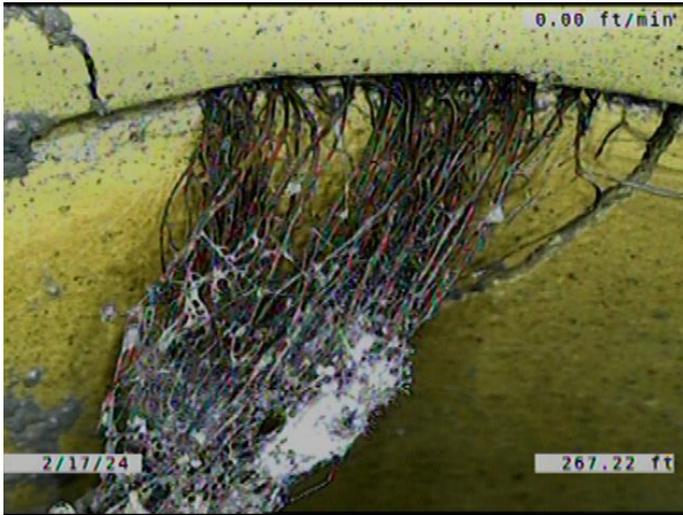
Code: **RFJ**  
 Description: **Roots Fine Joint**

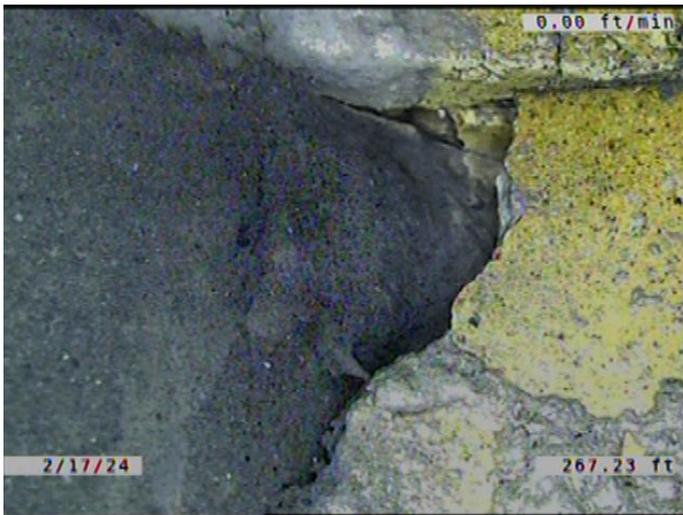
Code: **SMW**  
 Description: **Surface Damage Missing Wall**

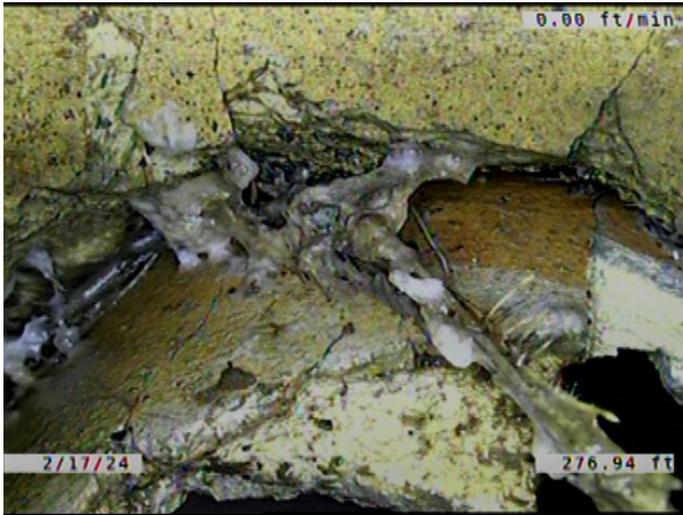
Code: **RFC**  
 Description: **Roots Fine Connection**
