Profile/Photo Observation Report

Date:	04/19/2018	Weather:		Coding:	PACP 6.0
Pipe Length (ft):	318.6	Owner:	NA	Pre Clean:	No Pre-Cleaning
P.O.#:		Surveyor:	Byrd Fitzgerald	PSR:	P-405-036-035
Customer:		Clean Date:	01/01/1900	Shape:	C

Street:	ALLEY BETWEEN SOFTWOOD DR & C	Flow Control:	Not Controlled
City:	Hobart, IN	Year Renewed:	
Location:	Yard	Tape/Media #:	
Purpose:	Routine Assessment	Dia/Height:	8"
Use:	Sanitary	Material:	PVC
Drain Area:	NA	Lining:	
Category:	NA		
Comment:	P_C At 173 ft roots

Location Details:		Direction of Survey:	Downstream
US MH:	M-405-035	DS MH:	M-405-036
		Total Length Surveyed (ft):	175.0

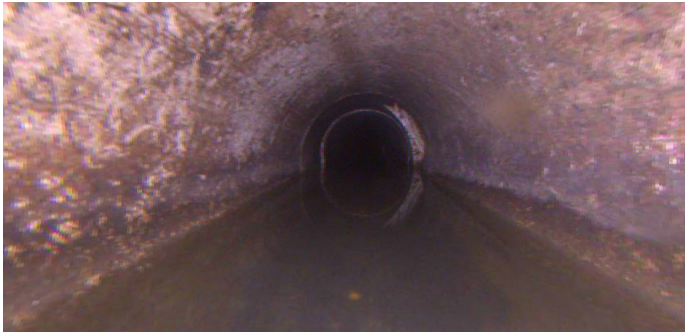
Code: **AMH**
Description: **Manhole**

Distance (ft): **.0**
Structural Grade: **0**
O&M Grade: **0**
Clock Start/From:
Clock To:
1st Value:
2nd Value:
Value Percent:
Continuous Index:
Within 8" of Joint: **NO**
Remarks: **M-405-035**

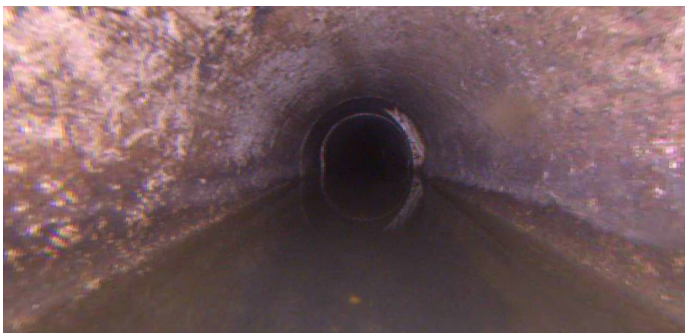
Code: **MWL**
Description: **Water Level**

Distance (ft): **.0**
Structural Grade: **0**
O&M Grade: **0**
Clock Start/From:
Clock To:
1st Value:
2nd Value:
Value Percent: **10.000**
Continuous Index:
Within 8" of Joint: **NO**
Remarks:

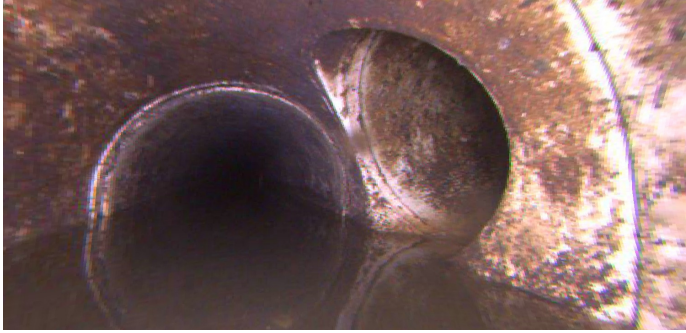
Code: **TF**
Description: **Tap Factory**

Distance (ft): **2.6**
Structural Grade: **0**
O&M Grade: **0**
Clock Start/From: **2**
Clock To:
1st Value: **6.000**
2nd Value:
Value Percent:
Continuous Index:
Within 8" of Joint: **YES**
Remarks:

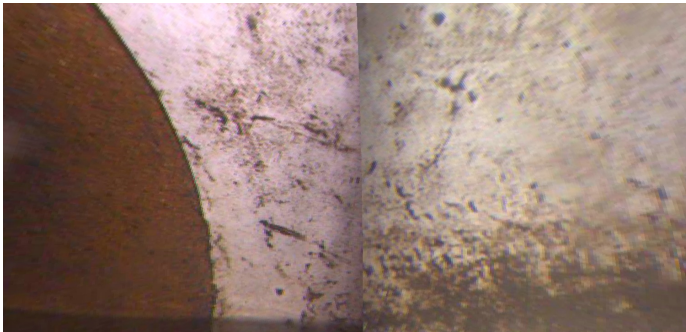
Code: **MMC**
Description: **Material Change**

Distance (ft): **27.9**
Structural Grade: **0**
O&M Grade: **0**
Clock Start/From:
Clock To:
1st Value:
2nd Value:
Value Percent:
Continuous Index:
Within 8" of Joint: **NO**
Remarks: **vcp**

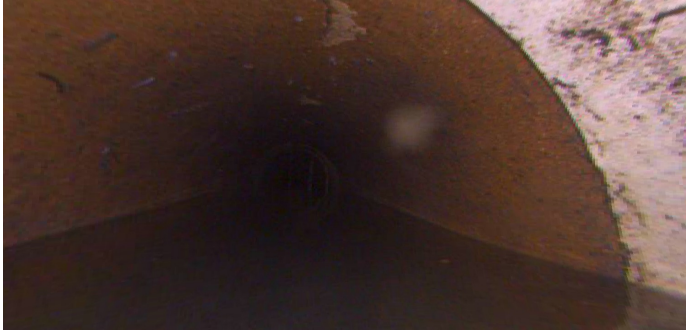
Code: **MWL**
Description: **Water Level**

Distance (ft): **27.9**
Structural Grade: **0**
O&M Grade: **0**
Clock Start/From:
Clock To:
1st Value:
2nd Value:
Value Percent: **50.000**
Continuous Index:
Within 8" of Joint: **NO**
Remarks:

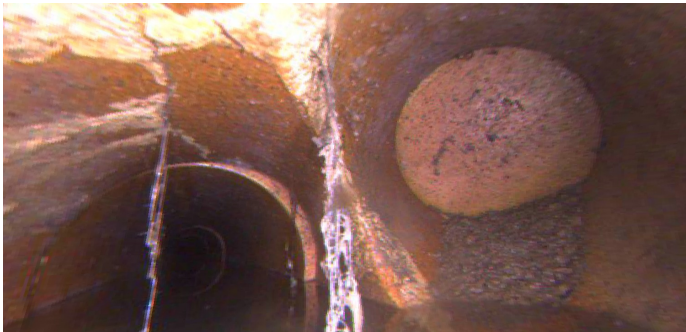
Code: **TFC**
Description: **Tap Factory Capped**

Distance (ft): **30.1**
Structural Grade: **0**
O&M Grade: **0**
Clock Start/From: **2**
Clock To:
1st Value: **4.000**
2nd Value:
Value Percent:
Continuous Index:
Within 8" of Joint: **YES**
Remarks:

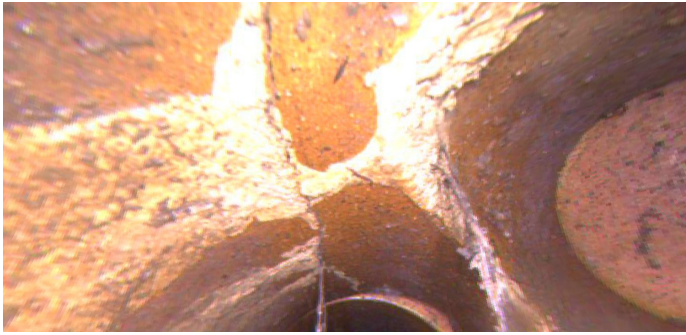
Code: **CL**
Description: **Crack Longitudinal**

Distance (ft): **30.1**
Structural Grade: **2**
O&M Grade: **0**
Clock Start/From: **12**
Clock To:
1st Value:
2nd Value:
Value Percent:
Continuous Index:
Within 8" of Joint: **YES**
Remarks:

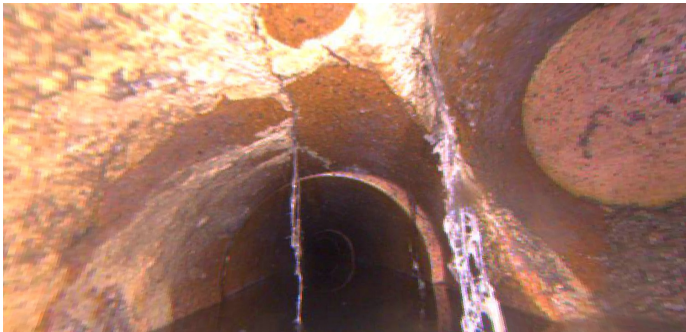
Code: **RFC**
Description: **Roots Fine Connection**

Distance (ft): **30.1**
Structural Grade: **0**
O&M Grade: **1**
Clock Start/From: **1**
Clock To:
1st Value:
2nd Value:
Value Percent:
Continuous Index:
Within 8" of Joint: **NO**
Remarks:

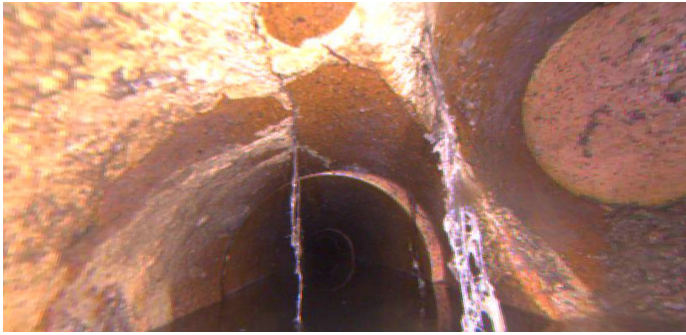
Code: **RFB**
Description: **Roots Fine Barrel**

Distance (ft): **30.1**
Structural Grade: **0**
O&M Grade: **2**
Clock Start/From: **12**
Clock To:
1st Value:
2nd Value:
Value Percent:
Continuous Index:
Within 8" of Joint: **NO**
Remarks:

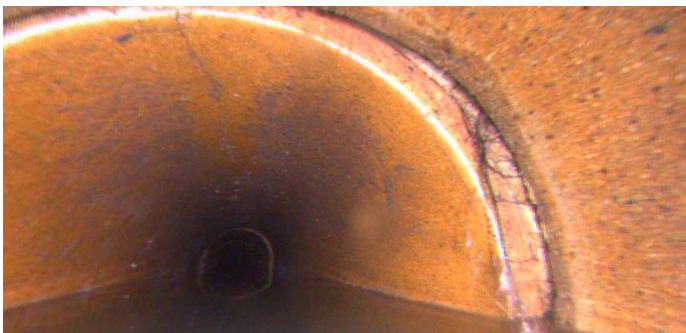
Code: **RFJ**
Description: **Roots Fine Joint**

Distance (ft): **30.7**
Structural Grade: **0**
O&M Grade: **1**
Clock Start/From: **2**
Clock To:
1st Value:
2nd Value:
Value Percent:
Continuous Index: **S01**
Within 8" of Joint: **YES**
Remarks: **wandering**

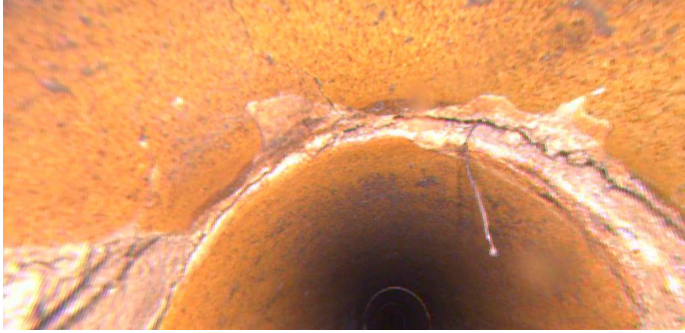
Code: **CM**
Description: **Crack Multiple**

Distance (ft): **33.7**
Structural Grade: **3**
O&M Grade: **0**
Clock Start/From: **10**
Clock To: **11**
1st Value:
2nd Value:
Value Percent:
Continuous Index: **S02**
Within 8" of Joint: **YES**
Remarks: **wnadering**

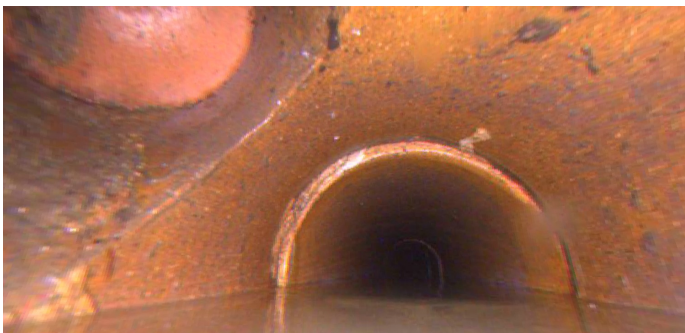
Code: **TFC**
Description: **Tap Factory Capped**

Distance (ft): **39.3**
Structural Grade: **0**
O&M Grade: **0**
Clock Start/From: **11**
Clock To:
1st Value: **4.000**
2nd Value:
Value Percent:
Continuous Index:
Within 8" of Joint: **YES**
Remarks:

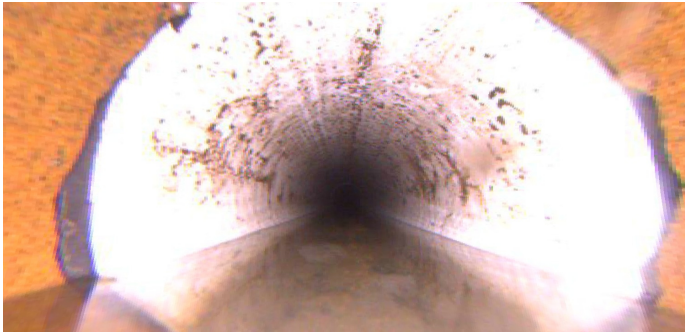
Code: **MMC**
Description: **Material Change**

Distance (ft): **57.2**
Structural Grade: **0**
O&M Grade: **0**
Clock Start/From:
Clock To:
1st Value:
2nd Value:
Value Percent:
Continuous Index:
Within 8" of Joint: **NO**
Remarks: **pvc**

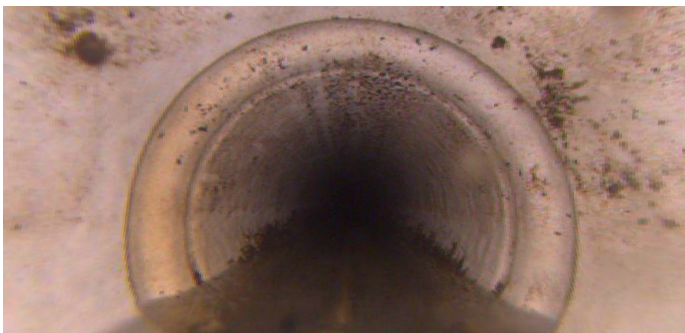
Code: **MWL**
Description: **Water Level**

Distance (ft): **62.8**
Structural Grade: **0**
O&M Grade: **0**
Clock Start/From:
Clock To:
1st Value:
2nd Value:
Value Percent: **5.000**
Continuous Index:
Within 8" of Joint: **NO**
Remarks:

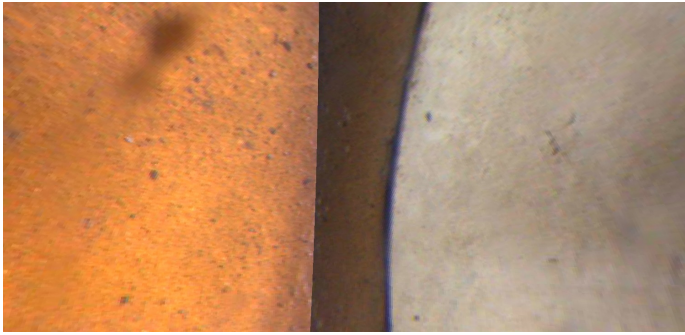
Code: **MMC**
Description: **Material Change**

Distance (ft): **76.3**
Structural Grade: **0**
O&M Grade: **0**
Clock Start/From:
Clock To:
1st Value:
2nd Value:
Value Percent:
Continuous Index:
Within 8" of Joint: **NO**
Remarks: **vcp**

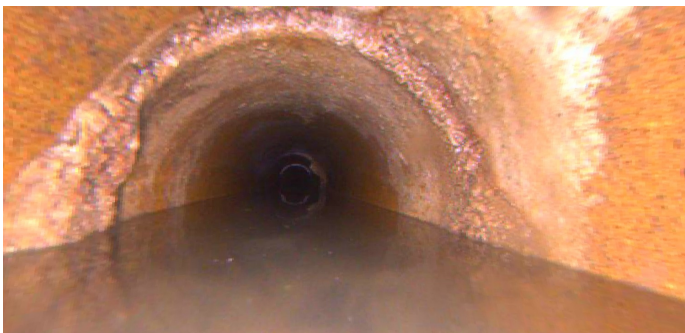
Code: **DAZ**
Description: **Deposits Attached Other**

Distance (ft): **78.7**
Structural Grade: **0**
O&M Grade: **2**
Clock Start/From: **8**
Clock To: **4**
1st Value:
2nd Value:
Value Percent: **5.000**
Continuous Index: **S03**
Within 8" of Joint: **YES**
Remarks: **wandering**

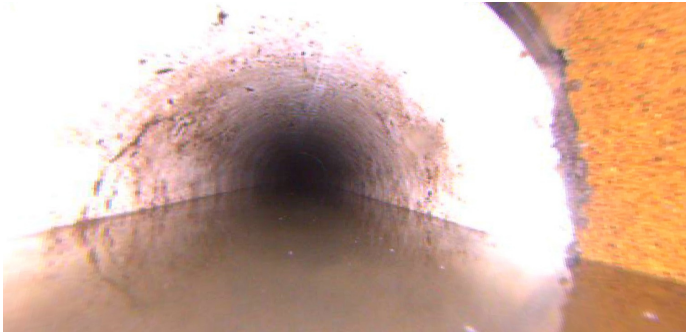
Code:	MMC
Description:	Material Change
Distance (ft):	84.7
Structural Grade:	0
O&M Grade:	0
Clock Start/From:	
Clock To:	
1st Value:	
2nd Value:	
Value Percent:	
Continuous Index:	
Within 8" of Joint:	NO
Remarks:	pvc

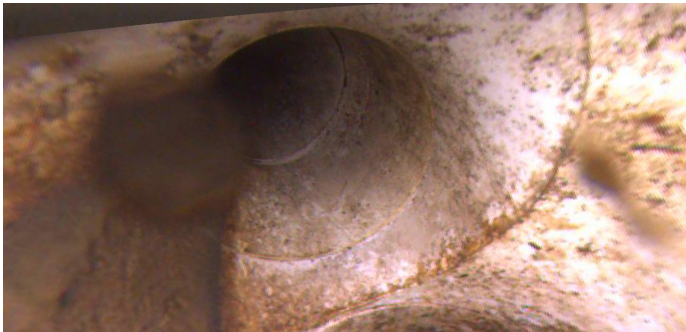
Code:	TF
Description:	Tap Factory
Distance (ft):	104.1
Structural Grade:	0
O&M Grade:	0
Clock Start/From:	11
Clock To:	
1st Value:	4.000
2nd Value:	
Value Percent:	
Continuous Index:	
Within 8" of Joint:	YES
Remarks:

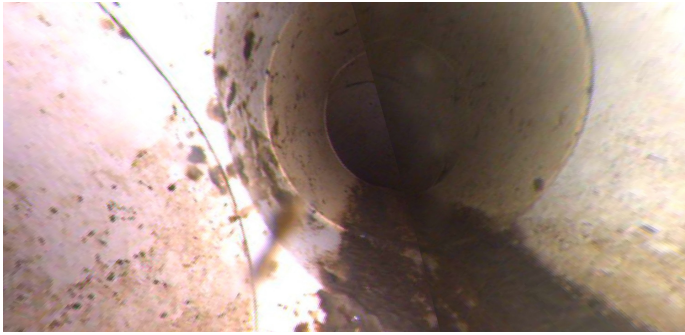
Code: **TF**
Description: **Tap Factory**

Distance (ft): **105.9**
Structural Grade: **0**
O&M Grade: **0**
Clock Start/From: **1**
Clock To:
1st Value: **4.000**
2nd Value:
Value Percent:
Continuous Index:
Within 8" of Joint: **YES**
Remarks:

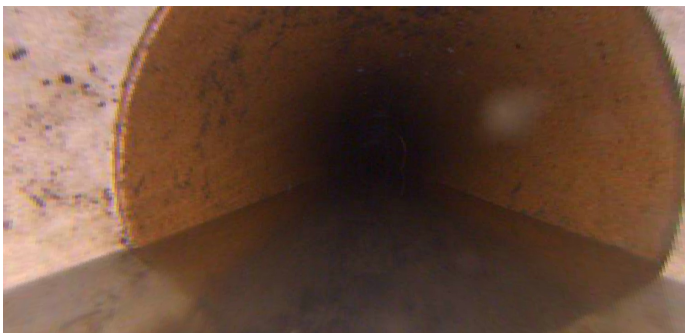
Code: **MMC**
Description: **Material Change**

Distance (ft): **120.9**
Structural Grade: **0**
O&M Grade: **0**
Clock Start/From:
Clock To:
1st Value:
2nd Value:
Value Percent:
Continuous Index:
Within 8" of Joint: **NO**
Remarks: **vcp**

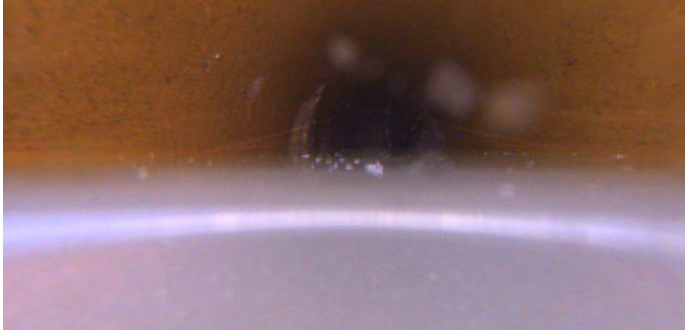
Code: **MWL**
Description: **Water Level**

Distance (ft): **170.7**
Structural Grade: **0**
O&M Grade: **0**
Clock Start/From:
Clock To:
1st Value:
2nd Value:
Value Percent: **50.000**
Continuous Index:
Within 8" of Joint: **NO**
Remarks:

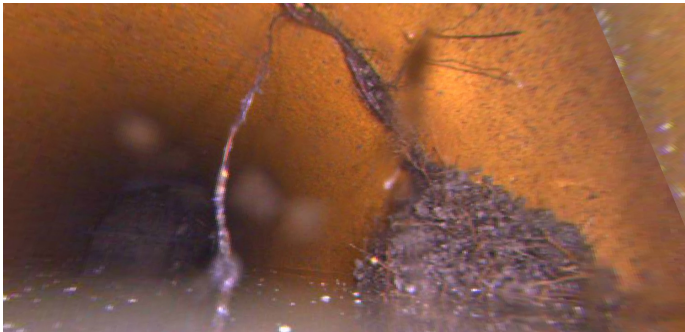
Code: **RMJ**
Description: **Roots Medium Joint**

Distance (ft): **172.1**
Structural Grade: **0**
O&M Grade: **3**
Clock Start/From: **3**
Clock To:
1st Value:
2nd Value:
Value Percent: **5.000**
Continuous Index:
Within 8" of Joint: **YES**
Remarks:

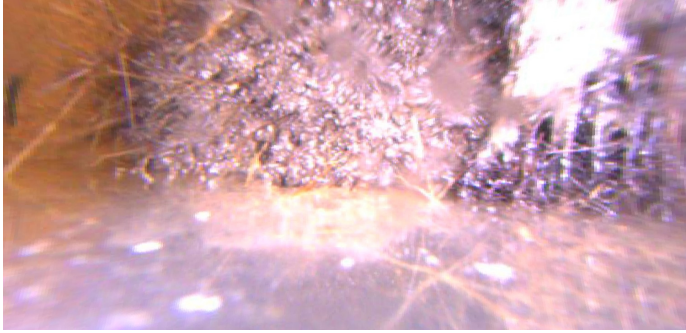
Code: **RBJ**
Description: **Roots Ball Joint**

Distance (ft): **174.1**
Structural Grade: **0**
O&M Grade: **4**
Clock Start/From: **9**
Clock To: **3**
1st Value:
2nd Value:
Value Percent: **100.000**
Continuous Index:
Within 8" of Joint: **YES**
Remarks:
