Profile/Photo Observation Report

Date:	02/17/2024	Weather:		Coding:	PACP 7.0
Pipe Length (ft):	319.0	Owner:	City of Hobart	Pre Clean:	Heavy Cleaning
P.O.#:	YES502259	Surveyor:	S. Bucklin	PSR:	P-405-036-035
Customer:	City of Hobart	Clean Date:	10/06/2023	Shape:	C

Street:	SOFTWOOD DR	Flow Control:	Not Controlled
City:	Hobart, IN	Year Renewed:	
Location:	Easement/Right of Way	Tape/Media #:	
Purpose:	Routine Assessment	Dia/Height:	8"
Use:	Sanitary Sewage Pipe	Material:	VCP
Drain Area:		Lining:	None
Category:	NA		
Comment:			
Location Details:		Direction of Survey:	Downstream
US MH:	M-405-035	DS MH:	M-405-036
		Total Length Surveyed (ft):	318.5

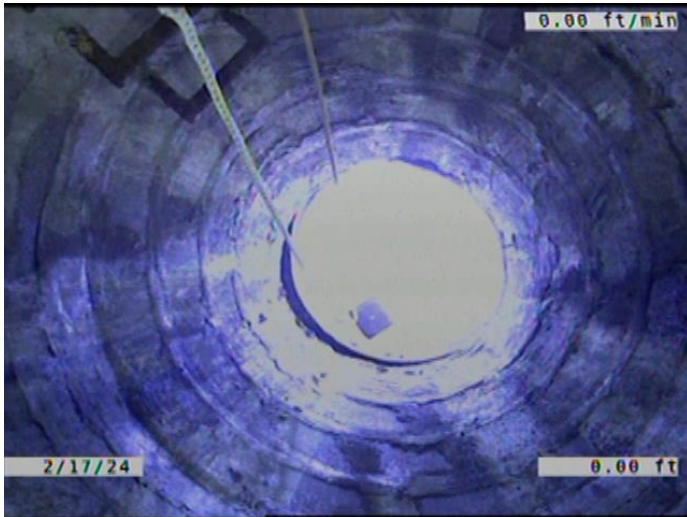
Code: **AMH**
Description: **Manhole**

Distance (ft): **.0**
Structural Grade: **0**
O&M Grade: **0**
Clock Start/From:
Clock To:
1st Value:
2nd Value:
Value Percent:
Continuous Index:
Within 8" of Joint: **NO**
Remarks: **M-405-035**

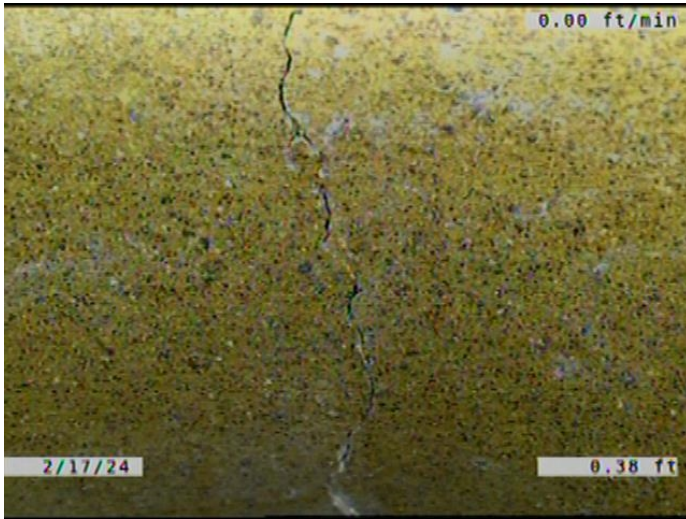
Code: **FM**
Description: **Fracture Multiple**

Distance (ft): **.4**
Structural Grade: **4**
O&M Grade: **0**
Clock Start/From: **9**
Clock To: **3**
1st Value:
2nd Value:
Value Percent:
Continuous Index: **S01**
Within 8" of Joint: **YES**
Remarks:

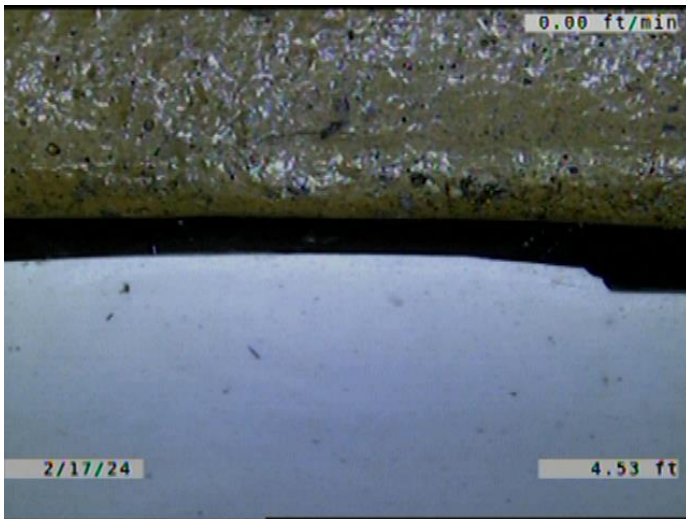
Code: **RPR**
Description: **Point Repair Replacement**

Distance (ft): **4.5**
Structural Grade: **0**
O&M Grade: **0**
Clock Start/From:
Clock To:
1st Value:
2nd Value:
Value Percent:
Continuous Index: **S02**
Within 8" of Joint: **YES**
Remarks: **REPLACED WITH PVC.**

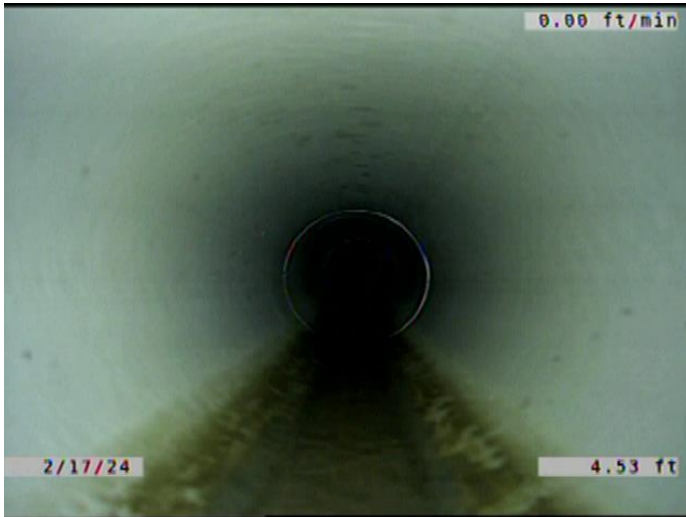
Code: **FM**
Description: **Fracture Multiple**

Distance (ft): **4.5**
Structural Grade: **4**
O&M Grade: **0**
Clock Start/From: **9**
Clock To: **3**
1st Value:
2nd Value:
Value Percent:
Continuous Index: **F01**
Within 8" of Joint: **YES**
Remarks:

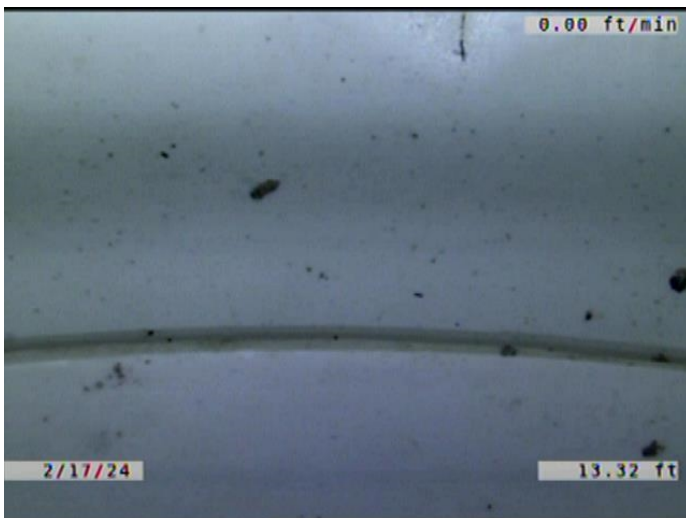
Code: **MGO**
Description: **Miscellaneous General Observation**

Distance (ft): **13.3**
Structural Grade: **0**
O&M Grade: **0**
Clock Start/From:
Clock To:
1st Value:
2nd Value:
Value Percent:
Continuous Index:
Within 8" of Joint: **NO**
Remarks: **JOINT/ PIPES NOT PUSHED ALL THE WAY TOGETHER WHEN INSTALLED**

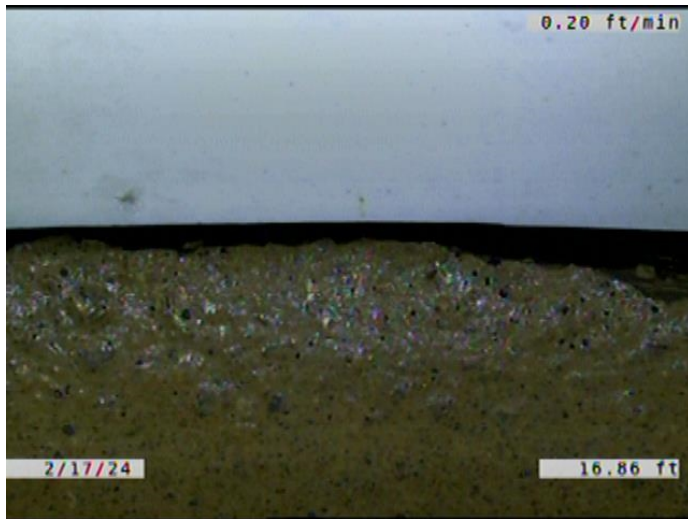
Code: **RPR**
Description: **Point Repair Replacement**

Distance (ft): **16.8**
Structural Grade: **0**
O&M Grade: **0**
Clock Start/From:
Clock To:
1st Value:
2nd Value:
Value Percent:
Continuous Index: **F02**
Within 8" of Joint: **YES**
Remarks: **REPLACED WITH PVC.**

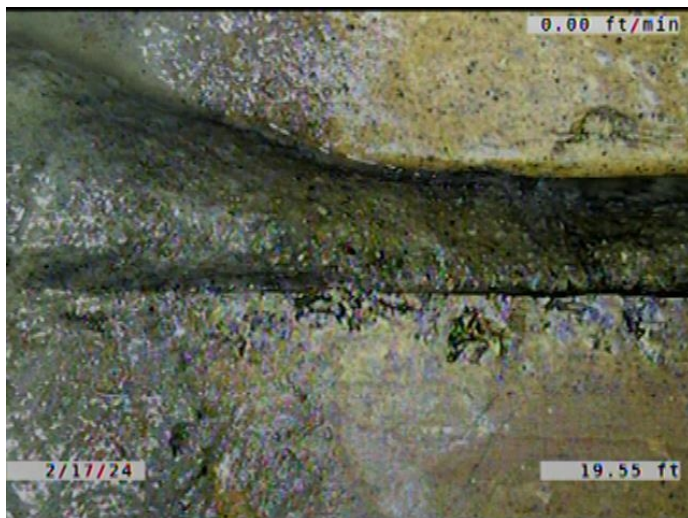
Code: **DAE**
Description: **Deposits Attached Encrustation**

Distance (ft): **19.5**
Structural Grade: **0**
O&M Grade: **2**
Clock Start/From: **7**
Clock To: **5**
1st Value:
2nd Value:
Value Percent: **5.000**
Continuous Index: **S03**
Within 8" of Joint: **YES**
Remarks:

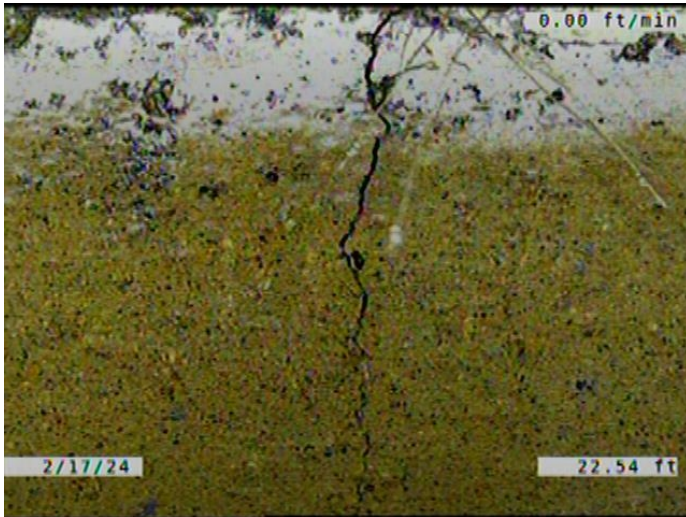
Code: **FM**
Description: **Fracture Multiple**

Distance (ft): **22.5**
Structural Grade: **4**
O&M Grade: **0**
Clock Start/From: **8**
Clock To: **4**
1st Value:
2nd Value:
Value Percent:
Continuous Index: **S04**
Within 8" of Joint: **YES**
Remarks:

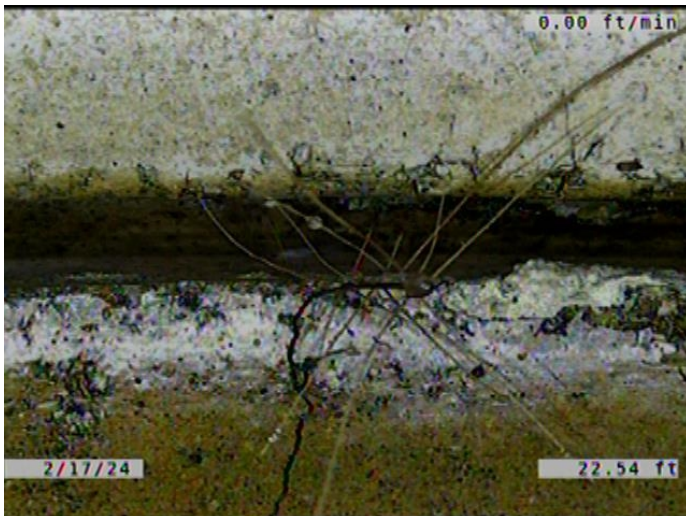
Code: **RFB**
Description: **Roots Fine Barrel**

Distance (ft): **22.5**
Structural Grade: **0**
O&M Grade: **2**
Clock Start/From: **8**
Clock To: **4**
1st Value:
2nd Value:
Value Percent:
Continuous Index: **S05**
Within 8" of Joint: **NO**
Remarks:

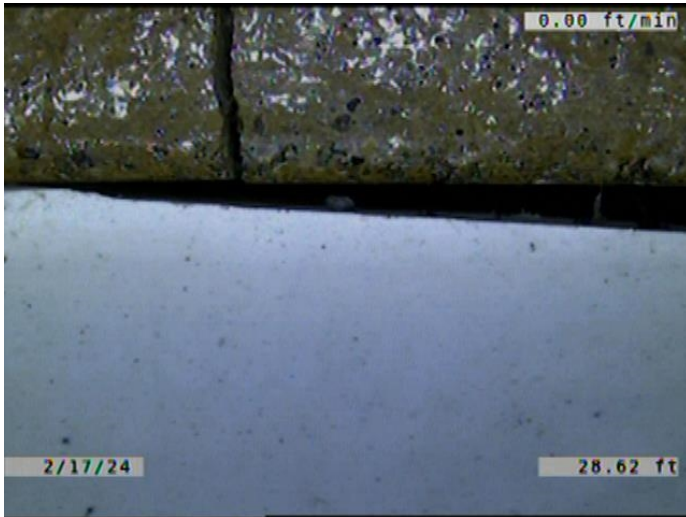
Code: **RPR**
Description: **Point Repair Replacement**

Distance (ft): **28.6**
Structural Grade: **0**
O&M Grade: **0**
Clock Start/From:
Clock To:
1st Value:
2nd Value:
Value Percent:
Continuous Index: **S07**
Within 8" of Joint: **YES**
Remarks: **REPLACED WITH PVC.**

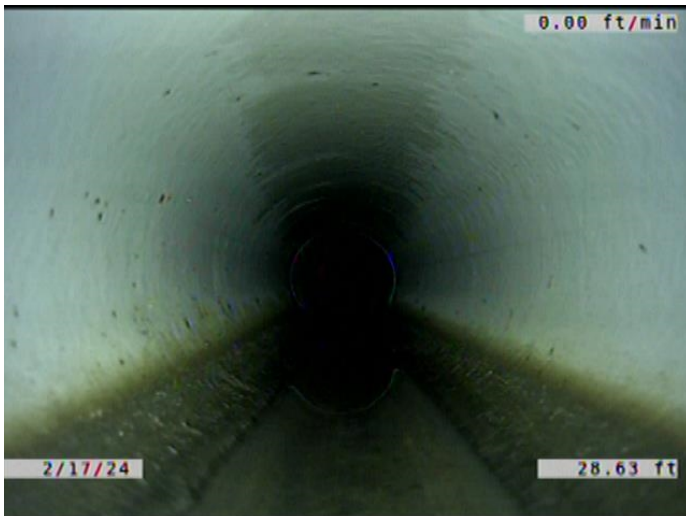
Code: **FM**
Description: **Fracture Multiple**

Distance (ft): **28.6**
Structural Grade: **4**
O&M Grade: **0**
Clock Start/From: **8**
Clock To: **4**
1st Value:
2nd Value:
Value Percent:
Continuous Index: **F04**
Within 8" of Joint: **YES**
Remarks:

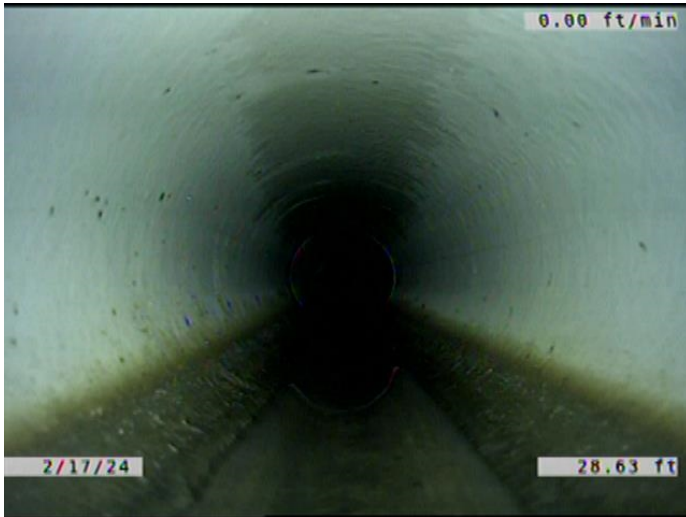
Code: **DAE**
Description: **Deposits Attached Encrustation**

Distance (ft): **28.6**
Structural Grade: **0**
O&M Grade: **2**
Clock Start/From: **7**
Clock To: **5**
1st Value:
2nd Value:
Value Percent: **5.000**
Continuous Index: **F03**
Within 8" of Joint: **YES**
Remarks:

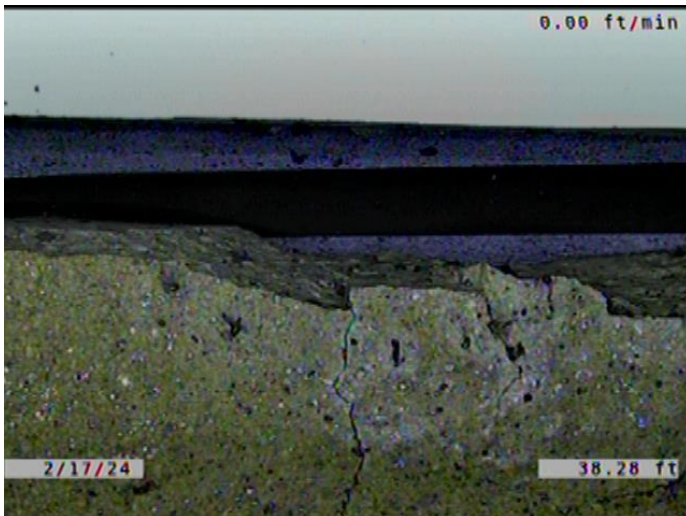
Code: **RPR**
Description: **Point Repair Replacement**

Distance (ft): **38.3**
Structural Grade: **0**
O&M Grade: **0**
Clock Start/From:
Clock To:
1st Value:
2nd Value:
Value Percent:
Continuous Index: **F07**
Within 8" of Joint: **YES**
Remarks: **REPLACED WITH PVC.**

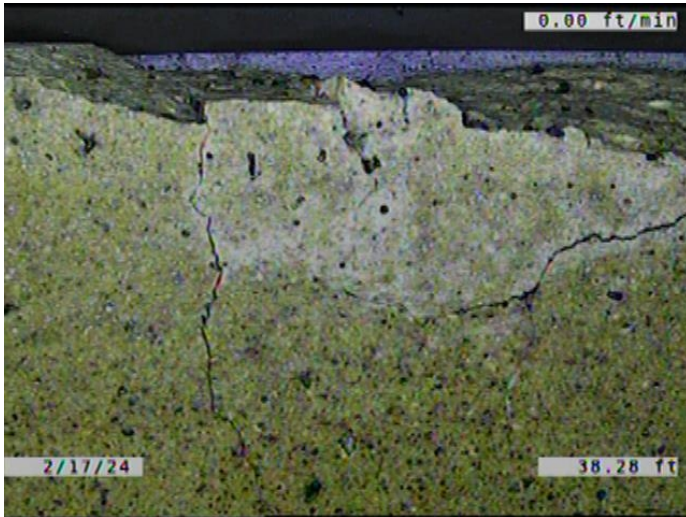
Code: **CM**
Description: **Crack Multiple**

Distance (ft): **38.3**
Structural Grade: **3**
O&M Grade: **0**
Clock Start/From: **10**
Clock To: **2**
1st Value:
2nd Value:
Value Percent:
Continuous Index:
Within 8" of Joint: **YES**
Remarks:

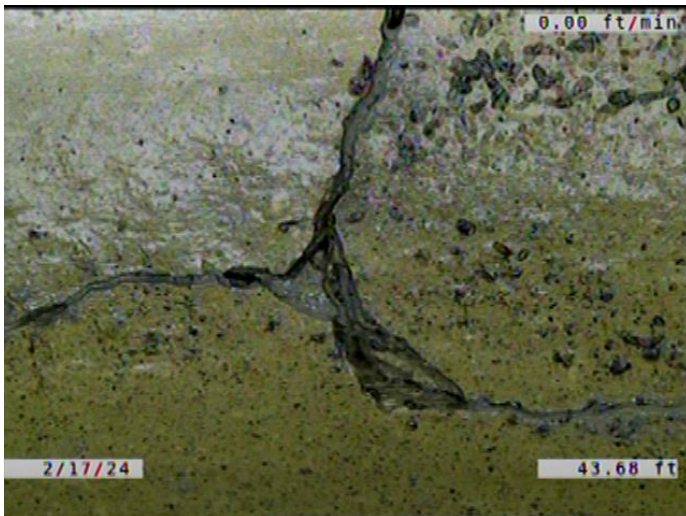
Code: **B**
Description: **Broken**

Distance (ft): **43.7**
Structural Grade: **4**
O&M Grade: **0**
Clock Start/From: **12**
Clock To: **12**
1st Value:
2nd Value:
Value Percent:
Continuous Index: **S08**
Within 8" of Joint: **YES**
Remarks:

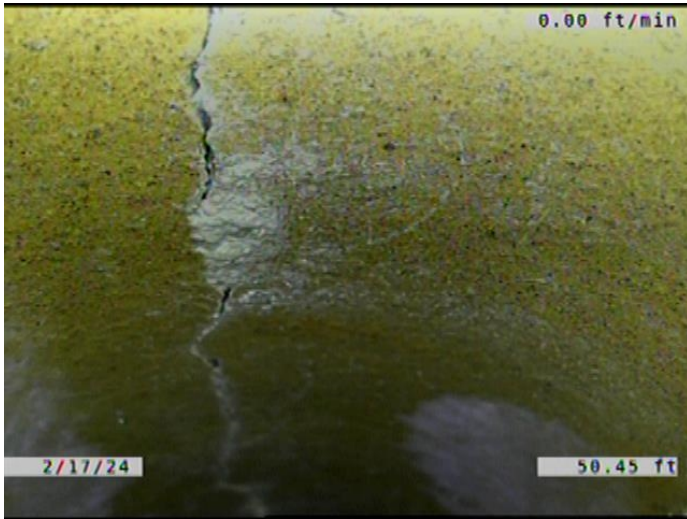
Code: **DAE**
Description: **Deposits Attached Encrustation**

Distance (ft): **50.4**
Structural Grade: **0**
O&M Grade: **2**
Clock Start/From: **7**
Clock To: **5**
1st Value:
2nd Value:
Value Percent: **5.000**
Continuous Index: **S09**
Within 8" of Joint: **YES**
Remarks:

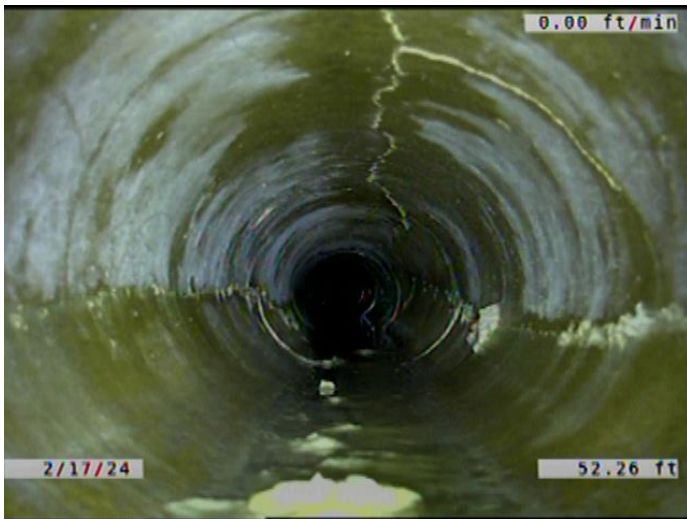
Code: **MWLS**
Description: **Miscellaneous Water Level Sag**

Distance (ft): **52.3**
Structural Grade: **2**
O&M Grade: **0**
Clock Start/From:
Clock To:
1st Value:
2nd Value:
Value Percent: **10.000**
Continuous Index: **F06**
Within 8" of Joint: **NO**
Remarks:

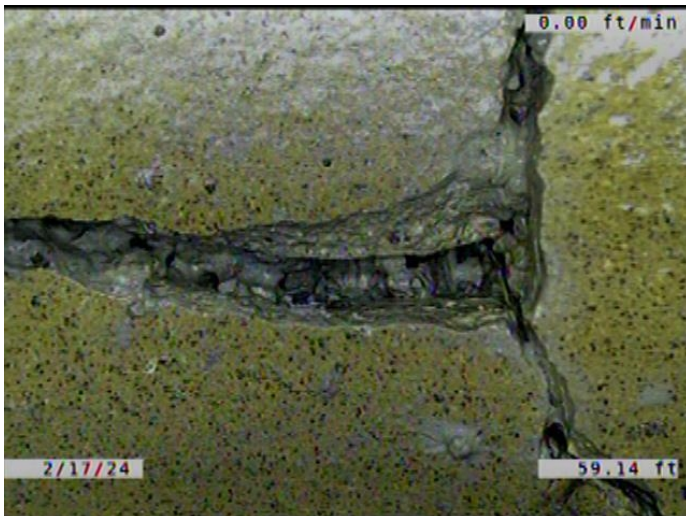
Code: **BSV**
 Description: **Broken Soil Visible**

Distance (ft): **59.1**
 Structural Grade: **5**
 O&M Grade: **0**
 Clock Start/From: **8**
 Clock To: **11**
 1st Value:
 2nd Value:
 Value Percent:
 Continuous Index:
 Within 8" of Joint: **YES**
 Remarks:

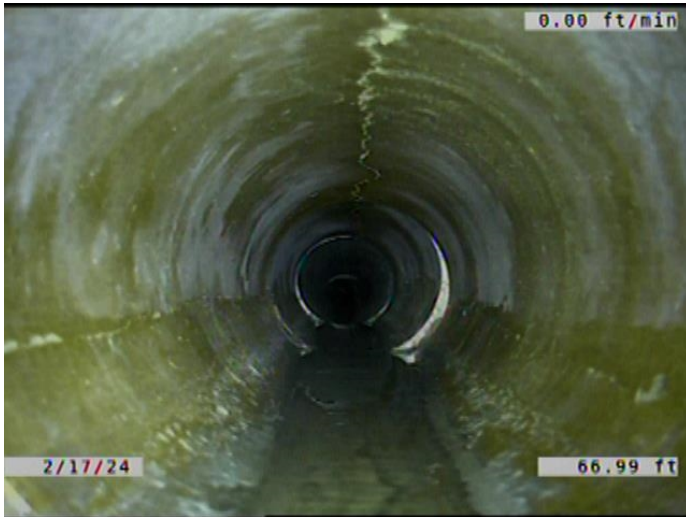
Code: **MWLS**
Description: **Miscellaneous Water Level Sag**

Distance (ft): **67.0**
Structural Grade: **2**
O&M Grade: **0**
Clock Start/From:
Clock To:
1st Value:
2nd Value:
Value Percent: **10.000**
Continuous Index: **F10**
Within 8" of Joint: **NO**
Remarks:

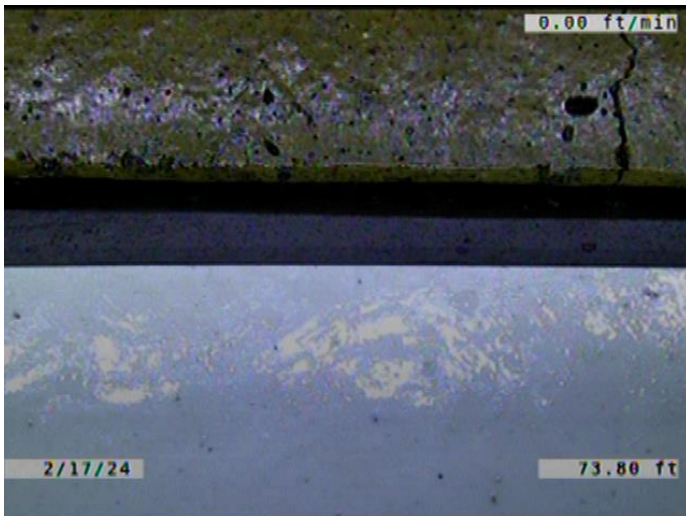
Code: **RPR**
Description: **Point Repair Replacement**

Distance (ft): **73.8**
Structural Grade: **0**
O&M Grade: **0**
Clock Start/From:
Clock To:
1st Value:
2nd Value:
Value Percent:
Continuous Index: **S11**
Within 8" of Joint: **YES**
Remarks: **REPLACED WITH PVC.**

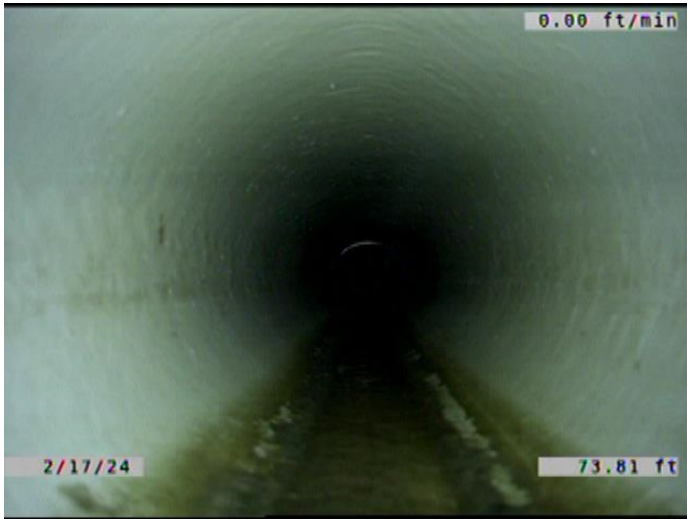
Code: **B**
Description: **Broken**

Distance (ft): **73.8**
Structural Grade: **4**
O&M Grade: **0**
Clock Start/From: **12**
Clock To: **12**
1st Value:
2nd Value:
Value Percent:
Continuous Index: **F08**
Within 8" of Joint: **YES**
Remarks:

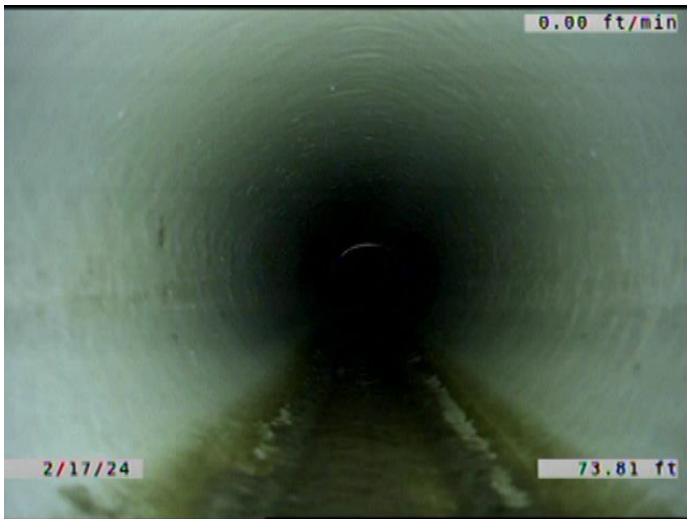
Code: **DAE**
Description: **Deposits Attached Encrustation**

Distance (ft): **73.8**
Structural Grade: **0**
O&M Grade: **2**
Clock Start/From: **7**
Clock To: **5**
1st Value:
2nd Value:
Value Percent: **5.000**
Continuous Index: **F09**
Within 8" of Joint: **YES**
Remarks:

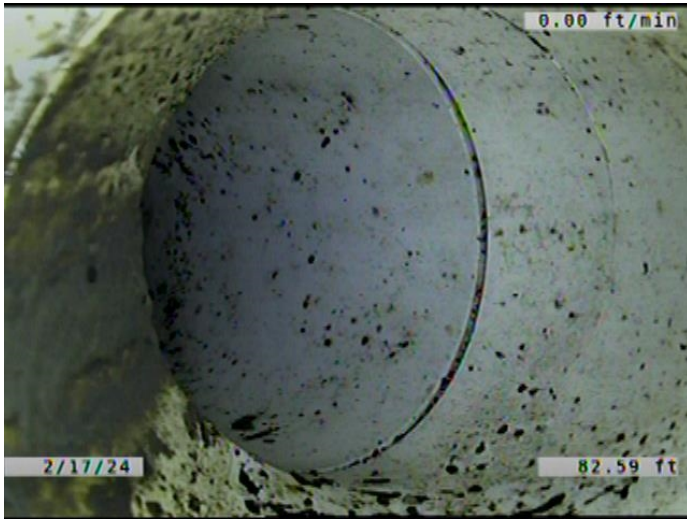
Code:	TF
Description:	Tap Factory
Distance (ft):	82.6
Structural Grade:	0
O&M Grade:	0
Clock Start/From:	11
Clock To:	
1st Value:	6.000
2nd Value:	
Value Percent:	
Continuous Index:	
Within 8" of Joint:	YES
Remarks:	CONSTANTLY RUNNING WATER.

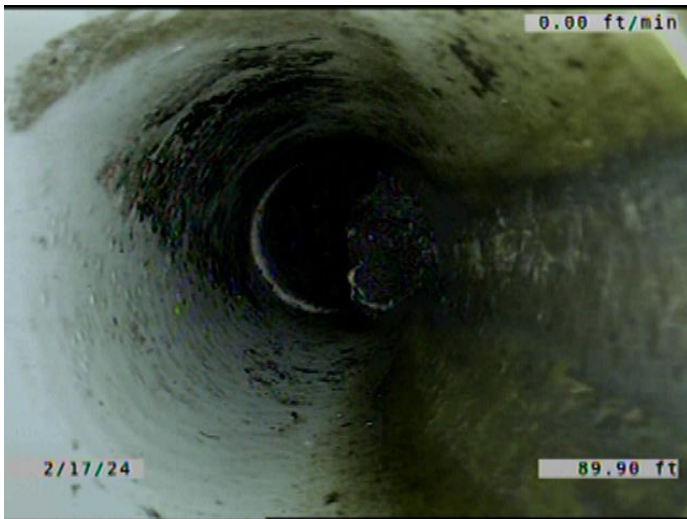
Code:	TF
Description:	Tap Factory
Distance (ft):	89.9
Structural Grade:	0
O&M Grade:	0
Clock Start/From:	2
Clock To:	
1st Value:	6.000
2nd Value:	
Value Percent:	
Continuous Index:	
Within 8" of Joint:	YES
Remarks:	PVC T. SERVICE IS VCP. ROOTS GROWING IN THE JOINTS OF THE SE

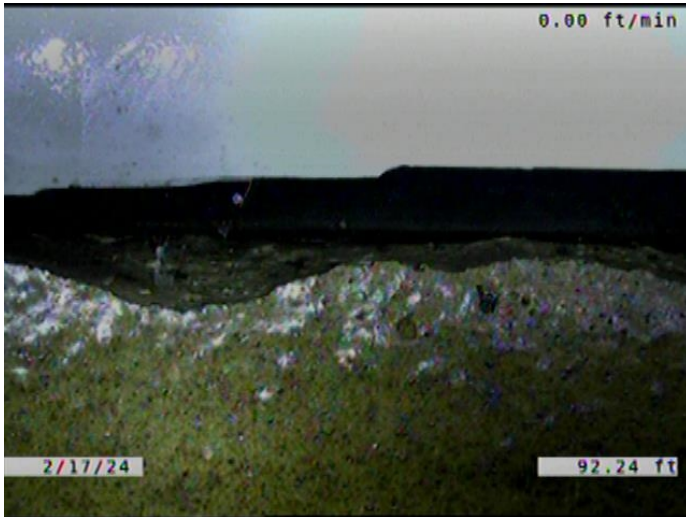
Code:	RPR
Description:	Point Repair Replacement
Distance (ft):	92.2
Structural Grade:	0
O&M Grade:	0
Clock Start/From:	
Clock To:	
1st Value:	
2nd Value:	
Value Percent:	
Continuous Index:	F11
Within 8" of Joint:	YES
Remarks:	REPLACED WITH PVC.

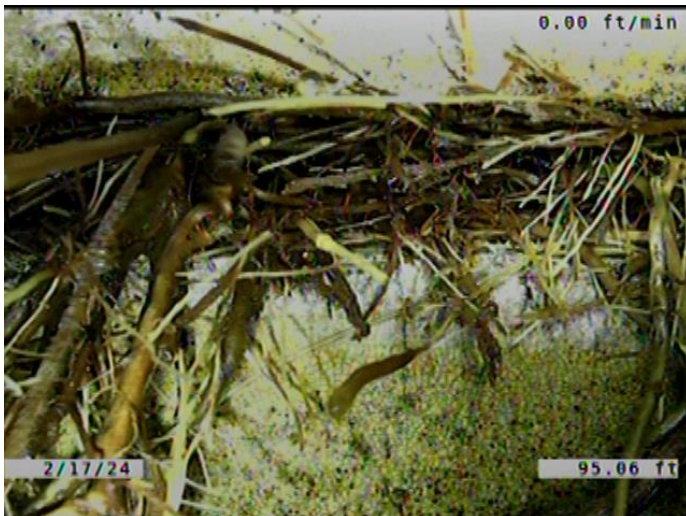
Code:	RMJ
Description:	Roots Medium Joint
Distance (ft):	95.0
Structural Grade:	0
O&M Grade:	3
Clock Start/From:	8
Clock To:	4
1st Value:	
2nd Value:	
Value Percent:	5.000
Continuous Index:	S12
Within 8" of Joint:	YES
Remarks:

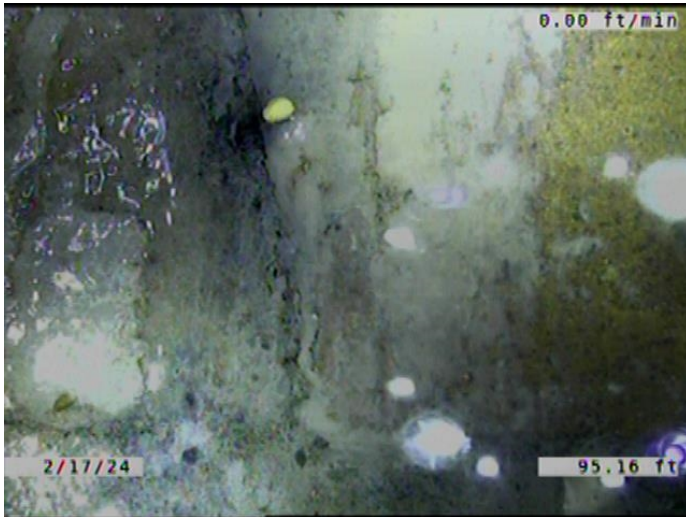
Code: **B**
Description: **Broken**

Distance (ft): **95.2**
Structural Grade: **4**
O&M Grade: **0**
Clock Start/From: **6**
Clock To: **7**
1st Value:
2nd Value:
Value Percent:
Continuous Index:
Within 8" of Joint: **YES**
Remarks:

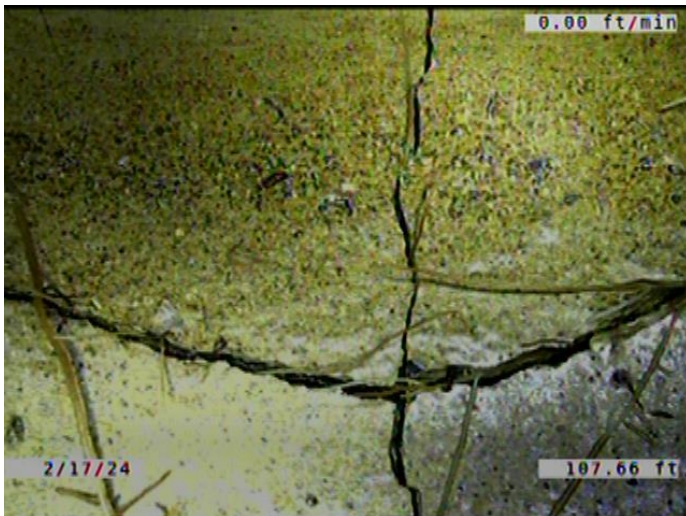
Code: **B**
Description: **Broken**

Distance (ft): **107.7**
Structural Grade: **4**
O&M Grade: **0**
Clock Start/From: **10**
Clock To: **2**
1st Value:
2nd Value:
Value Percent:
Continuous Index:
Within 8" of Joint: **YES**
Remarks:

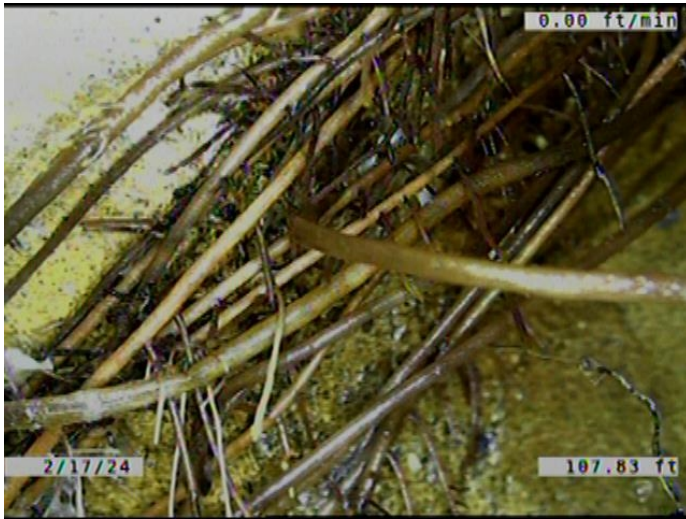
Code: **RFL**
Description: **Roots Fine Lateral**

Distance (ft): **107.8**
Structural Grade: **0**
O&M Grade: **1**
Clock Start/From: **9**
Clock To: **11**
1st Value:
2nd Value:
Value Percent:
Continuous Index:
Within 8" of Joint: **NO**
Remarks:

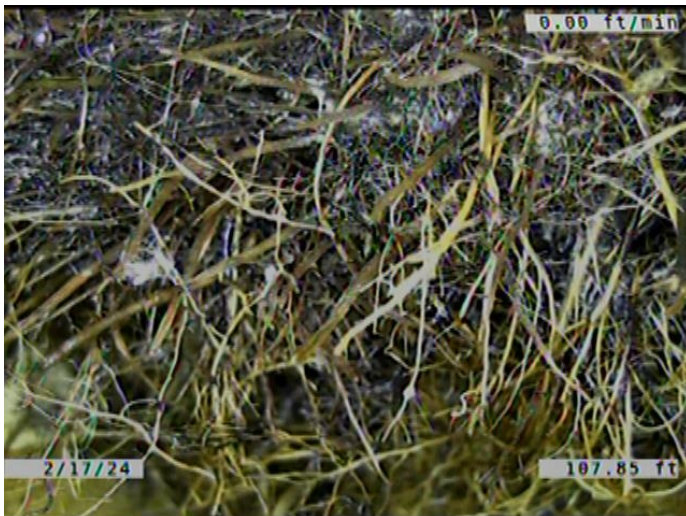
Code: **TFD**
Description: **Tap Factory Defective**

Distance (ft): **107.8**
Structural Grade: **0**
O&M Grade: **3**
Clock Start/From: **10**
Clock To:
1st Value: **6.000**
2nd Value:
Value Percent:
Continuous Index:
Within 8" of Joint: **YES**
Remarks: **TAP BROKEN. LOOKS TO BE 100% PLUGGED WITH ROOTS.**

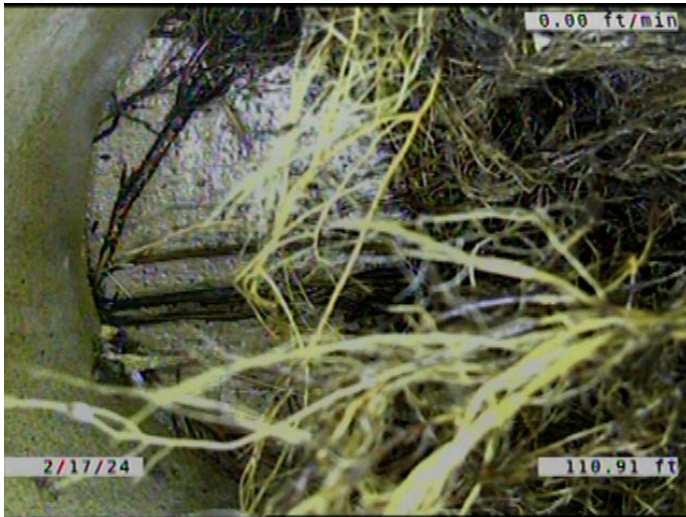
Code:	TFD
Description:	Tap Factory Defective
Distance (ft):	110.9
Structural Grade:	0
O&M Grade:	3
Clock Start/From:	2
Clock To:	
1st Value:	6.000
2nd Value:	
Value Percent:	
Continuous Index:	
Within 8" of Joint:	YES
Remarks:	CAPPED. TAP CRACKED. ROOTS GROWING AROUND THE CAP INTO T

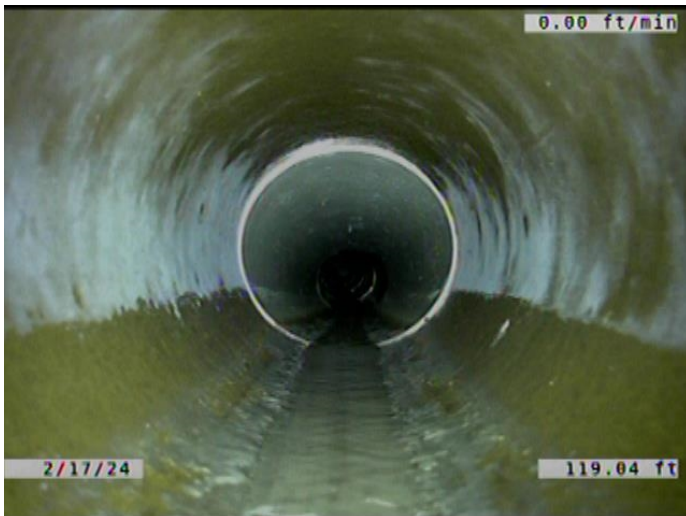
Code:	RMJ
Description:	Roots Medium Joint
Distance (ft):	119.0
Structural Grade:	0
O&M Grade:	3
Clock Start/From:	8
Clock To:	4
1st Value:	
2nd Value:	
Value Percent:	5.000
Continuous Index:	F12
Within 8" of Joint:	YES
Remarks:

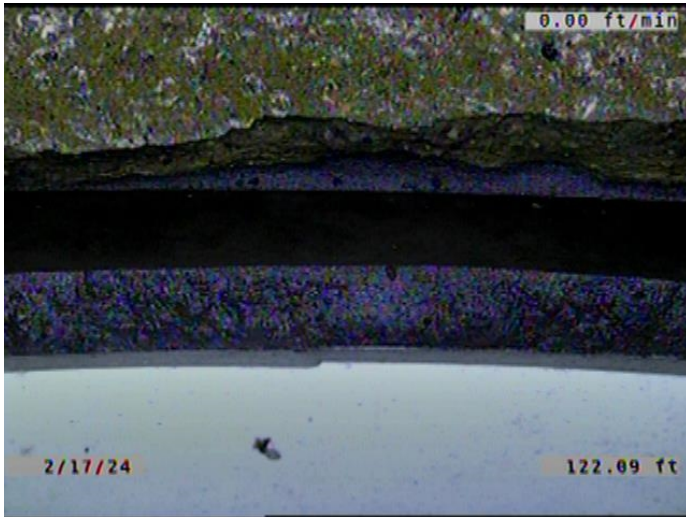
Code: **RPR**
Description: **Point Repair Replacement**

Distance (ft): **122.1**
Structural Grade: **0**
O&M Grade: **0**
Clock Start/From:
Clock To:
1st Value:
2nd Value:
Value Percent:
Continuous Index: **S13**
Within 8" of Joint: **YES**
Remarks: **REPLACED WITH PVC.**

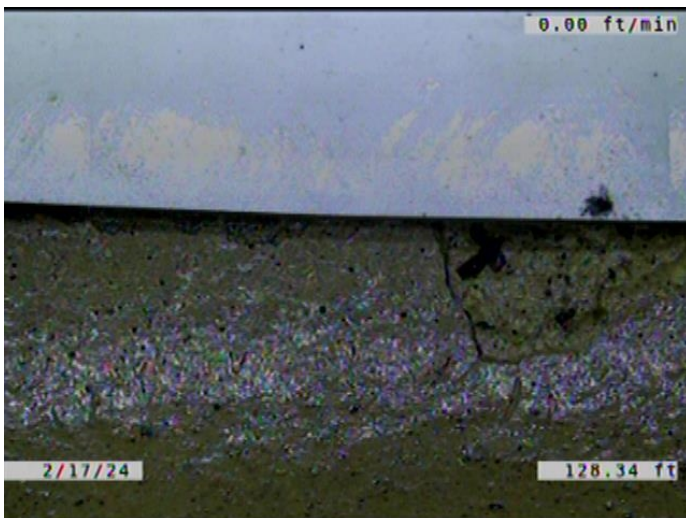
Code: **RPR**
Description: **Point Repair Replacement**

Distance (ft): **128.3**
Structural Grade: **0**
O&M Grade: **0**
Clock Start/From:
Clock To:
1st Value:
2nd Value:
Value Percent:
Continuous Index: **F13**
Within 8" of Joint: **YES**
Remarks: **REPLACED WITH PVC.**

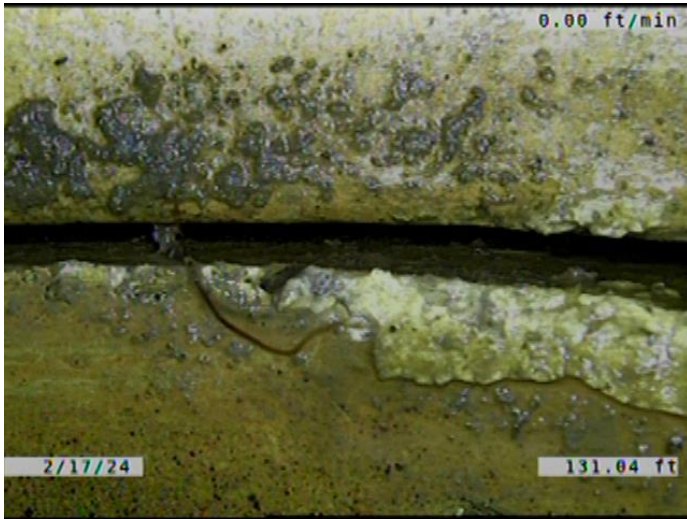
Code: **RFJ**
Description: **Roots Fine Joint**

Distance (ft): **131.0**
Structural Grade: **0**
O&M Grade: **1**
Clock Start/From: **7**
Clock To: **5**
1st Value:
2nd Value:
Value Percent:
Continuous Index: **S14**
Within 8" of Joint: **YES**
Remarks:

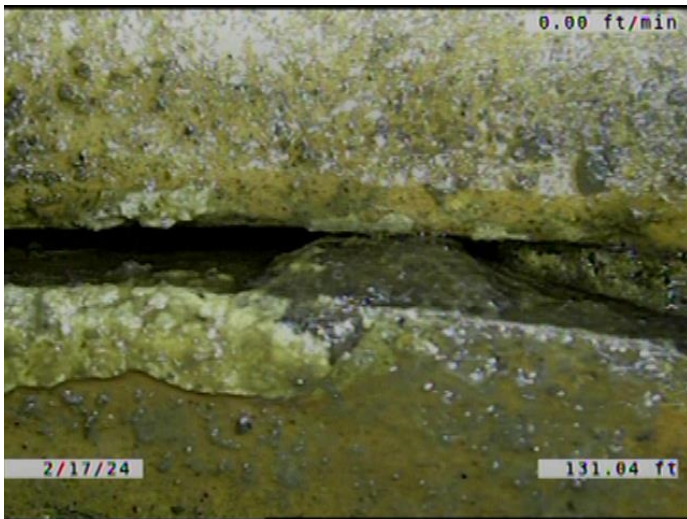
Code: **DAE**
Description: **Deposits Attached Encrustation**

Distance (ft): **131.0**
Structural Grade: **0**
O&M Grade: **2**
Clock Start/From: **7**
Clock To: **5**
1st Value:
2nd Value:
Value Percent: **5.000**
Continuous Index:
Within 8" of Joint: **YES**
Remarks:

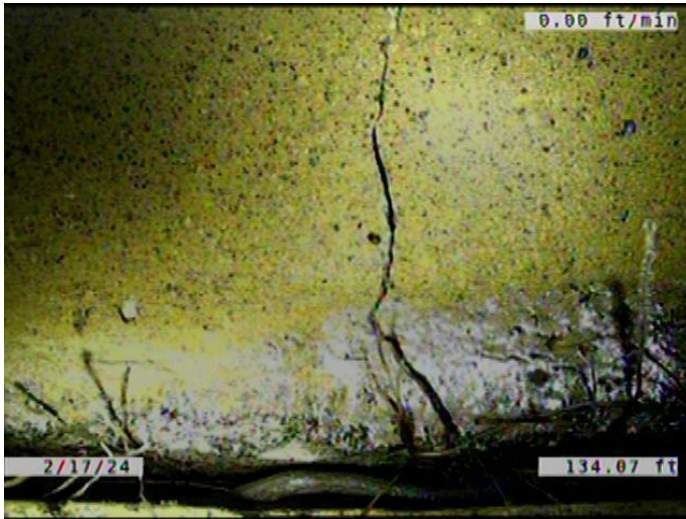
Code: **FM**
Description: **Fracture Multiple**

Distance (ft): **134.1**
Structural Grade: **4**
O&M Grade: **0**
Clock Start/From: **1**
Clock To: **4**
1st Value:
2nd Value:
Value Percent:
Continuous Index:
Within 8" of Joint: **YES**
Remarks:

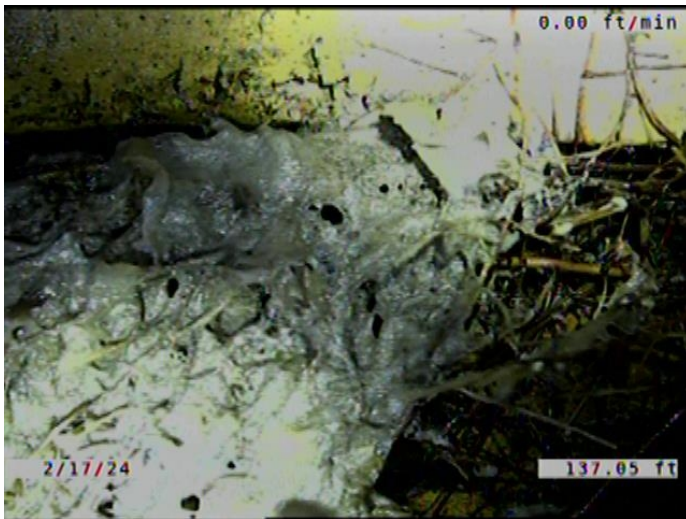
Code: **RMJ**
Description: **Roots Medium Joint**

Distance (ft): **137.0**
Structural Grade: **0**
O&M Grade: **3**
Clock Start/From: **7**
Clock To: **5**
1st Value:
2nd Value:
Value Percent: **5.000**
Continuous Index:
Within 8" of Joint: **YES**
Remarks:

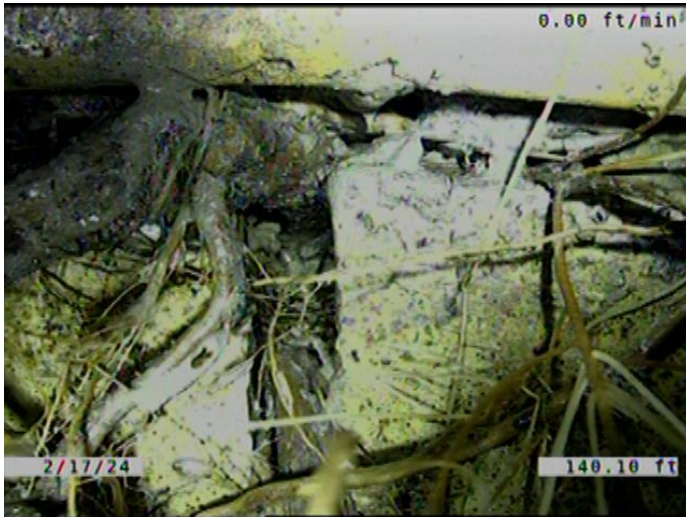
Code: **BSV**
 Description: **Broken Soil Visible**

Distance (ft): **140.1**
 Structural Grade: **5**
 O&M Grade: **0**
 Clock Start/From: **10**
 Clock To: **2**
 1st Value:
 2nd Value:
 Value Percent:
 Continuous Index:
 Within 8" of Joint: **YES**
 Remarks:

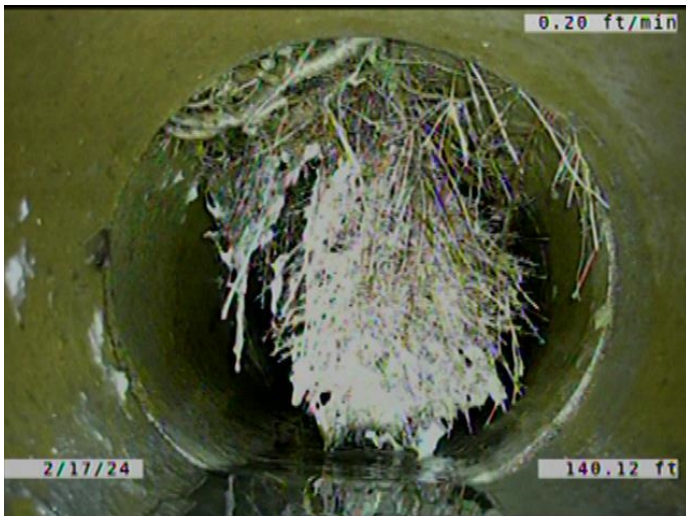
Code: **RMB**
 Description: **Roots Medium Barrel**

Distance (ft): **140.1**
 Structural Grade: **0**
 O&M Grade: **4**
 Clock Start/From: **10**
 Clock To: **3**
 1st Value:
 2nd Value:
 Value Percent: **50.000**
 Continuous Index:
 Within 8" of Joint: **NO**
 Remarks:

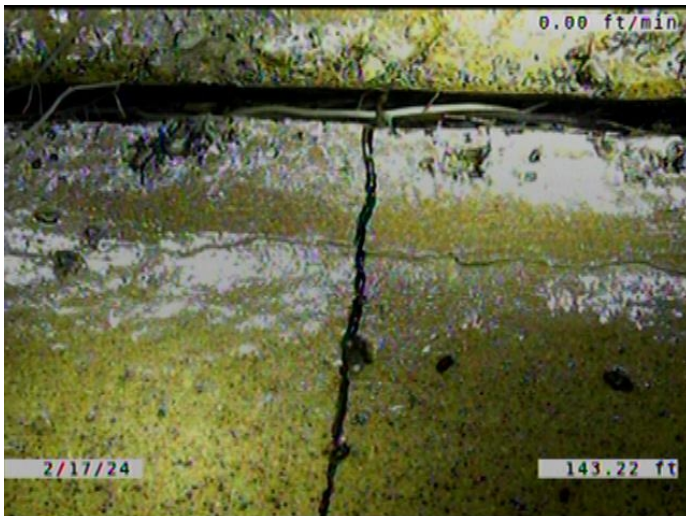
Code: **FM**
Description: **Fracture Multiple**

Distance (ft): **143.2**
Structural Grade: **4**
O&M Grade: **0**
Clock Start/From: **7**
Clock To: **5**
1st Value:
2nd Value:
Value Percent:
Continuous Index: **S15**
Within 8" of Joint: **YES**
Remarks:

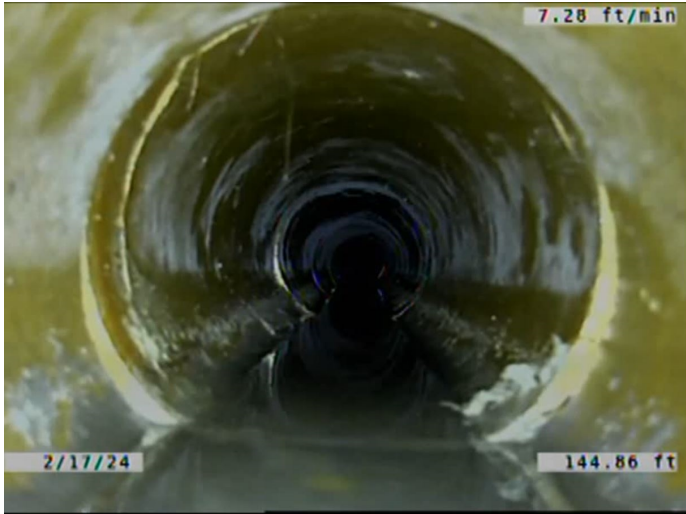
Code: **B**
Description: **Broken**

Distance (ft): **144.9**
Structural Grade: **4**
O&M Grade: **0**
Clock Start/From: **8**
Clock To: **11**
1st Value:
2nd Value:
Value Percent:
Continuous Index:
Within 8" of Joint: **YES**
Remarks:

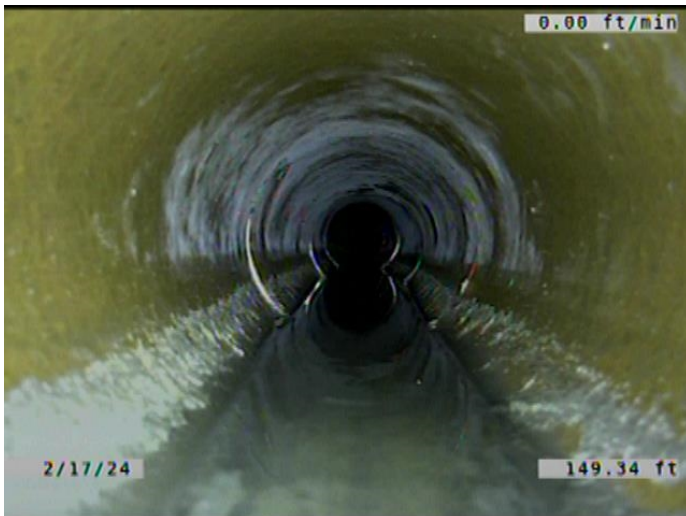
Code: **MWLS**
Description: **Miscellaneous Water Level Sag**

Distance (ft): **149.3**
Structural Grade: **2**
O&M Grade: **0**
Clock Start/From:
Clock To:
1st Value:
2nd Value:
Value Percent: **5.000**
Continuous Index: **S16**
Within 8" of Joint: **NO**
Remarks:

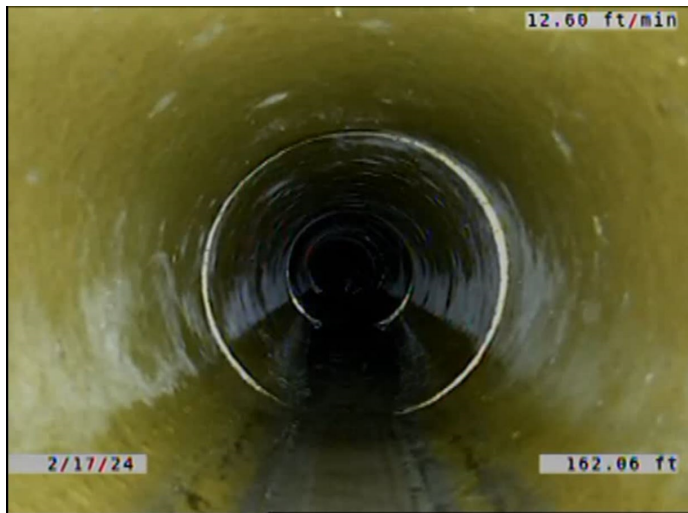
Code: **FM**
Description: **Fracture Multiple**

Distance (ft): **162.1**
Structural Grade: **4**
O&M Grade: **0**
Clock Start/From: **7**
Clock To: **5**
1st Value:
2nd Value:
Value Percent:
Continuous Index: **F15**
Within 8" of Joint: **YES**
Remarks: **Wandering 12 to 12**

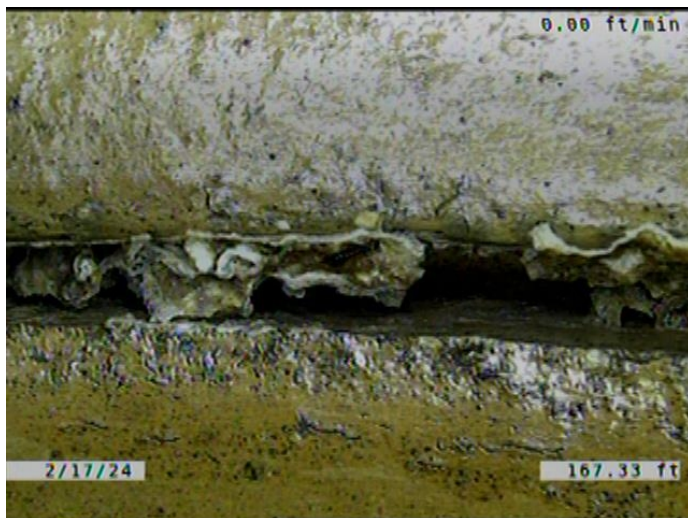
Code: **DAE**
Description: **Deposits Attached Encrustation**

Distance (ft): **167.3**
Structural Grade: **0**
O&M Grade: **2**
Clock Start/From: **7**
Clock To: **5**
1st Value:
2nd Value:
Value Percent: **5.000**
Continuous Index:
Within 8" of Joint: **YES**
Remarks:

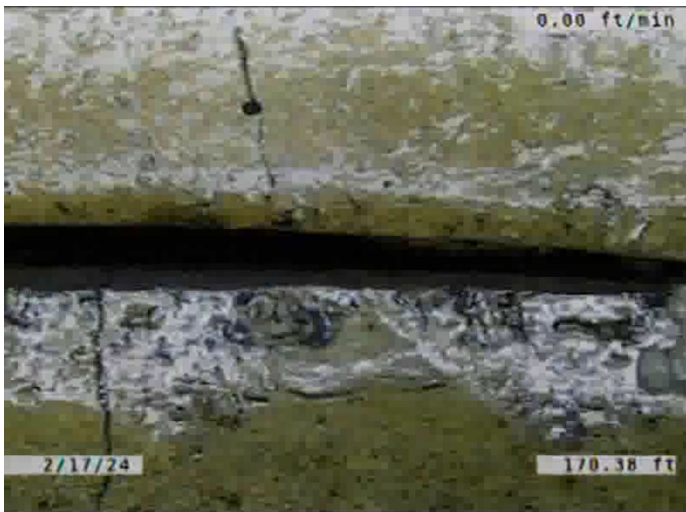
Code: **FM**
Description: **Fracture Multiple**

Distance (ft): **170.4**
Structural Grade: **4**
O&M Grade: **0**
Clock Start/From: **7**
Clock To: **5**
1st Value:
2nd Value:
Value Percent:
Continuous Index:
Within 8" of Joint: **YES**
Remarks:

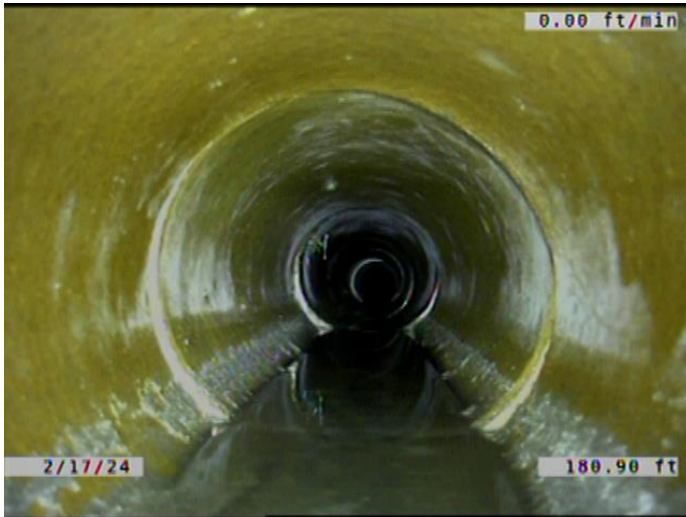
Code: **MWLS**
Description: **Miscellaneous Water Level Sag**

Distance (ft): **180.9**
Structural Grade: **2**
O&M Grade: **0**
Clock Start/From:
Clock To:
1st Value:
2nd Value:
Value Percent: **5.000**
Continuous Index: **S18**
Within 8" of Joint: **NO**
Remarks:

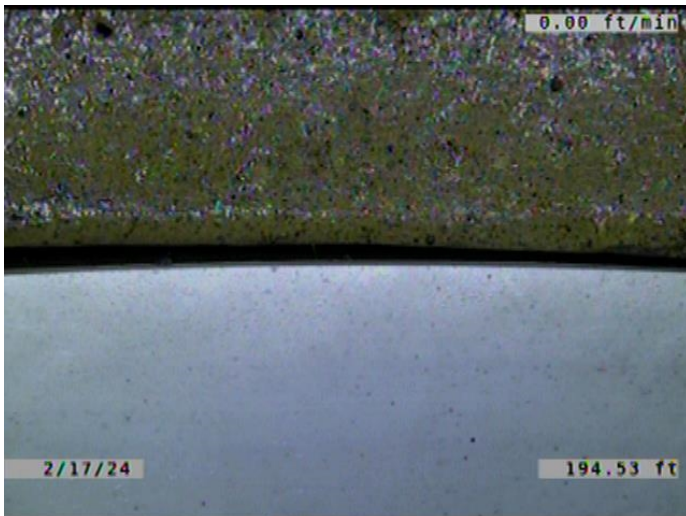
Code: **RPR**
Description: **Point Repair Replacement**

Distance (ft): **194.5**
Structural Grade: **0**
O&M Grade: **0**
Clock Start/From:
Clock To:
1st Value:
2nd Value:
Value Percent:
Continuous Index: **S19**
Within 8" of Joint: **YES**
Remarks: **REPLACED WITH PVC.**

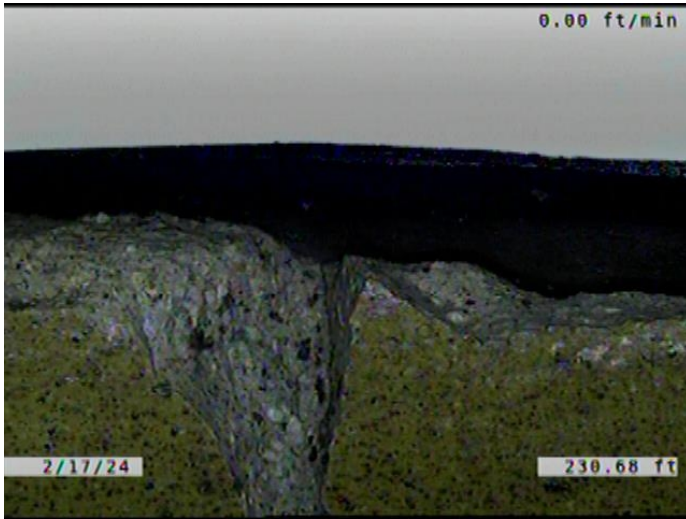
Code: **RPR**
Description: **Point Repair Replacement**

Distance (ft): **230.7**
Structural Grade: **0**
O&M Grade: **0**
Clock Start/From:
Clock To:
1st Value:
2nd Value:
Value Percent:
Continuous Index: **F19**
Within 8" of Joint: **YES**
Remarks: **REPLACED WITH PVC.**

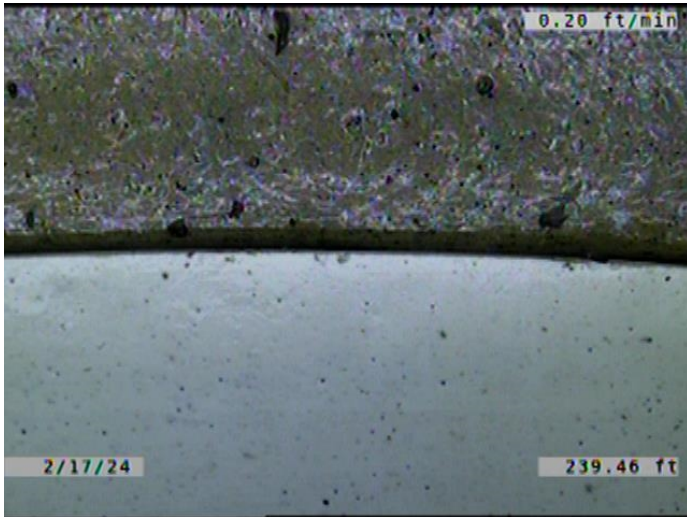
Code: **RPR**
Description: **Point Repair Replacement**

Distance (ft): **239.5**
Structural Grade: **0**
O&M Grade: **0**
Clock Start/From:
Clock To:
1st Value:
2nd Value:
Value Percent:
Continuous Index: **S22**
Within 8" of Joint: **YES**
Remarks: **REPLACED WITH PVC.**

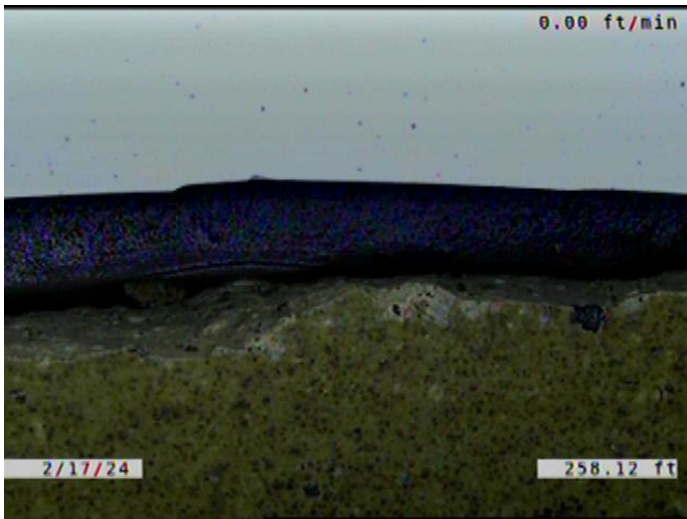
Code: **RPR**
Description: **Point Repair Replacement**

Distance (ft): **258.1**
Structural Grade: **0**
O&M Grade: **0**
Clock Start/From:
Clock To:
1st Value:
2nd Value:
Value Percent:
Continuous Index: **F22**
Within 8" of Joint: **YES**
Remarks: **REPLACED WITH PVC.**

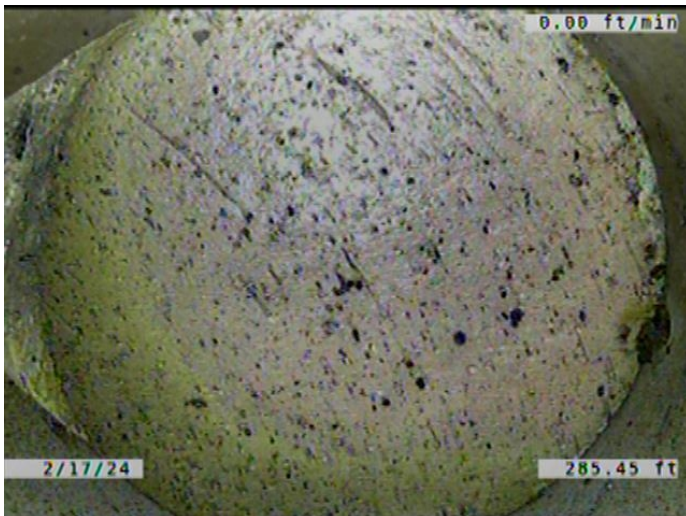
Code: **TFD**
Description: **Tap Factory Defective**

Distance (ft): **285.4**
Structural Grade: **0**
O&M Grade: **3**
Clock Start/From: **10**
Clock To:
1st Value: **6.000**
2nd Value:
Value Percent:
Continuous Index:
Within 8" of Joint: **YES**
Remarks: **CAPPED. TAP BROKEN.
ENCrustation COMING AROUND T**

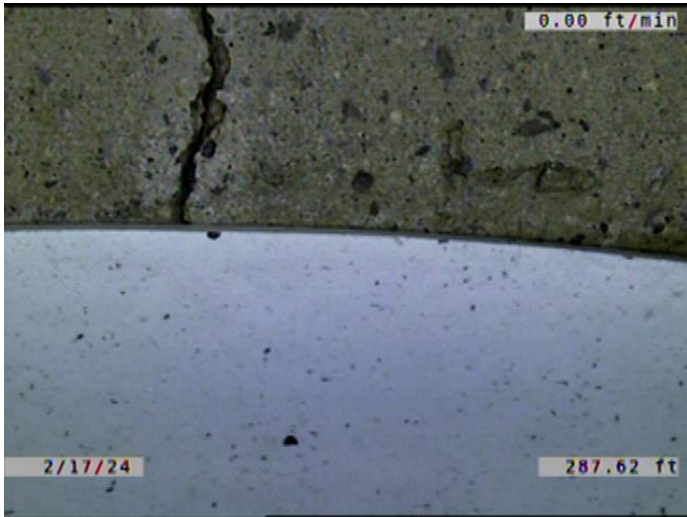
Code: **RPR**
Description: **Point Repair Replacement**

Distance (ft): **287.6**
Structural Grade: **0**
O&M Grade: **0**
Clock Start/From:
Clock To:
1st Value:
2nd Value:
Value Percent:
Continuous Index: **S25**
Within 8" of Joint: **YES**
Remarks: **REPLACED WITH PVC.**
