Profile/Photo Observation Report

Date:	02/17/2024	Weather:		Coding:	PACP 7.0
Pipe Length (ft):	319.0	Owner:	City of Hobart	Pre Clean:	Heavy Cleaning
P.O.#:	YES502259	Surveyor:	S. Bucklin	PSR:	P-405-036-035
Customer:	City of Hobart	Clean Date:	10/06/2023	Shape:	C

Street:	SOFTWOOD DR	Flow Control:	Not Controlled
City:	Hobart, IN	Year Renewed:	
Location:	Easement/Right of Way	Tape/Media #:	
Purpose:	Routine Assessment	Dia/Height:	8"
Use:	Sanitary Sewage Pipe	Material:	VCP
Drain Area:		Lining:	None
Category:	NA		
Comment:			
Location Details:		Direction of Survey:	Downstream
US MH:	M-405-035	DS MH:	M-405-036
		Total Length Surveyed (ft):	318.5

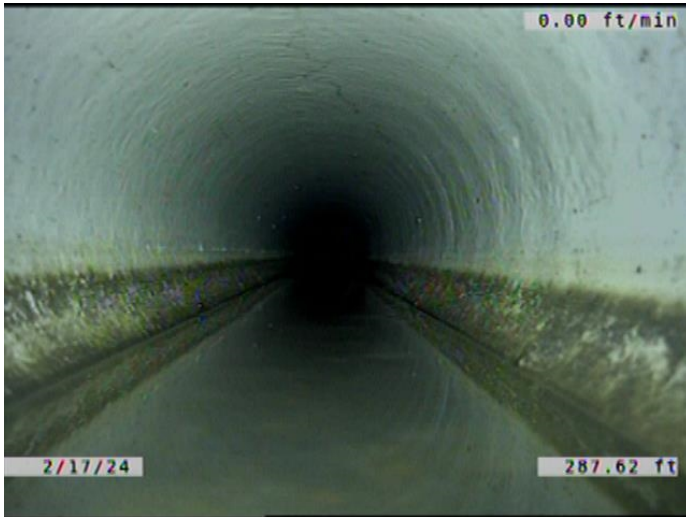
Code:	DAE
Description:	Deposits Attached Encrustation
Distance (ft):	287.6
Structural Grade:	0
O&M Grade:	2
Clock Start/From:	7
Clock To:	5
1st Value:	
2nd Value:	
Value Percent:	5.000
Continuous Index:	F24
Within 8" of Joint:	YES
Remarks:

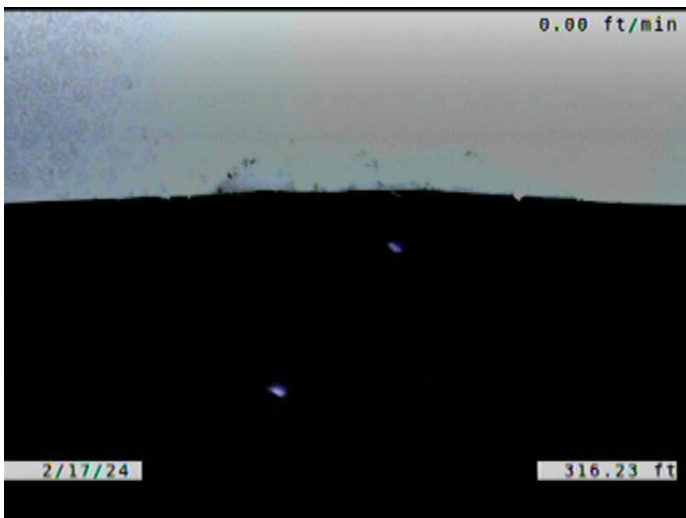
Code: **RPR**
Description: **Point Repair Replacement**

Distance (ft): **316.2**
Structural Grade: **0**
O&M Grade: **0**
Clock Start/From:
Clock To:
1st Value:
2nd Value:
Value Percent:
Continuous Index: **F25**
Within 8" of Joint: **YES**
Remarks: **REPLACED WITH PVC.**
