## Profile/Photo Observation Report

| Street: | <b>ALLEY BETWEEN SOFTWOOD DR &amp; C</b> | Flow Control: | <b>Not Controlled</b> |
| City: | <b>Hobart, IN</b> | Year Renewed: | |
| US MH: | <b>M-405-036</b> | DS MH: | <b>M-405-037</b> |

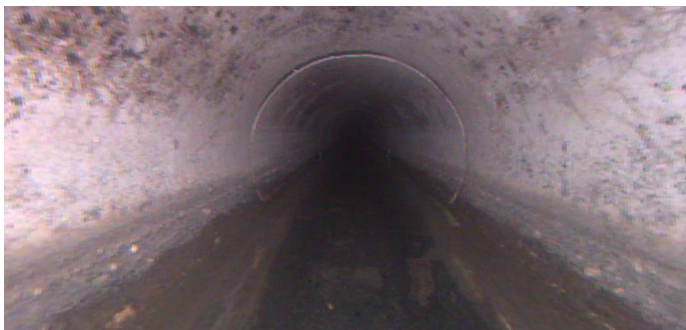
Code: **AMH**  
Description: **Manhole**

Distance (ft): **.0**  
Structural Grade: **0**  
O&M Grade: **0**  
Clock Start/From:  
Clock To:  
1st Value:  
2nd Value:  
Value Percent:  
Continuous Index:  
Within 8" of Joint: **NO**  
Remarks: **M-405-036**

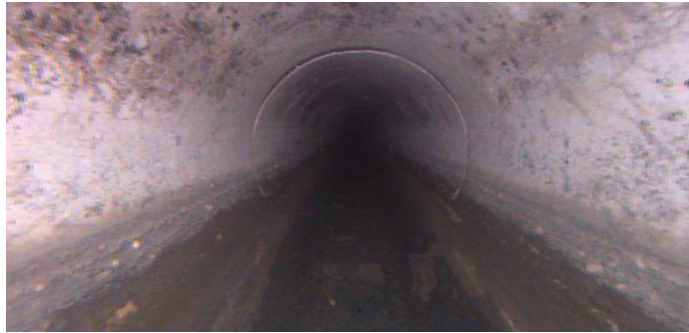
Code: **MWL**  
Description: **Water Level**

Distance (ft): **.0**  
Structural Grade: **0**  
O&M Grade: **0**  
Clock Start/From:  
Clock To:  
1st Value:  
2nd Value:  
Value Percent: **5.000**  
Continuous Index:  
Within 8" of Joint: **NO**  
Remarks:

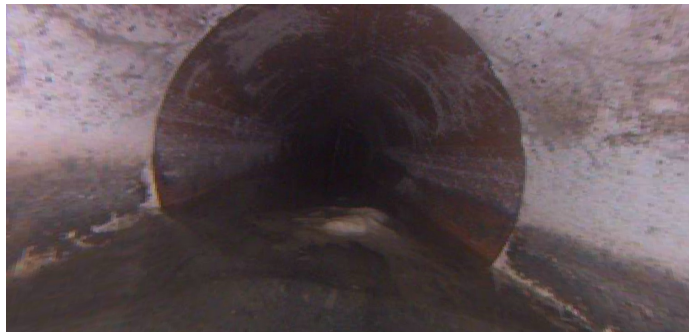
| | Position | Code | Observation | Video (sec) | Grade |
|---|---|---|---|---|---|
| | 6.7 | DSZ | Deposits Settled Other | 46 | M 2 |

Code: **DSZ**  
Description: **Deposits Settled Other**

Distance (ft): **6.7**  
Structural Grade: **0**  
O&M Grade: **2**  
Clock Start/From: **6**  
Clock To:  
1st Value:  
2nd Value:  
Value Percent: **5.000**  
Continuous Index:  
Within 8" of Joint: **NO**  
Remarks: **tissue**

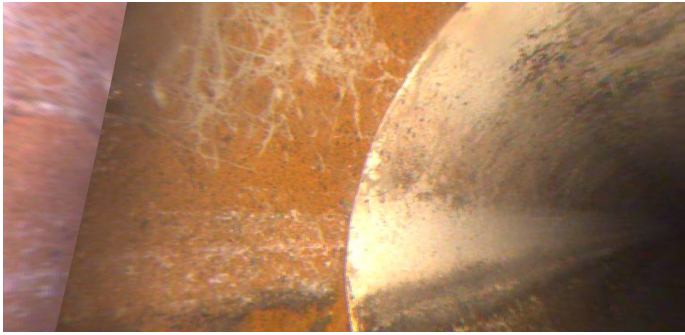
Code: **MMC**  
Description: **Material Change**

Distance (ft): **7.5**  
Structural Grade: **0**  
O&M Grade: **0**  
Clock Start/From:  
Clock To:  
1st Value:  
2nd Value:  
Value Percent:  
Continuous Index:  
Within 8" of Joint: **NO**  
Remarks: **vcp**

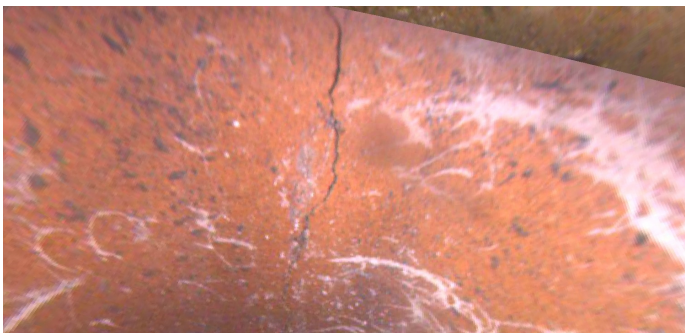
| | Position | Code | Observation | Video (sec) | Grade |
|---|---|---|---|---|---|
| | 7.5 | CL(S01) | Crack Longitudinal | 73 | S 2 |

Code: **CL**  
Description: **Crack Longitudinal**

Distance (ft): **7.5**  
Structural Grade: **2**  
O&M Grade: **0**  
Clock Start/From: **12**  
Clock To:  
1st Value:  
2nd Value:  
Value Percent:  
Continuous Index: **S01**  
Within 8" of Joint: **YES**  
Remarks:

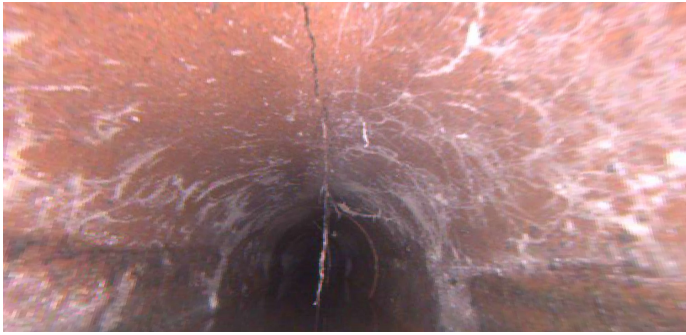
| | Position | Code | Observation | Video (sec) | Grade |
|---|---|---|---|---|---|
| | 8.4 | RFB | Roots Fine Barrel | 87 | M 2 |

Code: **RFB**  
Description: **Roots Fine Barrel**

Distance (ft): **8.4**  
Structural Grade: **0**  
O&M Grade: **2**  
Clock Start/From: **12**  
Clock To:  
1st Value:  
2nd Value:  
Value Percent:  
Continuous Index:  
Within 8" of Joint: **NO**  
Remarks:

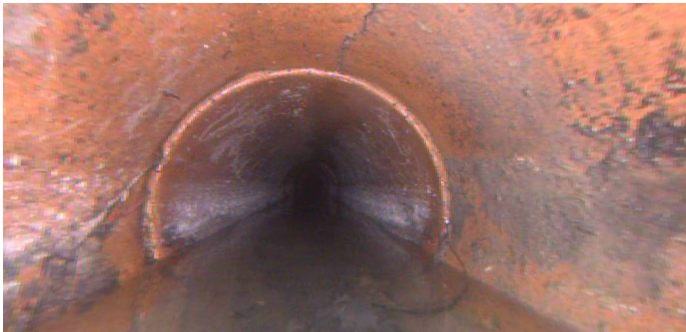
| | Position | Code | Observation | Video (sec) | Grade |
|---|---|---|---|---|---|
| | 12.5 | RFJ | Roots Fine Joint | 107 | M 1 |

Code: **RFJ**  
Description: **Roots Fine Joint**

Distance (ft): **12.5**  
Structural Grade: **0**  
O&M Grade: **1**  
Clock Start/From: **7**  
Clock To: **5**  
1st Value:  
2nd Value:  
Value Percent:  
Continuous Index:  
Within 8" of Joint: **YES**  
Remarks:

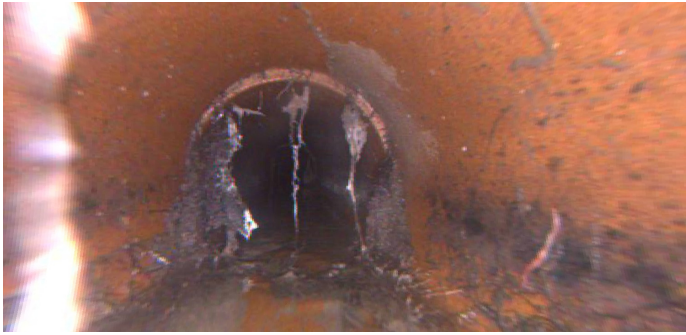
| | Position | Code | Observation | Video (sec) | Grade |
|---|---|---|---|---|---|
| | 27.2 | RMJ(S02) | Roots Medium Joint | 148 | M 3 |

Code: **RMJ**  
Description: **Roots Medium Joint**

Distance (ft): **27.2**  
Structural Grade: **0**  
O&M Grade: **3**  
Clock Start/From: **7**  
Clock To: **5**  
1st Value:  
2nd Value:  
Value Percent: **5.000**  
Continuous Index: **S02**  
Within 8" of Joint: **YES**  
Remarks:

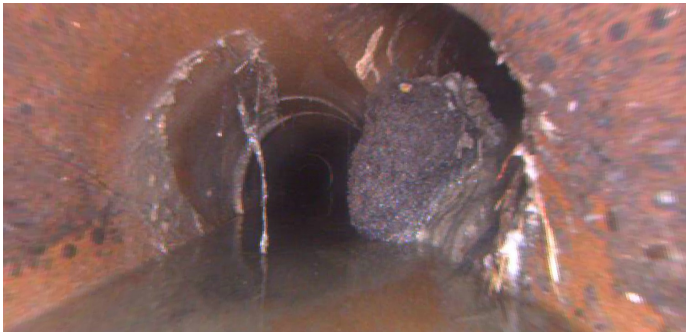
Code: **TF**  
Description: **Tap Factory**

Distance (ft): **32.8**  
Structural Grade: **0**  
O&M Grade: **0**  
Clock Start/From: **2**  
Clock To:  
1st Value: **4.000**  
2nd Value:  
Value Percent:  
Continuous Index:  
Within 8" of Joint:  
Remarks:

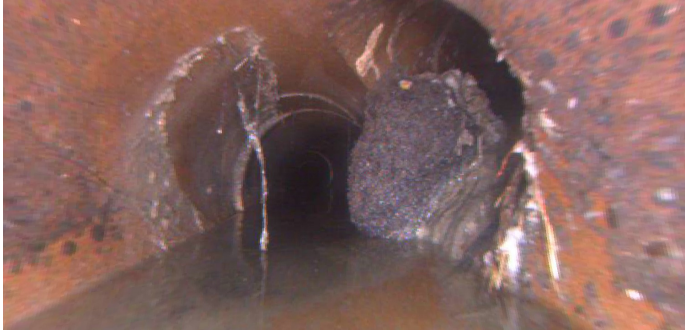
| | Position | Code | Observation | Video (sec) | Grade |
|---|---|---|---|---|---|
| | 32.8 | RML | Roots Medium Lateral | 182 | M 3 |

Code: **RML**  
Description: **Roots Medium Lateral**

Distance (ft): **32.8**  
Structural Grade: **0**  
O&M Grade: **3**  
Clock Start/From: **3**  
Clock To:  
1st Value:  
2nd Value:  
Value Percent: **20.000**  
Continuous Index:  
Within 8" of Joint: **NO**  
Remarks:

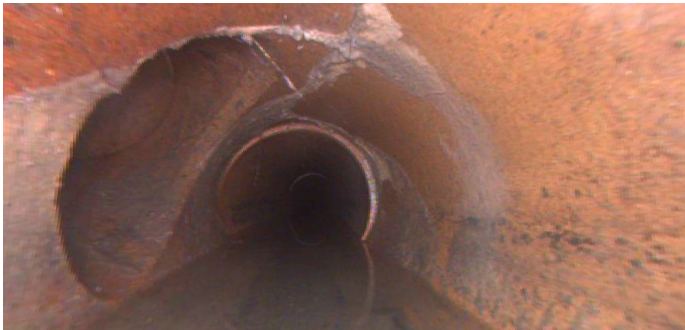
Code: **TF**  
Description: **Tap Factory**

Distance (ft): **35.9**  
Structural Grade: **0**  
O&M Grade: **0**  
Clock Start/From: **10**  
Clock To:  
1st Value: **4.000**  
2nd Value:  
Value Percent:  
Continuous Index:  
Within 8" of Joint: **YES**  
Remarks:

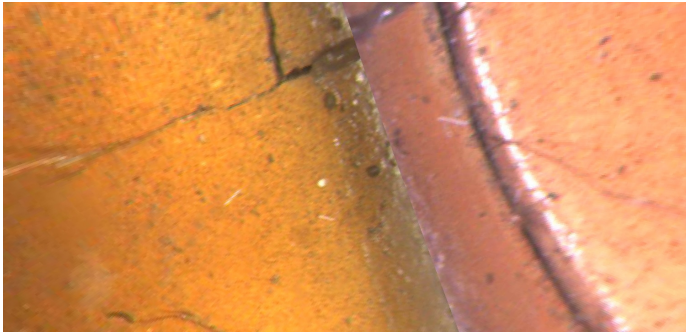
| | Position | Code | Observation | Video (sec) | Grade |
|---|---|---|---|---|---|
| | 49.1 | CM(S03) | Crack Multiple | 238 | S 3 |

Code: **CM**  
Description: **Crack Multiple**

Distance (ft): **49.1**  
Structural Grade: **3**  
O&M Grade: **0**  
Clock Start/From: **7**  
Clock To: **5**  
1st Value:  
2nd Value:  
Value Percent:  
Continuous Index: **S03**  
Within 8" of Joint: **YES**  
Remarks: **wandering**

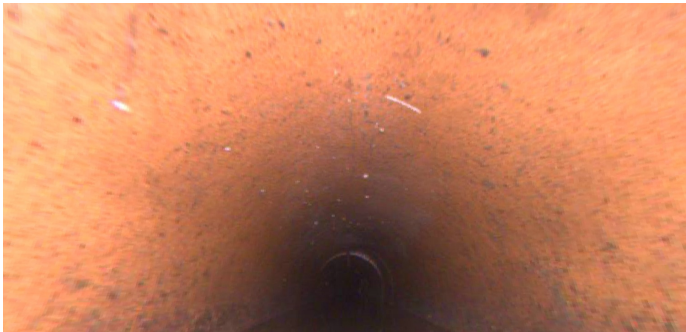
| | Position | Code | Observation | Video (sec) | Grade |
|---|---|---|---|---|---|
| | 49.1 | CL(F01) | Crack Longitudinal | 251 | S 2 |

Code: **CL**  
Description: **Crack Longitudinal**

Distance (ft): **49.1**  
Structural Grade: **2**  
O&M Grade: **0**  
Clock Start/From: **12**  
Clock To:  
1st Value:  
2nd Value:  
Value Percent:  
Continuous Index: **F01**  
Within 8" of Joint: **YES**  
Remarks:

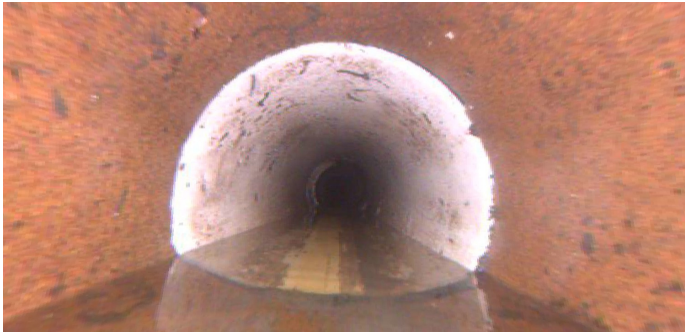
Code: **MMC**  
Description: **Material Change**

Distance (ft): **57.3**  
Structural Grade: **0**  
O&M Grade: **0**  
Clock Start/From:  
Clock To:  
1st Value:  
2nd Value:  
Value Percent:  
Continuous Index:  
Within 8" of Joint: **NO**  
Remarks: **pvc**

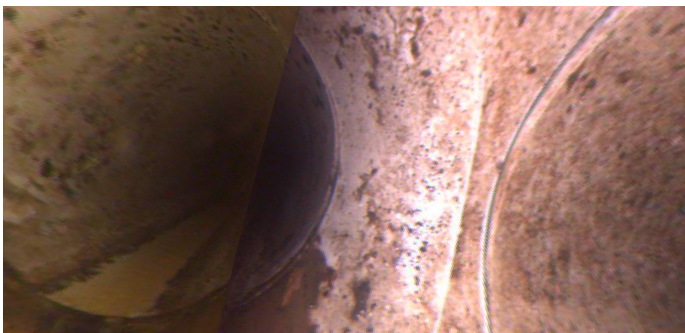
Code: **TF**  
Description: **Tap Factory**

Distance (ft): **60.6**  
Structural Grade: **0**  
O&M Grade: **0**  
Clock Start/From: **10**  
Clock To:  
1st Value: **4.000**  
2nd Value:  
Value Percent:  
Continuous Index:  
Within 8" of Joint: **YES**  
Remarks:

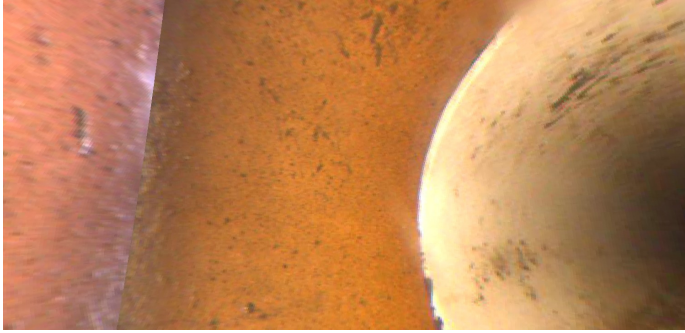
Code: **MMC**  
Description: **Material Change**

Distance (ft): **64.7**  
Structural Grade: **0**  
O&M Grade: **0**  
Clock Start/From:  
Clock To:  
1st Value:  
2nd Value:  
Value Percent:  
Continuous Index:  
Within 8" of Joint: **NO**  
Remarks: **vcp**

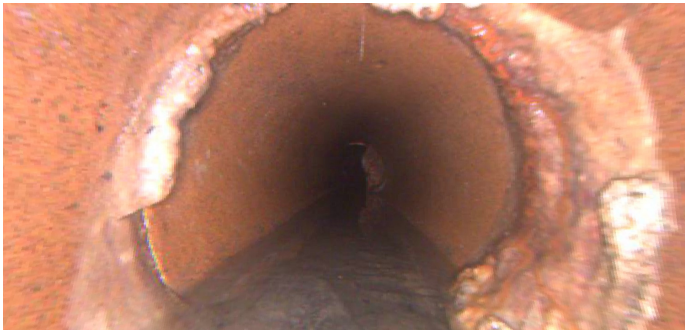
| | Position | Code | Observation | Video (sec) | Grade |
|---|---|---|---|---|---|
| | 72.8 | DAE | Deposits Attached Encrustation | 349 | M 2 |

Code: **DAE**  
Description: **Deposits Attached Encrustation**

Distance (ft): **72.8**  
Structural Grade: **0**  
O&M Grade: **2**  
Clock Start/From: **7**  
Clock To: **5**  
1st Value:  
2nd Value:  
Value Percent: **5.000**  
Continuous Index:  
Within 8" of Joint: **YES**  
Remarks:

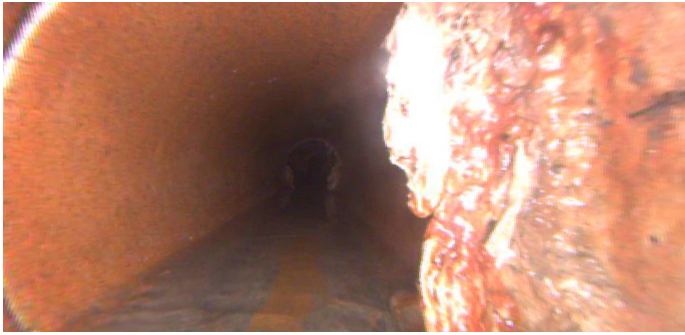
| Comment: | <b>P_C at 75 ft build up at the joint . Flow direction wrong</b> | | |

| | Position | Code | Observation | Video (sec) | Grade |
|---|---|---|---|---|---|
| | 75.9 | DAE | Deposits Attached Encrustation | 366 | M 4 |

Code: **DAE**  
Description: **Deposits Attached Encrustation**

Distance (ft): **75.9**  
Structural Grade: **0**  
O&M Grade: **4**  
Clock Start/From: **1**  
Clock To: **5**  
1st Value:  
2nd Value:  
Value Percent: **25.000**  
Continuous Index:  
Within 8" of Joint: **YES**  
Remarks:

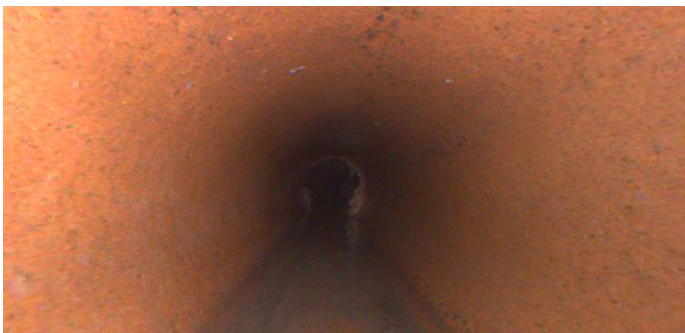
Code: **MSA**  
Description: **Abandoned Survey**

Distance (ft): **76.4**  
Structural Grade: **0**  
O&M Grade: **0**  
Clock Start/From:  
Clock To:  
1st Value:  
2nd Value:  
Value Percent:  
Continuous Index:  
Within 8" of Joint: **NO**  
Remarks: **dae at joint**

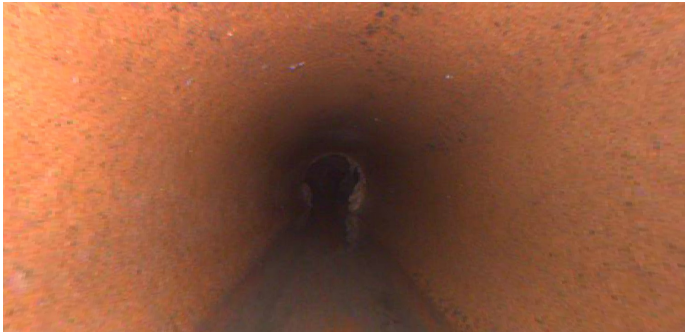
| | Position | Code | Observation | Video (sec) | Grade |
|---|---|---|---|---|---|
| | 76.4 | RMJ(F02) | Roots Medium Joint | 390 | M 3 |

Code: **RMJ**  
Description: **Roots Medium Joint**

Distance (ft): **76.4**  
Structural Grade: **0**  
O&M Grade: **3**  
Clock Start/From: **7**  
Clock To: **5**  
1st Value:  
2nd Value:  
Value Percent: **5.000**  
Continuous Index: **F02**  
Within 8" of Joint: **YES**  
Remarks:

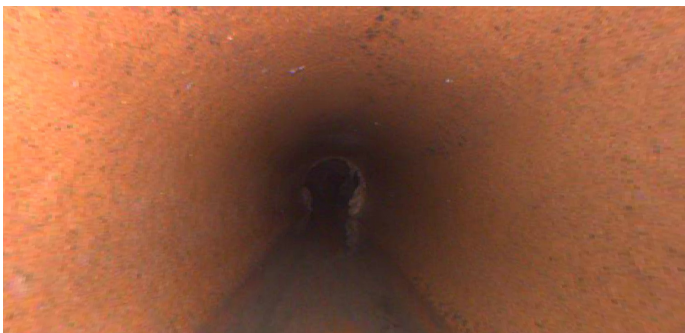
| | Position | Code | Observation | Video (sec) | Grade |
|---|---|---|---|---|---|
| | 76.4 | CM(F03) | Crack Multiple | 401 | S 3 |

Code: **CM**  
Description: **Crack Multiple**

Distance (ft): **76.4**  
Structural Grade: **3**  
O&M Grade: **0**  
Clock Start/From: **7**  
Clock To: **5**  
1st Value:  
2nd Value:  
Value Percent:  
Continuous Index: **F03**  
Within 8" of Joint: **YES**  
Remarks: **wandering**
