Profile/Photo Observation Report

Date:	04/20/2018	Weather:		Coding:	PACP 6.0
Pipe Length (ft):	294.3	Owner:	NA	Pre Clean:	No Pre-Cleaning
P.O.#:		Surveyor:	Byrd Fitzgerald	PSR:	P-405-037-036
Customer:		Clean Date:	01/01/1900	Shape:	C

Street:	FOXCROFT STREET	Flow Control:	Not Controlled
City:	Hobart, IN	Year Renewed:	
Location:	Yard	Tape/Media #:	
Purpose:	Routine Assessment	Dia/Height:	8"
Use:	Sanitary	Material:	PVC
Drain Area:	NA	Lining:	
Category:	NA		
Comment:	P_C at 75 ft build up at the joint . Flow direction wrong		
Location Details:		Direction of Survey:	Downstream
US MH:	M-405-036	DS MH:	M-405-037
		Total Length Surveyed (ft):	76.4

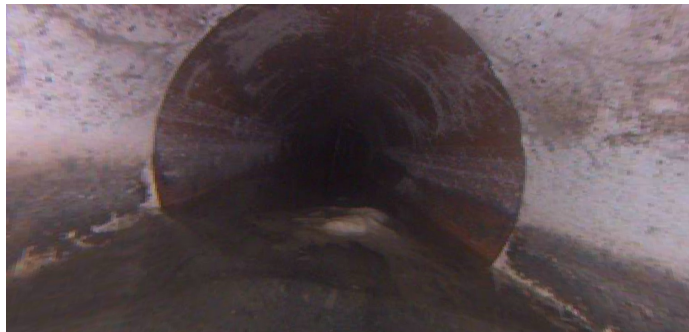
Code: **DSZ**
Description: **Deposits Settled Other**

Distance (ft): **6.7**
Structural Grade: **0**
O&M Grade: **2**
Clock Start/From: **6**
Clock To:
1st Value:
2nd Value:
Value Percent: **5.000**
Continuous Index:
Within 8" of Joint: **NO**
Remarks: **tissue**

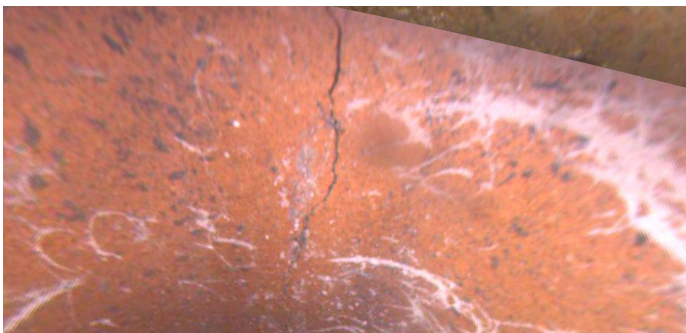
Code: **CL**
Description: **Crack Longitudinal**

Distance (ft): **7.5**
Structural Grade: **2**
O&M Grade: **0**
Clock Start/From: **12**
Clock To:
1st Value:
2nd Value:
Value Percent:
Continuous Index: **S01**
Within 8" of Joint: **YES**
Remarks:

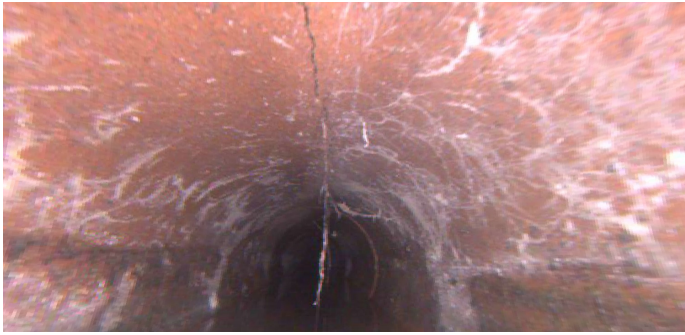
Code: **RFB**
Description: **Roots Fine Barrel**

Distance (ft): **8.4**
Structural Grade: **0**
O&M Grade: **2**
Clock Start/From: **12**
Clock To:
1st Value:
2nd Value:
Value Percent:
Continuous Index:
Within 8" of Joint: **NO**
Remarks:

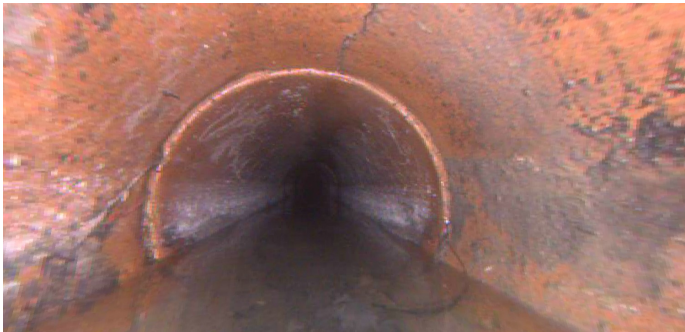
Code: **RFJ**
Description: **Roots Fine Joint**

Distance (ft): **12.5**
Structural Grade: **0**
O&M Grade: **1**
Clock Start/From: **7**
Clock To: **5**
1st Value:
2nd Value:
Value Percent:
Continuous Index:
Within 8" of Joint: **YES**
Remarks:

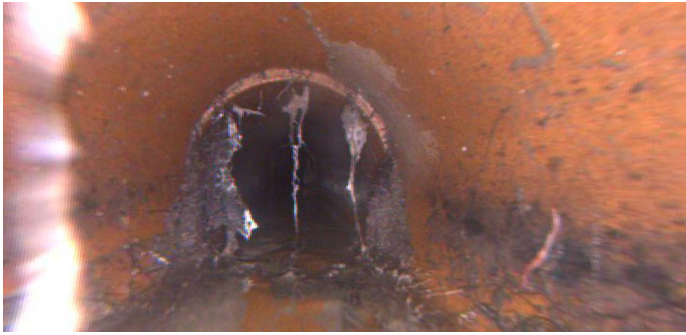
Code: **RMJ**
Description: **Roots Medium Joint**

Distance (ft): **27.2**
Structural Grade: **0**
O&M Grade: **3**
Clock Start/From: **7**
Clock To: **5**
1st Value:
2nd Value:
Value Percent: **5.000**
Continuous Index: **S02**
Within 8" of Joint: **YES**
Remarks:

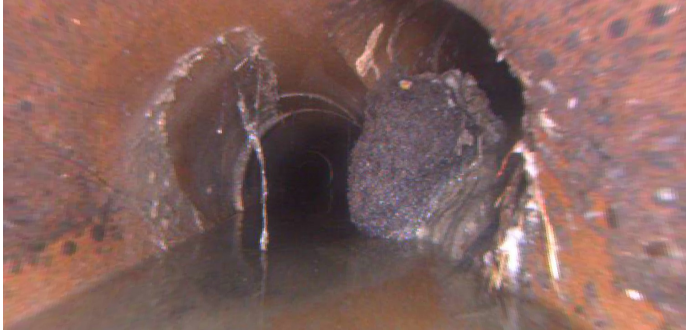
Code: **RML**
Description: **Roots Medium Lateral**

Distance (ft): **32.8**
Structural Grade: **0**
O&M Grade: **3**
Clock Start/From: **3**
Clock To:
1st Value:
2nd Value:
Value Percent: **20.000**
Continuous Index:
Within 8" of Joint: **NO**
Remarks:

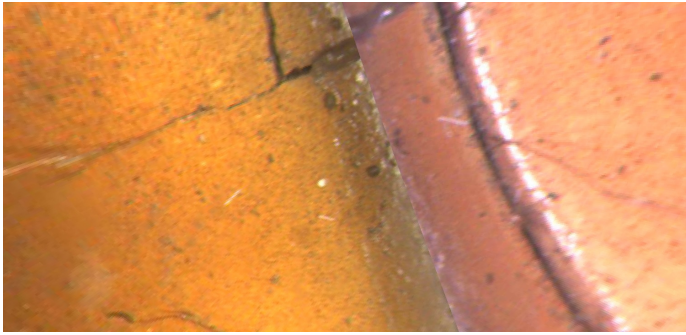
Code: **CM**
Description: **Crack Multiple**

Distance (ft): **49.1**
Structural Grade: **3**
O&M Grade: **0**
Clock Start/From: **7**
Clock To: **5**
1st Value:
2nd Value:
Value Percent:
Continuous Index: **S03**
Within 8" of Joint: **YES**
Remarks: **wandering**

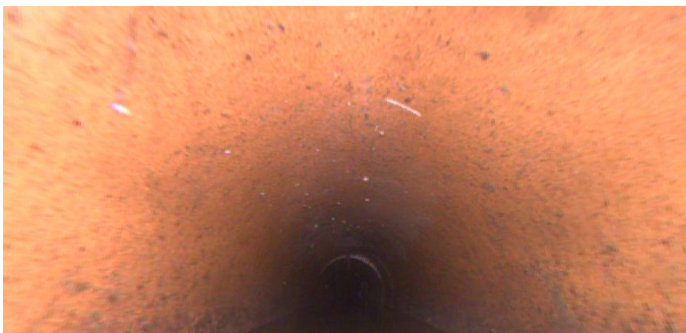
Code: **CL**
Description: **Crack Longitudinal**

Distance (ft): **49.1**
Structural Grade: **2**
O&M Grade: **0**
Clock Start/From: **12**
Clock To:
1st Value:
2nd Value:
Value Percent:
Continuous Index: **F01**
Within 8" of Joint: **YES**
Remarks:

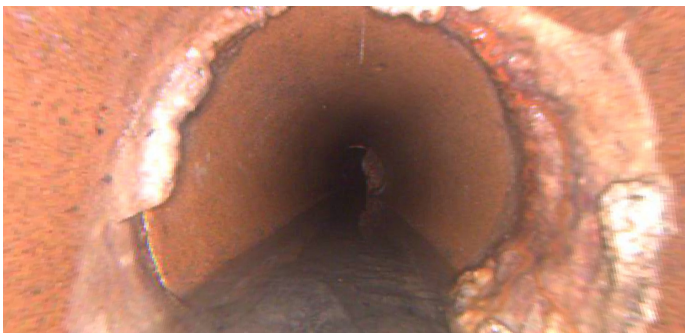
Code: **DAE**
Description: **Deposits Attached Encrustation**

Distance (ft): **72.8**
Structural Grade: **0**
O&M Grade: **2**
Clock Start/From: **7**
Clock To: **5**
1st Value:
2nd Value:
Value Percent: **5.000**
Continuous Index:
Within 8" of Joint: **YES**
Remarks:

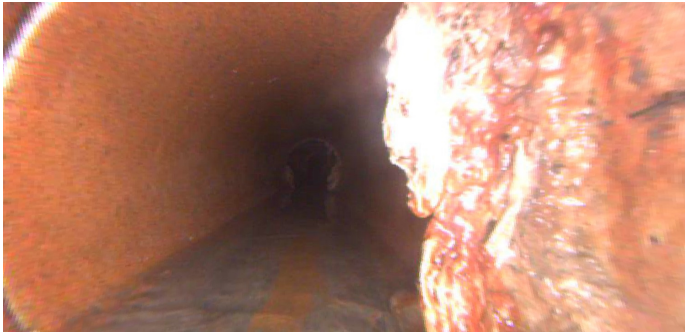
Code: **DAE**
Description: **Deposits Attached Encrustation**

Distance (ft): **75.9**
Structural Grade: **0**
O&M Grade: **4**
Clock Start/From: **1**
Clock To: **5**
1st Value:
2nd Value:
Value Percent: **25.000**
Continuous Index:
Within 8" of Joint: **YES**
Remarks:

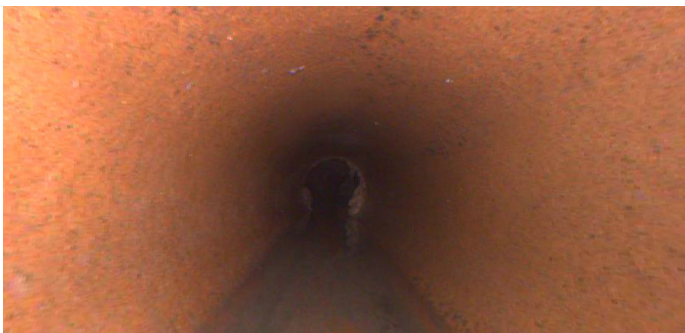
Code: **MSA**
Description: **Abandoned Survey**

Distance (ft): **76.4**
Structural Grade: **0**
O&M Grade: **0**
Clock Start/From:
Clock To:
1st Value:
2nd Value:
Value Percent:
Continuous Index:
Within 8" of Joint: **NO**
Remarks: **dae at joint**

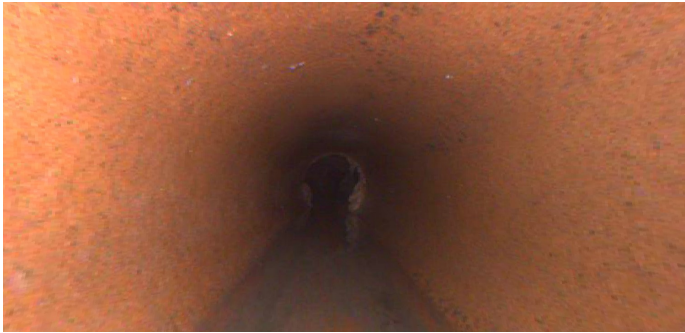
Code: **RMJ**
Description: **Roots Medium Joint**

Distance (ft): **76.4**
Structural Grade: **0**
O&M Grade: **3**
Clock Start/From: **7**
Clock To: **5**
1st Value:
2nd Value:
Value Percent: **5.000**
Continuous Index: **F02**
Within 8" of Joint: **YES**
Remarks:

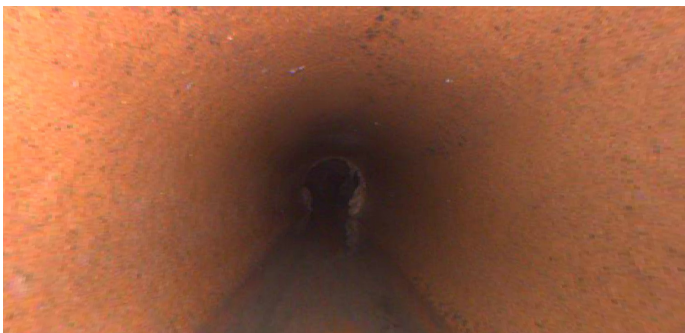
Code: **CM**
Description: **Crack Multiple**

Distance (ft): **76.4**
Structural Grade: **3**
O&M Grade: **0**
Clock Start/From: **7**
Clock To: **5**
1st Value:
2nd Value:
Value Percent:
Continuous Index: **F03**
Within 8" of Joint: **YES**
Remarks: **wandering**
