Profile/Photo Observation Report

Date:	02/17/2024	Weather:		Coding:	PACP 7.0
Pipe Length (ft):	294.0	Owner:	City of Hobart	Pre Clean:	Heavy Cleaning
P.O.#:	YES502259	Surveyor:	S. Bucklin	PSR:	P-405-037-036
Customer:	City of Hobart	Clean Date:	10/03/2023	Shape:	C

Street:	SOFTWOOD DR	Flow Control:	Not Controlled
City:	Hobart, IN	Year Renewed:	
Location:	Easement/Right of Way	Tape/Media #:	
Purpose:	Routine Assessment	Dia/Height:	8"
Use:	Sanitary Sewage Pipe	Material:	VCP
Drain Area:		Lining:	None
Category:	NA		
Comment:			
Location Details:		Direction of Survey:	Upstream
US MH:	M-405-036	DS MH:	M-405-037
		Total Length Surveyed (ft):	312.0

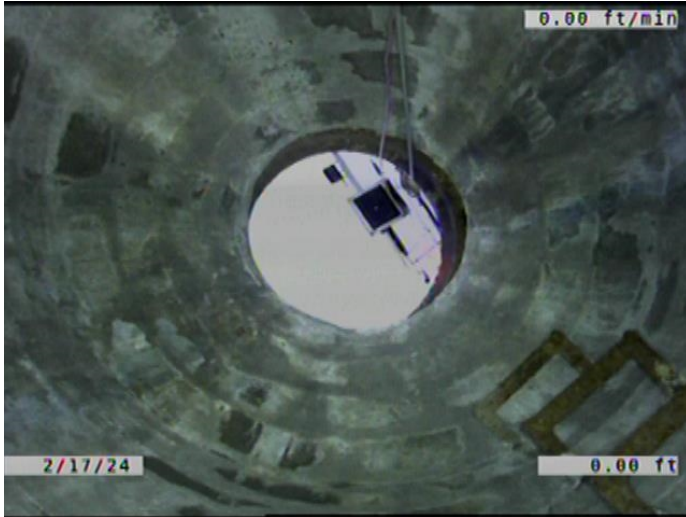
M-405-036

Code: **AMH**
Description: **Manhole**

Distance (ft): **.0**
Structural Grade: **0**
O&M Grade: **0**
Clock Start/From:
Clock To:
1st Value:
2nd Value:
Value Percent:
Continuous Index:
Within 8" of Joint: **NO**
Remarks: **M-405-037**

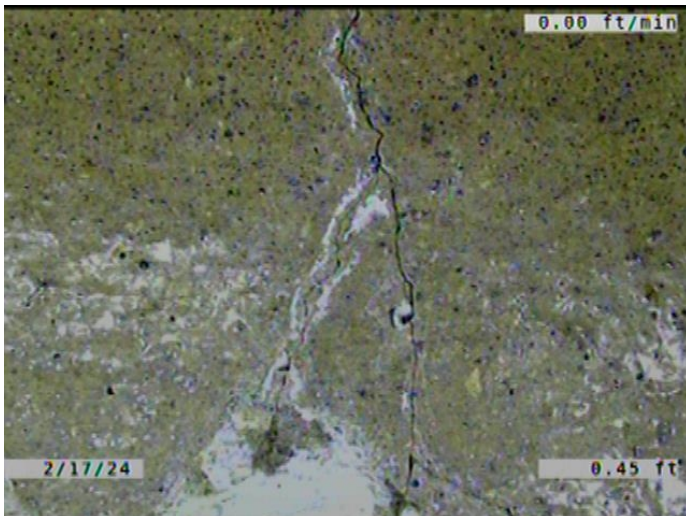
Code: **B**
Description: **Broken**

Distance (ft): **.5**
Structural Grade: **4**
O&M Grade: **0**
Clock Start/From: **8**
Clock To: **4**
1st Value:
2nd Value:
Value Percent:
Continuous Index:
Within 8" of Joint: **YES**
Remarks:

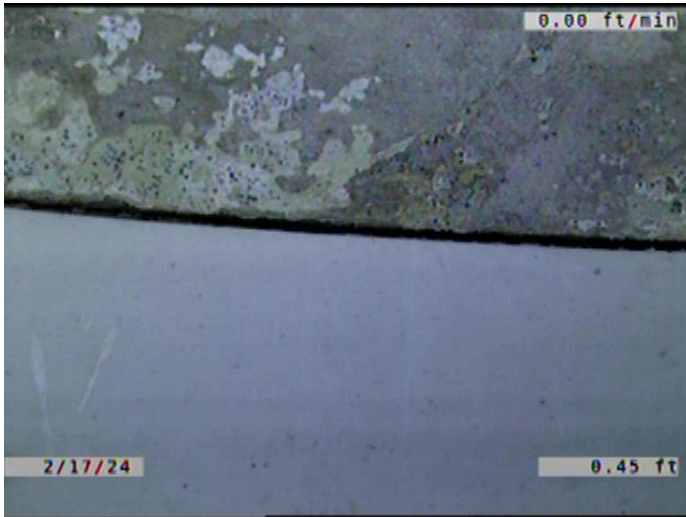
Code: **RPR**
Description: **Point Repair Replacement**

Distance (ft): **.5**
Structural Grade: **0**
O&M Grade: **0**
Clock Start/From:
Clock To:
1st Value:
2nd Value:
Value Percent:
Continuous Index: **S02**
Within 8" of Joint: **YES**
Remarks: **REPLACED WITH PVC.**

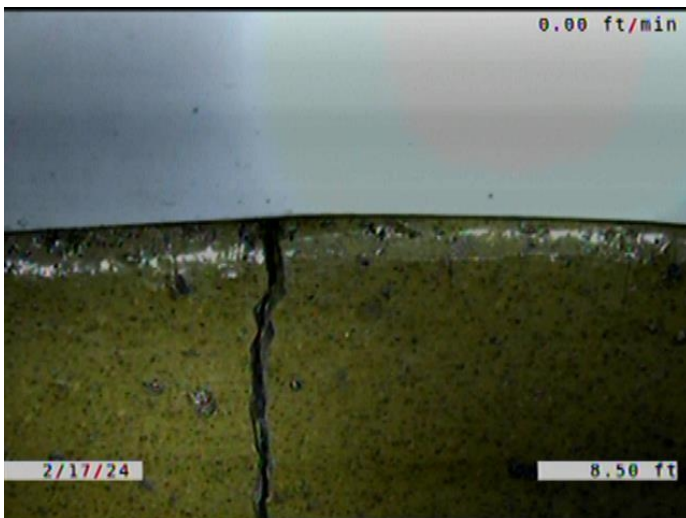
Code: **RPR**
Description: **Point Repair Replacement**

Distance (ft): **8.5**
Structural Grade: **0**
O&M Grade: **0**
Clock Start/From:
Clock To:
1st Value:
2nd Value:
Value Percent:
Continuous Index: **F02**
Within 8" of Joint: **YES**
Remarks: **REPLACED WITH PVC.**

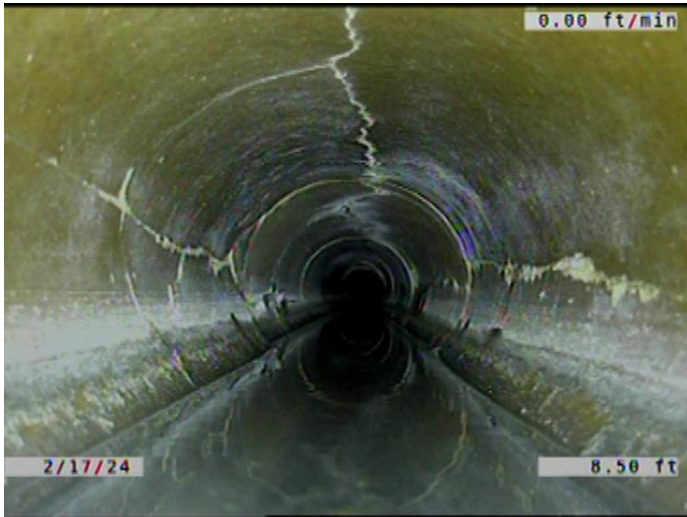
Code: **FM**
Description: **Fracture Multiple**

Distance (ft): **8.5**
Structural Grade: **4**
O&M Grade: **0**
Clock Start/From: **7**
Clock To: **5**
1st Value:
2nd Value:
Value Percent:
Continuous Index: **S03**
Within 8" of Joint: **YES**
Remarks:

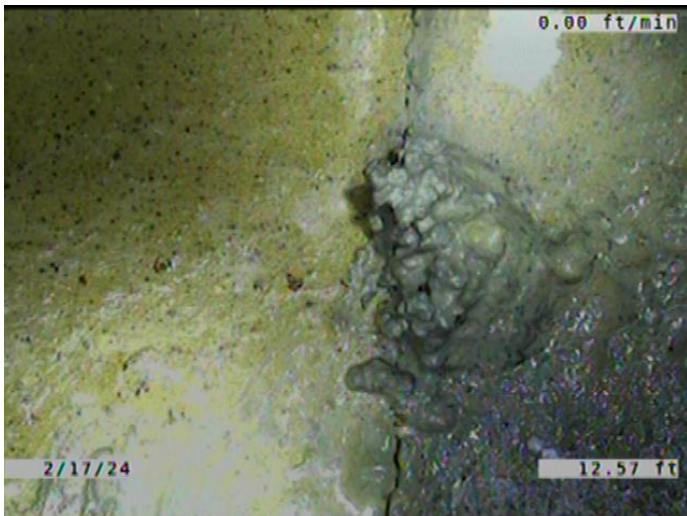
Code: **DAE**
Description: **Deposits Attached Encrustation**

Distance (ft): **12.6**
Structural Grade: **0**
O&M Grade: **2**
Clock Start/From: **7**
Clock To: **5**
1st Value:
2nd Value:
Value Percent: **5.000**
Continuous Index: **S04**
Within 8" of Joint: **YES**
Remarks:

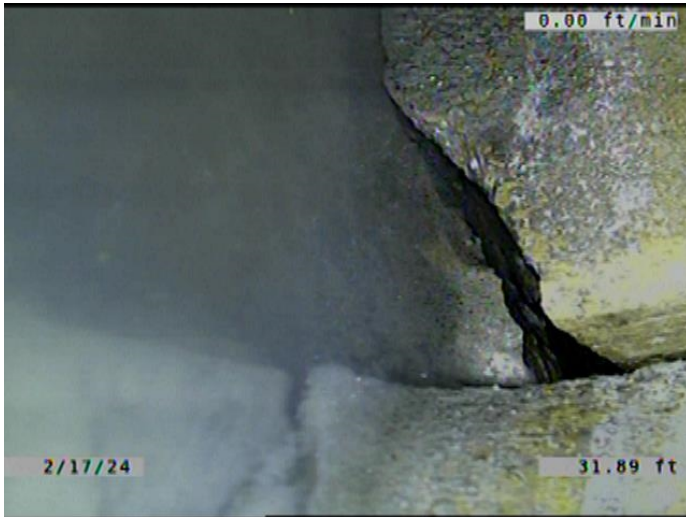
Code: **BVV**
 Description: **Broken Void Visible**

Distance (ft): **31.9**
 Structural Grade: **5**
 O&M Grade: **0**
 Clock Start/From: **4**
 Clock To: **8**
 1st Value:
 2nd Value:
 Value Percent:
 Continuous Index:
 Within 8" of Joint: **YES**
 Remarks: **VOID AND SOIL VISIBLE. WATER EXITING THE PIPE.**

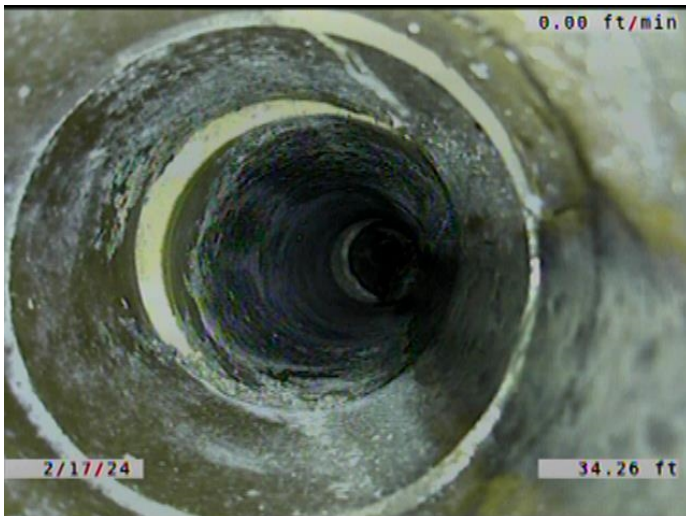
Code: **TFD**
 Description: **Tap Factory Defective**

Distance (ft): **34.3**
 Structural Grade: **0**
 O&M Grade: **3**
 Clock Start/From: **2**
 Clock To:
 1st Value: **6.000**
 2nd Value:
 Value Percent:
 Continuous Index:
 Within 8" of Joint: **YES**
 Remarks: **TAP BROKEN. SOIL VISIBLE. SERVICE HAS DROPPED. SOIL VISIBLE THERE**

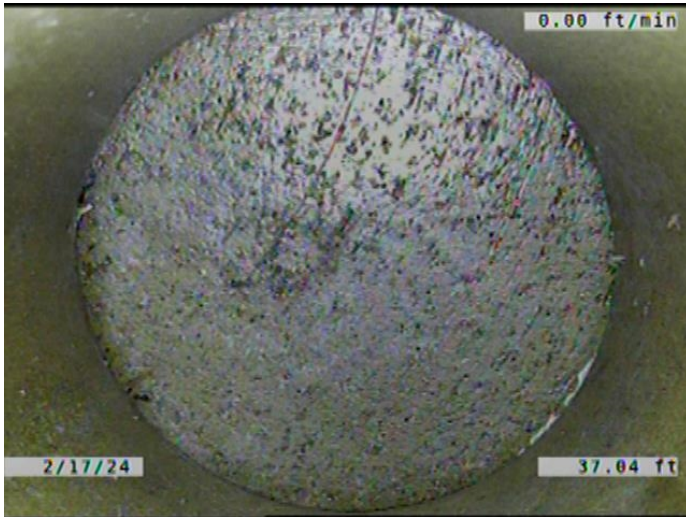
Code: **TFD**
Description: **Tap Factory Defective**

Distance (ft): **37.0**
Structural Grade: **0**
O&M Grade: **3**
Clock Start/From: **10**
Clock To:
1st Value: **6.000**
2nd Value:
Value Percent:
Continuous Index:
Within 8" of Joint: **YES**
Remarks: **CAPPED. TAP BROKEN.**

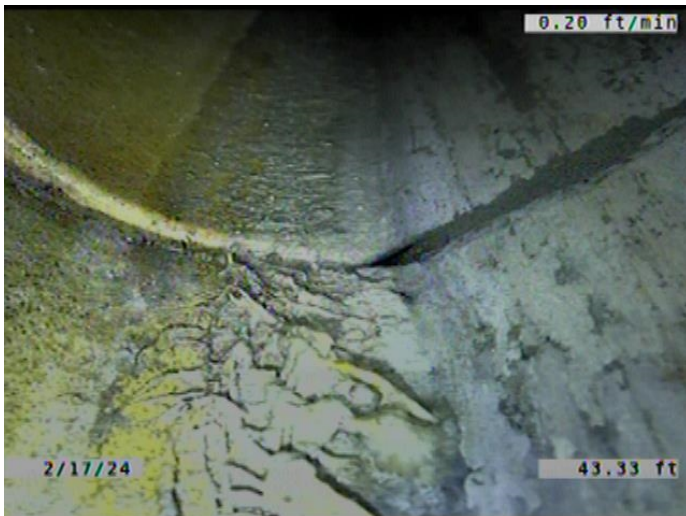
Code: **RFJ**
Description: **Roots Fine Joint**

Distance (ft): **43.3**
Structural Grade: **0**
O&M Grade: **1**
Clock Start/From: **4**
Clock To: **8**
1st Value:
2nd Value:
Value Percent:
Continuous Index:
Within 8" of Joint: **YES**
Remarks:

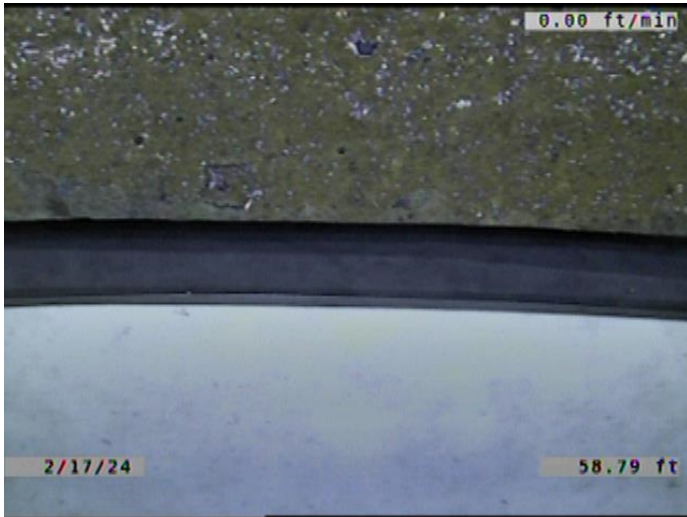
Code: **RPR**
Description: **Point Repair Replacement**

Distance (ft): **58.8**
Structural Grade: **0**
O&M Grade: **0**
Clock Start/From:
Clock To:
1st Value:
2nd Value:
Value Percent:
Continuous Index: **S06**
Within 8" of Joint: **YES**
Remarks: **REPLACED WITH PVC.**

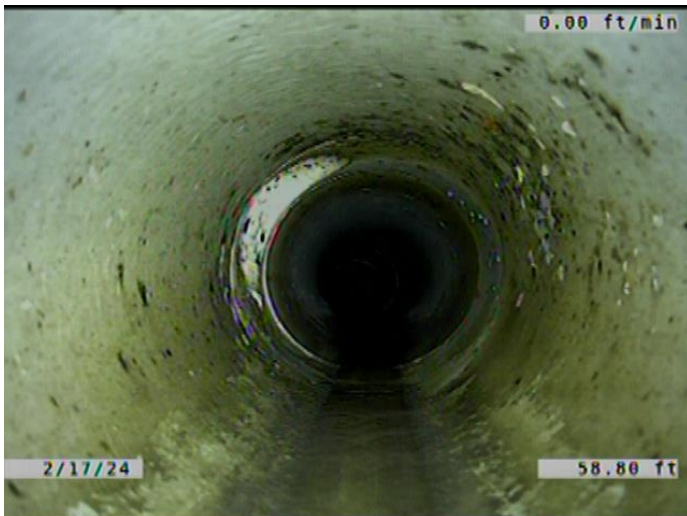
Code: **FM**
Description: **Fracture Multiple**

Distance (ft): **58.8**
Structural Grade: **4**
O&M Grade: **0**
Clock Start/From: **7**
Clock To: **5**
1st Value:
2nd Value:
Value Percent:
Continuous Index: **F03**
Within 8" of Joint: **YES**
Remarks:

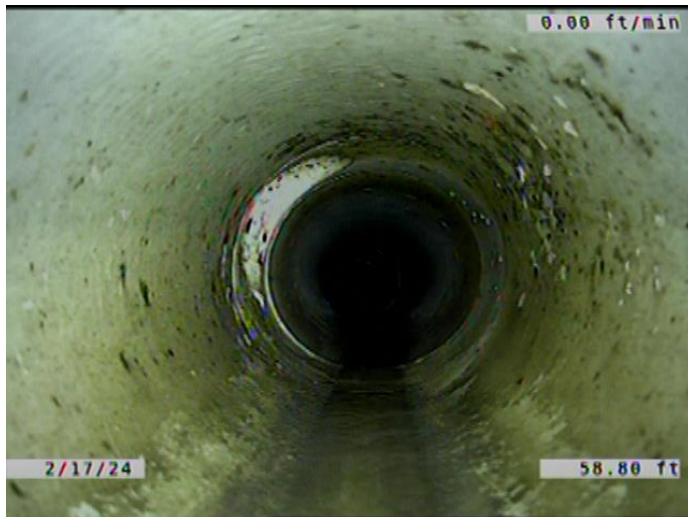
Code: **DAE**
Description: **Deposits Attached Encrustation**

Distance (ft): **58.8**
Structural Grade: **0**
O&M Grade: **2**
Clock Start/From: **7**
Clock To: **5**
1st Value:
2nd Value:
Value Percent: **5.000**
Continuous Index: **F04**
Within 8" of Joint: **YES**
Remarks:

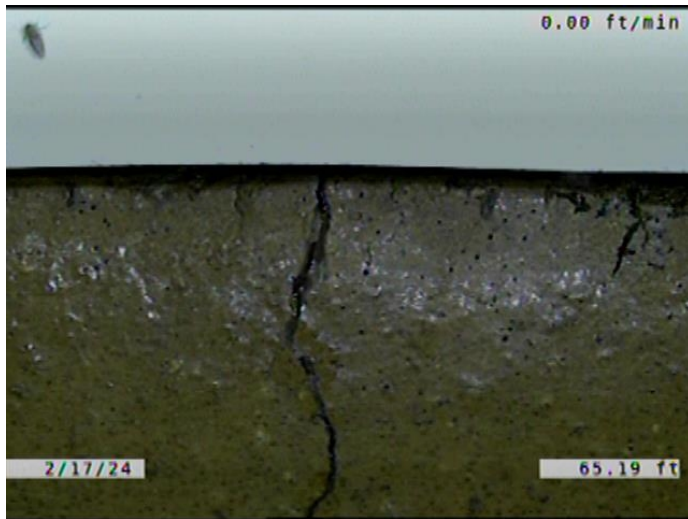
Code: **RPR**
Description: **Point Repair Replacement**

Distance (ft): **65.2**
Structural Grade: **0**
O&M Grade: **0**
Clock Start/From:
Clock To:
1st Value:
2nd Value:
Value Percent:
Continuous Index: **F06**
Within 8" of Joint: **YES**
Remarks: **REPLACED WITH PVC.**

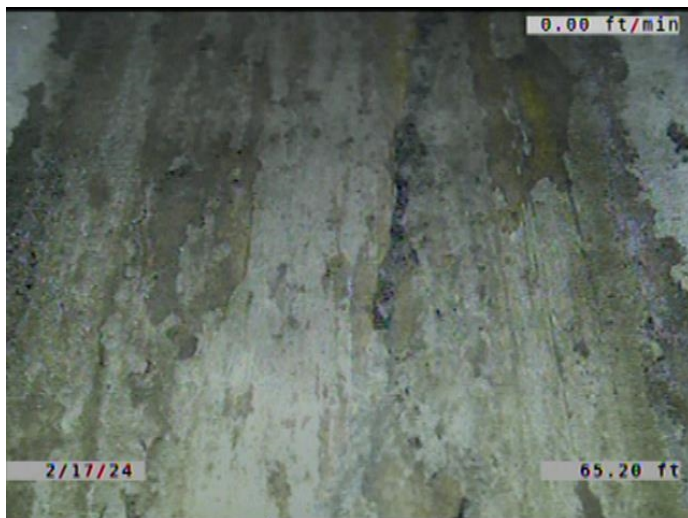
Code: **FM**
Description: **Fracture Multiple**

Distance (ft): **65.2**
Structural Grade: **4**
O&M Grade: **0**
Clock Start/From: **12**
Clock To: **12**
1st Value:
2nd Value:
Value Percent:
Continuous Index: **S07**
Within 8" of Joint: **YES**
Remarks:

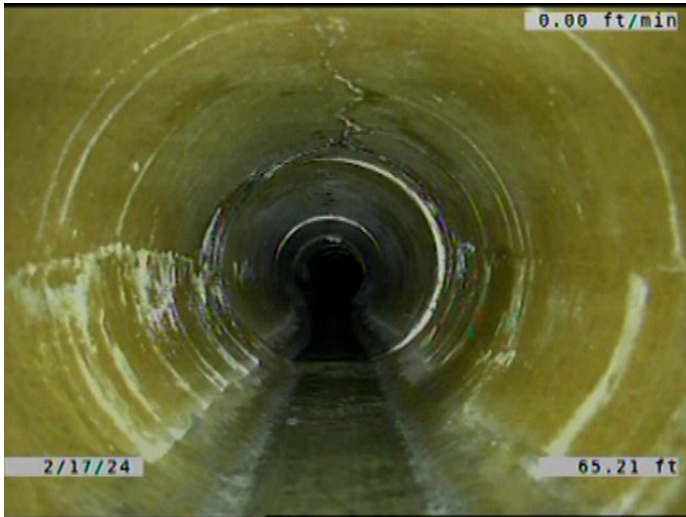
Code: **DAE**
Description: **Deposits Attached Encrustation**

Distance (ft): **65.2**
Structural Grade: **0**
O&M Grade: **2**
Clock Start/From: **7**
Clock To: **5**
1st Value:
2nd Value:
Value Percent: **5.000**
Continuous Index: **S08**
Within 8" of Joint: **YES**
Remarks:

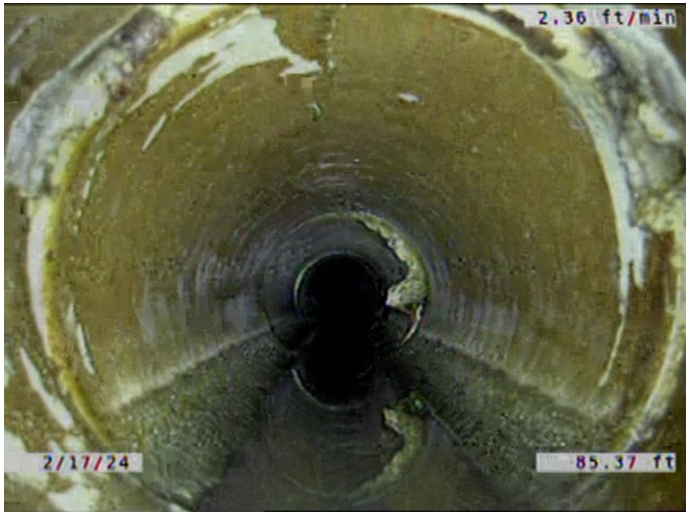
Code: **FM**
Description: **Fracture Multiple**

Distance (ft): **85.4**
Structural Grade: **4**
O&M Grade: **0**
Clock Start/From: **12**
Clock To: **12**
1st Value:
2nd Value:
Value Percent:
Continuous Index: **F07**
Within 8" of Joint: **YES**
Remarks:

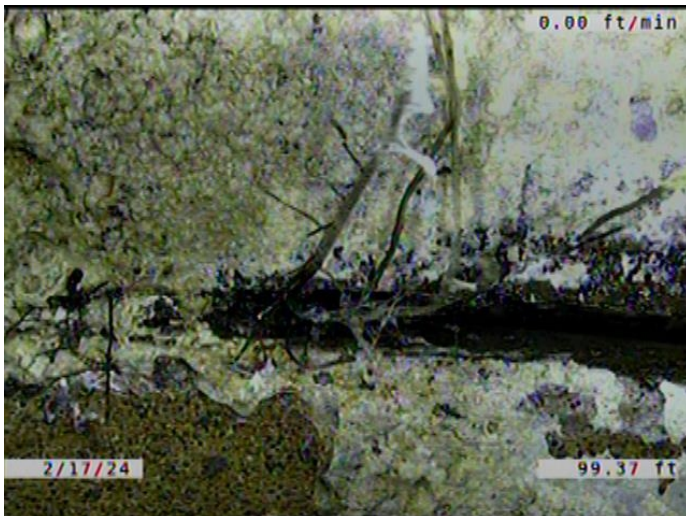
Code: **RFJ**
Description: **Roots Fine Joint**

Distance (ft): **99.4**
Structural Grade: **0**
O&M Grade: **1**
Clock Start/From: **3**
Clock To: **5**
1st Value:
2nd Value:
Value Percent:
Continuous Index:
Within 8" of Joint: **YES**
Remarks:

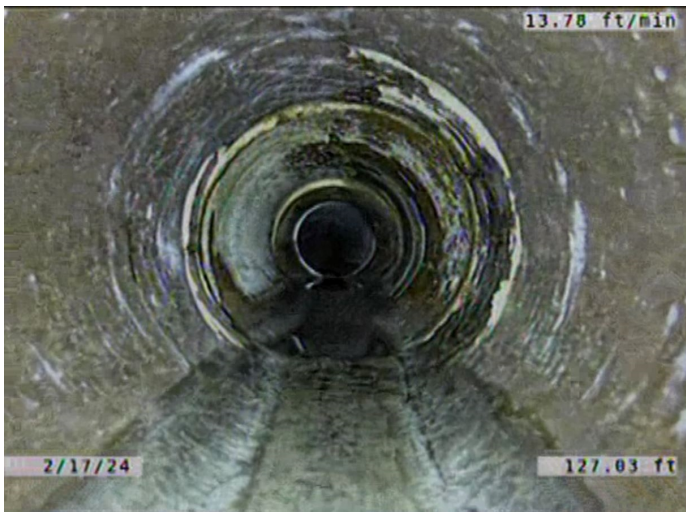
Code: **FM**
Description: **Fracture Multiple**

Distance (ft): **127.0**
Structural Grade: **4**
O&M Grade: **0**
Clock Start/From: **7**
Clock To: **5**
1st Value:
2nd Value:
Value Percent:
Continuous Index: **S28**
Within 8" of Joint: **YES**
Remarks:

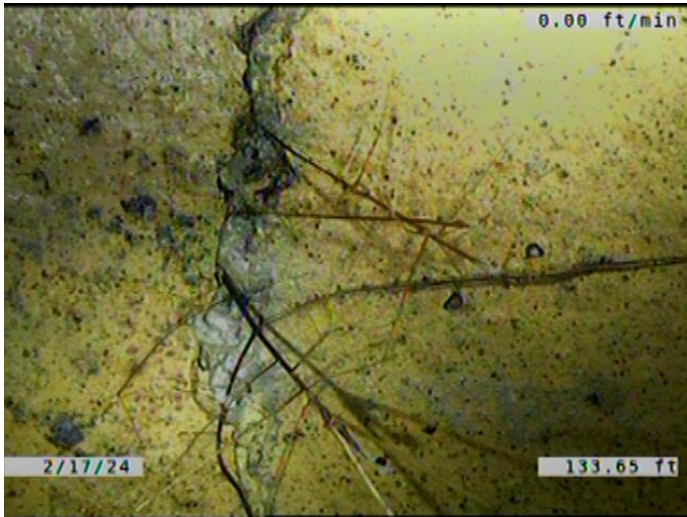
Code: **RFB**
 Description: **Roots Fine Barrel**

Distance (ft): **133.6**
 Structural Grade: **0**
 O&M Grade: **2**
 Clock Start/From: **3**
 Clock To:
 1st Value:
 2nd Value:
 Value Percent:
 Continuous Index:
 Within 8" of Joint: **NO**
 Remarks:

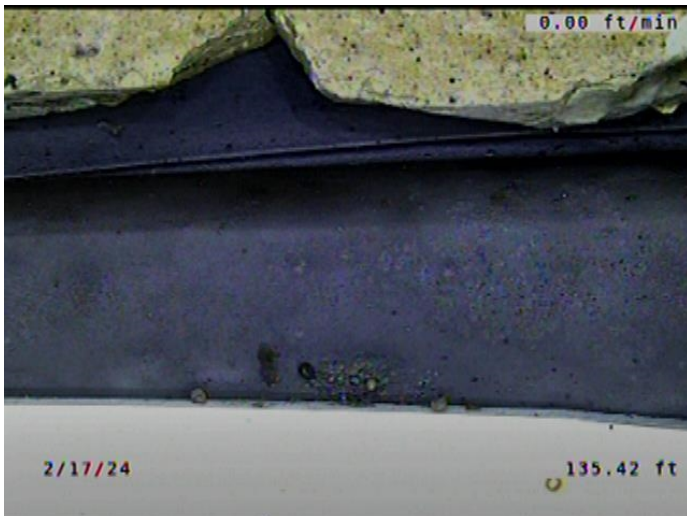
Code: **RPR**
 Description: **Point Repair Replacement**

Distance (ft): **135.4**
 Structural Grade: **0**
 O&M Grade: **0**
 Clock Start/From:
 Clock To:
 1st Value:
 2nd Value:
 Value Percent:
 Continuous Index: **S11**
 Within 8" of Joint: **YES**
 Remarks: **REPLACED WITH PVC.**

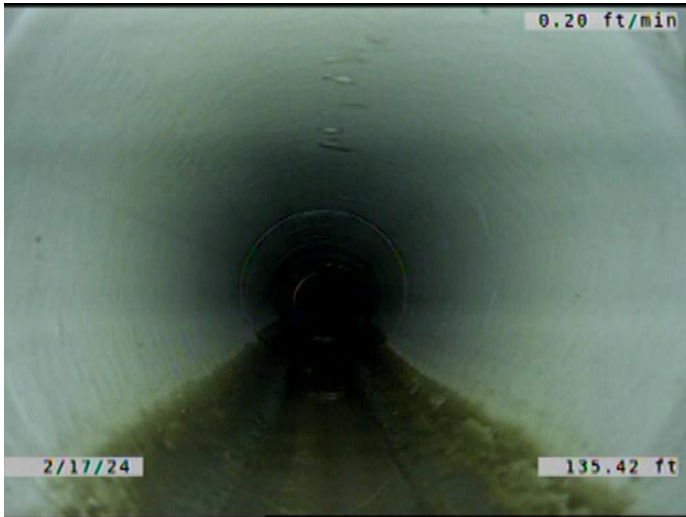
Code: **FM**
Description: **Fracture Multiple**

Distance (ft): **135.4**
Structural Grade: **4**
O&M Grade: **0**
Clock Start/From: **7**
Clock To: **5**
1st Value:
2nd Value:
Value Percent:
Continuous Index: **F28**
Within 8" of Joint: **YES**
Remarks:

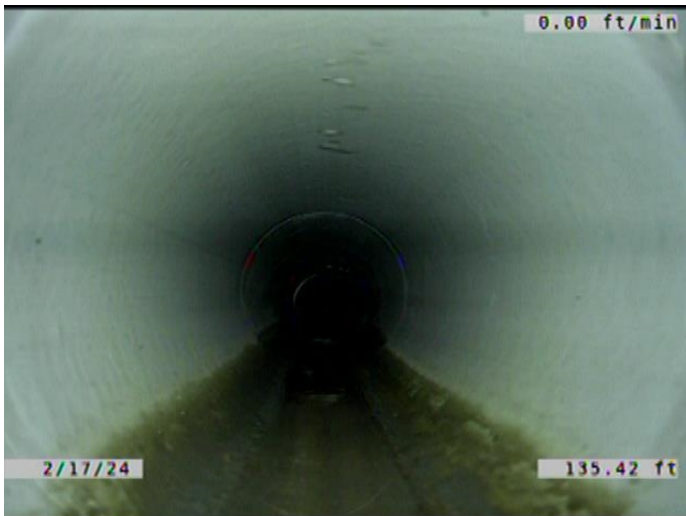
Code: **DAE**
Description: **Deposits Attached Encrustation**

Distance (ft): **135.4**
Structural Grade: **0**
O&M Grade: **2**
Clock Start/From: **7**
Clock To: **5**
1st Value:
2nd Value:
Value Percent: **5.000**
Continuous Index: **F08**
Within 8" of Joint: **YES**
Remarks:

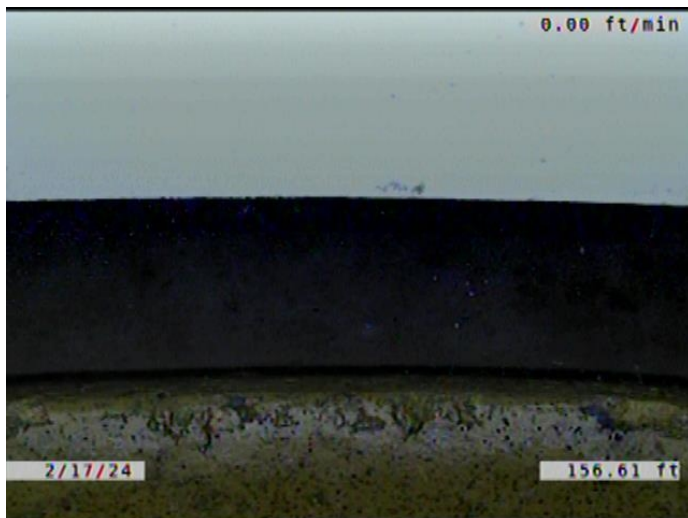
Code: **RPR**
Description: **Point Repair Replacement**

Distance (ft): **156.6**
Structural Grade: **0**
O&M Grade: **0**
Clock Start/From:
Clock To:
1st Value:
2nd Value:
Value Percent:
Continuous Index: **F11**
Within 8" of Joint: **YES**
Remarks: **REPLACED WITH PVC.**

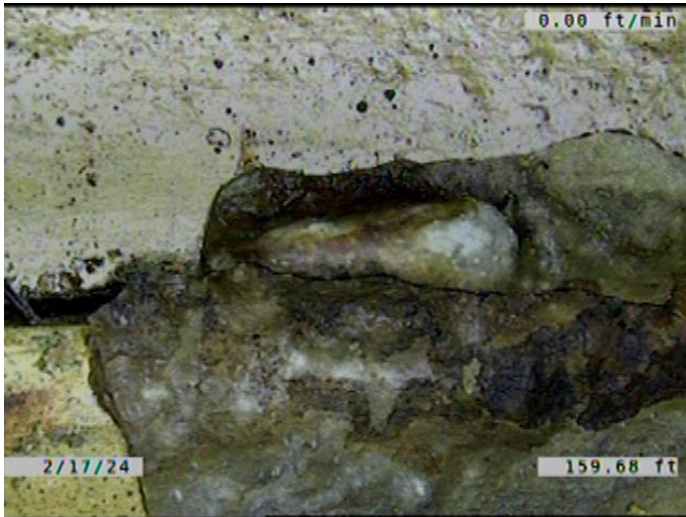
Code: **DAE**
Description: **Deposits Attached Encrustation**

Distance (ft): **159.7**
Structural Grade: **0**
O&M Grade: **2**
Clock Start/From: **7**
Clock To: **5**
1st Value:
2nd Value:
Value Percent: **5.000**
Continuous Index:
Within 8" of Joint: **YES**
Remarks:

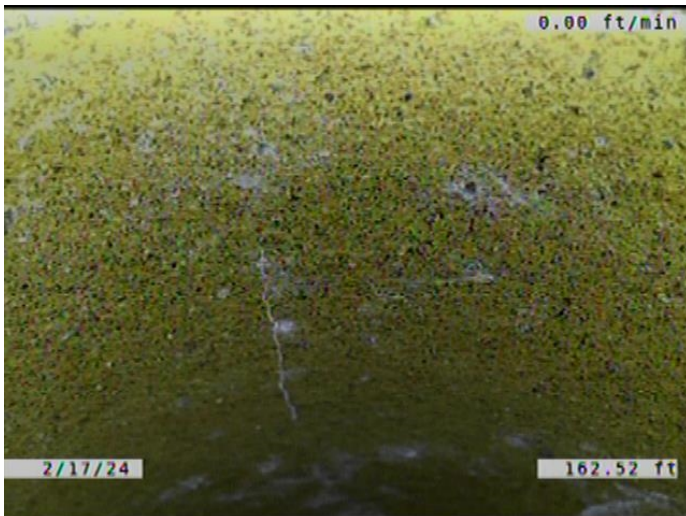
Code: **CM**
Description: **Crack Multiple**

Distance (ft): **162.5**
Structural Grade: **3**
O&M Grade: **0**
Clock Start/From: **11**
Clock To: **1**
1st Value:
2nd Value:
Value Percent:
Continuous Index:
Within 8" of Joint: **YES**
Remarks:

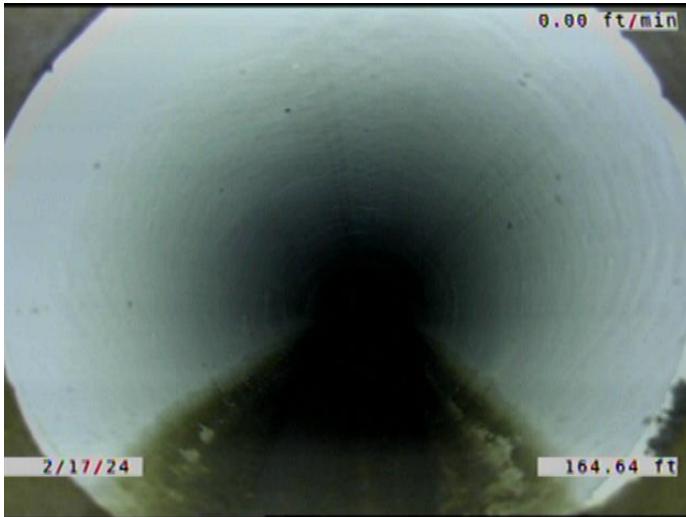
Code: **MWLS**
Description: **Miscellaneous Water Level Sag**

Distance (ft): **164.6**
Structural Grade: **2**
O&M Grade: **0**
Clock Start/From:
Clock To:
1st Value:
2nd Value:
Value Percent: **10.000**
Continuous Index: **S13**
Within 8" of Joint: **NO**
Remarks:

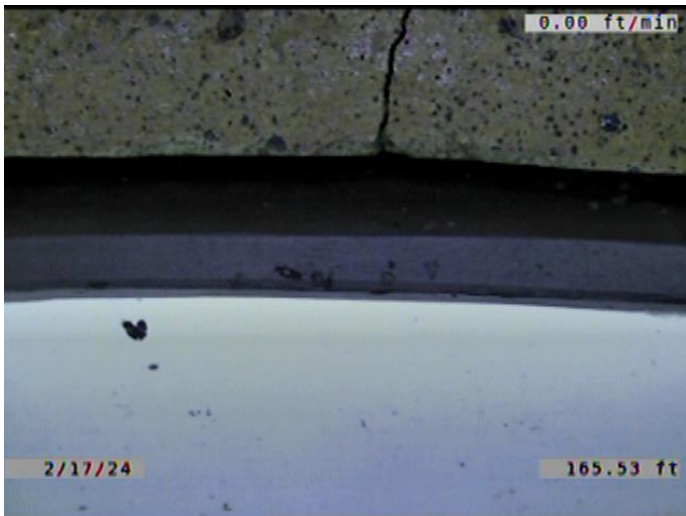
Code: **RPR**
Description: **Point Repair Replacement**

Distance (ft): **165.5**
Structural Grade: **0**
O&M Grade: **0**
Clock Start/From:
Clock To:
1st Value:
2nd Value:
Value Percent:
Continuous Index: **S14**
Within 8" of Joint: **YES**
Remarks: **REPLACED WITH PVC.**

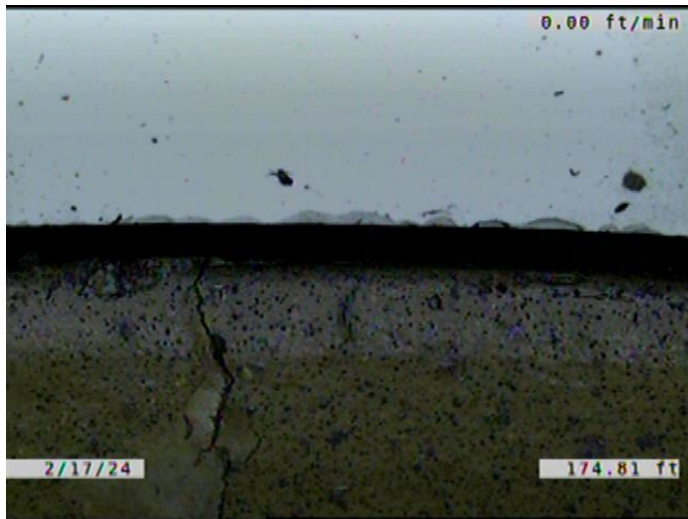
Code: **RPR**
Description: **Point Repair Replacement**

Distance (ft): **174.8**
Structural Grade: **0**
O&M Grade: **0**
Clock Start/From:
Clock To:
1st Value:
2nd Value:
Value Percent:
Continuous Index: **F14**
Within 8" of Joint: **YES**
Remarks: **REPLACED WITH PVC.**

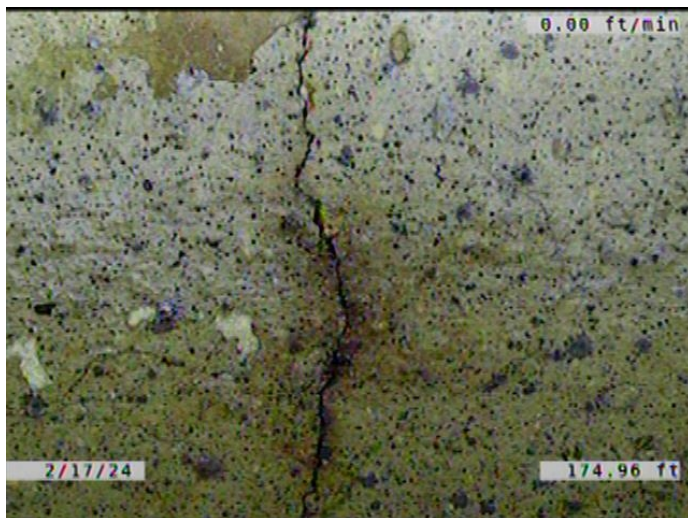
Code: **CL**
Description: **Crack Longitudinal**

Distance (ft): **175.0**
Structural Grade: **2**
O&M Grade: **0**
Clock Start/From: **12**
Clock To:
1st Value:
2nd Value:
Value Percent:
Continuous Index:
Within 8" of Joint: **YES**
Remarks:

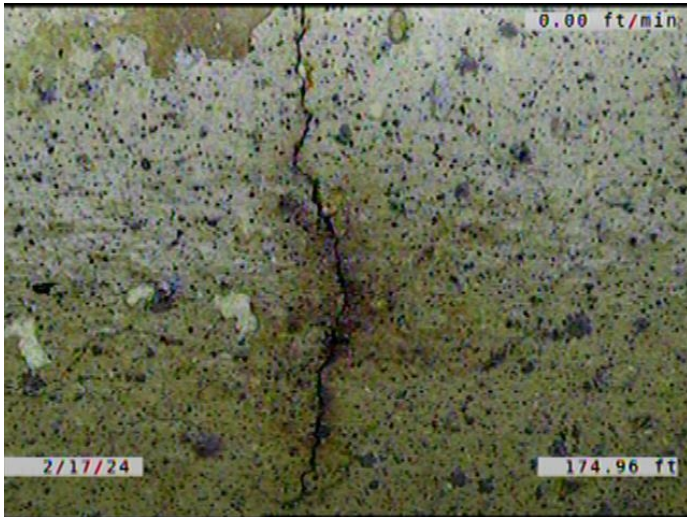
Code: **ISB**
Description: **Infiltration Stain Barrel**

Distance (ft): **175.0**
Structural Grade: **0**
O&M Grade: **1**
Clock Start/From: **12**
Clock To:
1st Value:
2nd Value:
Value Percent:
Continuous Index:
Within 8" of Joint: **YES**
Remarks:

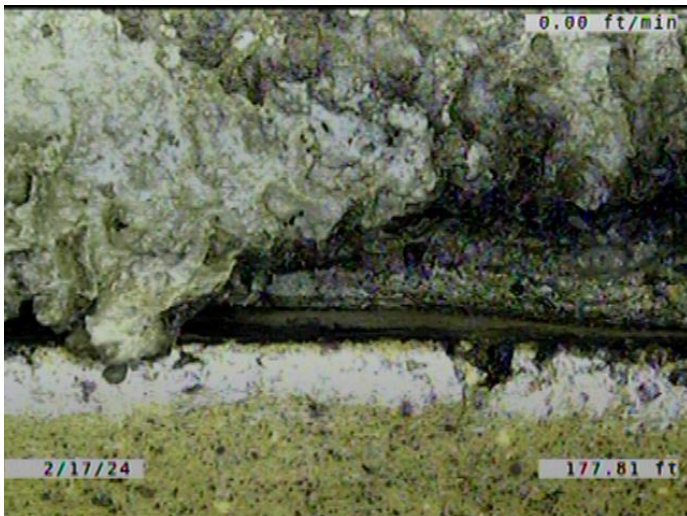
Code: **DAE**
Description: **Deposits Attached Encrustation**

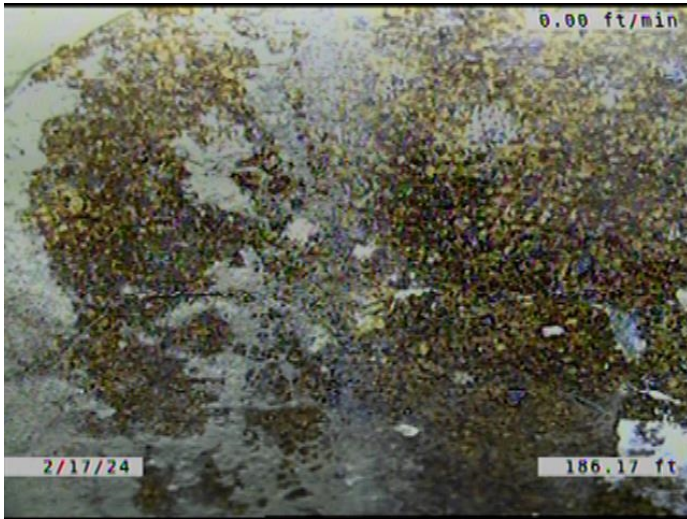
Code: **CM**
Description: **Crack Multiple**

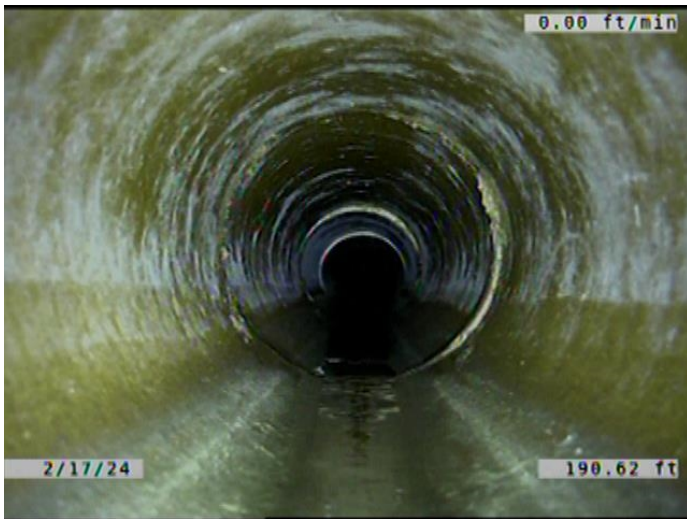
Code: **MWLS**
Description: **Miscellaneous Water Level Sag**

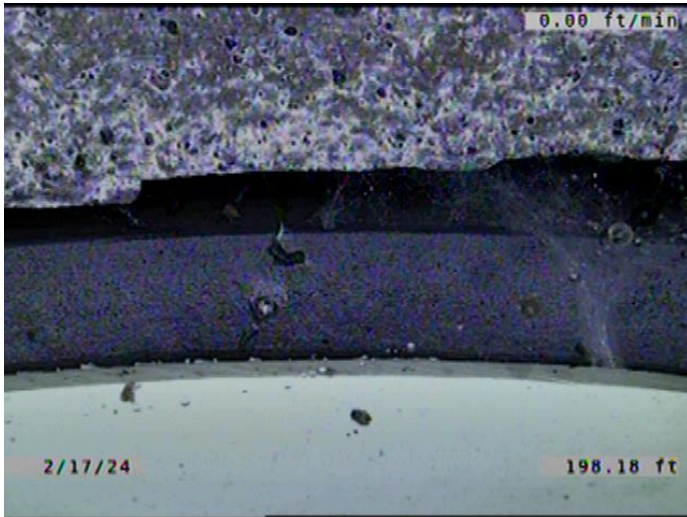
Code: **RPR**
Description: **Point Repair Replacement**

Distance (ft): **198.2**
Structural Grade: **0**
O&M Grade: **0**
Clock Start/From:
Clock To:
1st Value:
2nd Value:
Value Percent:
Continuous Index: **S16**
Within 8" of Joint: **YES**
Remarks: **REPLACED WITH PVC.**

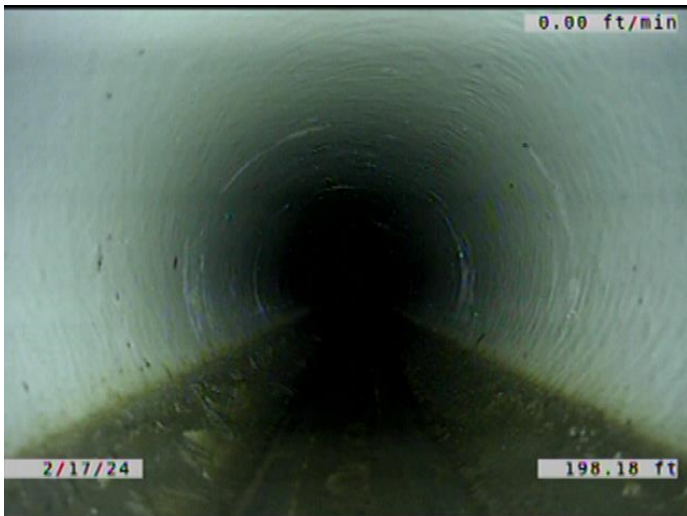
Code: **DAE**
Description: **Deposits Attached Encrustation**

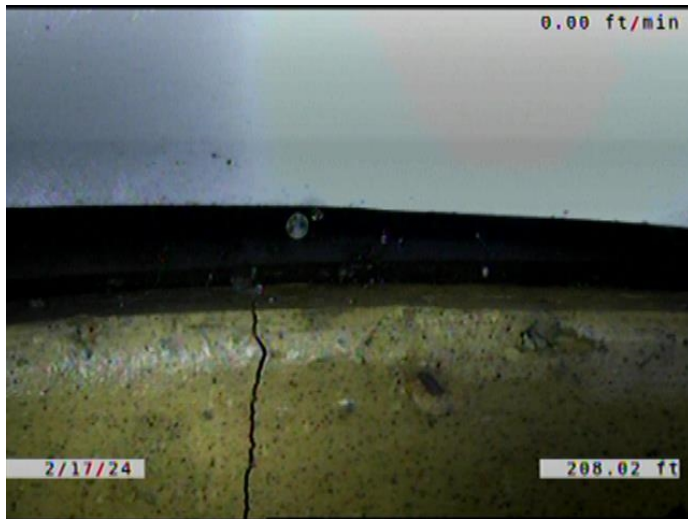
Code: **RPR**
Description: **Point Repair Replacement**

Distance (ft): **208.0**
Structural Grade: **0**
O&M Grade: **0**
Clock Start/From:
Clock To:
1st Value:
2nd Value:
Value Percent:
Continuous Index: **F16**
Within 8" of Joint: **YES**
Remarks: **REPLACED WITH PVC.**

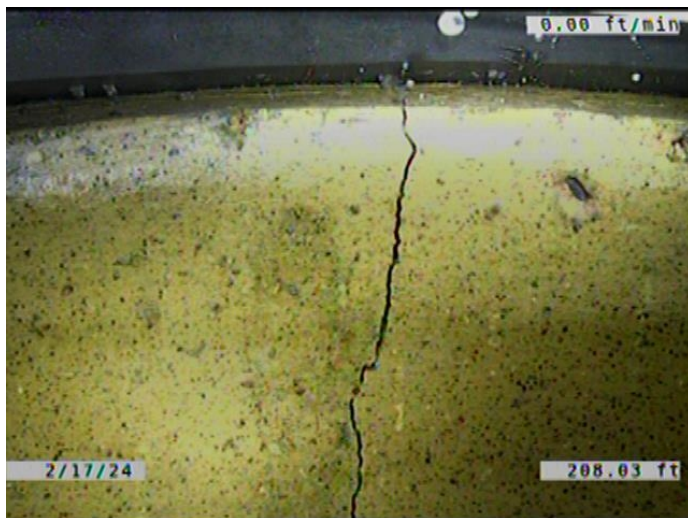
Code: **FM**
Description: **Fracture Multiple**

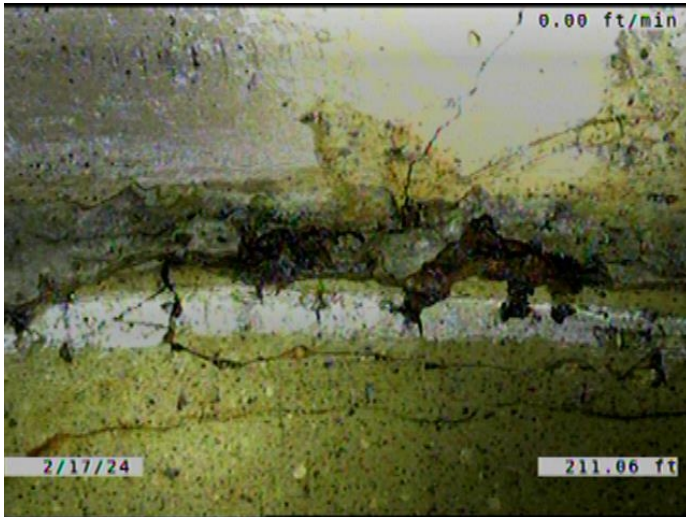
Code: **DAE**
Description: **Deposits Attached Encrustation**

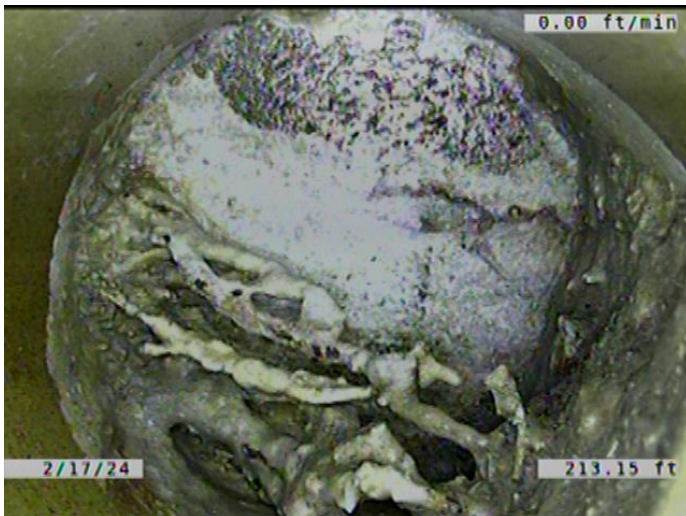
Code: **TFD**
Description: **Tap Factory Defective**

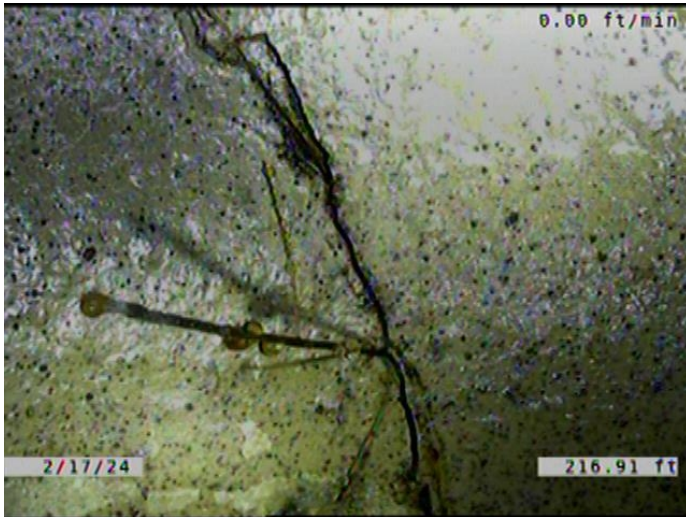
Code: **RFB**
 Description: **Roots Fine Barrel**

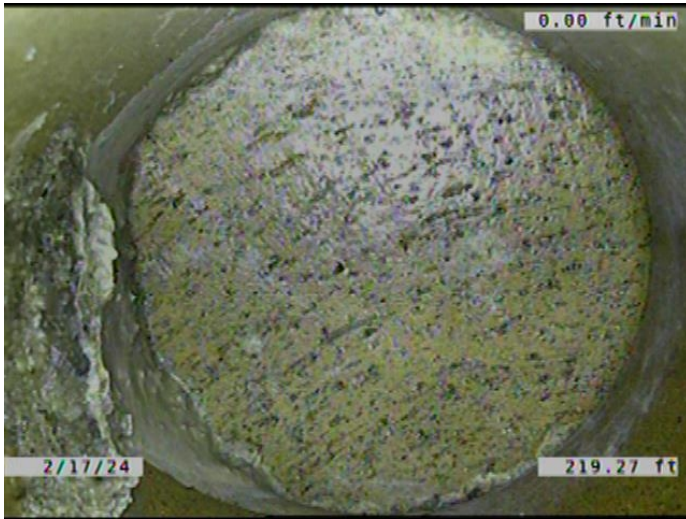
Code:	TFD
Description:	Tap Factory Defective
Distance (ft):	219.3
Structural Grade:	0
O&M Grade:	3
Clock Start/From:	10
Clock To:	
1st Value:	6.000
2nd Value:	
Value Percent:	
Continuous Index:	
Within 8" of Joint:	YES
Remarks:	CAPPED. TAP BROKEN. ENCrustation COMING AROUND T

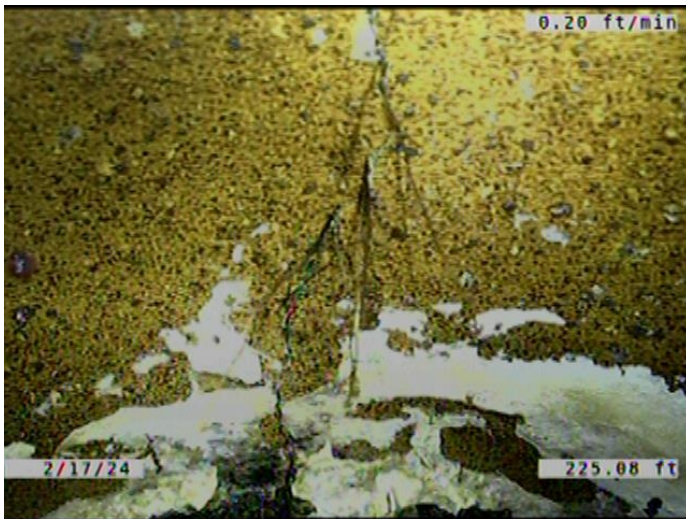
Code:	RFB
Description:	Roots Fine Barrel
Distance (ft):	225.0
Structural Grade:	0
O&M Grade:	2
Clock Start/From:	12
Clock To:	
1st Value:	
2nd Value:	
Value Percent:	
Continuous Index:	
Within 8" of Joint:	NO
Remarks:

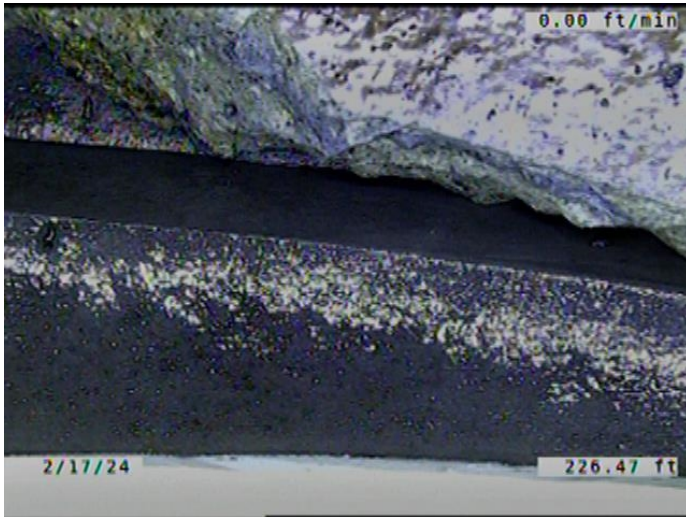
Code: **RPR**
Description: **Point Repair Replacement**

Distance (ft): **226.5**
Structural Grade: **0**
O&M Grade: **0**
Clock Start/From:
Clock To:
1st Value:
2nd Value:
Value Percent:
Continuous Index: **S19**
Within 8" of Joint: **YES**
Remarks: **REPLACED WITH PVC.**

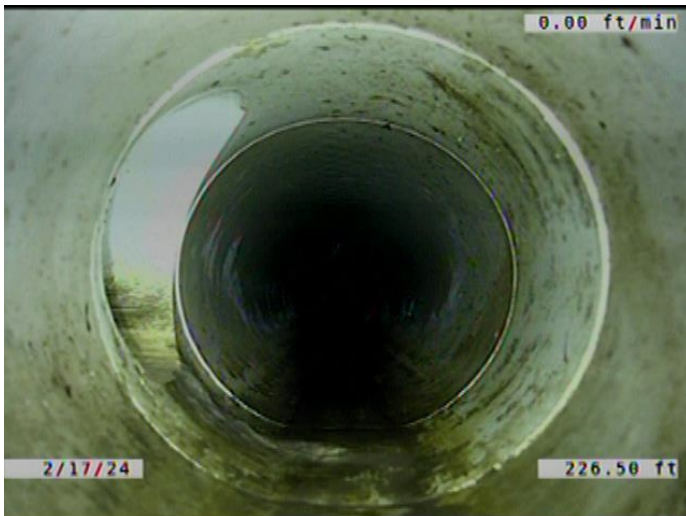
Code: **FM**
Description: **Fracture Multiple**

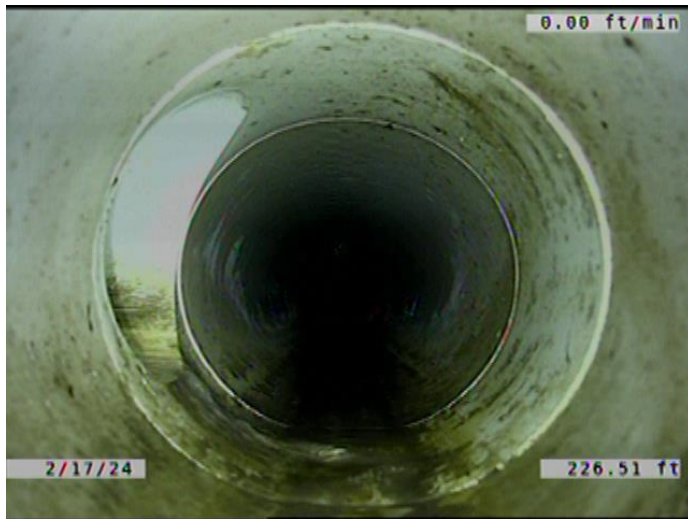
Code: **DAE**
Description: **Deposits Attached Encrustation**

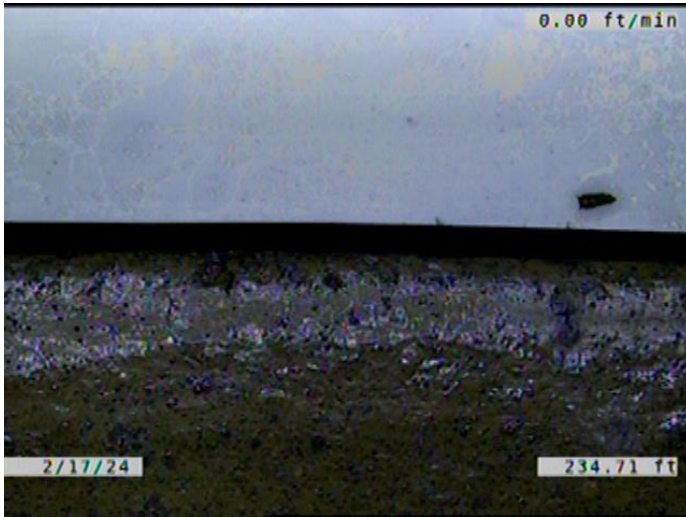
Code: **RPR**
Description: **Point Repair Replacement**

Distance (ft): **234.7**
Structural Grade: **0**
O&M Grade: **0**
Clock Start/From:
Clock To:
1st Value:
2nd Value:
Value Percent:
Continuous Index: **F19**
Within 8" of Joint: **YES**
Remarks: **REPLACED WITH PVC.**

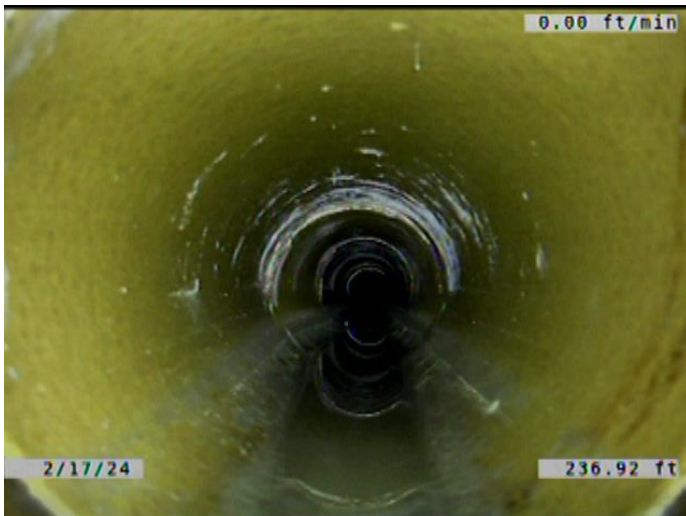
Code: **MWLS**
Description: **Miscellaneous Water Level Sag**

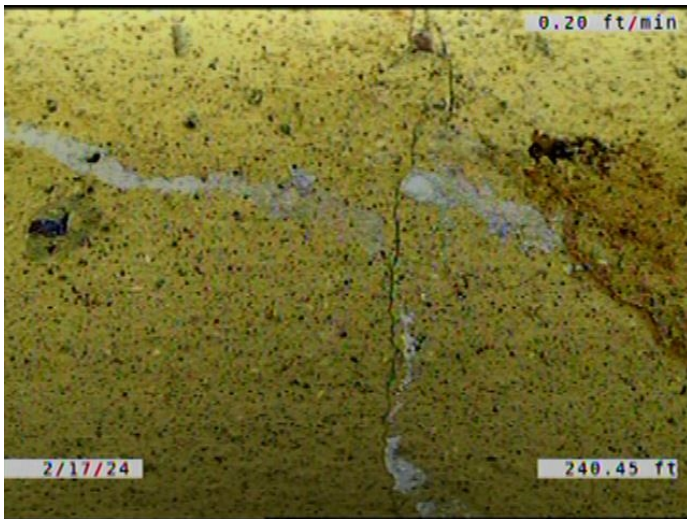
Code: **CL**
Description: **Crack Longitudinal**

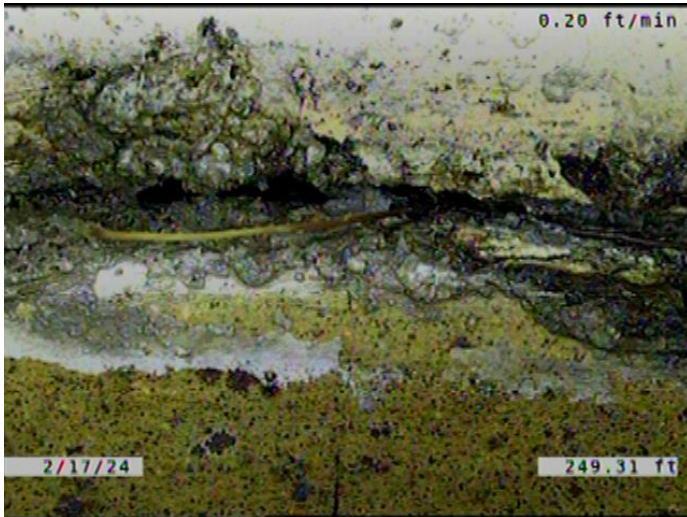
Code: **RFJ**
Description: **Roots Fine Joint**

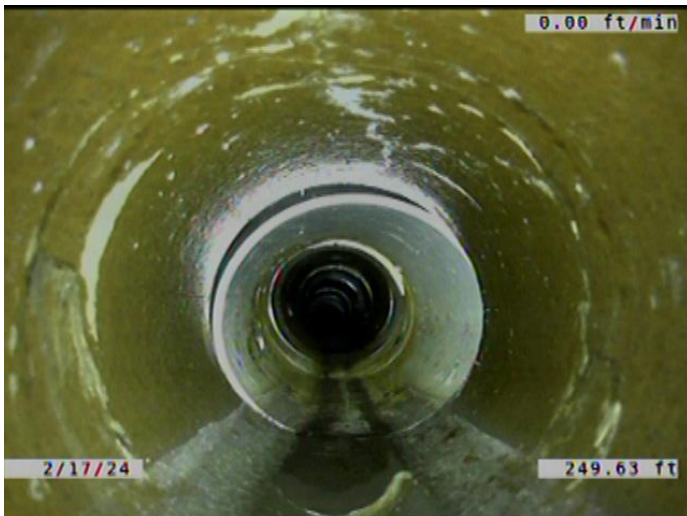
Code: **CM**
Description: **Crack Multiple**

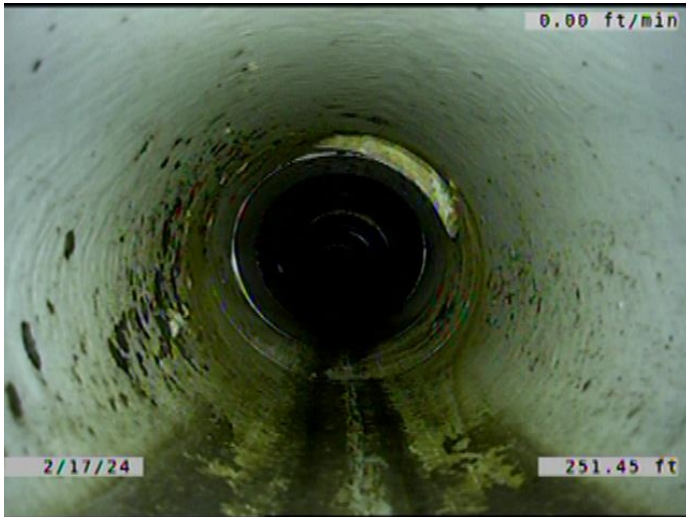
Code: **MWLS**
Description: **Miscellaneous Water Level Sag**

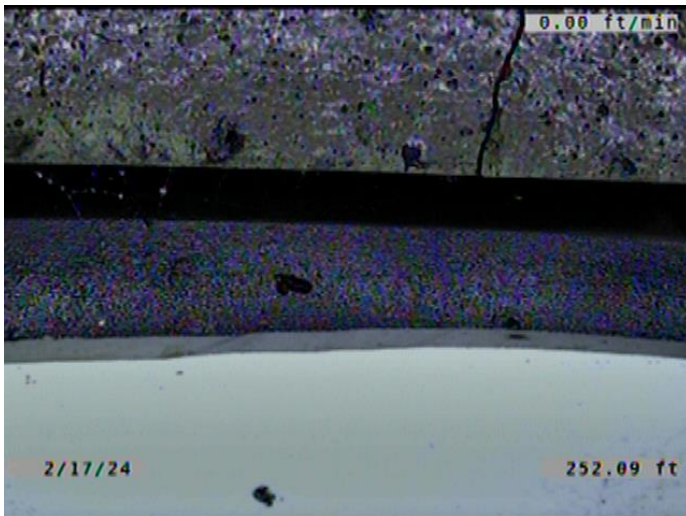
Code: **RPR**
Description: **Point Repair Replacement**

Distance (ft): **252.0**
Structural Grade: **0**
O&M Grade: **0**
Clock Start/From:
Clock To:
1st Value:
2nd Value:
Value Percent:
Continuous Index: **S22**
Within 8" of Joint: **YES**
Remarks: **REPLACED WITH PVC.**

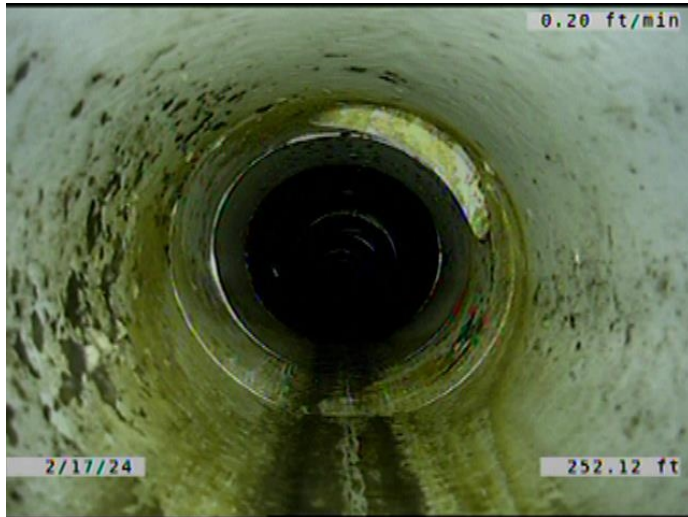
Code: **DAE**
Description: **Deposits Attached Encrustation**

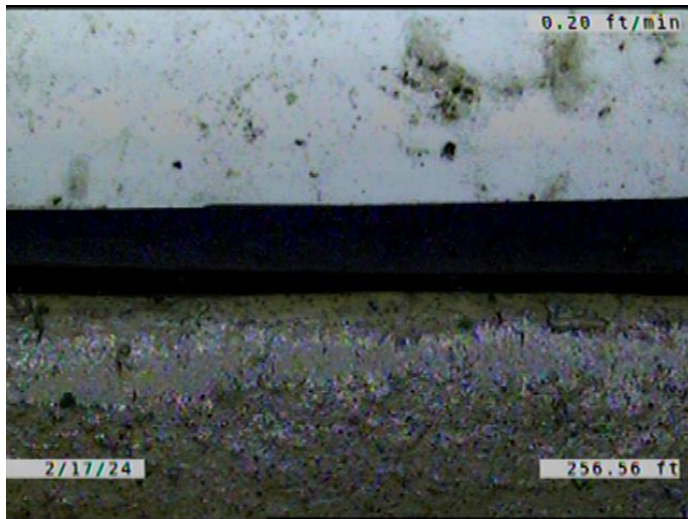
Code: **RPR**
Description: **Point Repair Replacement**

Distance (ft): **256.5**
Structural Grade: **0**
O&M Grade: **0**
Clock Start/From:
Clock To:
1st Value:
2nd Value:
Value Percent:
Continuous Index: **F22**
Within 8" of Joint: **YES**
Remarks: **REPLACED WITH PVC.**
