Profile/Photo Observation Report

Date:	02/17/2024	Weather:		Coding:	PACP 7.0
Pipe Length (ft):	294.0	Owner:	City of Hobart	Pre Clean:	Heavy Cleaning
P.O.#:	YES502259	Surveyor:	S. Bucklin	PSR:	P-405-037-036
Customer:	City of Hobart	Clean Date:	10/03/2023	Shape:	C

Street:	SOFTWOOD DR	Flow Control:	Not Controlled
City:	Hobart, IN	Year Renewed:	
Location:	Easement/Right of Way	Tape/Media #:	
Purpose:	Routine Assessment	Dia/Height:	8"
Use:	Sanitary Sewage Pipe	Material:	VCP
Drain Area:		Lining:	None
Category:	NA		
Comment:			
Location Details:		Direction of Survey:	Upstream
US MH:	M-405-036	DS MH:	M-405-037
		Total Length Surveyed (ft):	312.0

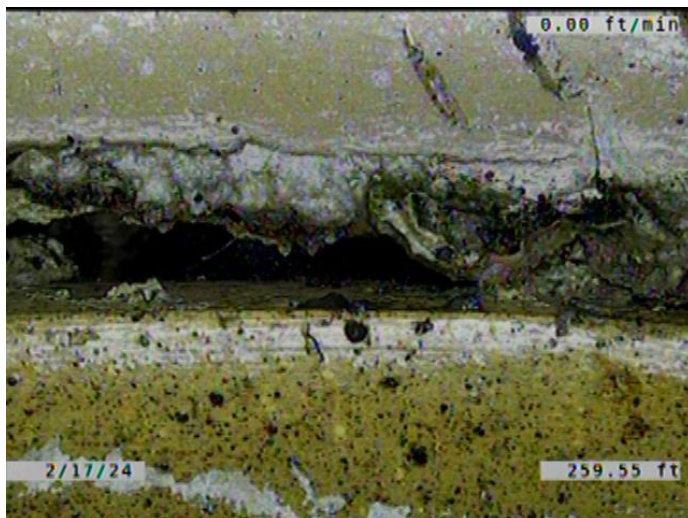
Code: **DAE**
Description: **Deposits Attached Encrustation**

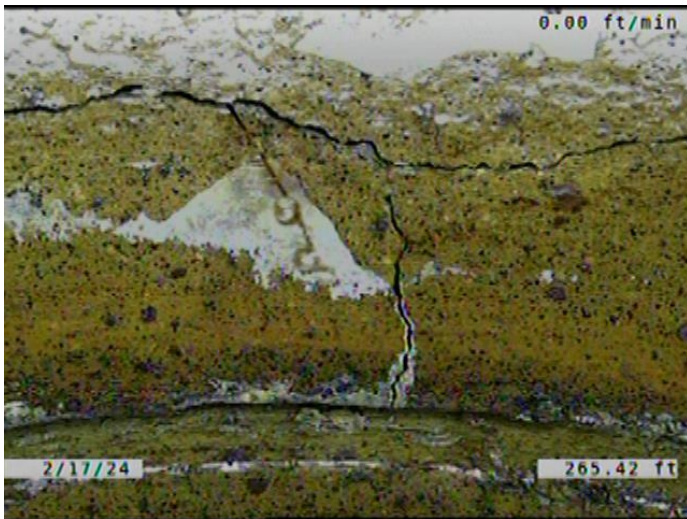
Code: **FM**
Description: **Fracture Multiple**

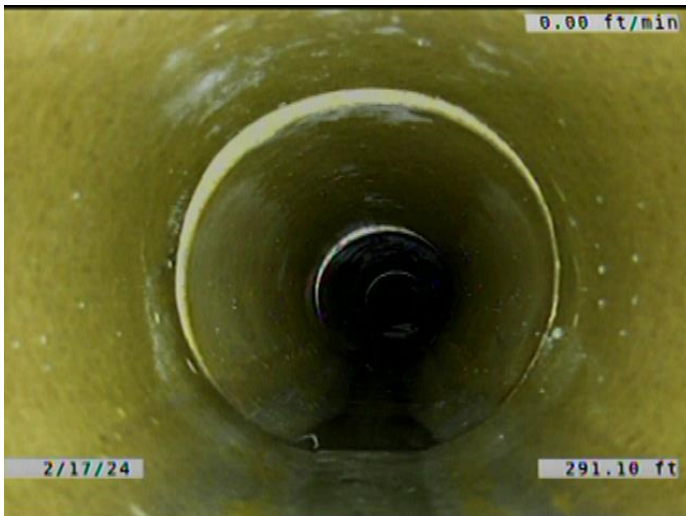
Code: **MWLS**
Description: **Miscellaneous Water Level Sag**

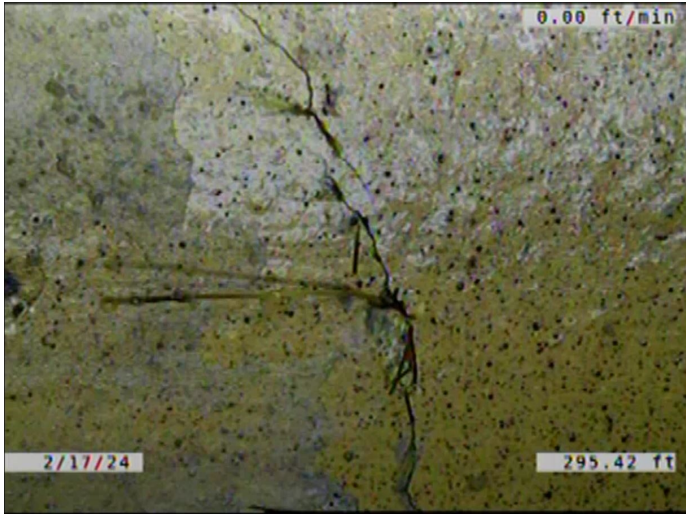
Code: **CL**
Description: **Crack Longitudinal**

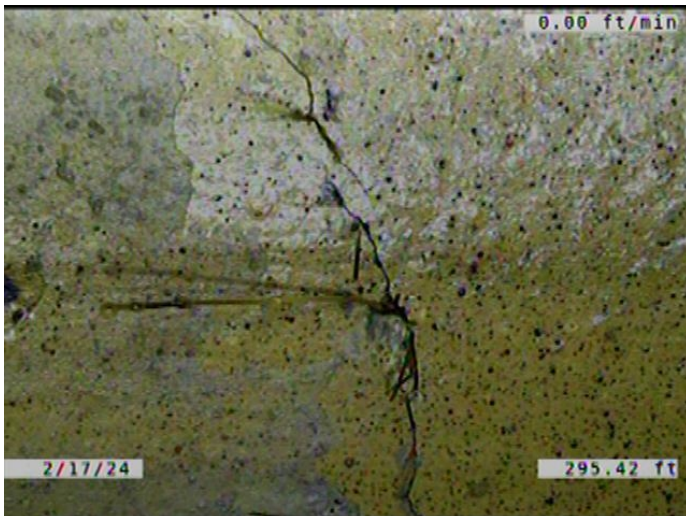
Code: **RFB**
Description: **Roots Fine Barrel**

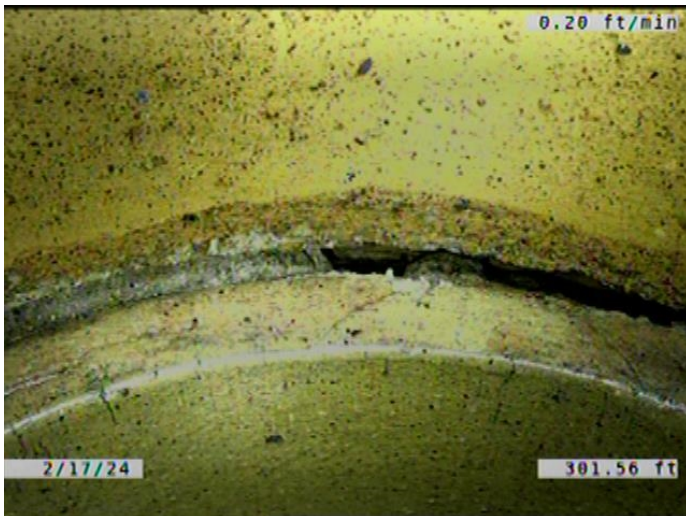
Code: **JOMD**
Description: **Joint Offset Medium Defective**

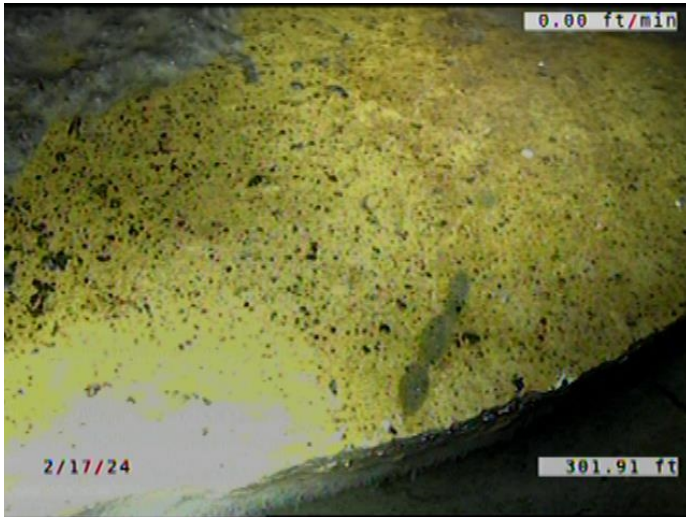
Code: **OBM**
Description: **Obstruction Pipe Material in Invert**

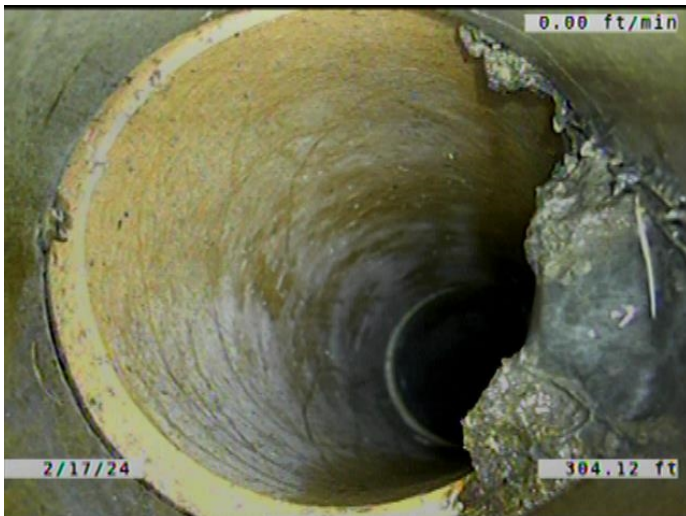
Code:	TFD
Description:	Tap Factory Defective
Distance (ft):	304.1
Structural Grade:	0
O&M Grade:	3
Clock Start/From:	2
Clock To:	
1st Value:	6.000
2nd Value:	
Value Percent:	
Continuous Index:	
Within 8" of Joint:	YES
Remarks:	TAP BROKEN. SOIL VISIBLE AROUND THE SERVICE TO MAIN CONNECTION

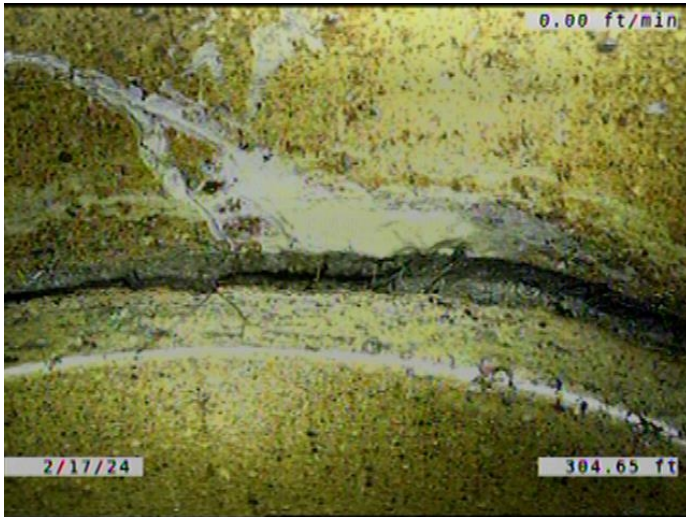
Code: **JOMD**
Description: **Joint Offset Medium Defective**

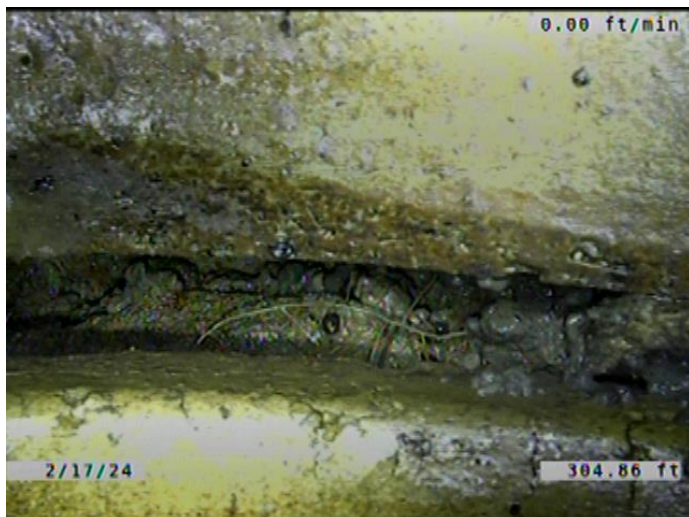
Code: **RFJ**
 Description: **Roots Fine Joint**

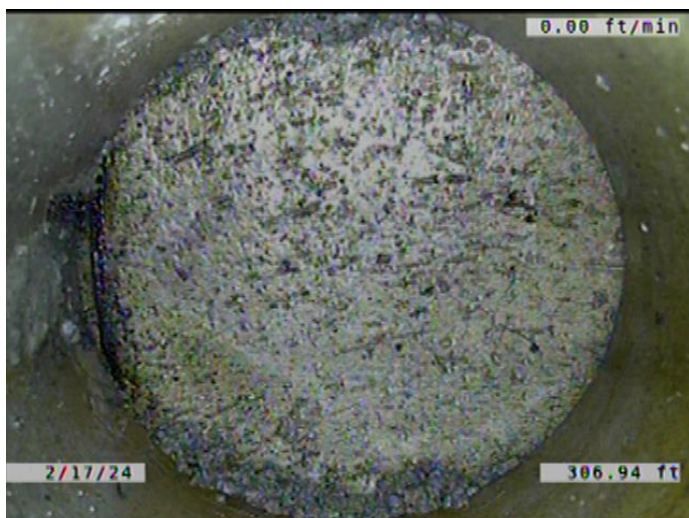
Code: **TFD**
 Description: **Tap Factory Defective**

Distance (ft): **306.9**
 Structural Grade: **0**
 O&M Grade: **3**
 Clock Start/From: **9**
 Clock To:
 1st Value: **6.000**
 2nd Value:
 Value Percent:
 Continuous Index:
 Within 8" of Joint: **YES**
 Remarks: **CAPPED. TAP BROKEN. ROOTS GROWING AROUND THE CAP.**

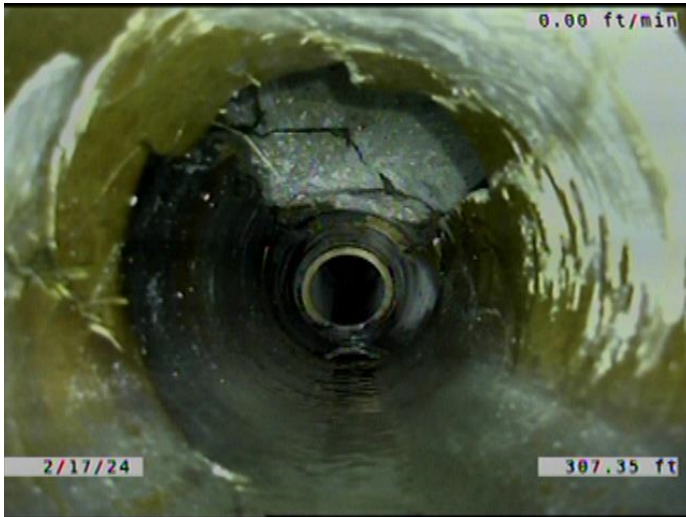
Code: **MWLS**
Description: **Miscellaneous Water Level Sag**

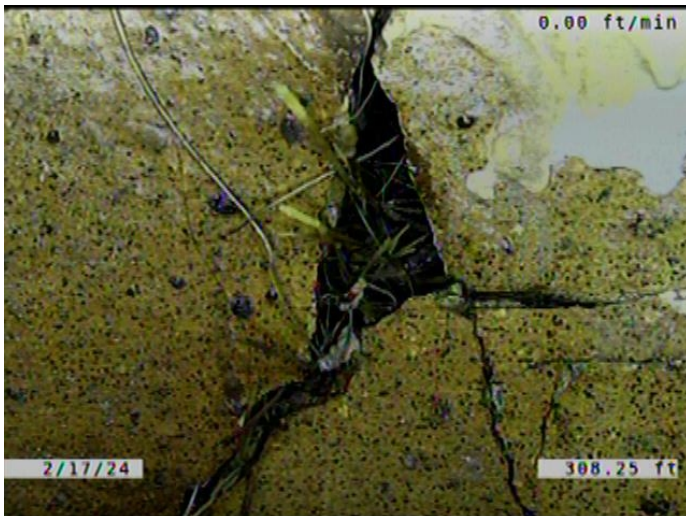
Code: **HVV**
Description: **Hole Void Visible**

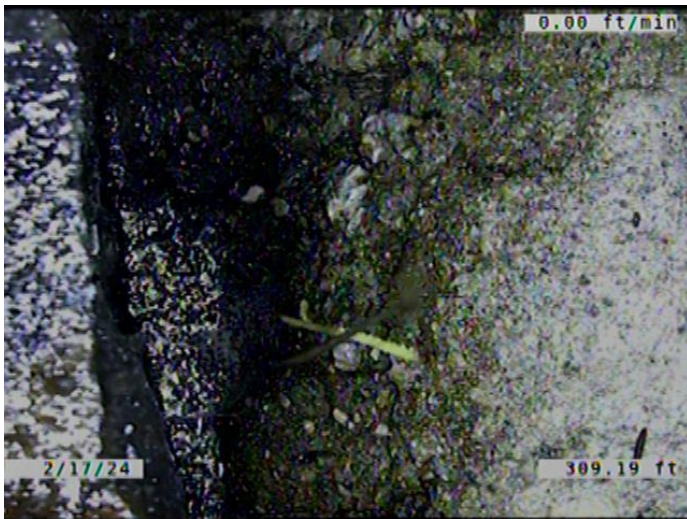
Code: **SMW**
Description: **Surface Damage Missing Wall**

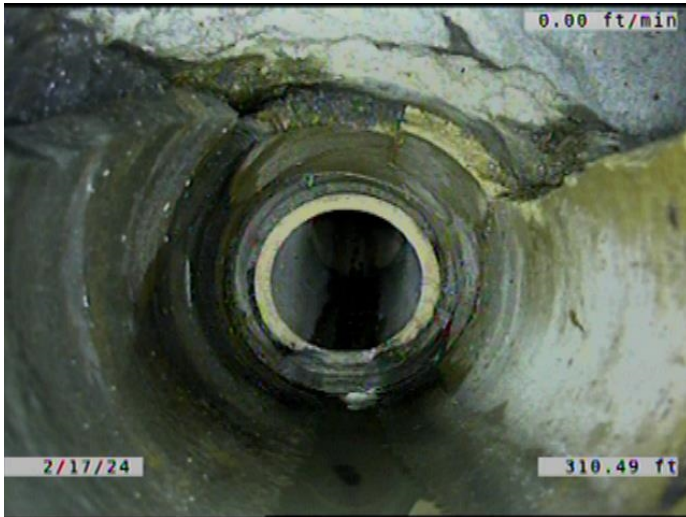
Code: **DAE**
Description: **Deposits Attached Encrustation**
