Profile/Photo Observation Report

Date:	04/20/2018	Weather:		Coding:	PACP 6.0
Pipe Length (ft):	264.1	Owner:	NA	Pre Clean:	No Pre-Cleaning
P.O.#:		Surveyor:	Byrd Fitzgerald	PSR:	P-405-040-039
Customer:		Clean Date:	01/01/1900	Shape:	C

Street:	ALLEY BETWEEN SOFTWOOD DR & 3	Flow Control:	Not Controlled
City:	Hobart, IN	Year Renewed:	
Location:	Yard	Tape/Media #:	
Purpose:	Routine Assessment	Dia/Height:	8"
Use:	Sanitary	Material:	PVC
Drain Area:	NA	Lining:	
Category:	NA		
Comment:	P_C at 180 ft debris / roots		
Location Details:		Direction of Survey:	Downstream
US MH:	M-405-039	DS MH:	M-405-040
		Total Length Surveyed (ft):	181.8

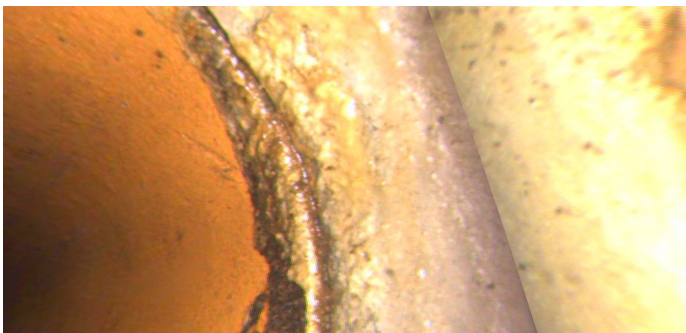
Code: **DAZ**
Description: **Deposits Attached Other**

Distance (ft): **21.5**
Structural Grade: **0**
O&M Grade: **2**
Clock Start/From: **7**
Clock To: **5**
1st Value:
2nd Value:
Value Percent: **5.000**
Continuous Index: **S02**
Within 8" of Joint: **YES**
Remarks: **wandering**

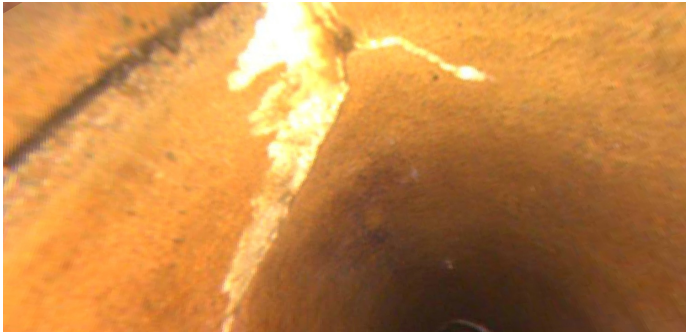
Code: **DAZ**
Description: **Deposits Attached Other**

Distance (ft): **24.7**
Structural Grade: **0**
O&M Grade: **2**
Clock Start/From: **1**
Clock To: **5**
1st Value:
2nd Value:
Value Percent: **5.000**
Continuous Index:
Within 8" of Joint: **NO**
Remarks:

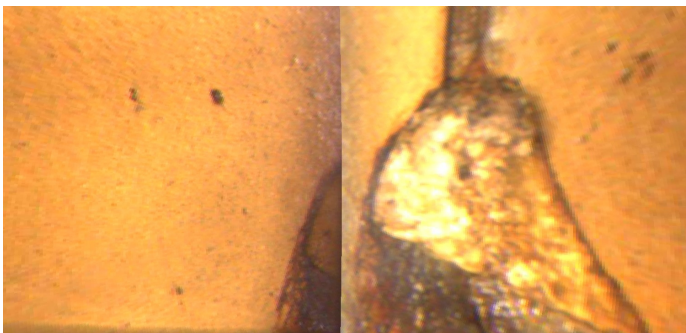
Code: **DAE**
Description: **Deposits Attached Encrustation**

Distance (ft): **81.2**
Structural Grade: **0**
O&M Grade: **2**
Clock Start/From: **3**
Clock To:
1st Value:
2nd Value:
Value Percent: **5.000**
Continuous Index:
Within 8" of Joint: **YES**
Remarks:

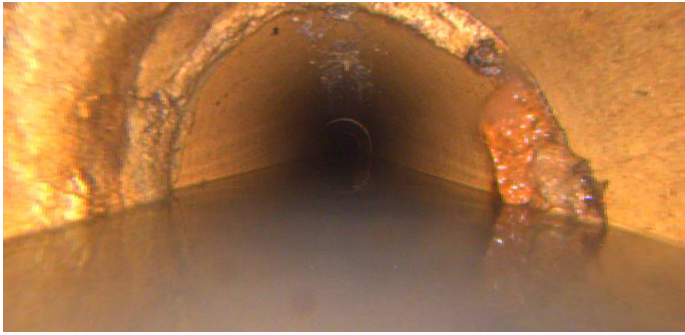
Code: **DAE**
Description: **Deposits Attached Encrustation**

Distance (ft): **83.6**
Structural Grade: **0**
O&M Grade: **2**
Clock Start/From: **8**
Clock To: **4**
1st Value:
2nd Value:
Value Percent: **5.000**
Continuous Index:
Within 8" of Joint: **YES**
Remarks:

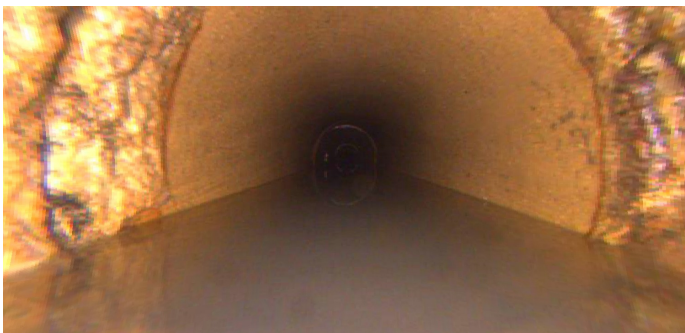
Code: **DAE**
Description: **Deposits Attached Encrustation**

Distance (ft): **92.8**
Structural Grade: **0**
O&M Grade: **2**
Clock Start/From: **8**
Clock To: **4**
1st Value:
2nd Value:
Value Percent: **5.000**
Continuous Index:
Within 8" of Joint: **YES**
Remarks:

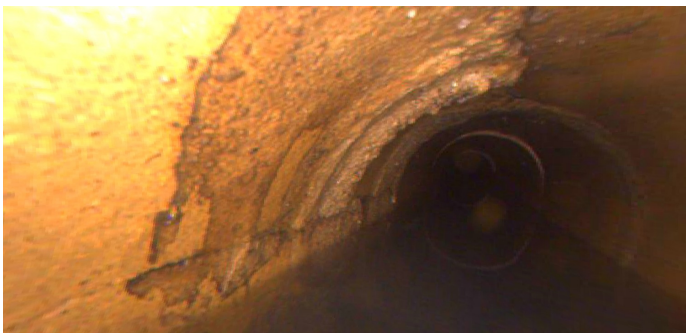
Code: **CM**
Description: **Crack Multiple**

Distance (ft): **111.6**
Structural Grade: **3**
O&M Grade: **0**
Clock Start/From: **8**
Clock To: **12**
1st Value:
2nd Value:
Value Percent:
Continuous Index: **S01**
Within 8" of Joint:
Remarks: **wandering**

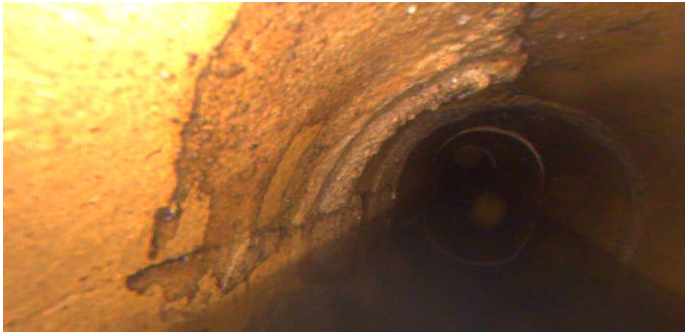
Code: **DAZ**
Description: **Deposits Attached Other**

Distance (ft): **111.6**
Structural Grade: **0**
O&M Grade: **2**
Clock Start/From: **8**
Clock To: **12**
1st Value:
2nd Value:
Value Percent: **5.000**
Continuous Index:
Within 8" of Joint: **NO**
Remarks:

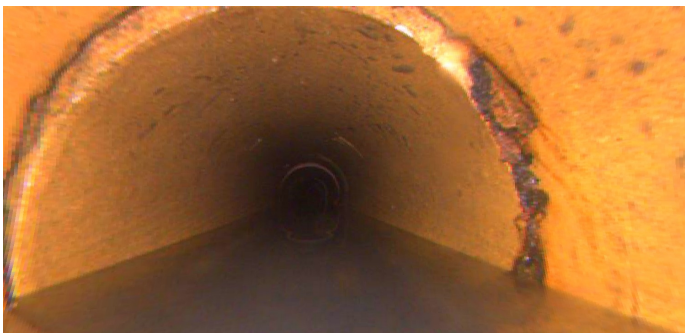
Code: **DAE**
Description: **Deposits Attached Encrustation**

Distance (ft): **131.0**
Structural Grade: **0**
O&M Grade: **2**
Clock Start/From: **2**
Clock To:
1st Value:
2nd Value:
Value Percent: **5.000**
Continuous Index:
Within 8" of Joint: **YES**
Remarks:

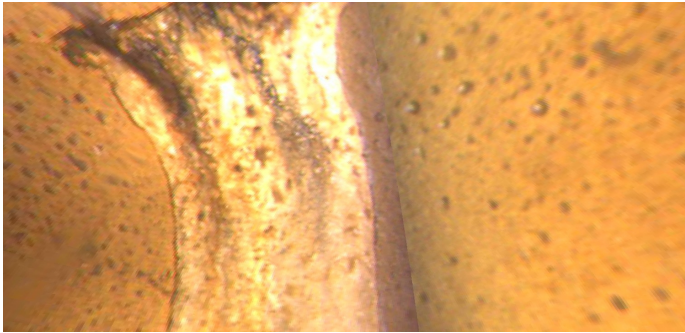
Code: **DAZ**
Description: **Deposits Attached Other**

Distance (ft): **133.3**
Structural Grade: **0**
O&M Grade: **2**
Clock Start/From: **2**
Clock To: **5**
1st Value:
2nd Value:
Value Percent: **5.000**
Continuous Index:
Within 8" of Joint: **NO**
Remarks:

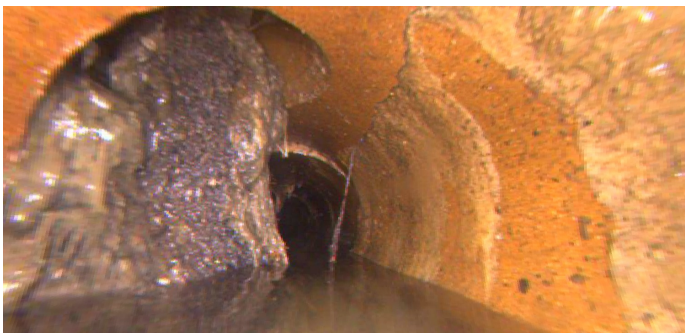
Code: **TFD**
Description: **Tap Factory Defective**

Distance (ft): **180.3**
Structural Grade: **0**
O&M Grade: **2**
Clock Start/From: **11**
Clock To:
1st Value: **4.000**
2nd Value:
Value Percent:
Continuous Index:
Within 8" of Joint:
Remarks: **blocked by roots**

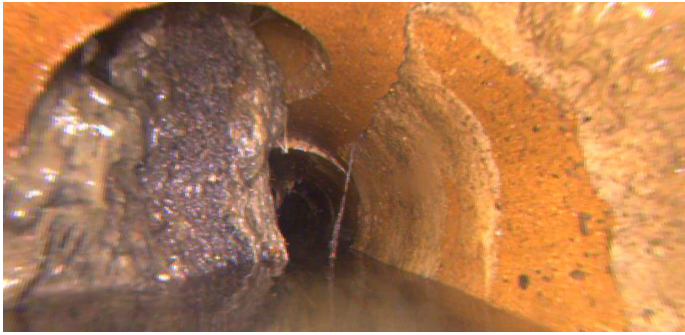
Code: **RBL**
Description: **Roots Ball Lateral**

Distance (ft): **180.3**
Structural Grade: **0**
O&M Grade: **4**
Clock Start/From: **8**
Clock To: **12**
1st Value:
2nd Value:
Value Percent: **55.000**
Continuous Index:
Within 8" of Joint: **NO**
Remarks:

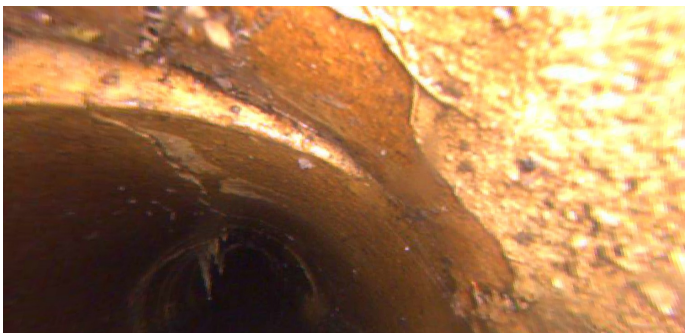
Code: **MSA**
Description: **Abandoned Survey**

Distance (ft): **181.8**
Structural Grade: **0**
O&M Grade: **0**
Clock Start/From:
Clock To:
1st Value:
2nd Value:
Value Percent:
Continuous Index:
Within 8" of Joint: **NO**
Remarks: **rbl**

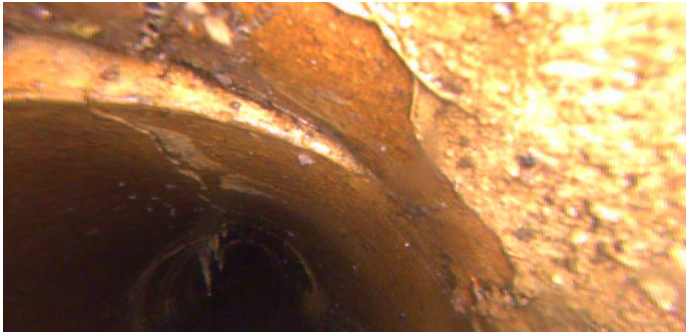
Code: **CM**
Description: **Crack Multiple**

Distance (ft): **181.8**
Structural Grade: **3**
O&M Grade: **0**
Clock Start/From: **8**
Clock To: **12**
1st Value:
2nd Value:
Value Percent:
Continuous Index: **F01**
Within 8" of Joint:
Remarks: **wandering**

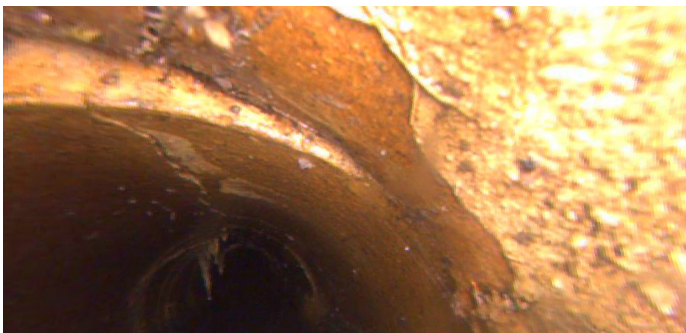
Code: **DAZ**
Description: **Deposits Attached Other**

Distance (ft): **181.8**
Structural Grade: **0**
O&M Grade: **2**
Clock Start/From: **7**
Clock To: **5**
1st Value:
2nd Value:
Value Percent: **5.000**
Continuous Index: **F02**
Within 8" of Joint: **YES**
Remarks: **wandering**
