Profile/Photo Observation Report

Street:	FOXCROFT STREET	Flow Control:	Not Controlled
City:	Hobart, IN	Year Renewed:	
Location:	Yard	Tape/Media #:	
Purpose:	Routine Assessment	Dia/Height:	8"
Use:	Sanitary	Material:	PVC
Drain Area:	NA	Lining:	
Category:	NA		
Comment:	P_C at 180 ft debris / roots

Location Details:		Direction of Survey:	Downstream
US MH:	M-405-039	DS MH:	M-405-040
		Total Length Surveyed (ft):	181.8

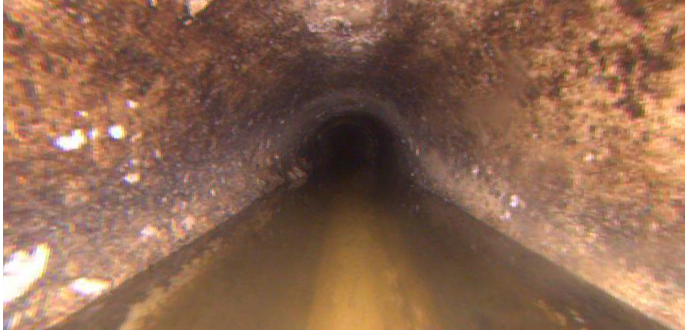
Code: **AMH**
Description: **Manhole**

Distance (ft): **.0**
Structural Grade: **0**
O&M Grade: **0**
Clock Start/From:
Clock To:
1st Value:
2nd Value:
Value Percent:
Continuous Index:
Within 8" of Joint: **NO**
Remarks: **M-405-039**

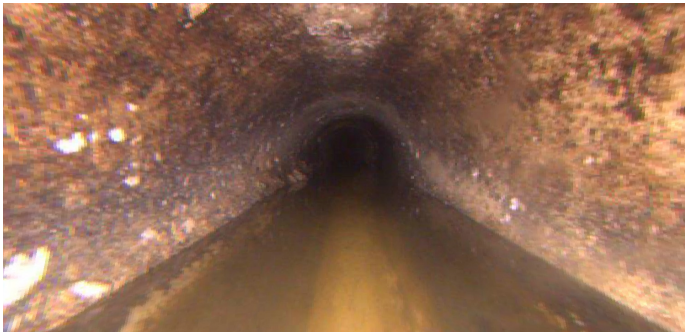
Code: **MWL**
Description: **Water Level**

Distance (ft): **.0**
Structural Grade: **0**
O&M Grade: **0**
Clock Start/From:
Clock To:
1st Value:
2nd Value:
Value Percent: **5.000**
Continuous Index:
Within 8" of Joint: **NO**
Remarks:

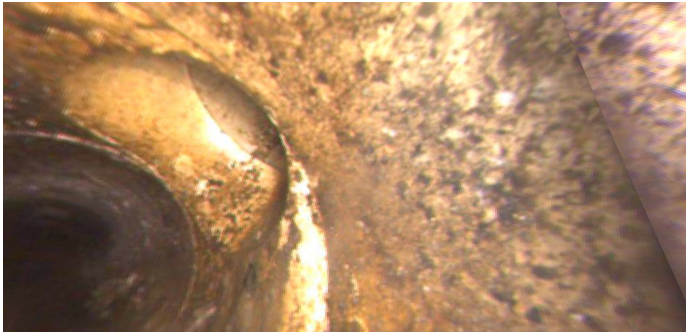
Code: **TF**
Description: **Tap Factory**

Distance (ft): **4.8**
Structural Grade: **0**
O&M Grade: **0**
Clock Start/From: **10**
Clock To:
1st Value: **4.000**
2nd Value:
Value Percent:
Continuous Index:
Within 8" of Joint: **YES**
Remarks:

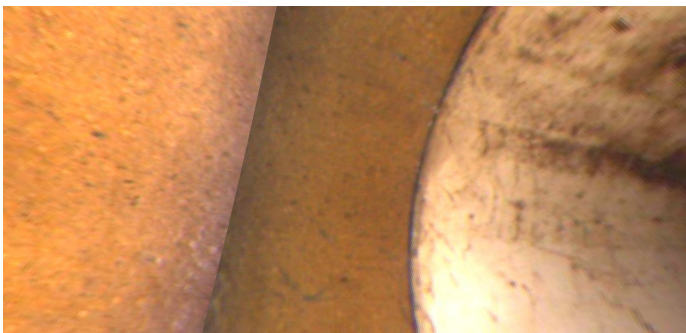
Code: **MMC**
Description: **Material Change**

Distance (ft): **19.0**
Structural Grade: **0**
O&M Grade: **0**
Clock Start/From:
Clock To:
1st Value:
2nd Value:
Value Percent:
Continuous Index:
Within 8" of Joint: **NO**
Remarks: **vcp**

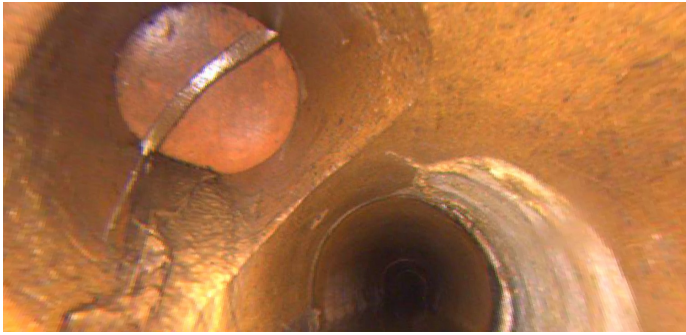
Code: **TFC**
Description: **Tap Factory Capped**

Distance (ft): **20.7**
Structural Grade: **0**
O&M Grade: **0**
Clock Start/From: **11**
Clock To:
1st Value: **4.000**
2nd Value:
Value Percent:
Continuous Index:
Within 8" of Joint: **YES**
Remarks:

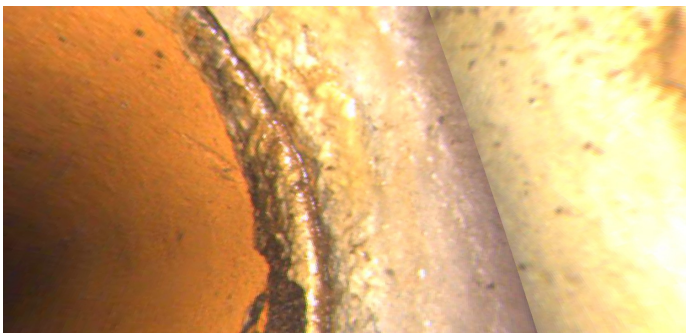
Code: **DAZ**
Description: **Deposits Attached Other**

Distance (ft): **21.5**
Structural Grade: **0**
O&M Grade: **2**
Clock Start/From: **7**
Clock To: **5**
1st Value:
2nd Value:
Value Percent: **5.000**
Continuous Index: **S02**
Within 8" of Joint: **YES**
Remarks: **wandering**

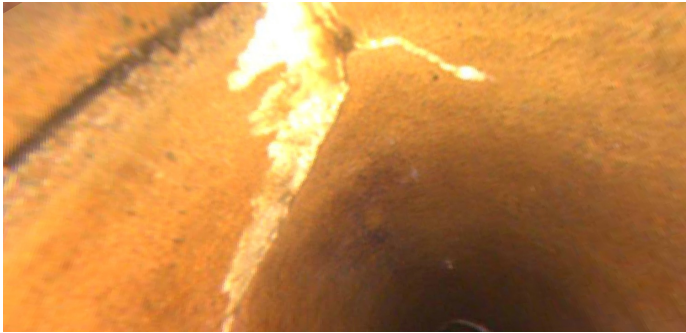
Code:	DAZ
Description:	Deposits Attached Other

Distance (ft):	24.7
Structural Grade:	0
O&M Grade:	2
Clock Start/From:	1
Clock To:	5
1st Value:	
2nd Value:	
Value Percent:	5.000
Continuous Index:	
Within 8" of Joint:	NO
Remarks:

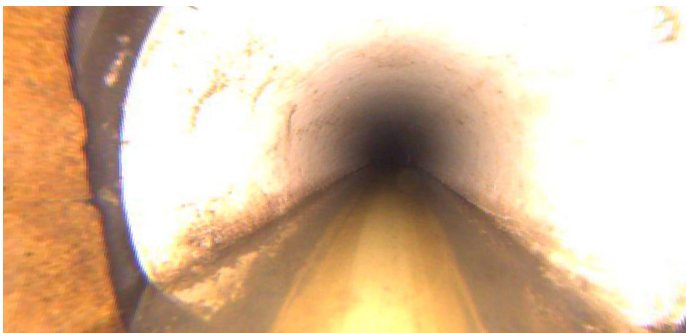
Code:	MMC
Description:	Material Change

Distance (ft):	27.2
Structural Grade:	0
O&M Grade:	0
Clock Start/From:	
Clock To:	
1st Value:	
2nd Value:	
Value Percent:	
Continuous Index:	
Within 8" of Joint:	NO
Remarks:	pvc

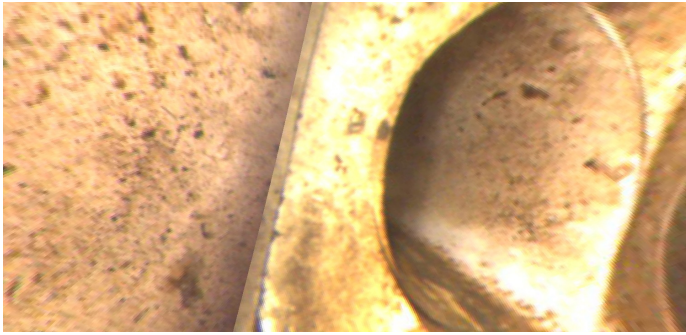
Code: **TF**
Description: **Tap Factory**

Distance (ft): **47.4**
Structural Grade: **0**
O&M Grade: **0**
Clock Start/From: **2**
Clock To:
1st Value: **4.000**
2nd Value:
Value Percent:
Continuous Index:
Within 8" of Joint: **YES**
Remarks:

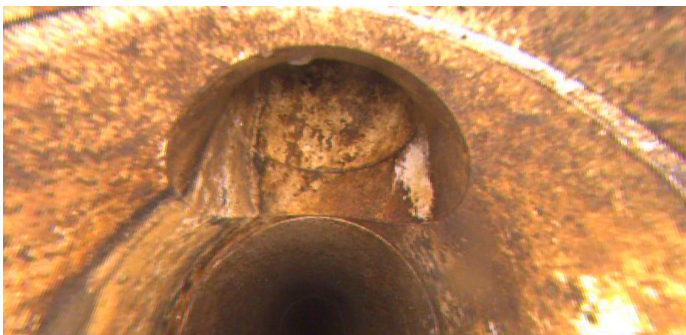
Code: **TF**
Description: **Tap Factory**

Distance (ft): **56.3**
Structural Grade: **0**
O&M Grade: **0**
Clock Start/From: **12**
Clock To:
1st Value: **4.000**
2nd Value:
Value Percent:
Continuous Index:
Within 8" of Joint: **YES**
Remarks:

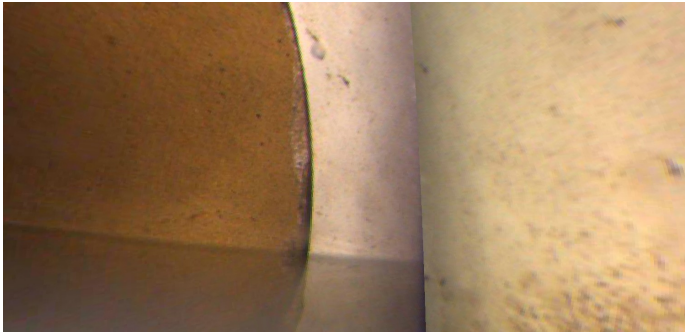
Code: **MMC**
Description: **Material Change**

Distance (ft): **72.3**
Structural Grade: **0**
O&M Grade: **0**
Clock Start/From:
Clock To:
1st Value:
2nd Value:
Value Percent:
Continuous Index:
Within 8" of Joint: **NO**
Remarks: **vcp**

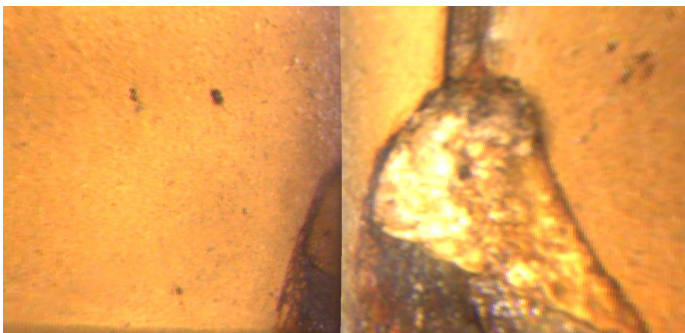
Code: **DAE**
Description: **Deposits Attached Encrustation**

Distance (ft): **81.2**
Structural Grade: **0**
O&M Grade: **2**
Clock Start/From: **3**
Clock To:
1st Value:
2nd Value:
Value Percent: **5.000**
Continuous Index:
Within 8" of Joint: **YES**
Remarks:

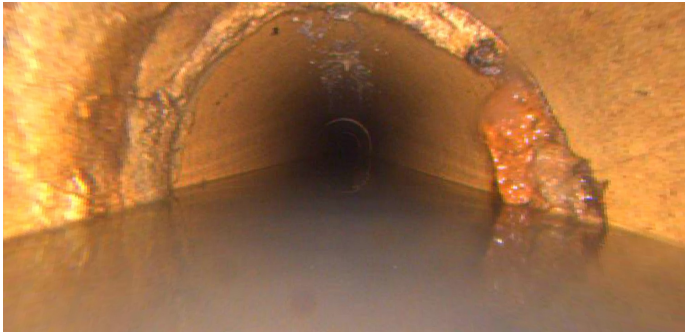
Code: **DAE**
Description: **Deposits Attached Encrustation**

Distance (ft): **83.6**
Structural Grade: **0**
O&M Grade: **2**
Clock Start/From: **8**
Clock To: **4**
1st Value:
2nd Value:
Value Percent: **5.000**
Continuous Index:
Within 8" of Joint: **YES**
Remarks:

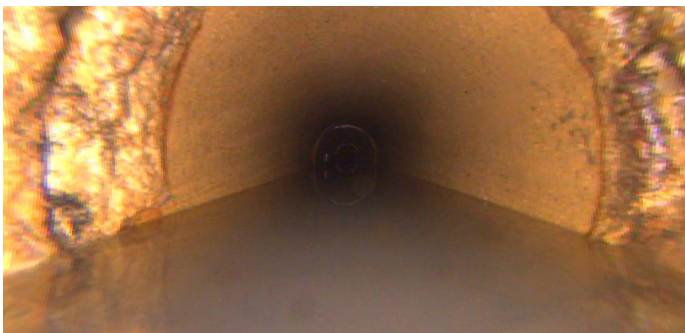
Code: **DAE**
Description: **Deposits Attached Encrustation**

Distance (ft): **92.8**
Structural Grade: **0**
O&M Grade: **2**
Clock Start/From: **8**
Clock To: **4**
1st Value:
2nd Value:
Value Percent: **5.000**
Continuous Index:
Within 8" of Joint: **YES**
Remarks:

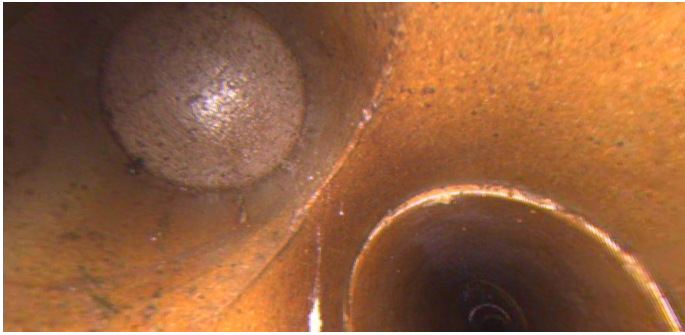
Code: **TFC**
Description: **Tap Factory Capped**

Distance (ft): **95.2**
Structural Grade: **0**
O&M Grade: **0**
Clock Start/From: **11**
Clock To:
1st Value: **4.000**
2nd Value:
Value Percent:
Continuous Index:
Within 8" of Joint: **YES**
Remarks:

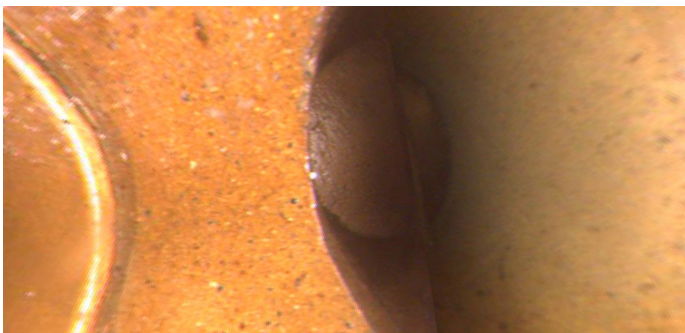
Code: **TFC**
Description: **Tap Factory Capped**

Distance (ft): **98.4**
Structural Grade: **0**
O&M Grade: **0**
Clock Start/From: **2**
Clock To:
1st Value: **4.000**
2nd Value:
Value Percent:
Continuous Index:
Within 8" of Joint: **YES**
Remarks:

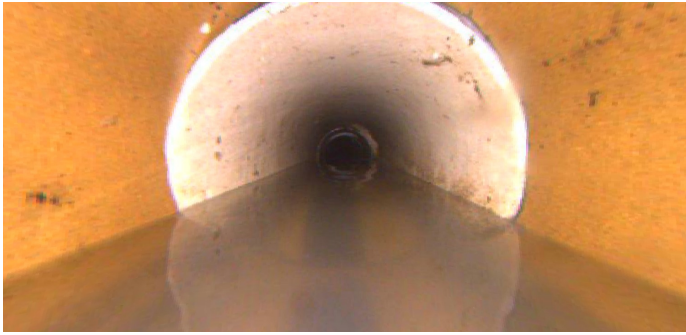
Code: **MMC**
Description: **Material Change**

Distance (ft): **101.0**
Structural Grade: **0**
O&M Grade: **0**
Clock Start/From:
Clock To:
1st Value:
2nd Value:
Value Percent:
Continuous Index:
Within 8" of Joint: **NO**
Remarks: **pvc**

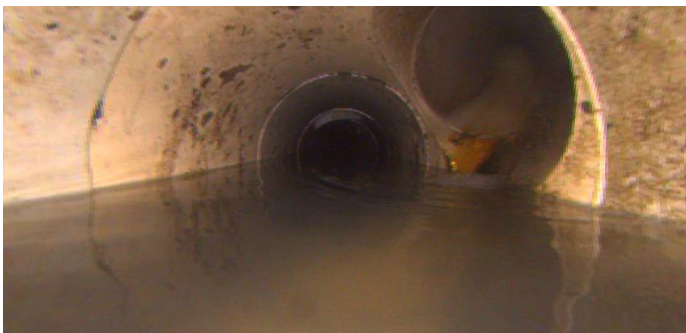
Code: **TF**
Description: **Tap Factory**

Distance (ft): **103.5**
Structural Grade: **0**
O&M Grade: **0**
Clock Start/From: **2**
Clock To:
1st Value: **4.000**
2nd Value:
Value Percent:
Continuous Index:
Within 8" of Joint: **YES**
Remarks:

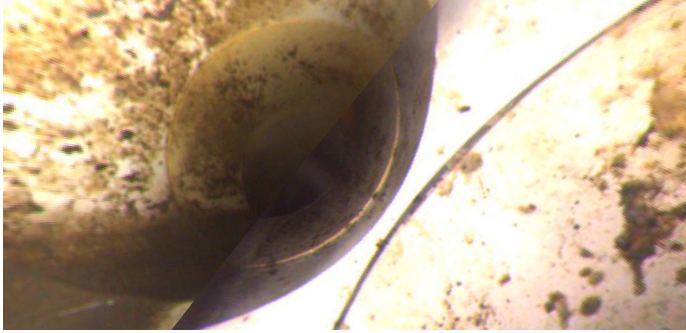
Code: **TF**
Description: **Tap Factory**

Distance (ft): **106.0**
Structural Grade: **0**
O&M Grade: **0**
Clock Start/From: **11**
Clock To:
1st Value: **4.000**
2nd Value:
Value Percent:
Continuous Index:
Within 8" of Joint: **YES**
Remarks:

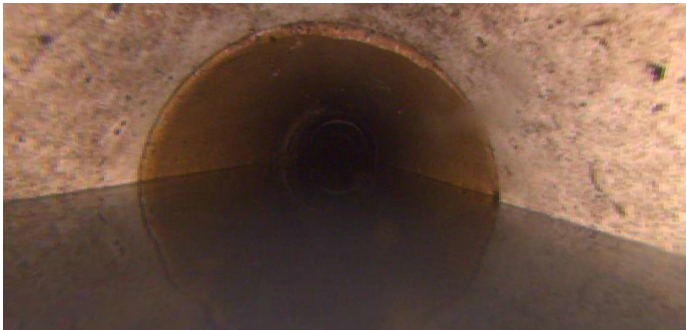
Code: **MWL**
Description: **Water Level**

Distance (ft): **110.2**
Structural Grade: **0**
O&M Grade: **0**
Clock Start/From:
Clock To:
1st Value:
2nd Value:
Value Percent: **50.000**
Continuous Index:
Within 8" of Joint: **NO**
Remarks:

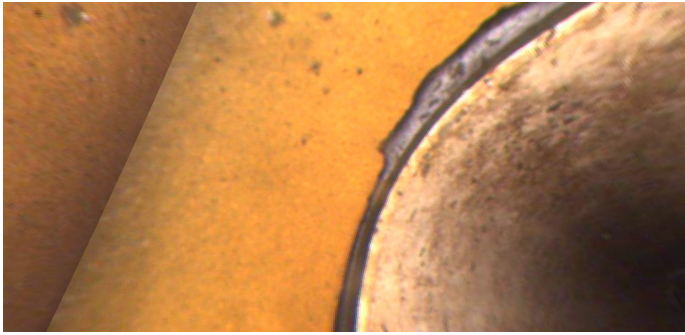
Code: **MMC**
Description: **Material Change**

Distance (ft): **111.0**
Structural Grade: **0**
O&M Grade: **0**
Clock Start/From:
Clock To:
1st Value:
2nd Value:
Value Percent:
Continuous Index:
Within 8" of Joint: **NO**
Remarks: **vcp**

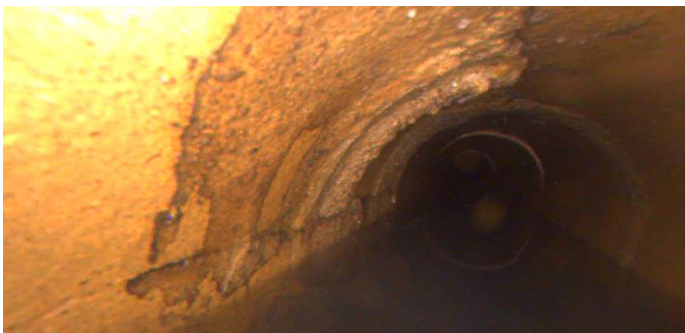
Code: **CM**
Description: **Crack Multiple**

Distance (ft): **111.6**
Structural Grade: **3**
O&M Grade: **0**
Clock Start/From: **8**
Clock To: **12**
1st Value:
2nd Value:
Value Percent:
Continuous Index: **S01**
Within 8" of Joint:
Remarks: **wandering**

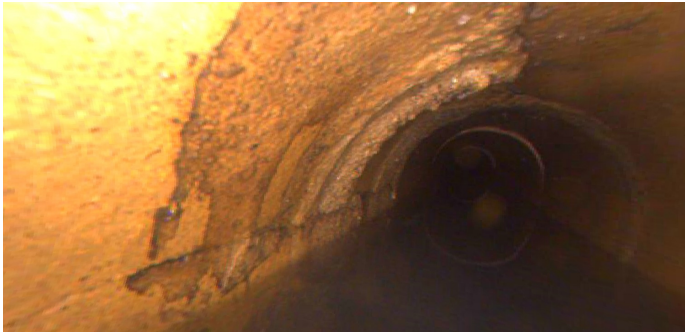
Code: **DAZ**
Description: **Deposits Attached Other**

Distance (ft): **111.6**
Structural Grade: **0**
O&M Grade: **2**
Clock Start/From: **8**
Clock To: **12**
1st Value:
2nd Value:
Value Percent: **5.000**
Continuous Index:
Within 8" of Joint: **NO**
Remarks:

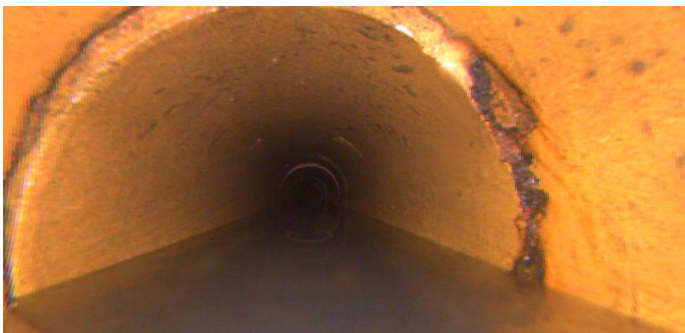
Code: **DAE**
Description: **Deposits Attached Encrustation**

Distance (ft): **131.0**
Structural Grade: **0**
O&M Grade: **2**
Clock Start/From: **2**
Clock To:
1st Value:
2nd Value:
Value Percent: **5.000**
Continuous Index:
Within 8" of Joint: **YES**
Remarks:

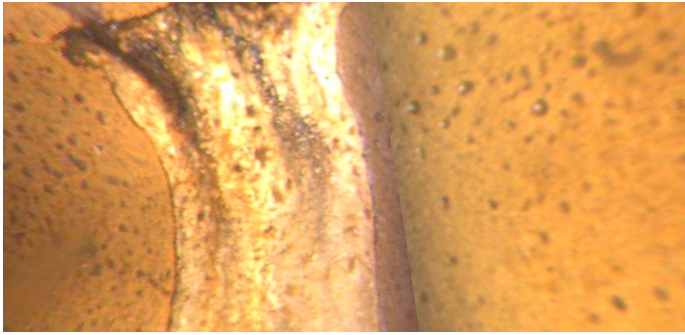
Code: **DAZ**
Description: **Deposits Attached Other**

Distance (ft): **133.3**
Structural Grade: **0**
O&M Grade: **2**
Clock Start/From: **2**
Clock To: **5**
1st Value:
2nd Value:
Value Percent: **5.000**
Continuous Index:
Within 8" of Joint: **NO**
Remarks:

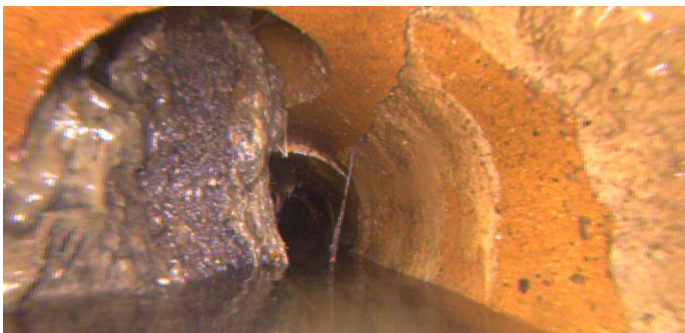
Code: **TFD**
Description: **Tap Factory Defective**

Distance (ft): **180.3**
Structural Grade: **0**
O&M Grade: **2**
Clock Start/From: **11**
Clock To:
1st Value: **4.000**
2nd Value:
Value Percent:
Continuous Index:
Within 8" of Joint:
Remarks: **blocked by roots**

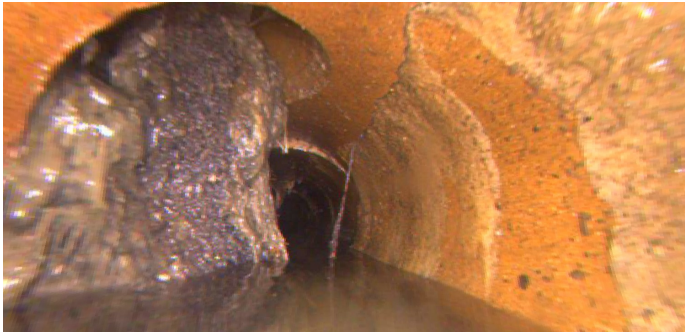
Code: **RBL**
Description: **Roots Ball Lateral**

Distance (ft): **180.3**
Structural Grade: **0**
O&M Grade: **4**
Clock Start/From: **8**
Clock To: **12**
1st Value:
2nd Value:
Value Percent: **55.000**
Continuous Index:
Within 8" of Joint: **NO**
Remarks:

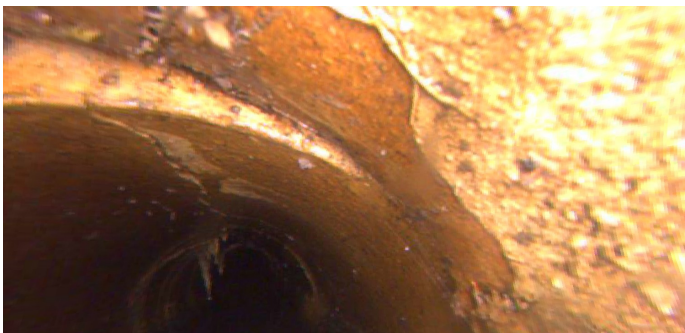
Code: **MSA**
Description: **Abandoned Survey**

Distance (ft): **181.8**
Structural Grade: **0**
O&M Grade: **0**
Clock Start/From:
Clock To:
1st Value:
2nd Value:
Value Percent:
Continuous Index:
Within 8" of Joint: **NO**
Remarks: **rbl**

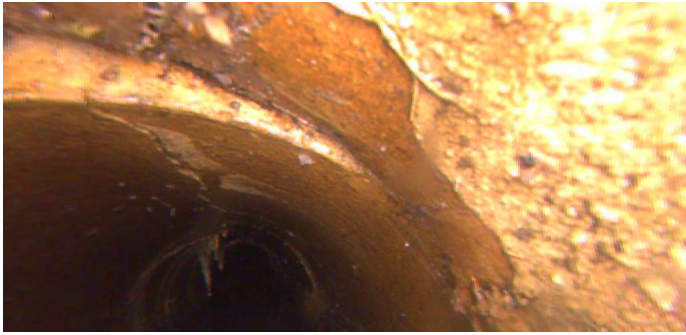
Code: **CM**
Description: **Crack Multiple**

Distance (ft): **181.8**
Structural Grade: **3**
O&M Grade: **0**
Clock Start/From: **8**
Clock To: **12**
1st Value:
2nd Value:
Value Percent:
Continuous Index: **F01**
Within 8" of Joint:
Remarks: **wandering**

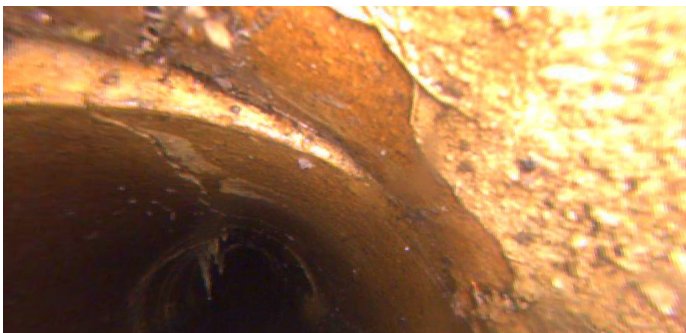
Code: **DAZ**
Description: **Deposits Attached Other**

Distance (ft): **181.8**
Structural Grade: **0**
O&M Grade: **2**
Clock Start/From: **7**
Clock To: **5**
1st Value:
2nd Value:
Value Percent: **5.000**
Continuous Index: **F02**
Within 8" of Joint: **YES**
Remarks: **wandering**
